# MONTANA DEPARTMENT OF TRANSPORTATION WETLAND MITIGATION MONITORING REPORT: YEAR 2014

*Easton Ranch  
Park County, Montana*

*Easton Ranch*  
*Park County, Montana*  
Constructed: 2009

MDT Project Number STPX-0034(14)  
Control Number 4866

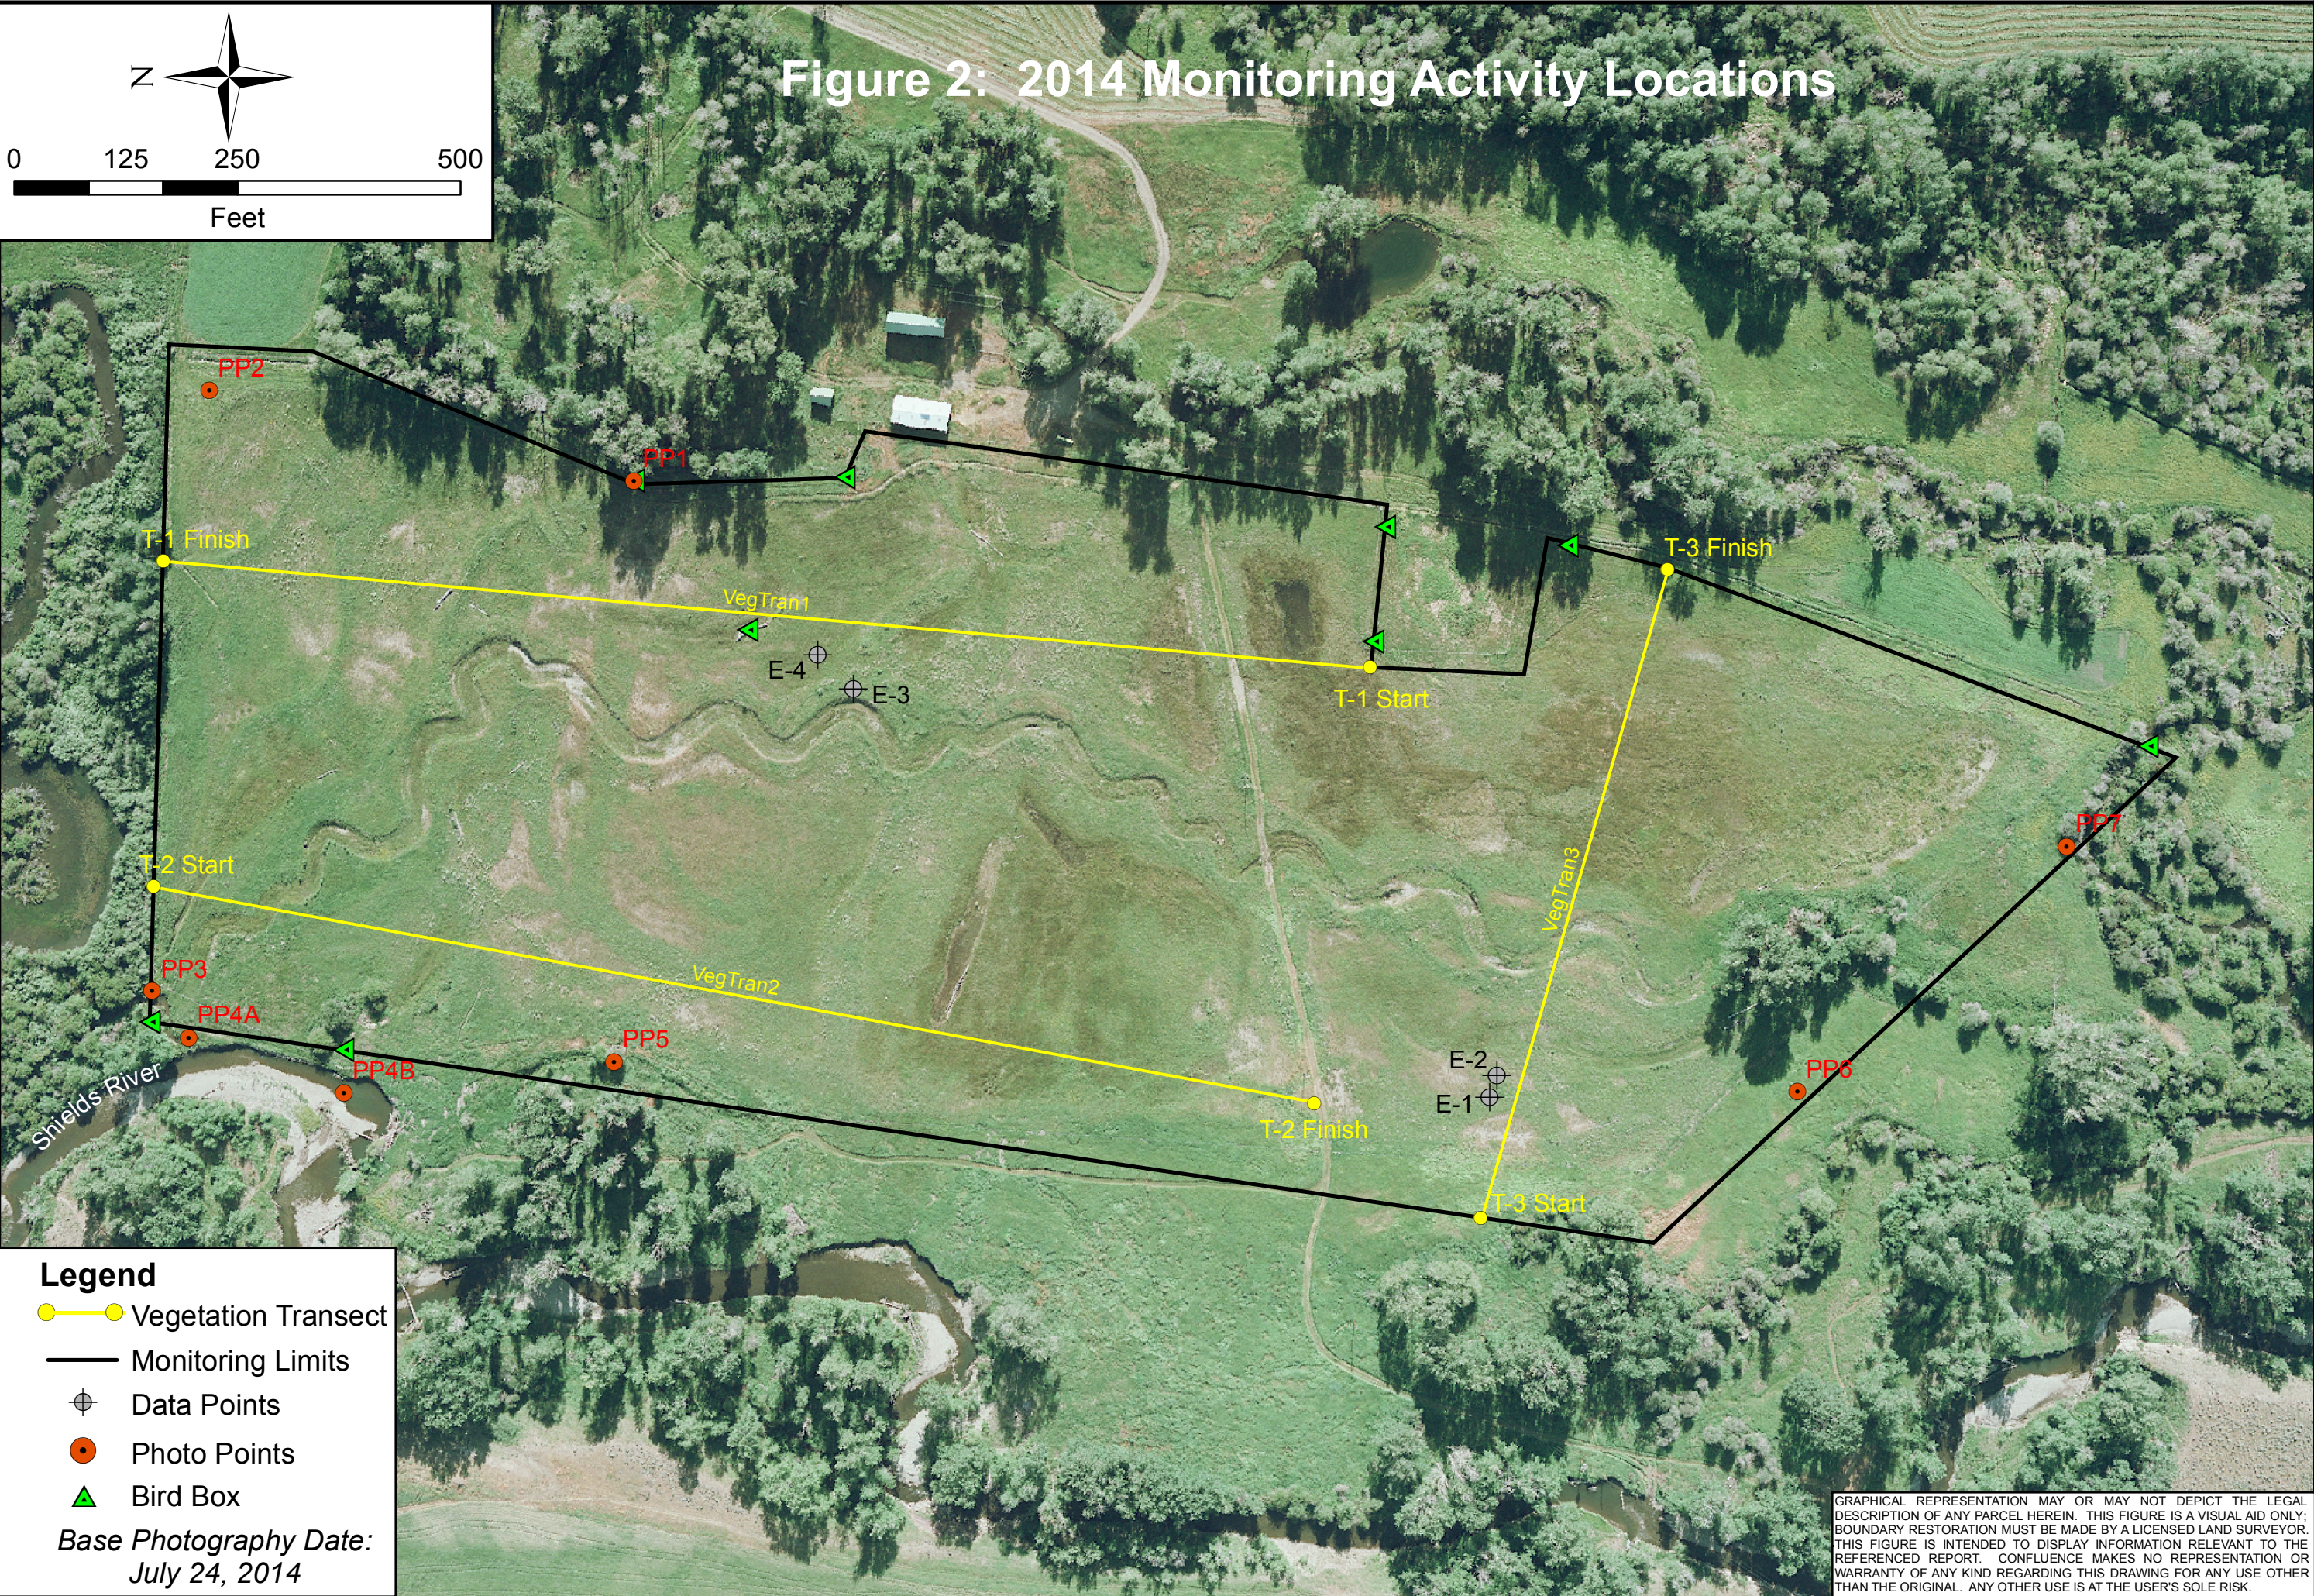
Figure 2: 2014 Monitoring Activity Locations

Monitoring at photo points provided supplemental information documenting wetland, upland, and vegetation transect conditions; site trends; and current land uses surrounding the site. Photographs were taken at established photo points throughout the mitigation area during the site visit (Appendix C). Photo point locations were recorded with a resource grade GPS unit (Figure 2, Appendix A).

Soil test pits were excavated at four locations, all within what was originally mapped as the Meadowcreek series (E-1 through E-4, Figure 2, Appendix A). Data point E-1 and E-3 were located within upland Community 8 and upland Community 1, respectively. Data points E-2 and E-4 were located in shallow constructed wetland depressions in Community 11 on the west and east project boundaries. The soil profile at E-1 revealed a dark brown (10YR 3/3) silt loam. Soil profile E-3 was a brownish black (10YR 3/2) sandy loam soil. The soils observed at data points E-1 and E-3 had no hydric soil indicators. The profile at E-2 revealed a brown (10 YR 4/1) silt loam with twenty percent brown (7.5YR 4/4) redox concentrations in the matrix. This soil met the criteria for depleted matrix (F3) and classification as a hydric soil. Data point E-4 exhibited a grayish yellow brown sandy loam soil (10YR 4/2) and met the criteria for depleted matrix (F3) and classification as hydric soil. The soil profiles in the test pits did not generally correlate with the map unit, likely as a result of mixing that occurred during construction.

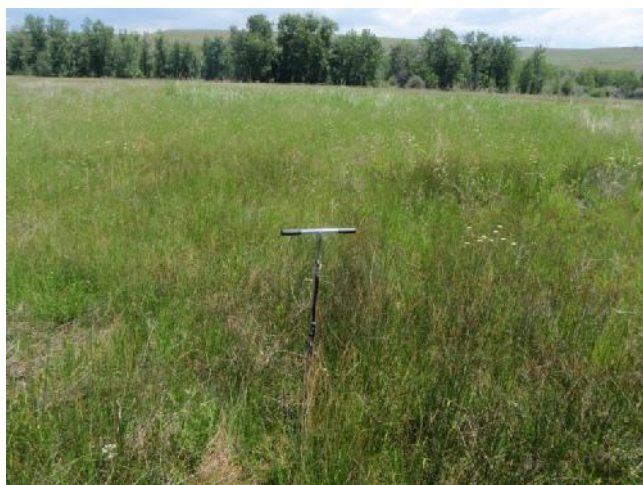
**Data Point: E-1**  
**Bearing:**

**Location: Veg community 8**  
**Taken in 2014**

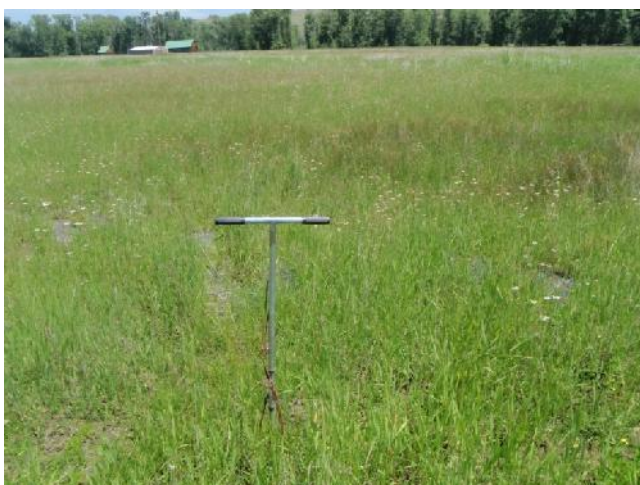
Four data points were sampled to determine the wetland/upland boundaries. There were no hydrologic indicators observed at E-1 or E-3. Data points E-2 and E-4 were located in areas that met the wetland criteria. No primary wetland hydrology indicators were observed at wetland data point E-2, which was located within an excavated wetland cell. Positive wetland hydrology indicators at this data point included positive FAC-neutral test and geomorphic position. Positive hydrologic indicators documented at data point E-4, located in an excavated swale near the southern boundary of the site, included saturation within 8 inches of the soil surface. Additional hydrological indicators observed in various wetland areas of the Easton Ranch site included surface water, sparsely vegetated concave surfaces, water stained leaves, algal crust, soil cracks, drift and sediment deposits, and dry season water table. Site wide saturation and inundation levels were similar to those observed in 2011 and 2012, and greater

**Data Point: E-2**  
**Bearing:**

**Location: Veg community 11**  
**Taken in 2014**

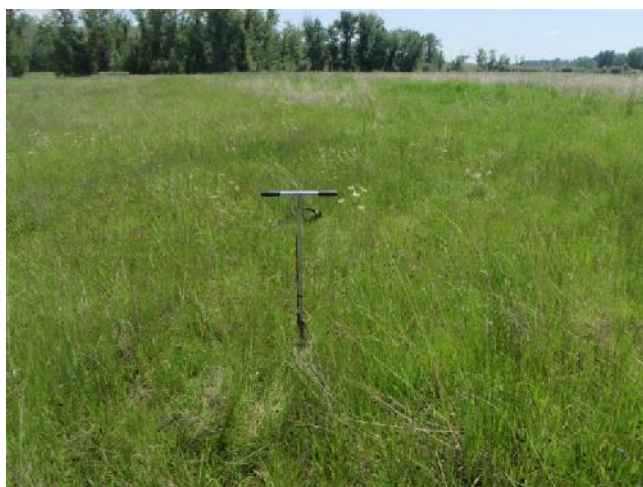
**Data Point: E-3**  
**Bearing:**

**Location: Veg community 8**  
**Taken in 2014**

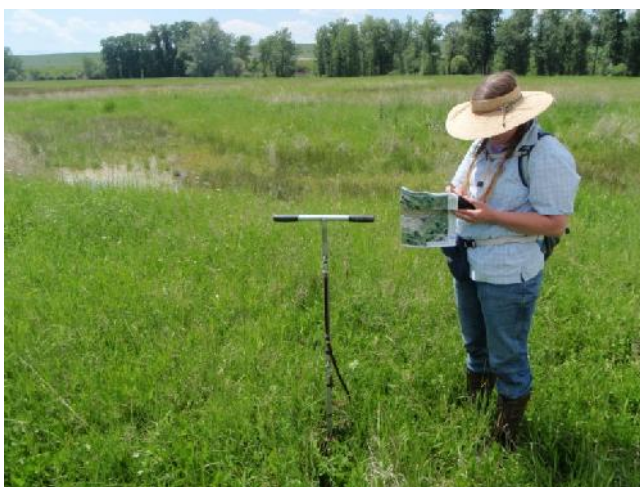
**Data Point: E-4**  
**Bearing:**

**Location: Veg community 11**  
**Taken in 2014**
