**MONTANA DEPARTMENT OF TRANSPORTATION
WETLAND MITIGATION MONITORING REPORT: YEAR 2014**

*I-90 East Bozeman
Gallatin County, Montana*

MDT Project Number STPX- 0016 (057)
Control Number 5710

SPA # MDT-R3-62-2007
Corps #: NWO-2007-3408-MTH

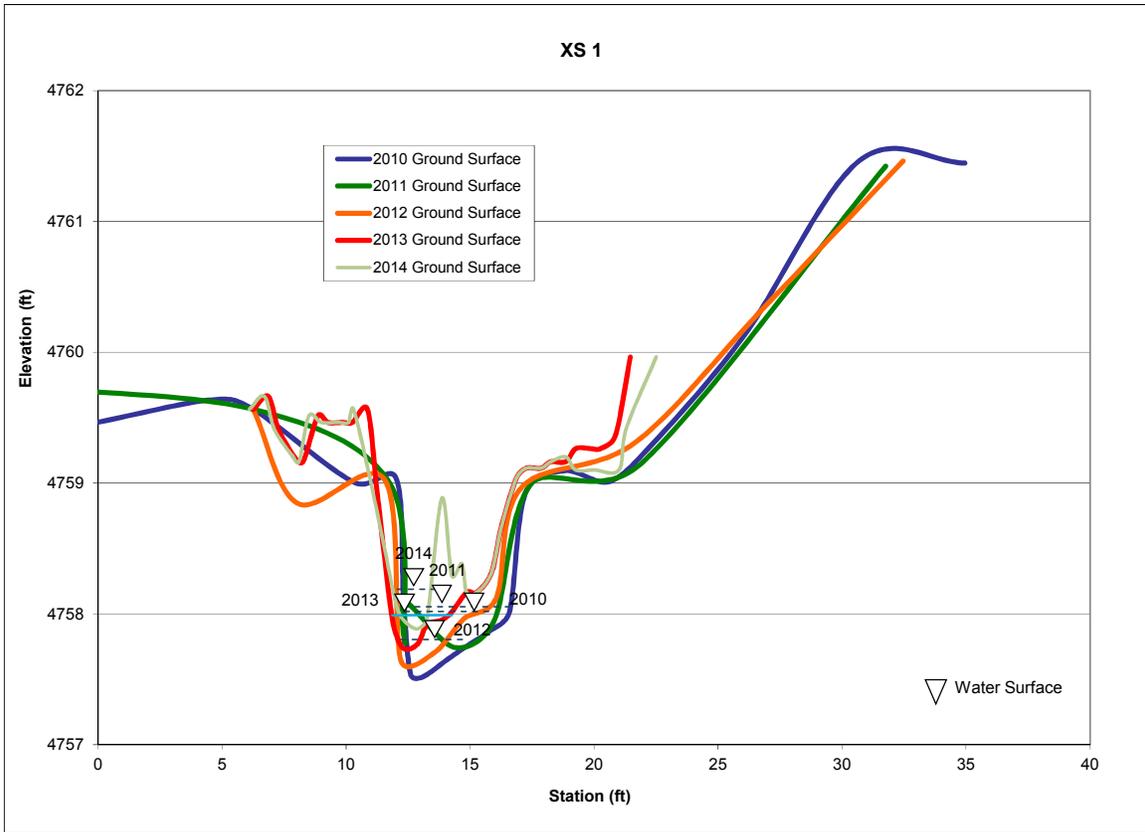
Chart 1. Survey data collected at cross-section 1 from 2010 to 2014.

Cross-section 1 has remained stable and has not displayed any notable lateral adjustment from 2010 to 2014 (Chart 1). The banks of this cross-section are entirely vegetated with reed canary grass (*Phalaris arundinacea*) and exhibit highly stable conditions. Approximately two inches of accumulation of fine-sediment streambed material was noted on the right side of the channel bottom in 2013. Aside from a clump of sod that had washed into the cross-section in

2014, as noted by the peak within bankfull, very little change was noted in channel geometry as XS-1 between 2013 and 2014.

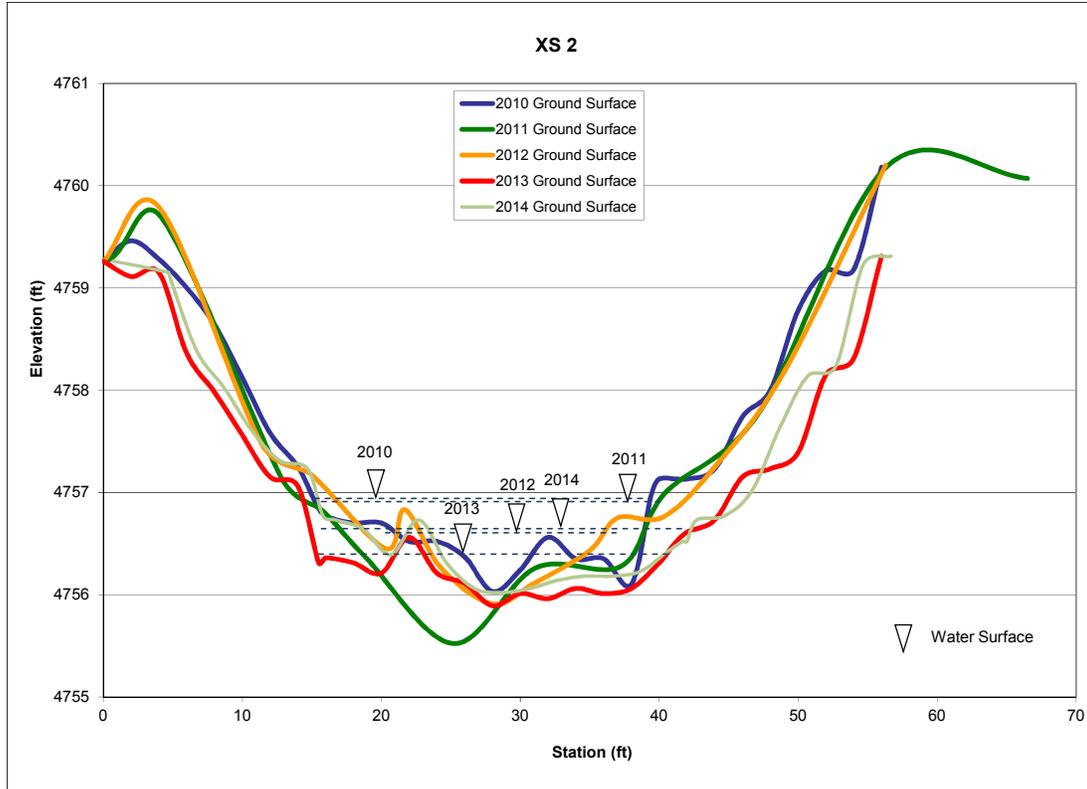
Chart 2. Survey data collected at cross-section 2 from 2010 to 2014.

The channel width at cross-section 2 is approximately 25 feet, much greater than the 2 to 3 feet stipulated in the design (Chart 2). Natural fluvial geomorphological adjustments at this cross-section have included a slight narrowing of the channel width with aggradation (accumulation of material) on the left and right edges of the channel bottom. Vegetation establishment along both banks have also effectively narrowed the surface water flow channel and thalweg. The average width of the constructed creek channel down-gradient of the culvert outlet averages 10 to 15 feet. Continued aggradation of the channel appears to be improving the width/depth ratio and general aquatic habitat quality of this stream. A natural constriction at the connection between the new and old channel appears to impede flow and backs up water at cross-section 2, resulting in the inundation of the adjacent low floodplain.

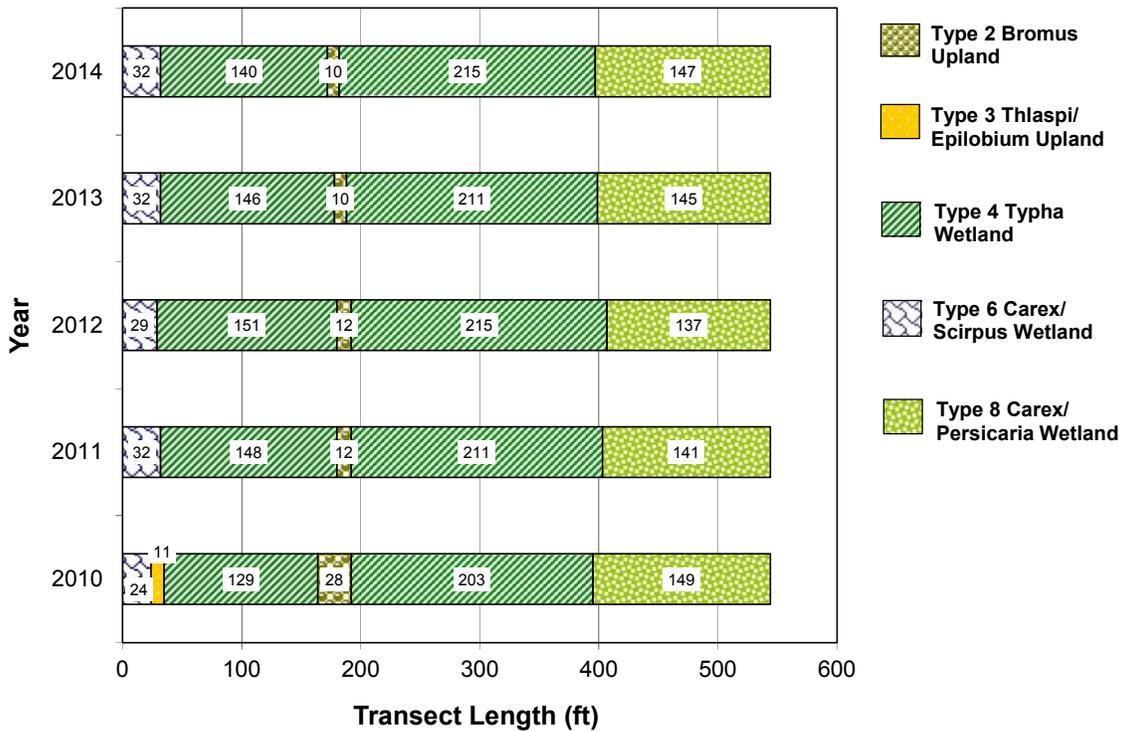
Chart 3. Transect map showing community types on Transect 1 from 2010 to 2014 from start (0 feet) to finish (544 feet) at the I-90 East Bozeman Wetland Mitigation Site.

The vegetation transect traversed the site from southwest to northeast across WL-1 and WL-2 (wetland cells identified on the Project Plan Sheet in Appendix D) and a portion of the pre-existing wetland. The transect intersected wetland communities 4, 6, and 8 and upland community 2. Hydrophytic vegetation communities dominated 98.2 percent of the transect intervals in 2014. Thirty-five vegetative species were observed along the transect in 2014 reflecting a continued upward trend in diversity since the first year of monitoring.

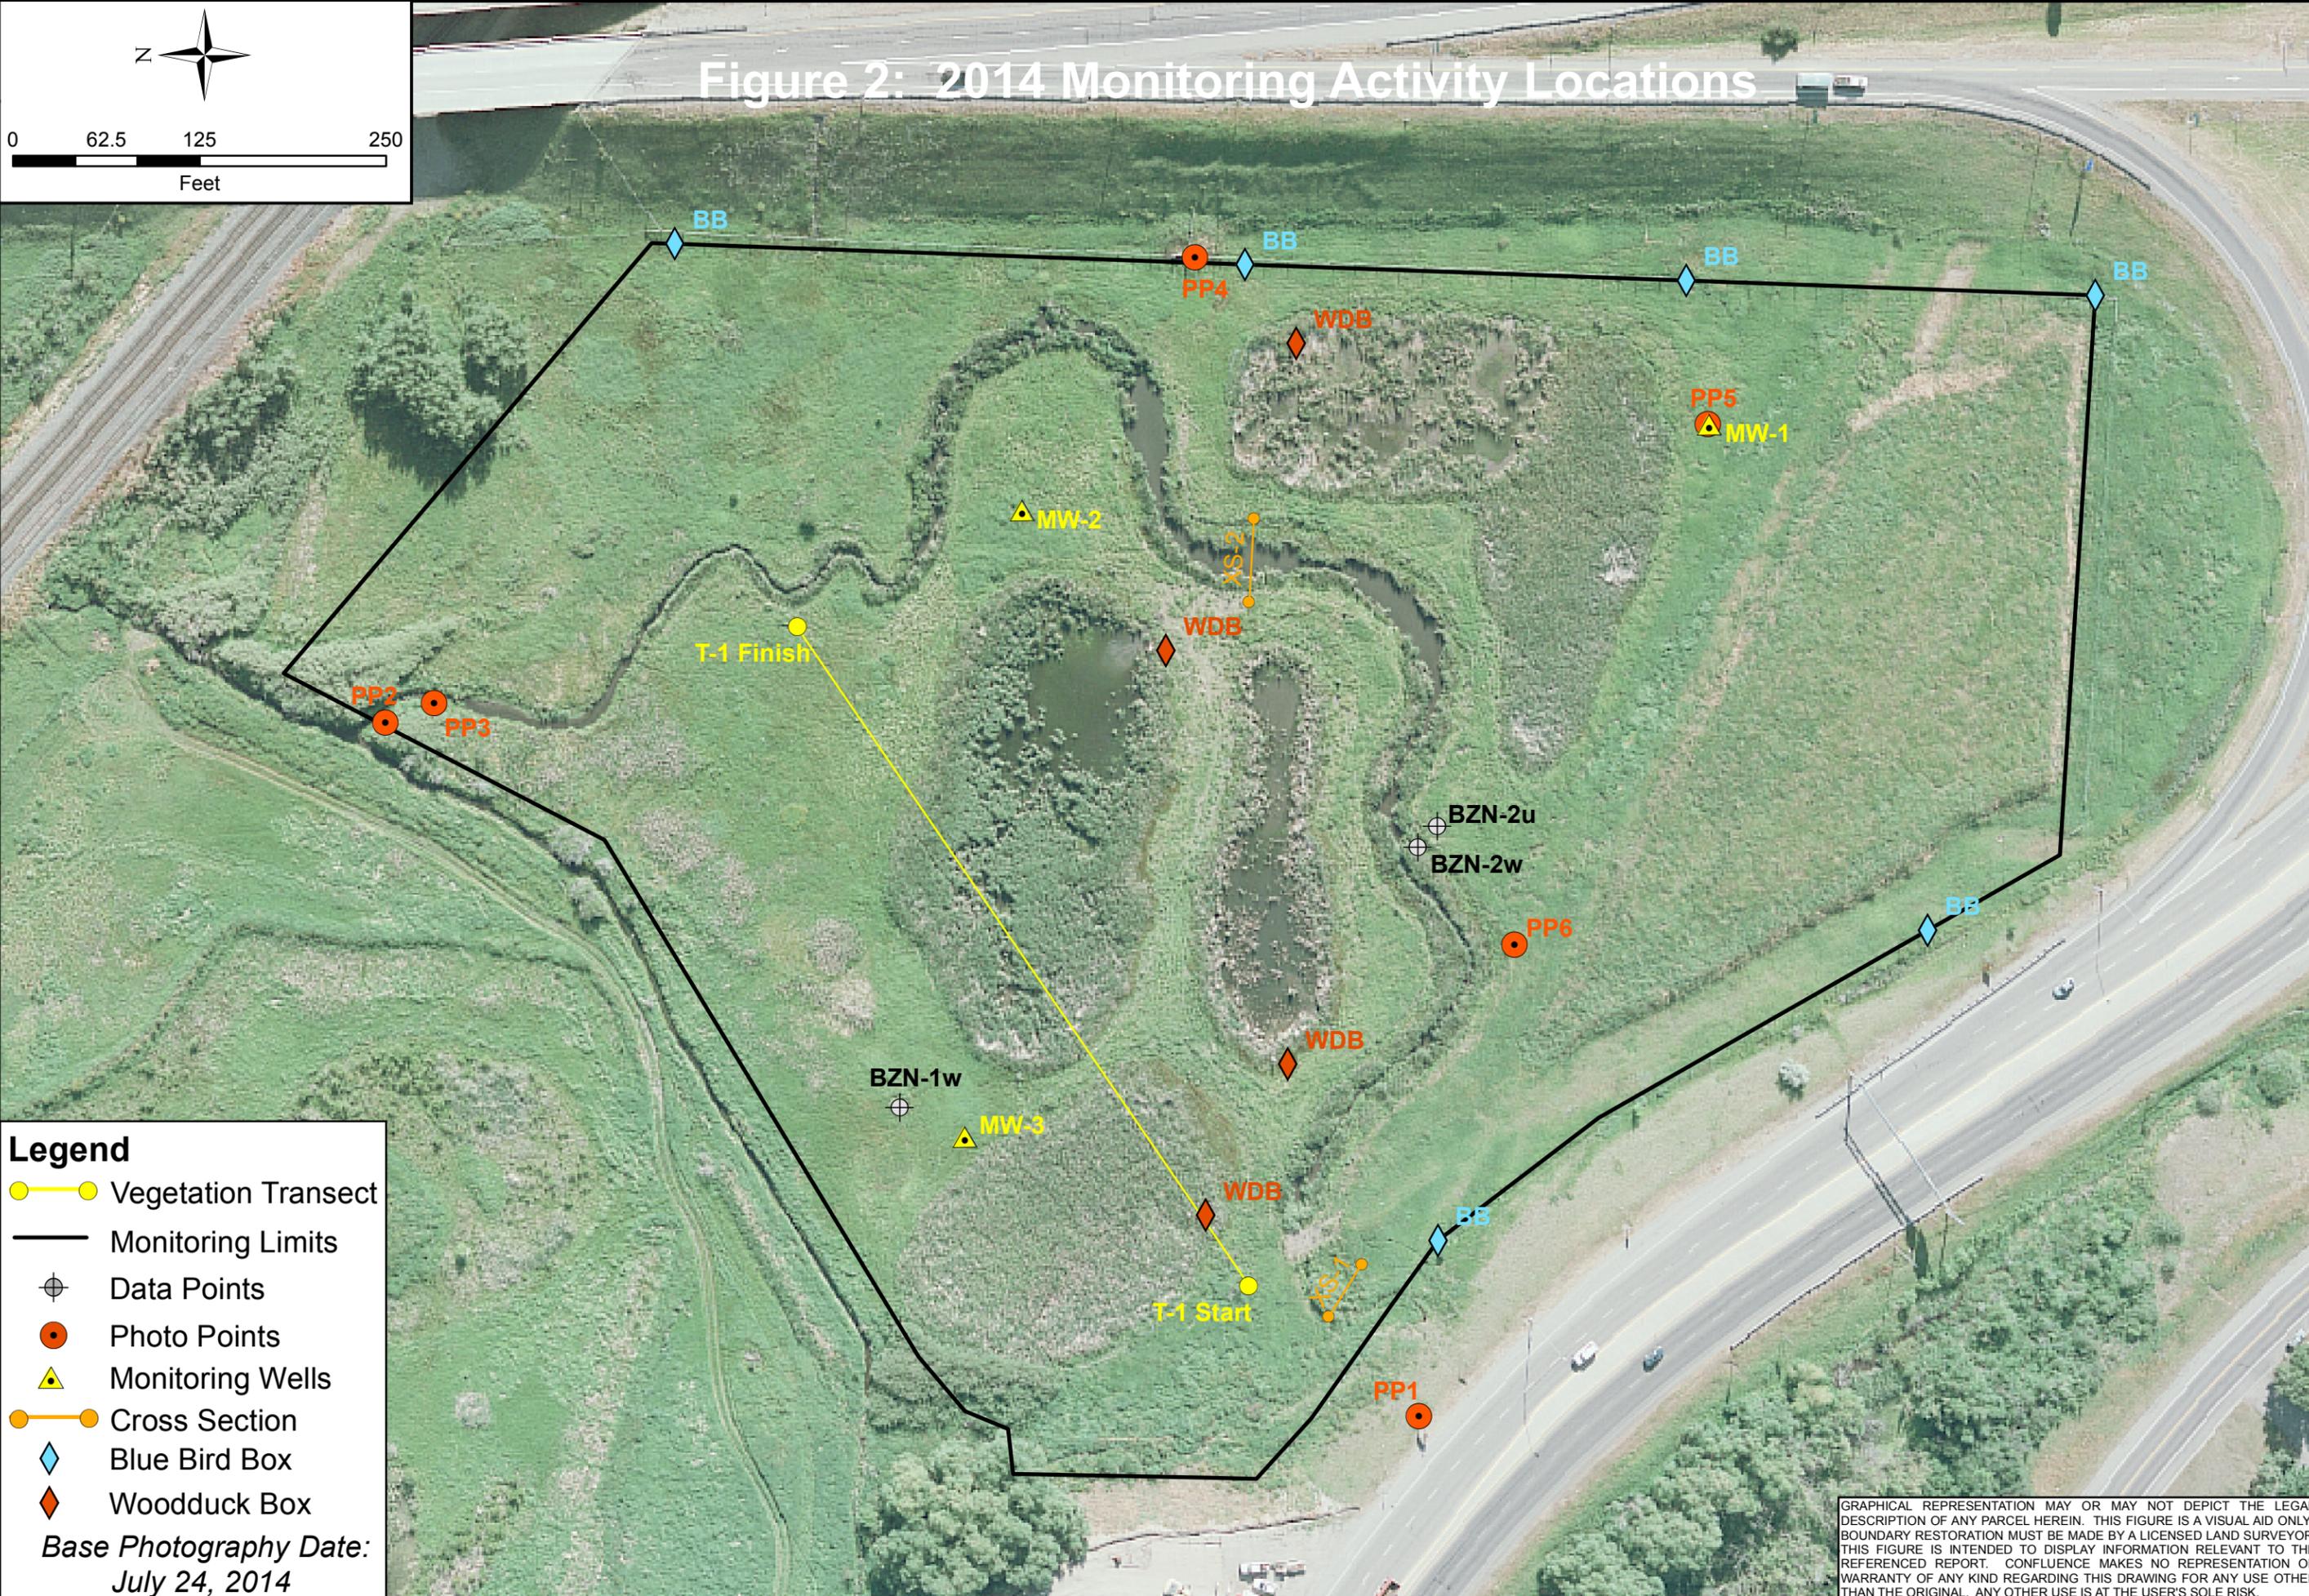
Figure 2: 2014 Monitoring Activity Locations

Monitoring at photo points provided supplemental information documenting wetland conditions, site trends, current land uses on the adjacent property, upland conditions, and vegetation transect cover development. Photographs were taken at established photo points during the site visit (Appendix C). Photo point locations were recorded with a resource grade GPS unit (Figure 2, Appendix A).

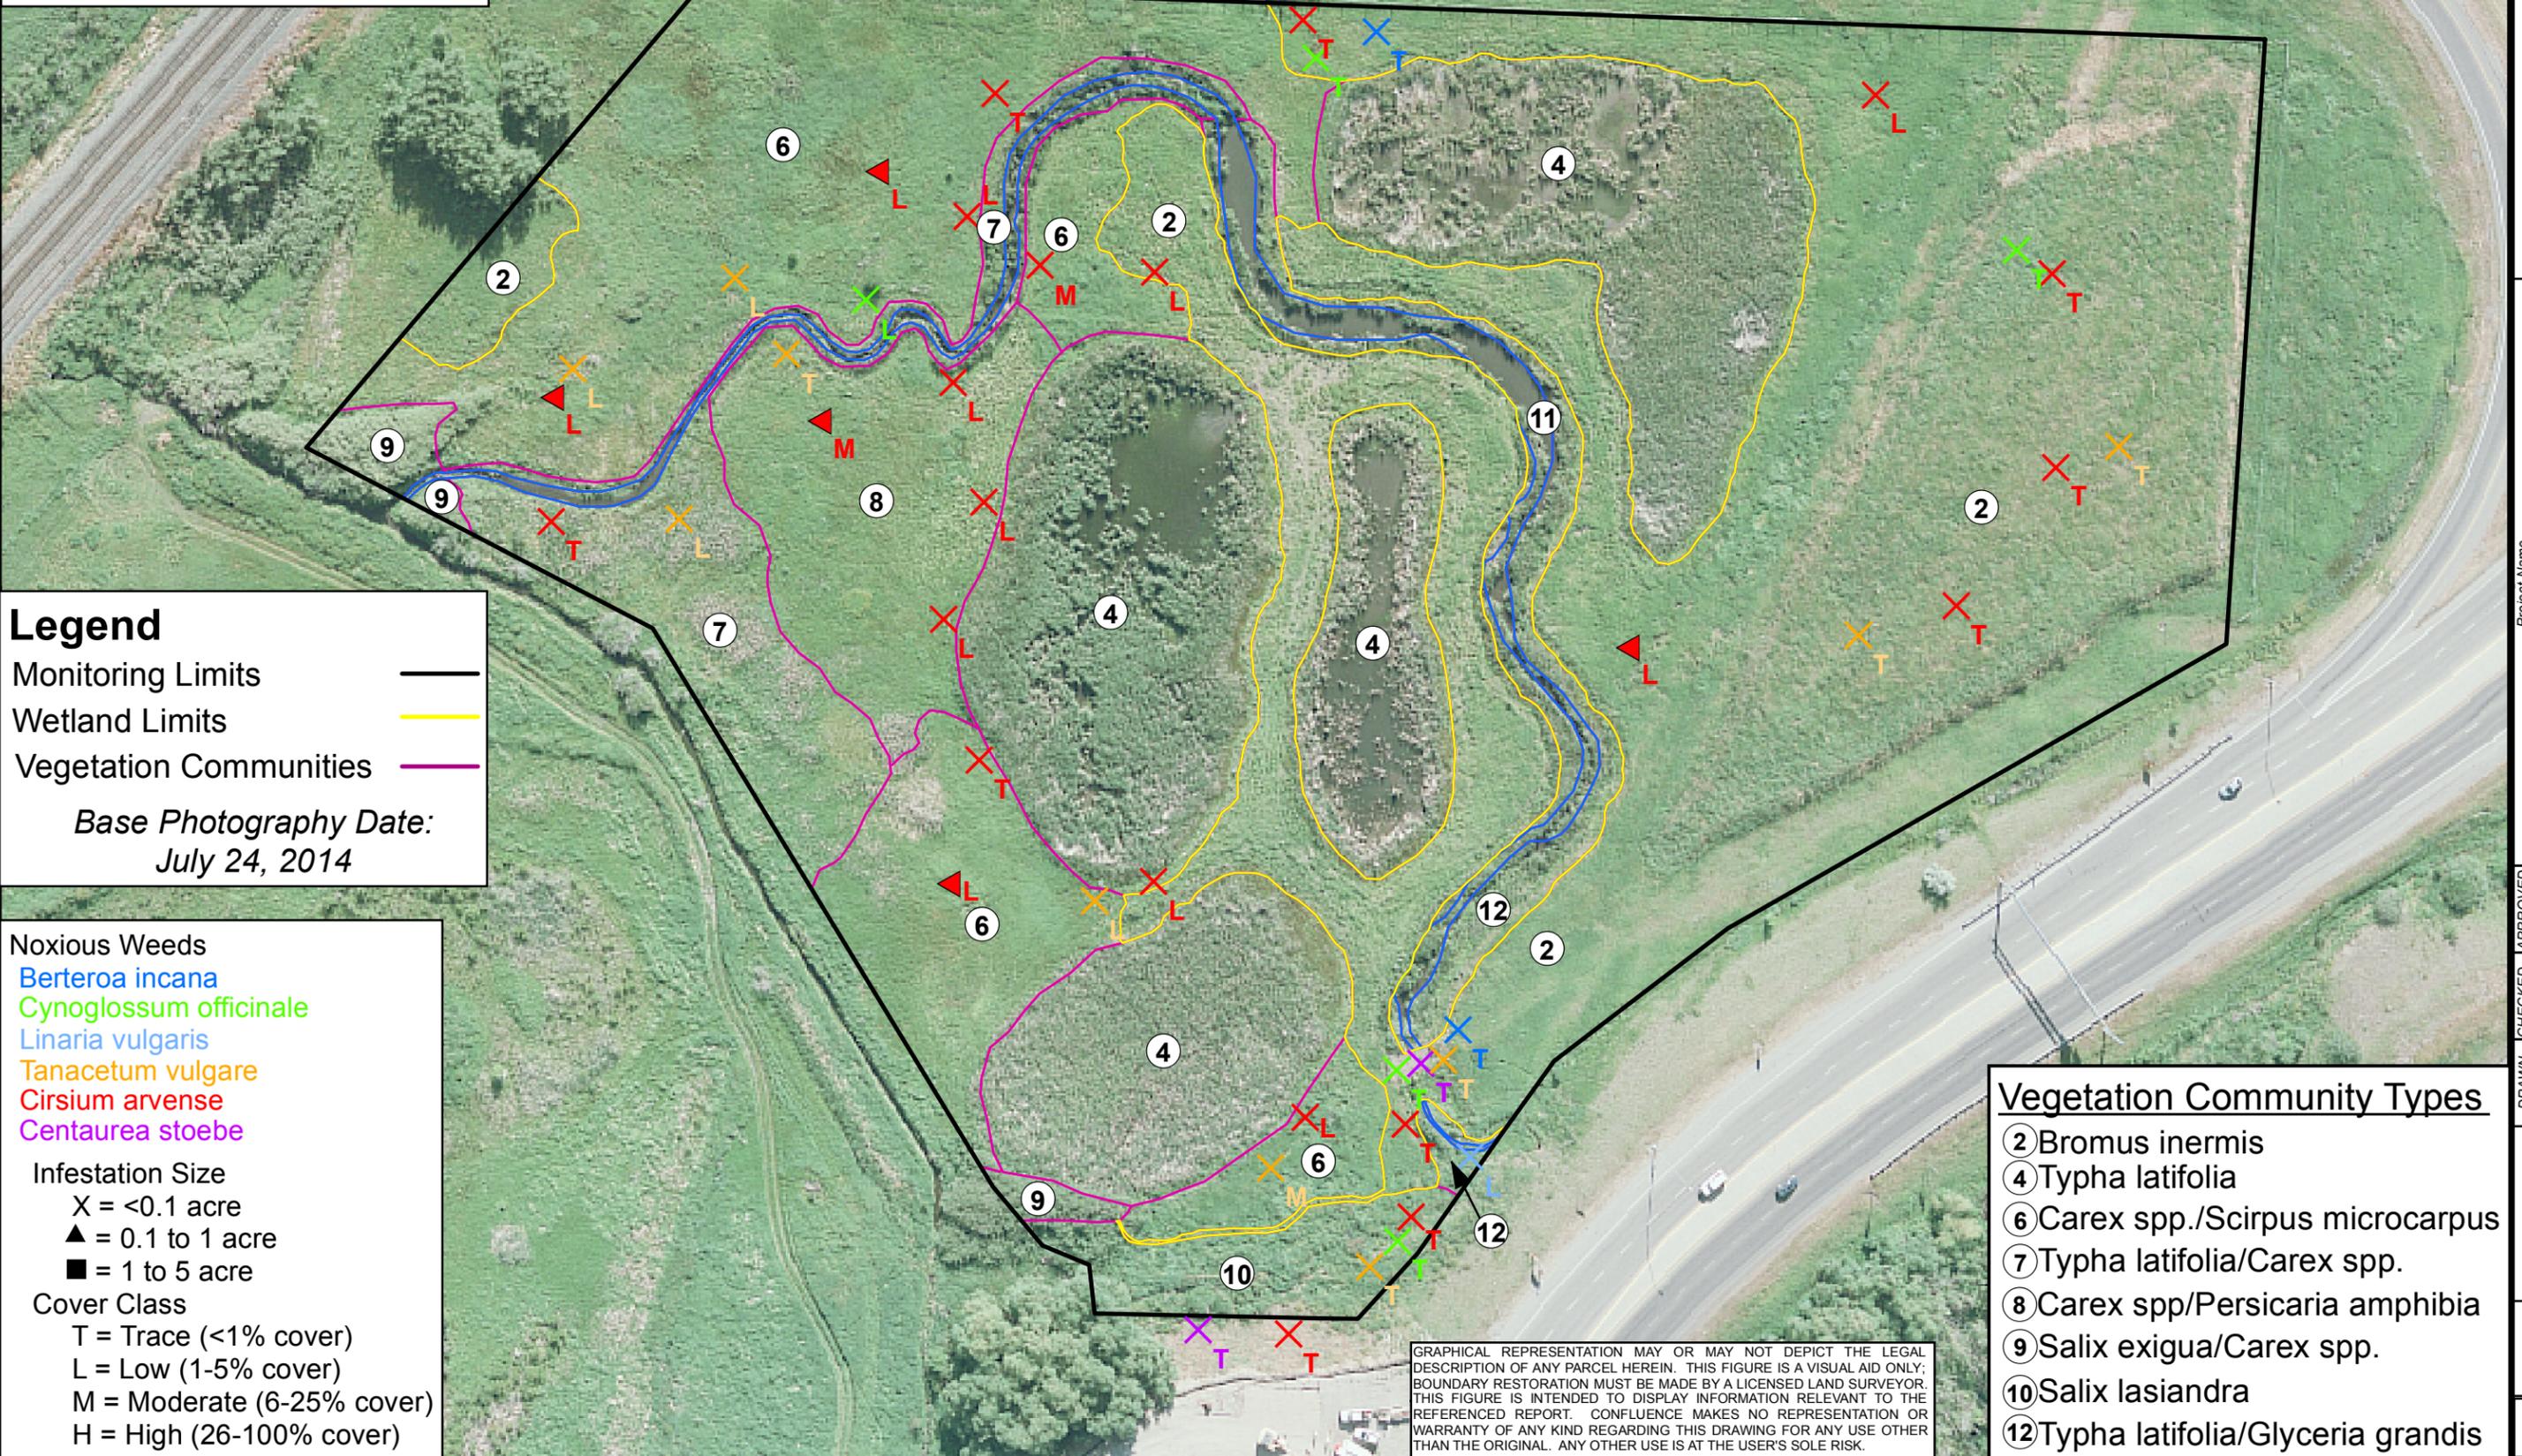
Figure 3 - 2014 Mapped Site Features

The location of 44 infestations of Priority 2B weeds mapped during the 2014 site visit are shown on Figure 3 (Appendix A) and included hoary false-alyssum (*Berteroa incana*), gypsy flower (*Cynoglossum officinale*), Canadian thistle (*Cirsium arvense*), common tansy (*Tanacetum vulgare*), spotted knapweed (*Centaurea stoebe*), and butter and eggs (Yellow toadflax-*Linaria vulgaris*). Hoary false-alyssum and gypsy flower were mapped on the site for the first time in 2014. They were observed in trace amounts on less than 0.1 acre located primarily near the property boundaries. The prevalence of Canadian thistle decreased site-wide from 2011 to 2013 and 2014 as a result of herbicide spraying by MDT’s contractor on the site every year since 2010. The transect photos on page C-8 show a decrease in the prevalence of Canadian thistle within Community Type 8 in 2013 and 2014. Isolated Canadian thistle plants were still present in Community Types 6, 7, 8, 10, and 12 in 2014. The size of the infestations ranged from less than 0.1 acre to 1.0 acre with cover classes ranging from trace to moderate. Common tansy appears to have spread from the confluence of the Story Ditch and historic channel to the constructed channel and south portion of the site. Two infestations of common tansy were noted near the site entry at the southwest boundary. The size was less than 0.1 acre with cover ranging from low to moderate (less than 1 percent to a high of 25 percent). One isolated spotted knapweed infestation was noted at the west boundary (outside of the site). However, the location was included on Figure 3 based on the aggressive nature of knapweed. A small infestation of butter and eggs was identified near the East Main culvert outlet on the west boundary for the first time in 2013. The weed was also observed at the east boundary in 2014.

Project Area	14.80 acres
WUS inc. Wetlands	9.03 acres
Existing Wetlands	3.51 acres
WUS (11)	0.34 acres
Created Wetlands	5.18 acres
Upland	5.77 acres

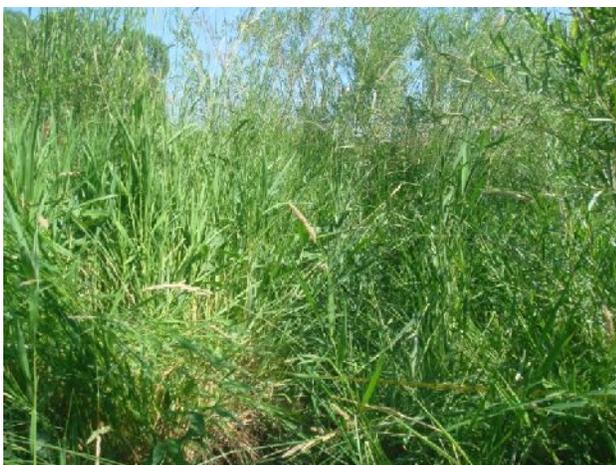
Cross Section 1
Bearing: 350 Degrees

Location: XS-1 looking downstream
Taken in 2014

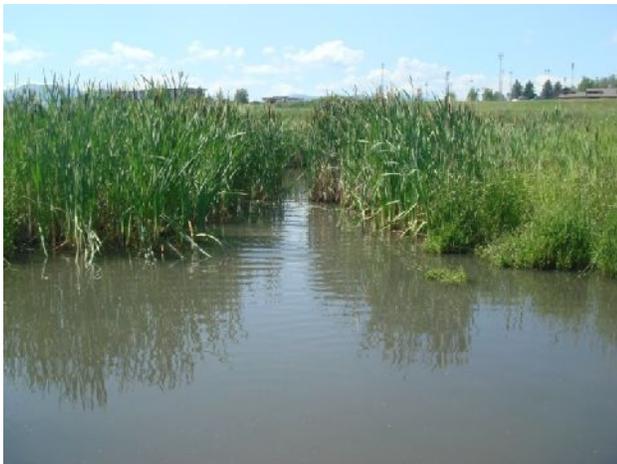
Cross Section 2 – Photo 1
Bearing: 310 Degrees

Location: XS-2 looking upstream
Taken in 2014

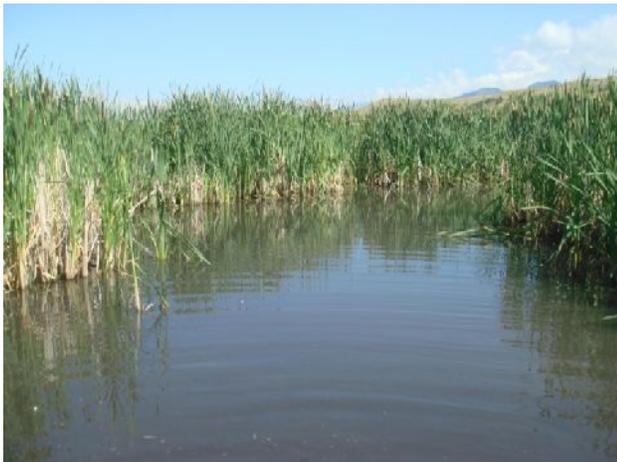
Cross Section 2 – Photo 2
Bearing: 150 Degrees

Location: XS-2 looking downstream
Taken in 2014
