MONTANA DEPARTMENT OF TRANSPORTATION WETLAND MITIGATION MONITORING REPORT: YEAR 2014

*Rostad Ranch
Meagher County, Montana*

MDT Project Number STPX-0002 (749)
Control Number 5565

USACE: NWO-2006-90851-MTB

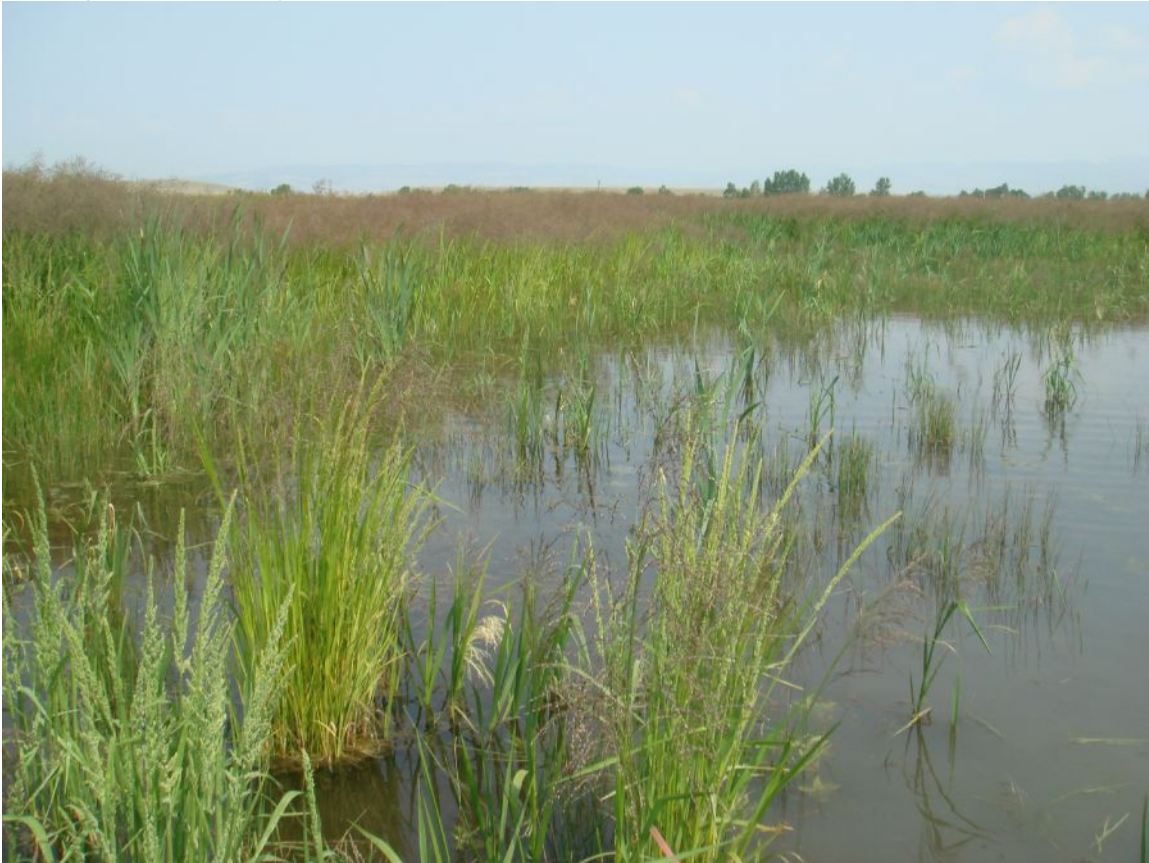
Cover: View of hydrophytic vegetation development along the inundated man-made northern impoundment at the Rostad Ranch wetland mitigation site.
