## SCHRIEBER LAKE MITIGATION SITE

**Monitoring Year:** 2020

**Monitoring Conducted By:** Confluence Consulting Inc.

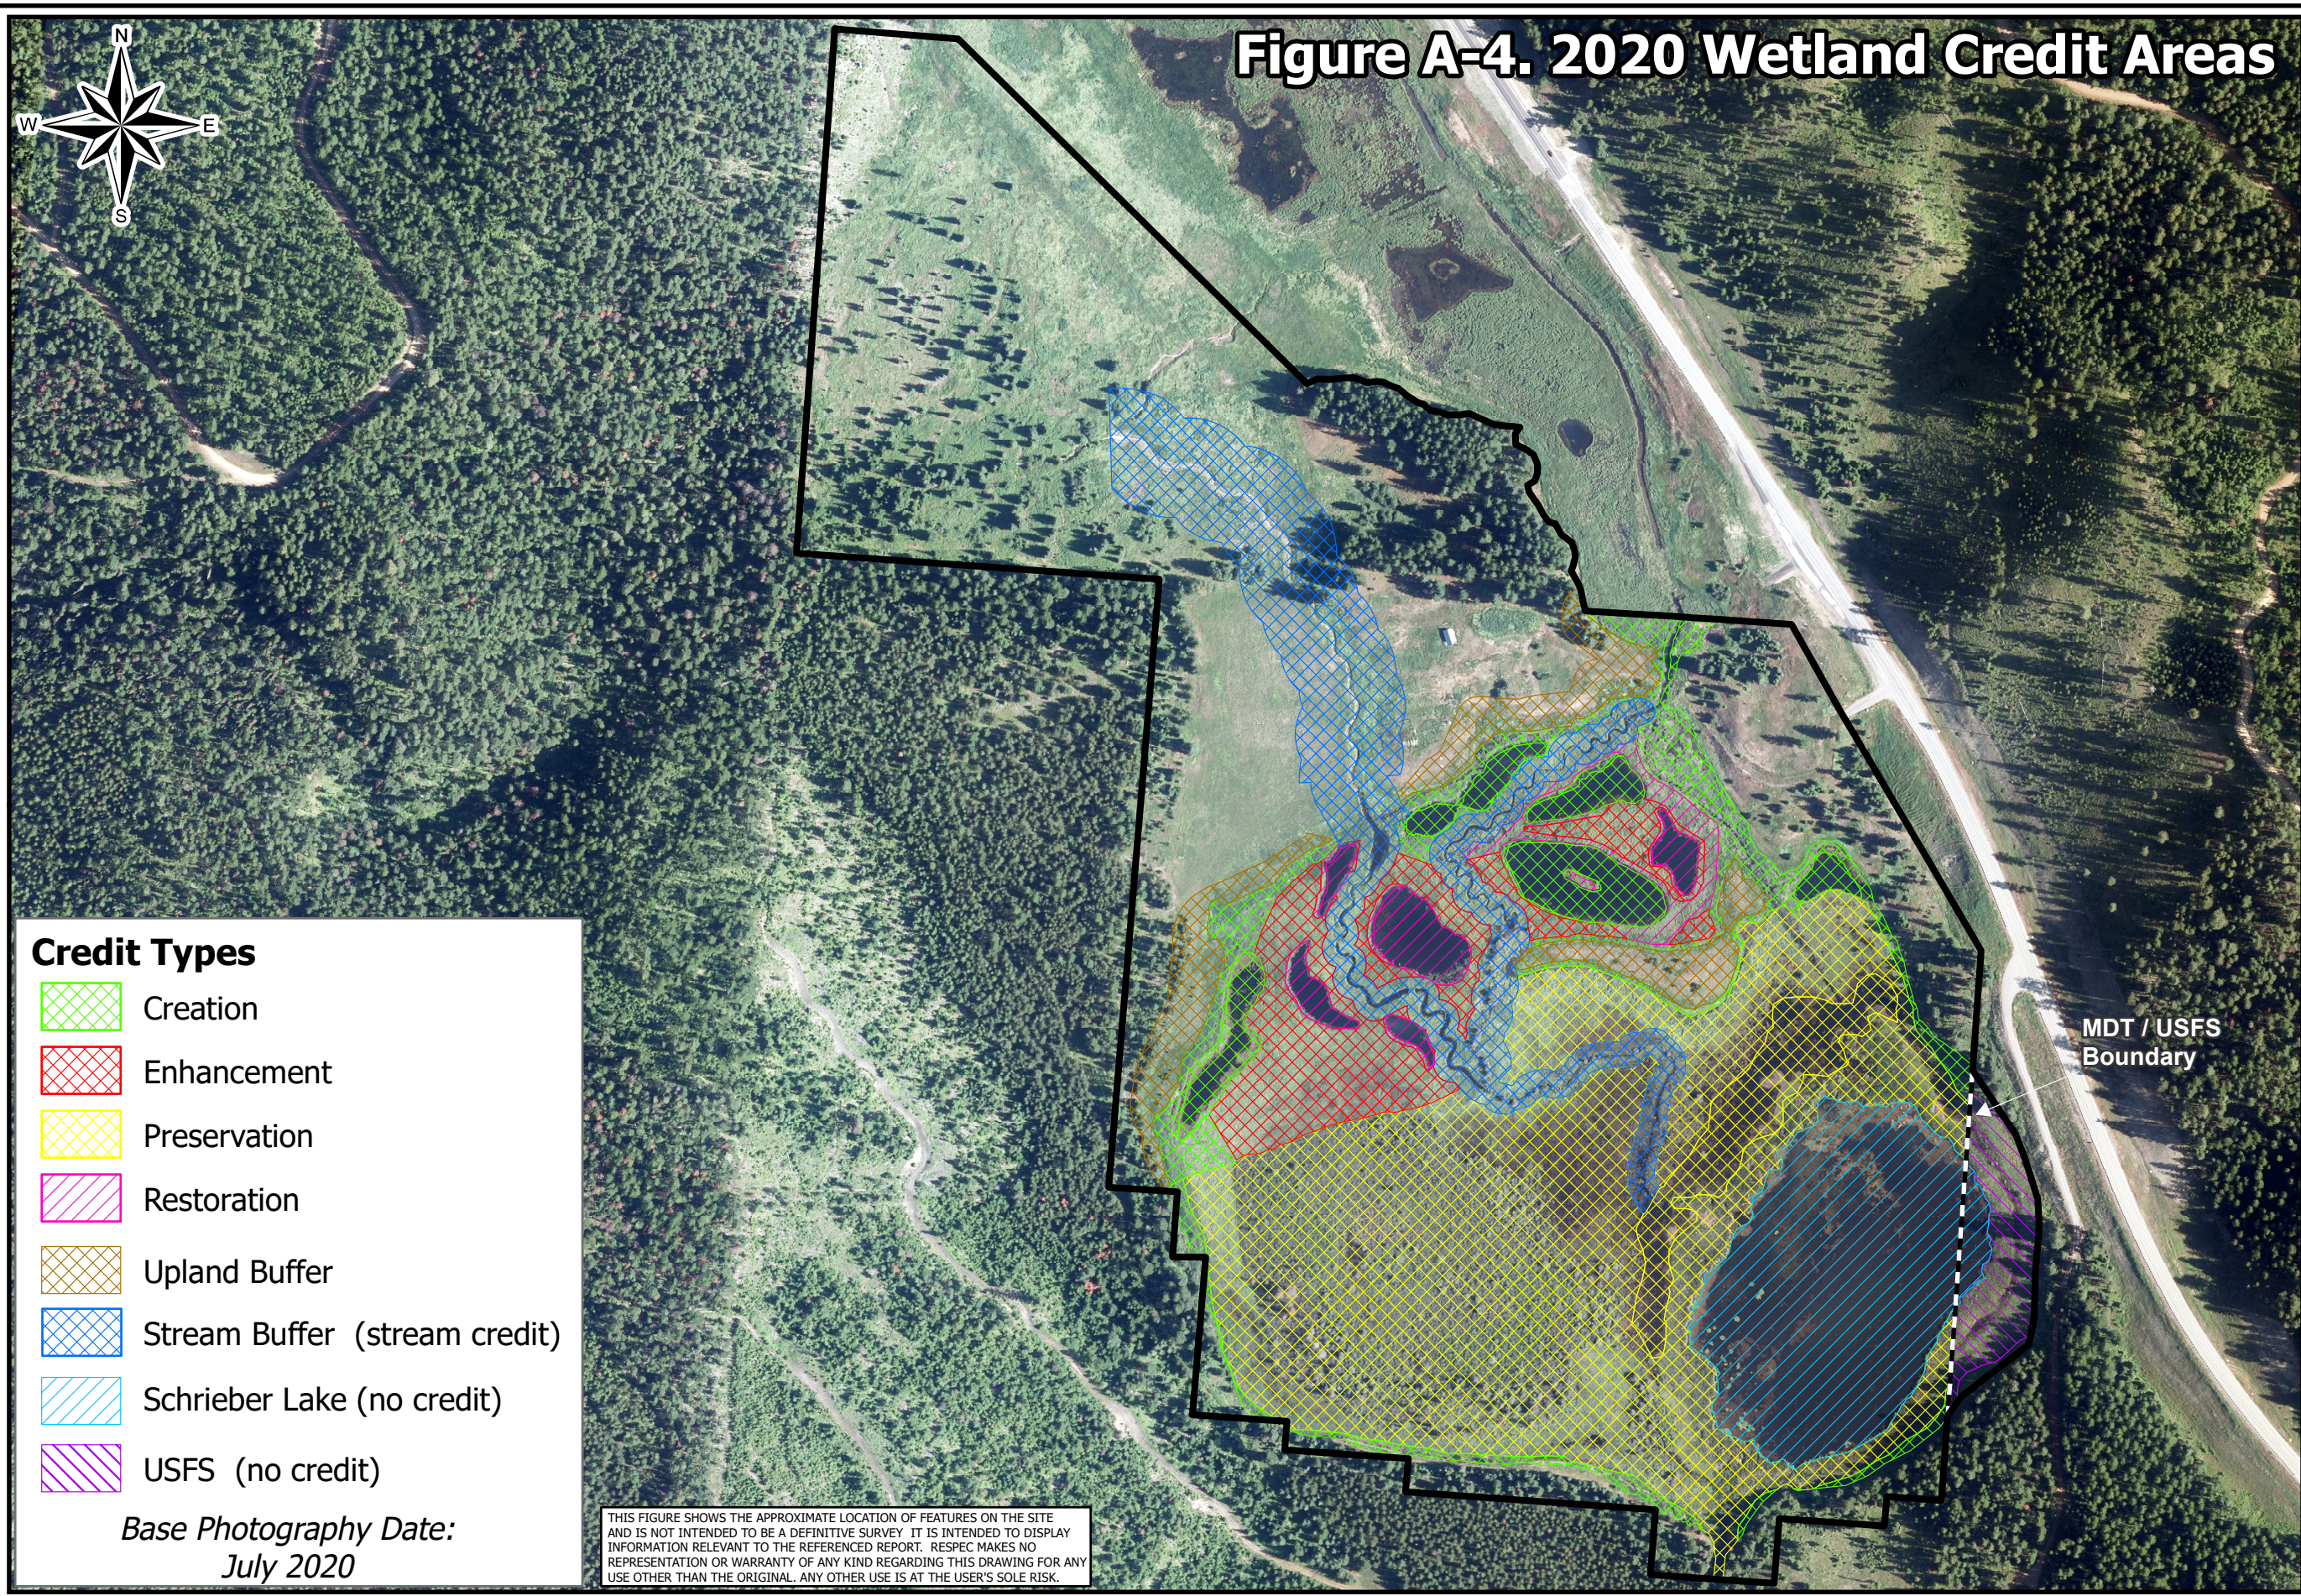
**Schrieber Lake Mitigation Site**  
**2020 Wetland Credit Areas**

***Wetland Delineation*** –The total jurisdictional wetland and aquatic habitat delineated at the Schrieber Lake mitigation site in 2020 was 55.23 acres, an increase of 3.13 acres since 2019 (Table 2; see maps in Appendix A). Schrieber Lake occupied 8.00 acres and remaining ‘open water’ areas represented a total of 6.24 acres. The extensive wetland development at this site is the result of the excavation of wetland cells, construction of channel plugs, and the restoration of meanders and bed elevations for the Schrieber and Coyote creek channels. Beaver activity, noted for the first time in 2019, was also observed in 2020 and is contributing to wetland development at the site. The recently constructed beaver dam at the outlet of Schrieber Lake has increased inundation levels across the site in both 2019 and 2020. The continued influence from this beaver activity is expected to increase deep-water inundation levels and create shifts in vegetation communities as open water habitat expands across the site.

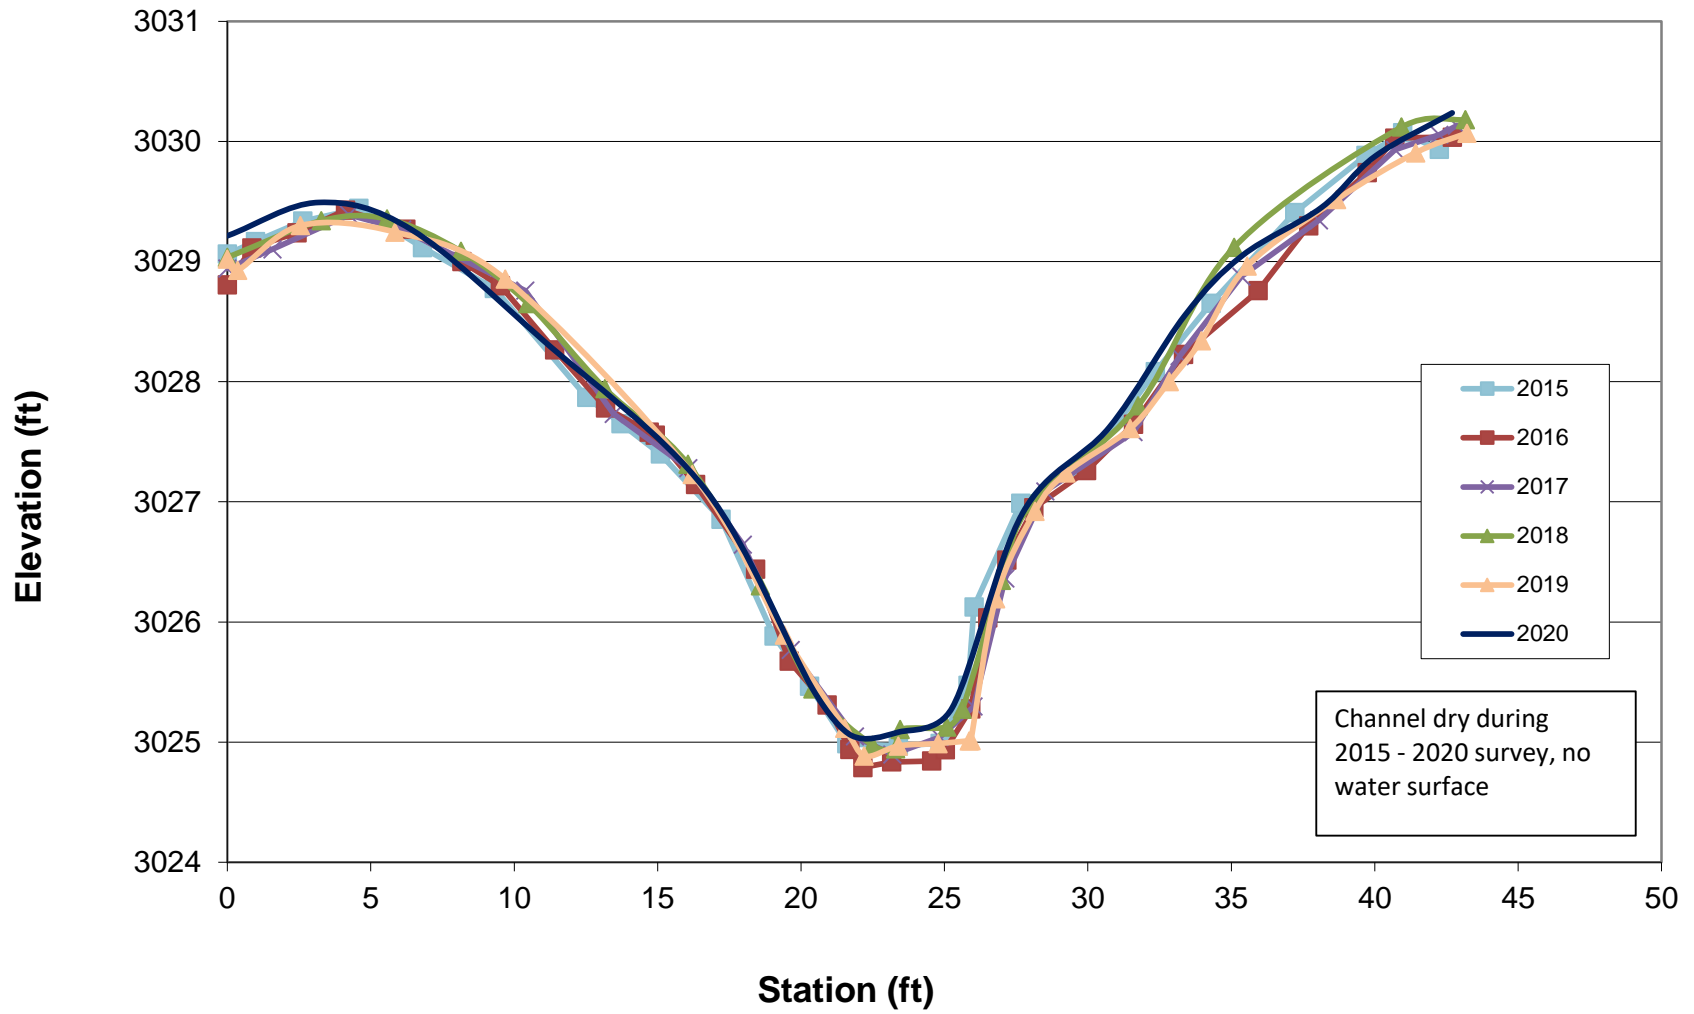
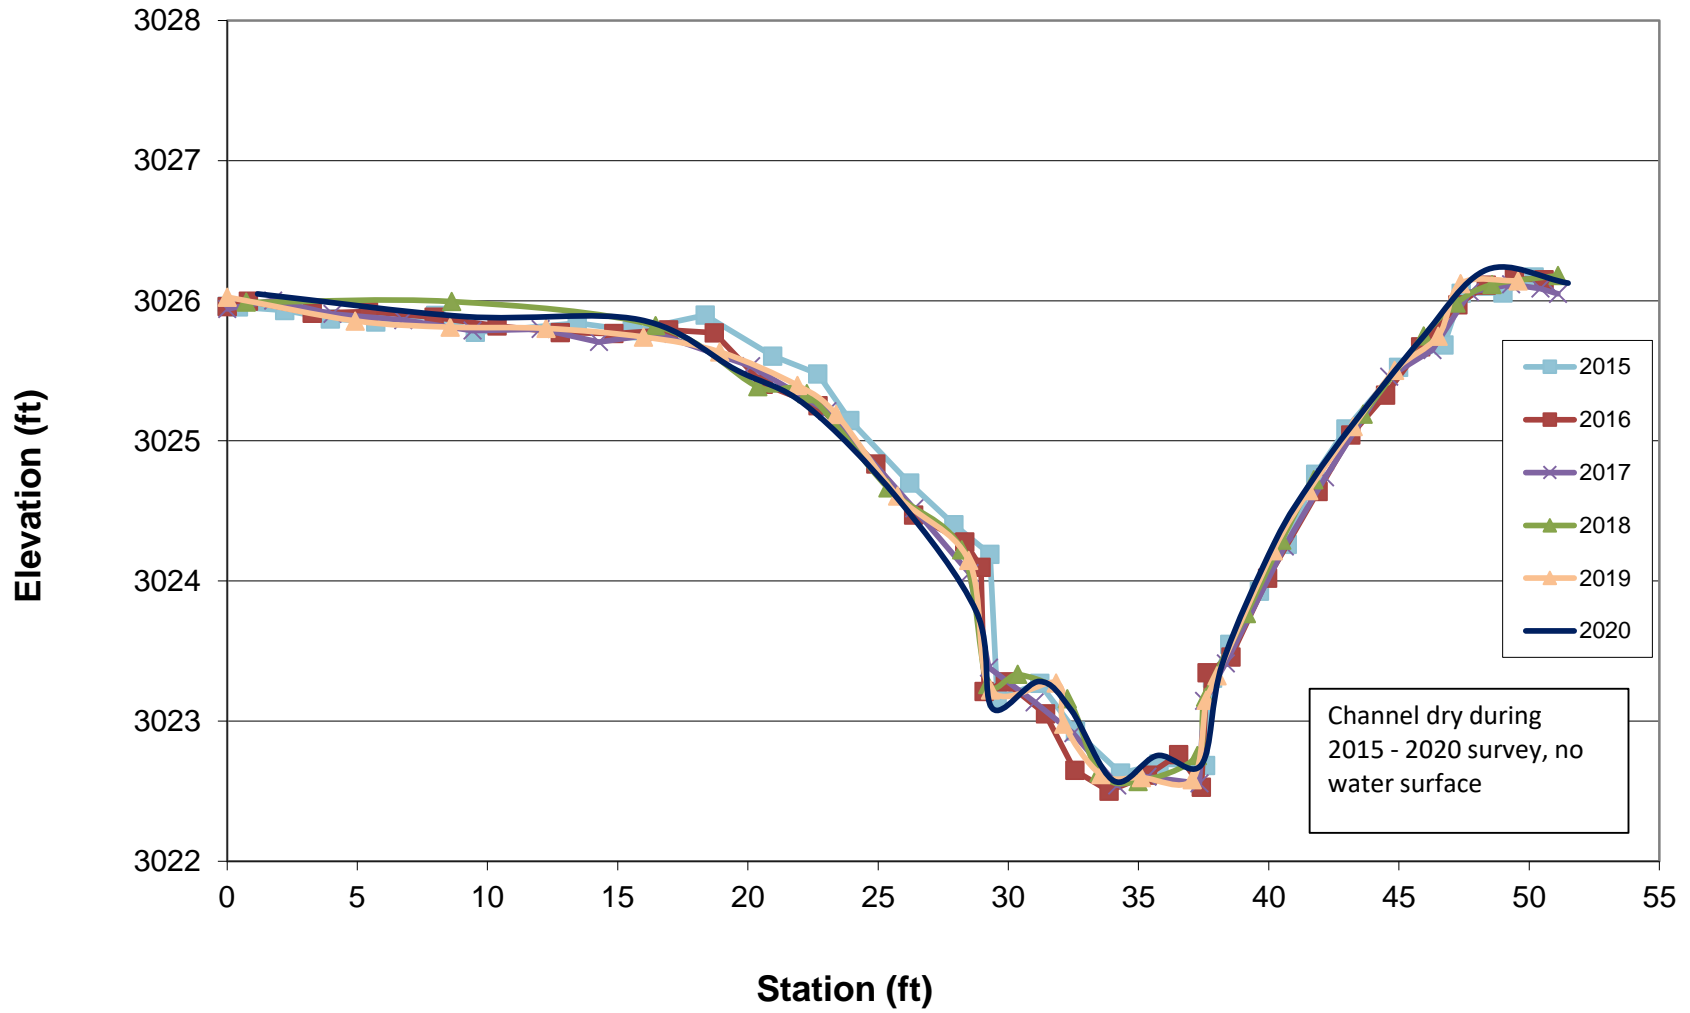
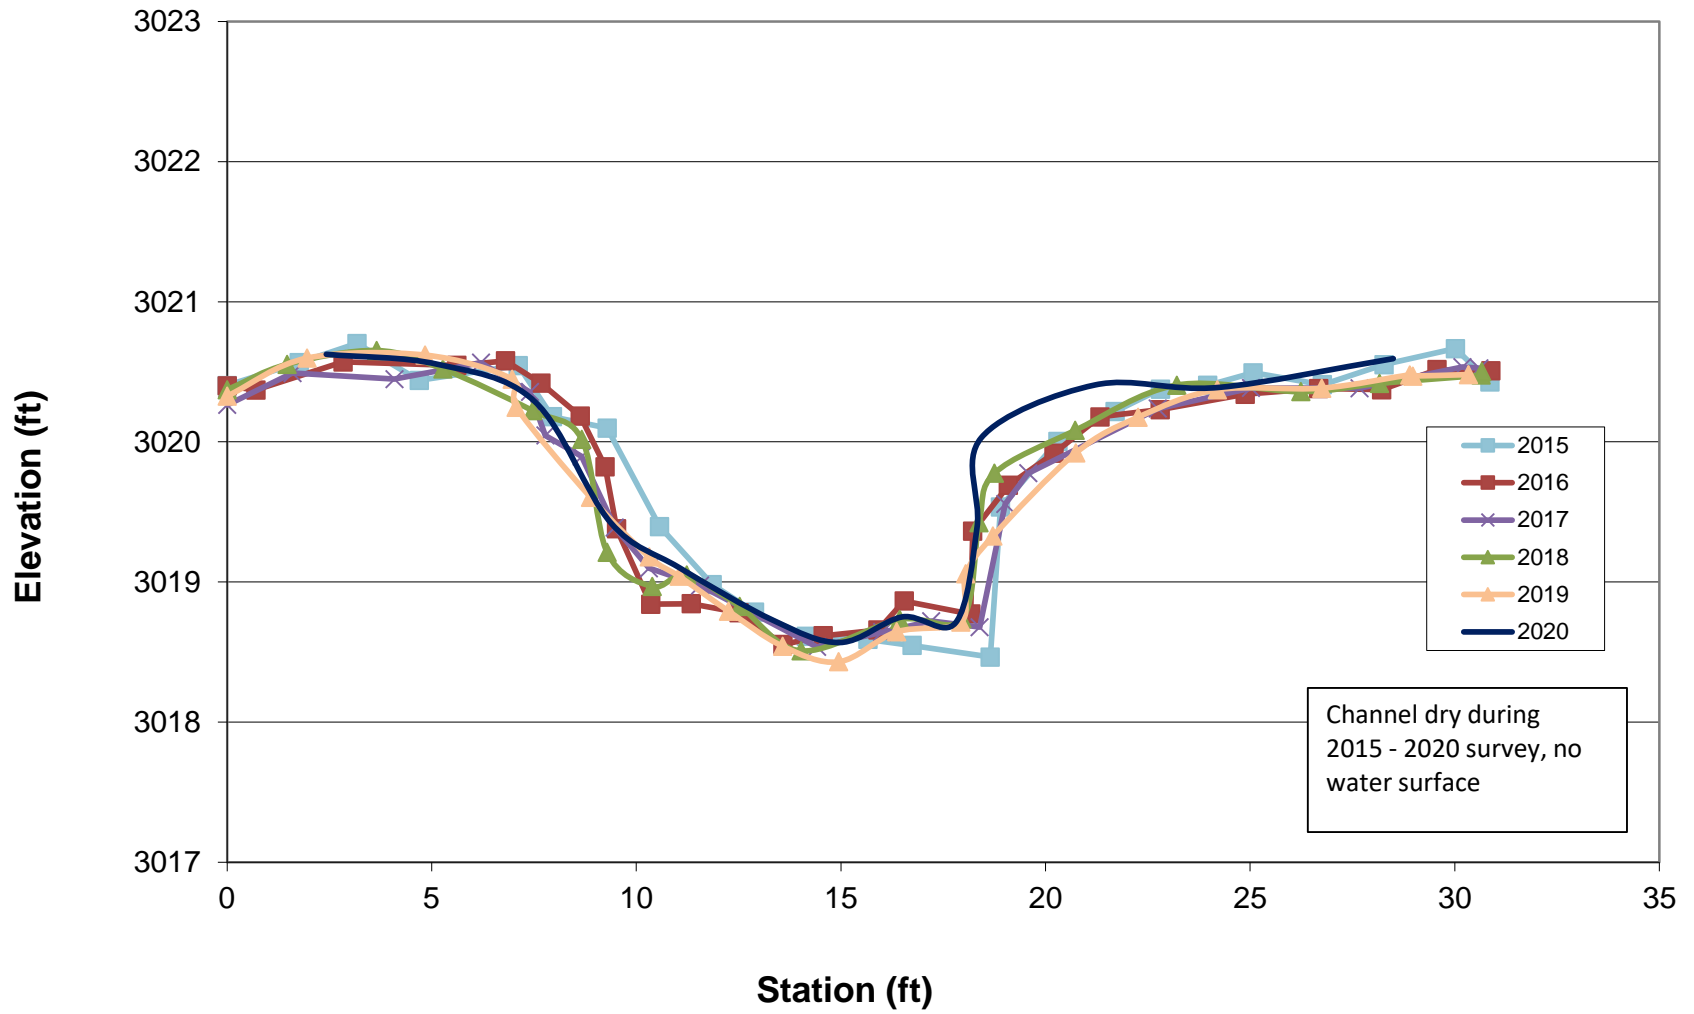
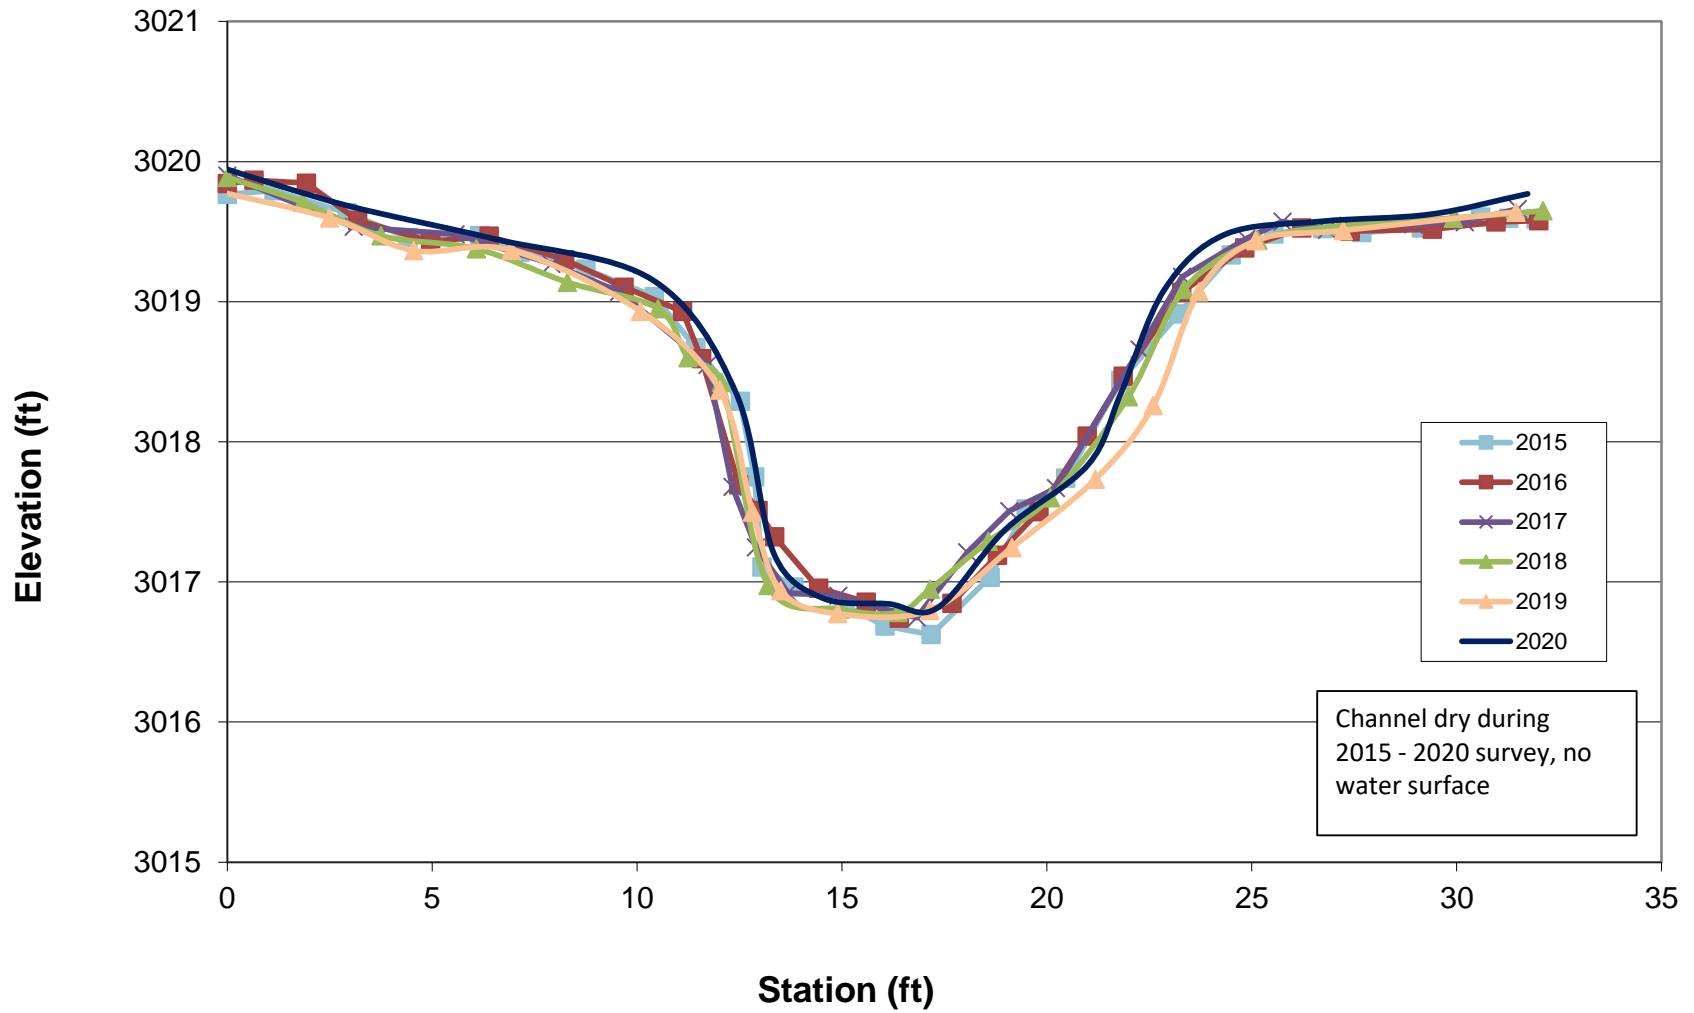
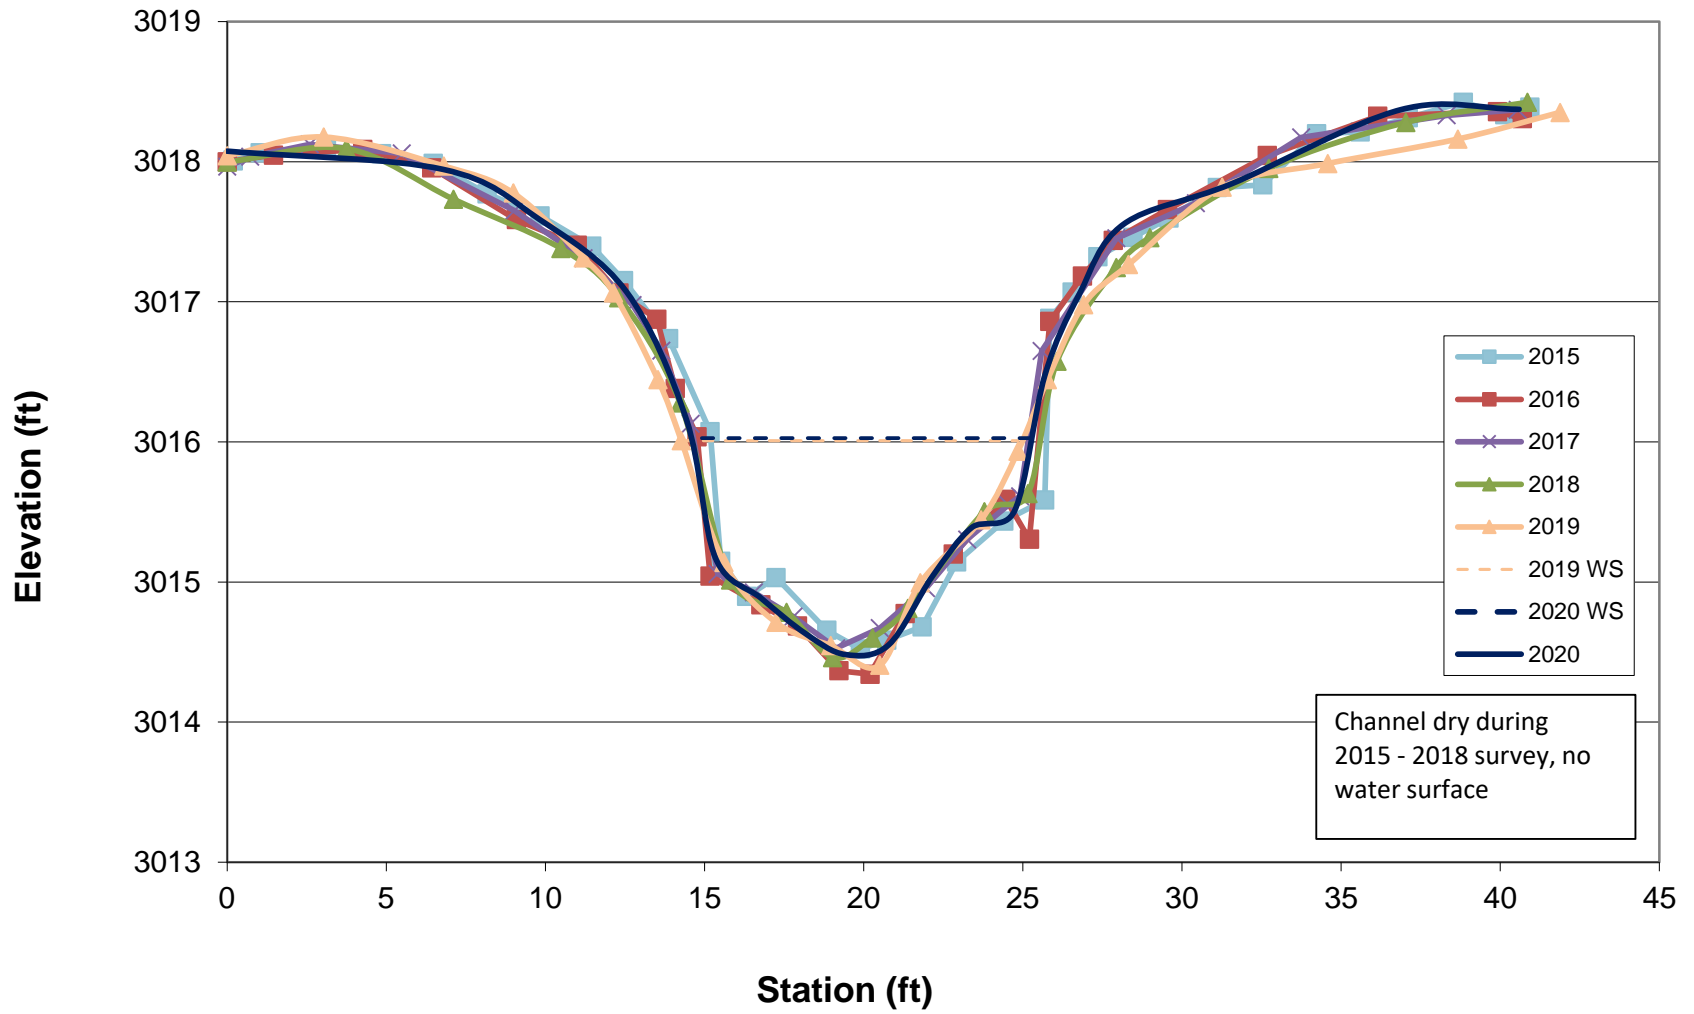
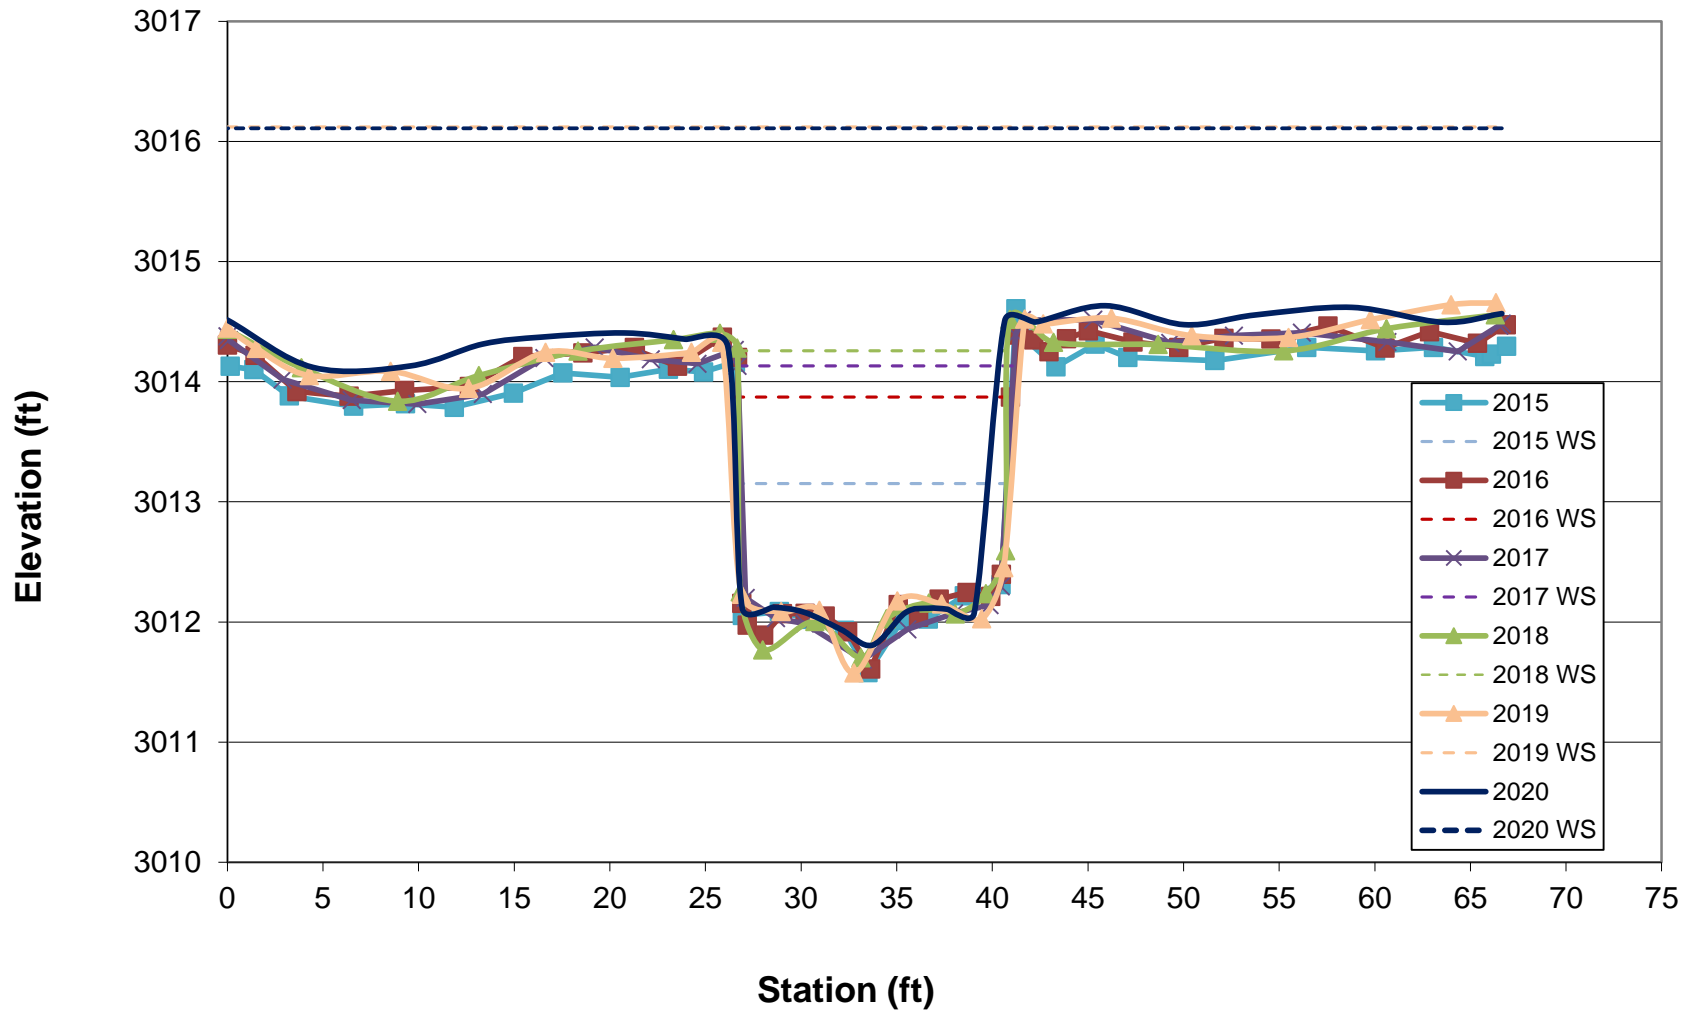
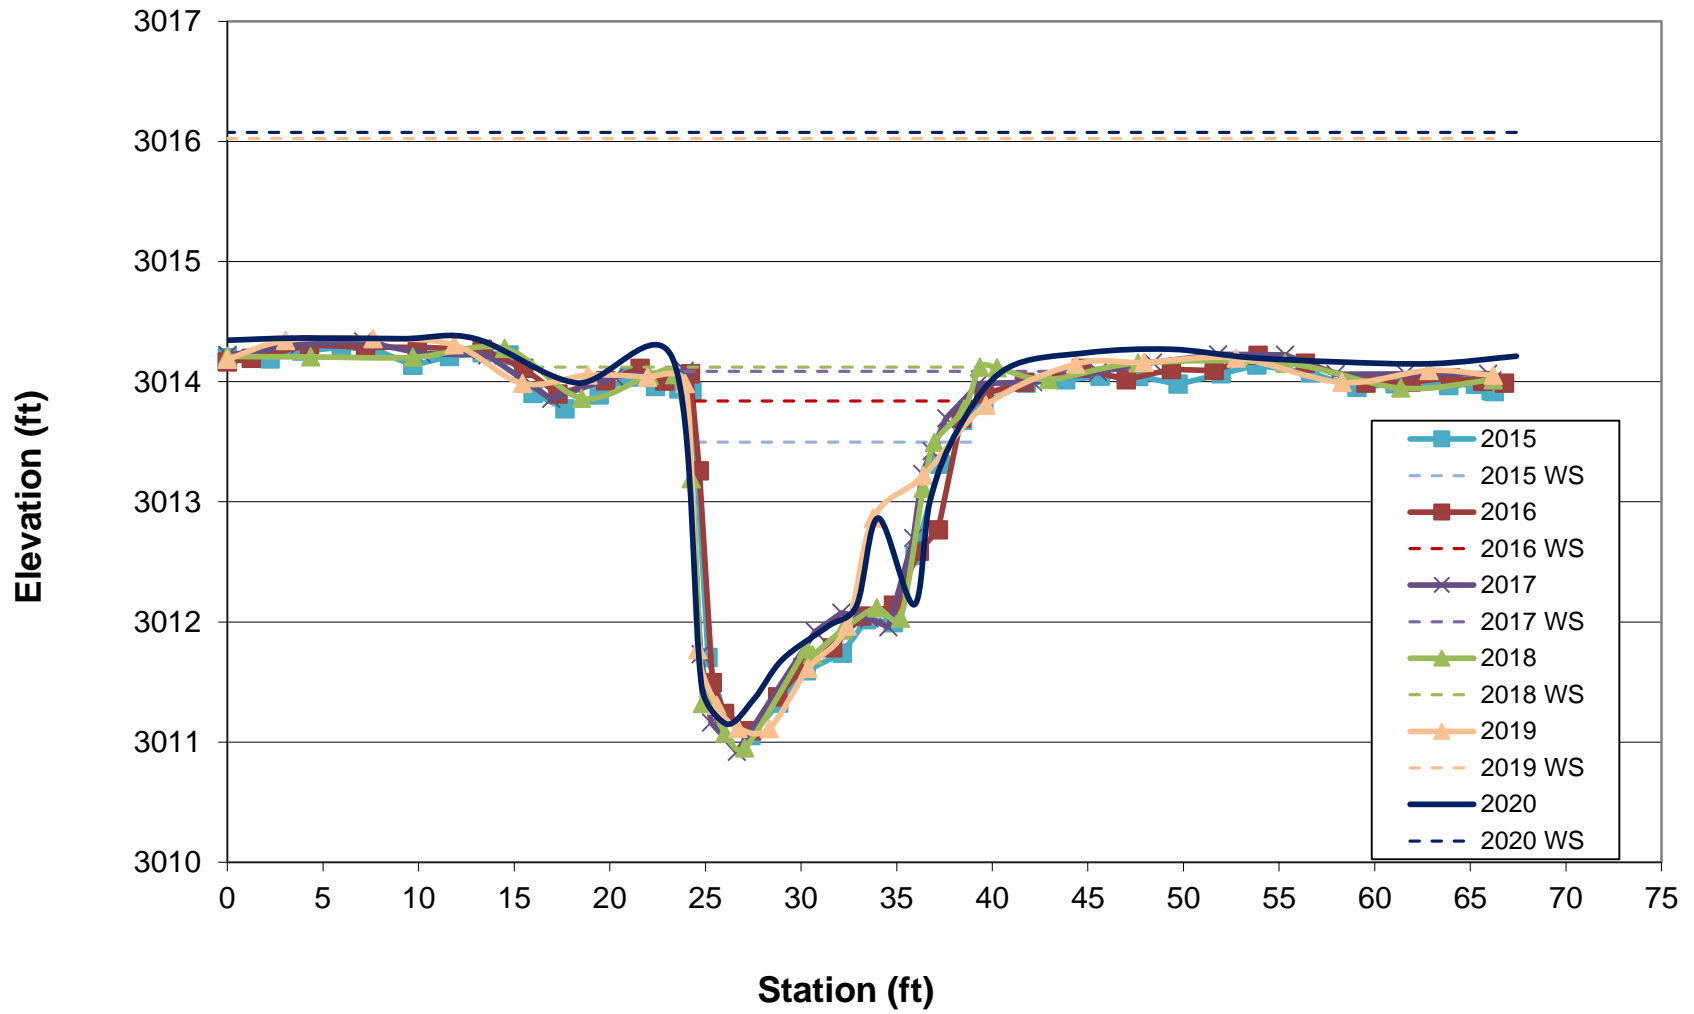
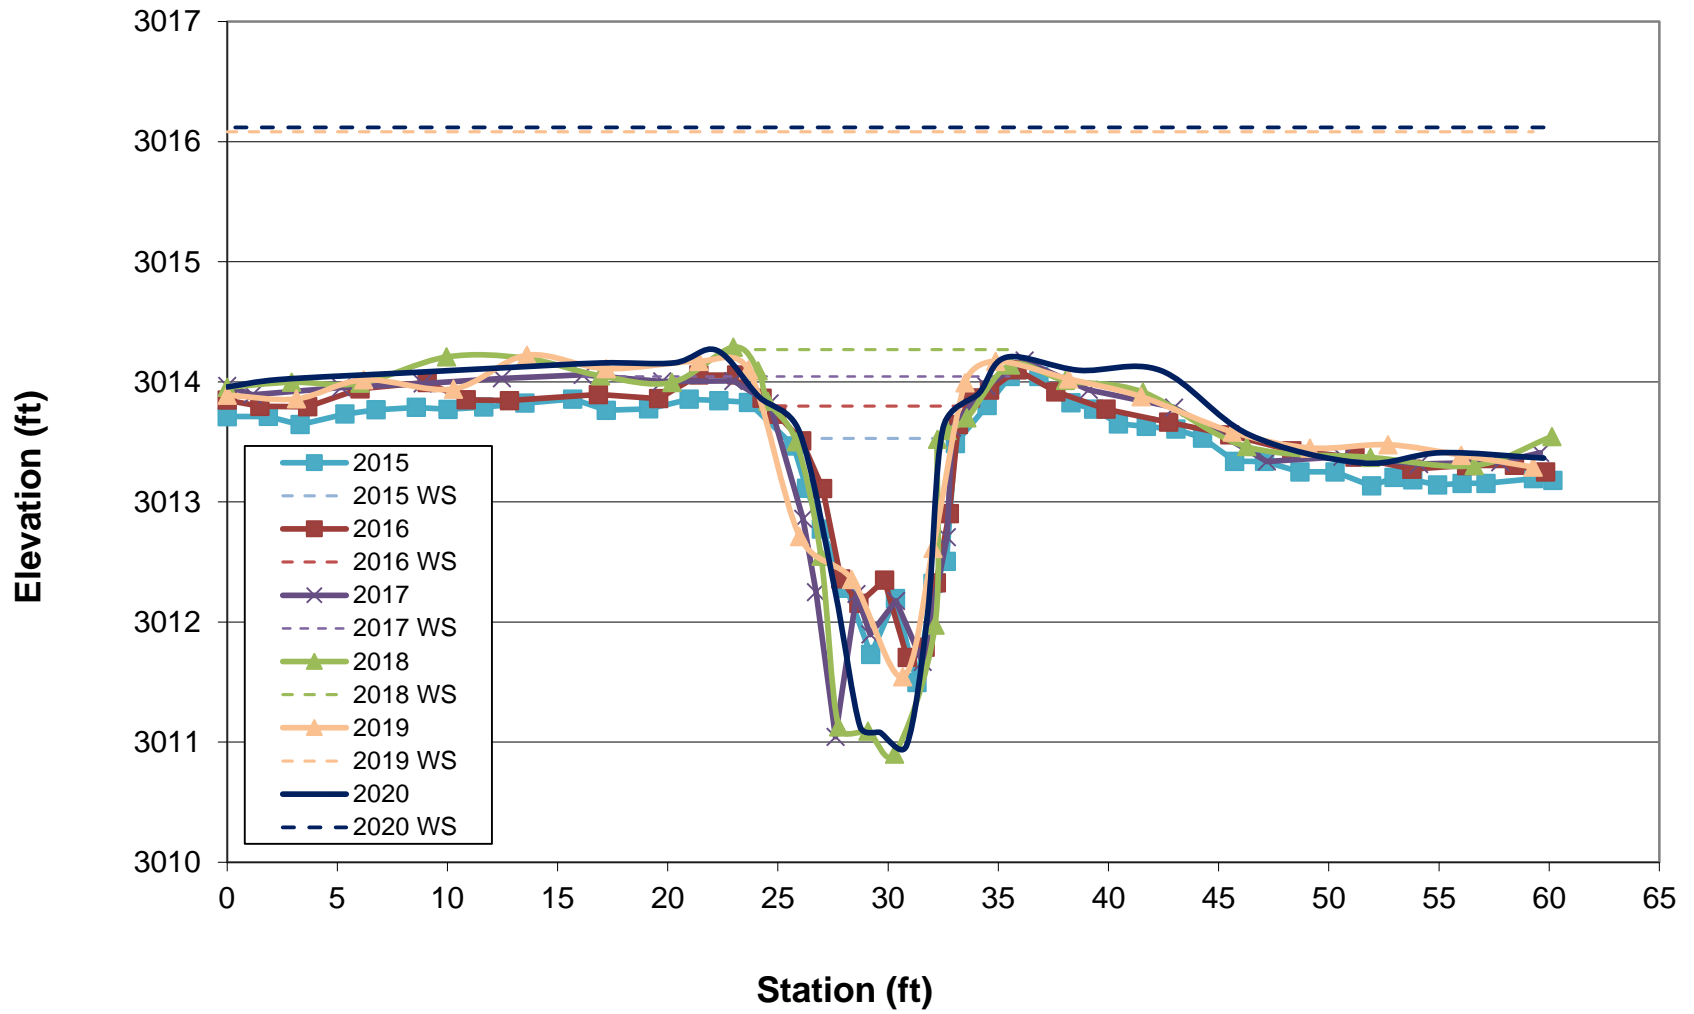
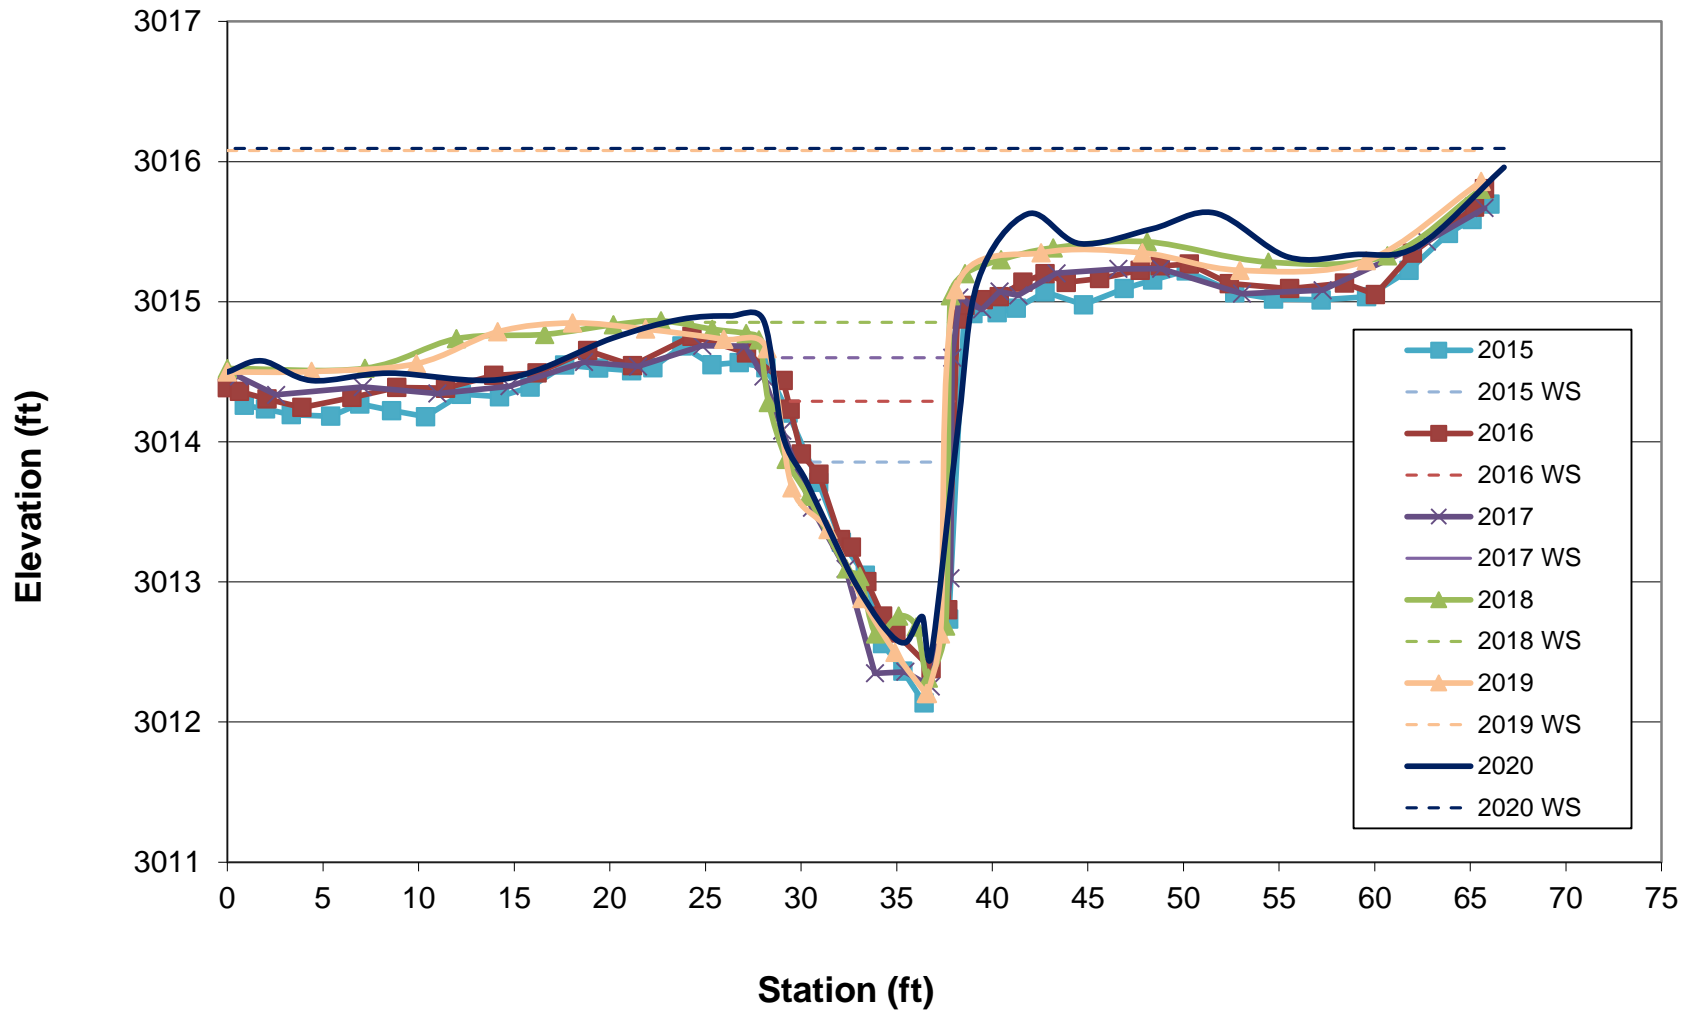
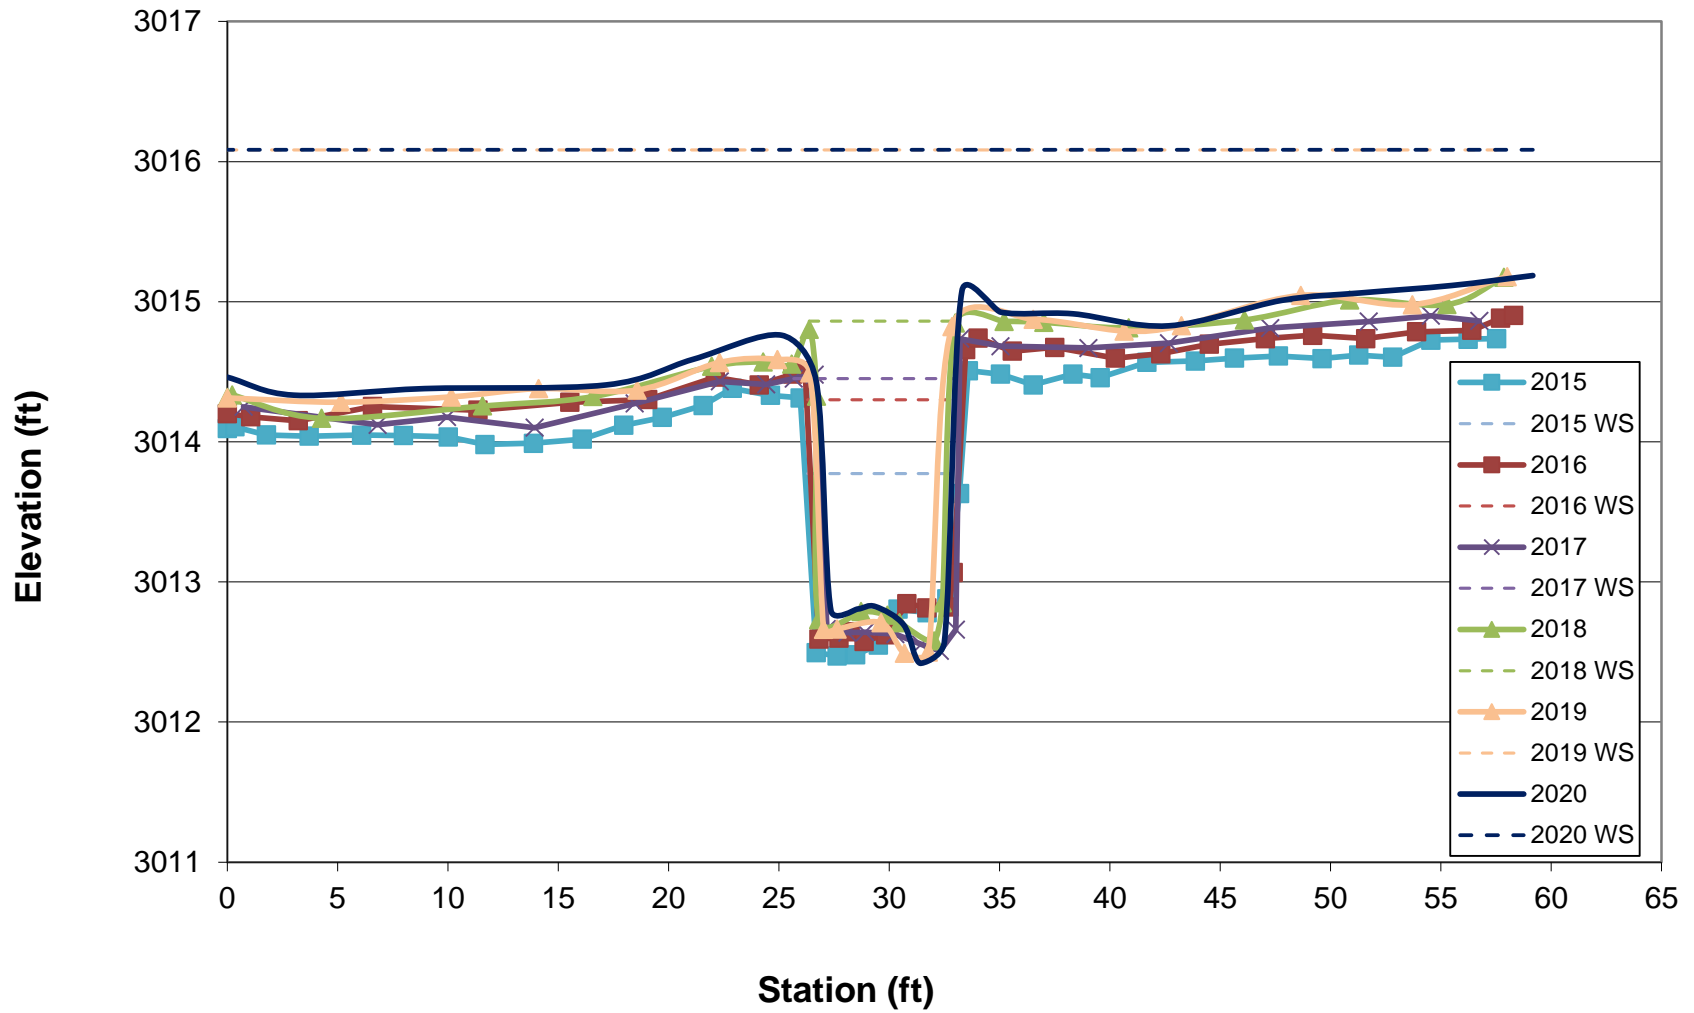
**Stream Monitoring** – The survey results for 11 permanent cross sections that were established along the constructed Coyote and Schrieber Creeks (Figure A-2, Appendix A) are shown in Appendix D. The 2020 data were compared to the previous surveys and discussions to assess stream channel stability. The banks of the constructed channels were generally well-vegetated and exhibited stable conditions. Consequently, no major channel morphological changes have been observed throughout any of the monitoring years.

The ephemeral reaches of Schrieber Creek are establishing at different rates. Reach SC1 is at a higher elevation, with a steeper longitudinal slope, and steeper bank slopes, which are all contributing to slower vegetation establishment. Reach SC2 is at a lower elevation with less steep bank slopes, and deep-rooted vegetation is becoming more established, likely due to the higher moisture availability. In 2020, vegetation identified along Reach SC1 included a dominance by shallow-rooted spreading bent (*Agrostis stolonifera*) and creeping wild rye (*Elymus repens*), with minimal cover from deep-rooted species such as reed canary grass (*Phalaris arundinacea*). As a result, Reach SC1 is not currently meeting the channel restoration success criteria; however, Reach SC2 is now meeting this success criteria. The downstream reaches of Schrieber Creek (Reaches SC3 and SC7) and both reaches of Coyote Creek (CC1A and CC1B) also meet the channel restoration success criteria as they are dominated by reed canary grass, which has a root stability index of 9.
