SCHRIEBER LAKE MITIGATION SITE

Project Overview

MDT Project Number: NH 27 (029) UPN # 1027007

Monitoring Year: 2022

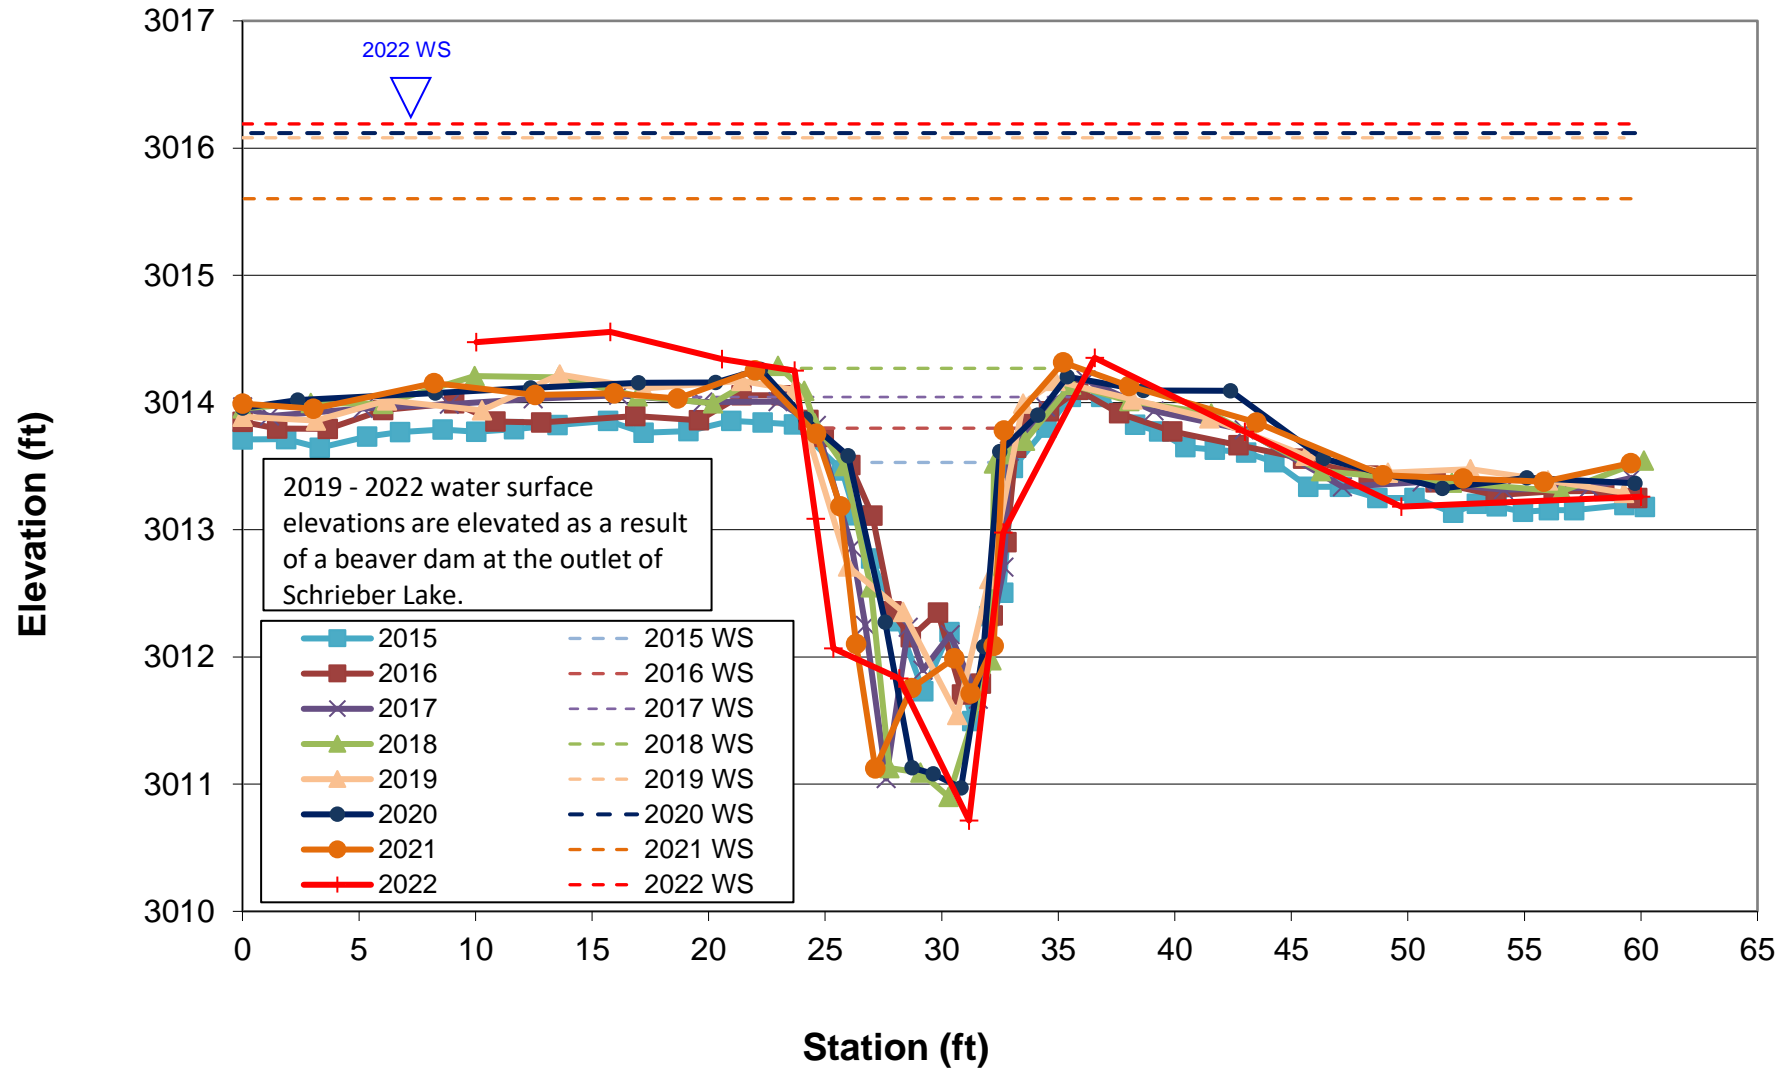
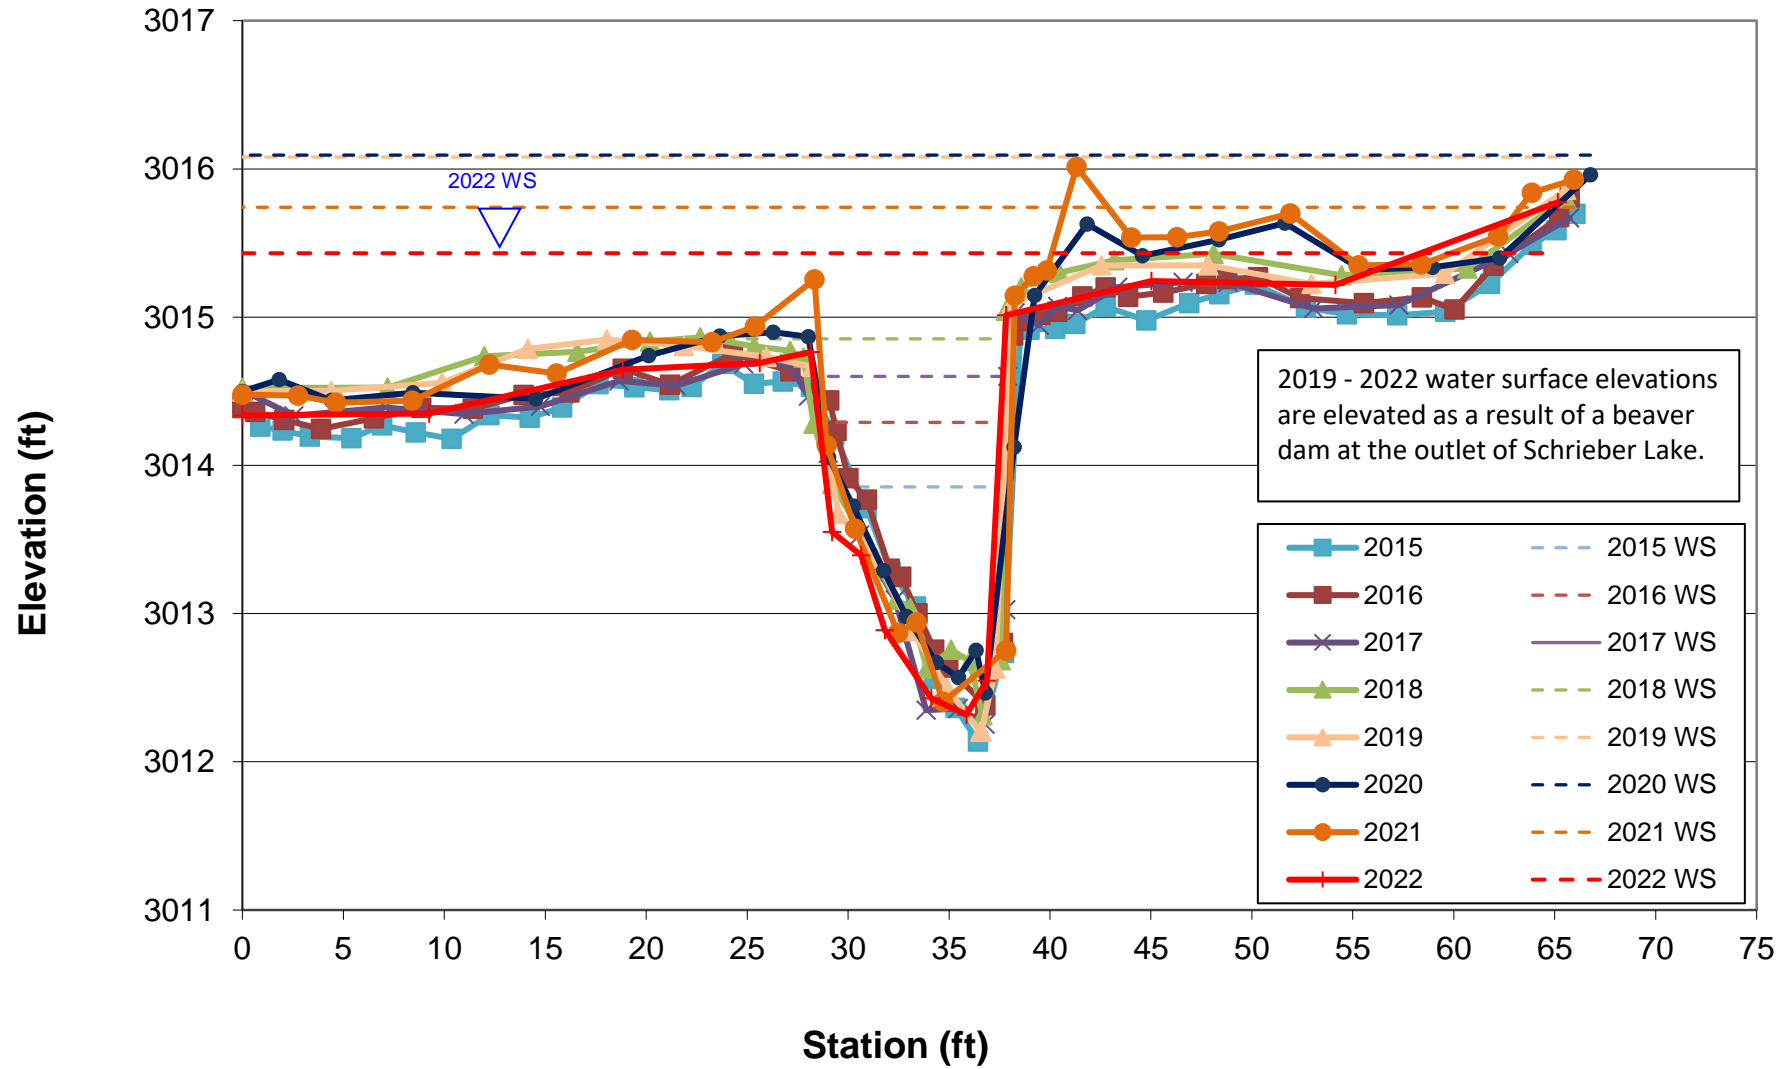
Stream Monitoring – The survey results for 11 permanent cross sections that were established along the constructed Coyote and Schrieber Creeks (Figure A-2, Appendix A) are shown in Appendix D. The 2022 data were compared to the previous surveys to assess stream channel stability. In 2022, the banks of the constructed channels exhibited stable conditions and were generally well-vegetated with deep-rooted plant species, except for Schrieber Creek Reach 1 (SC1). The stream monitoring survey indicates that little to no channel morphological changes occurred between 2021 and 2022. The nine cross-sections within the 2022 wetland boundary, exhibited surface water elevations lower than or equal to those surveyed in 2021 except SC7-1, which exhibited an approximately 0.5-foot surface water elevation increase. Surface water elevations across the rest of the transects decreased by 0.1 to 0.7 feet.
