Montana Department of Transportation Wetland Mitigation Monitoring Report

EASTON RANCH MITIGATION SITE

Monitoring Year: 2023

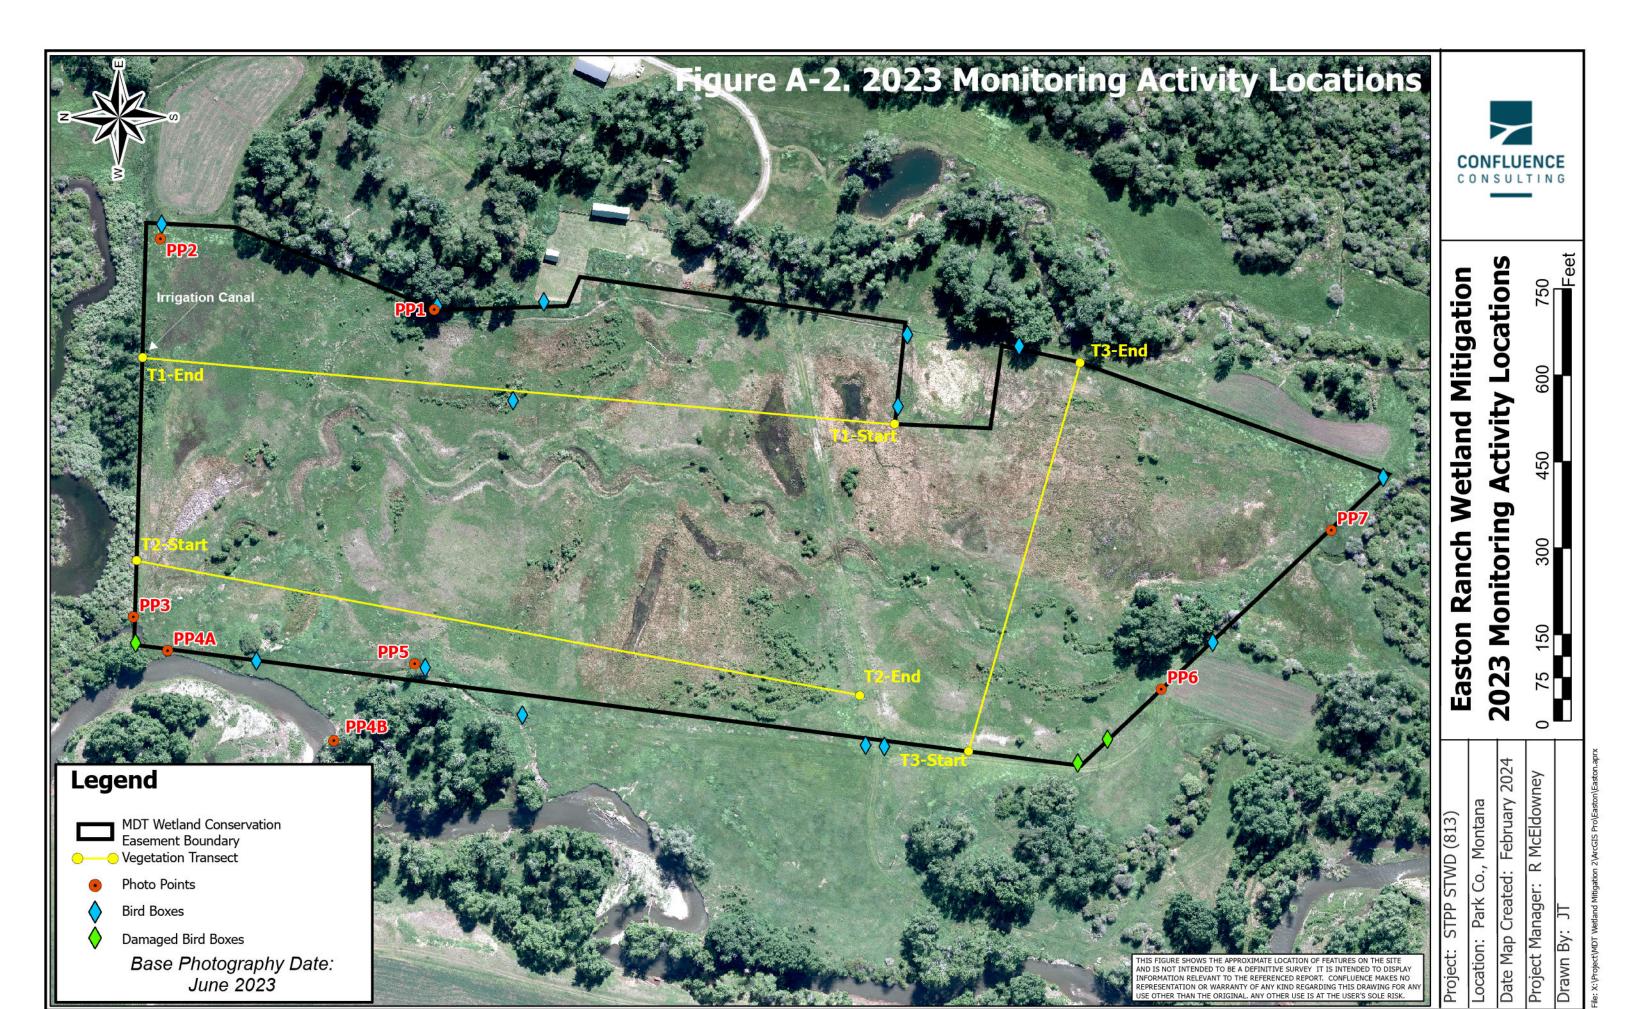
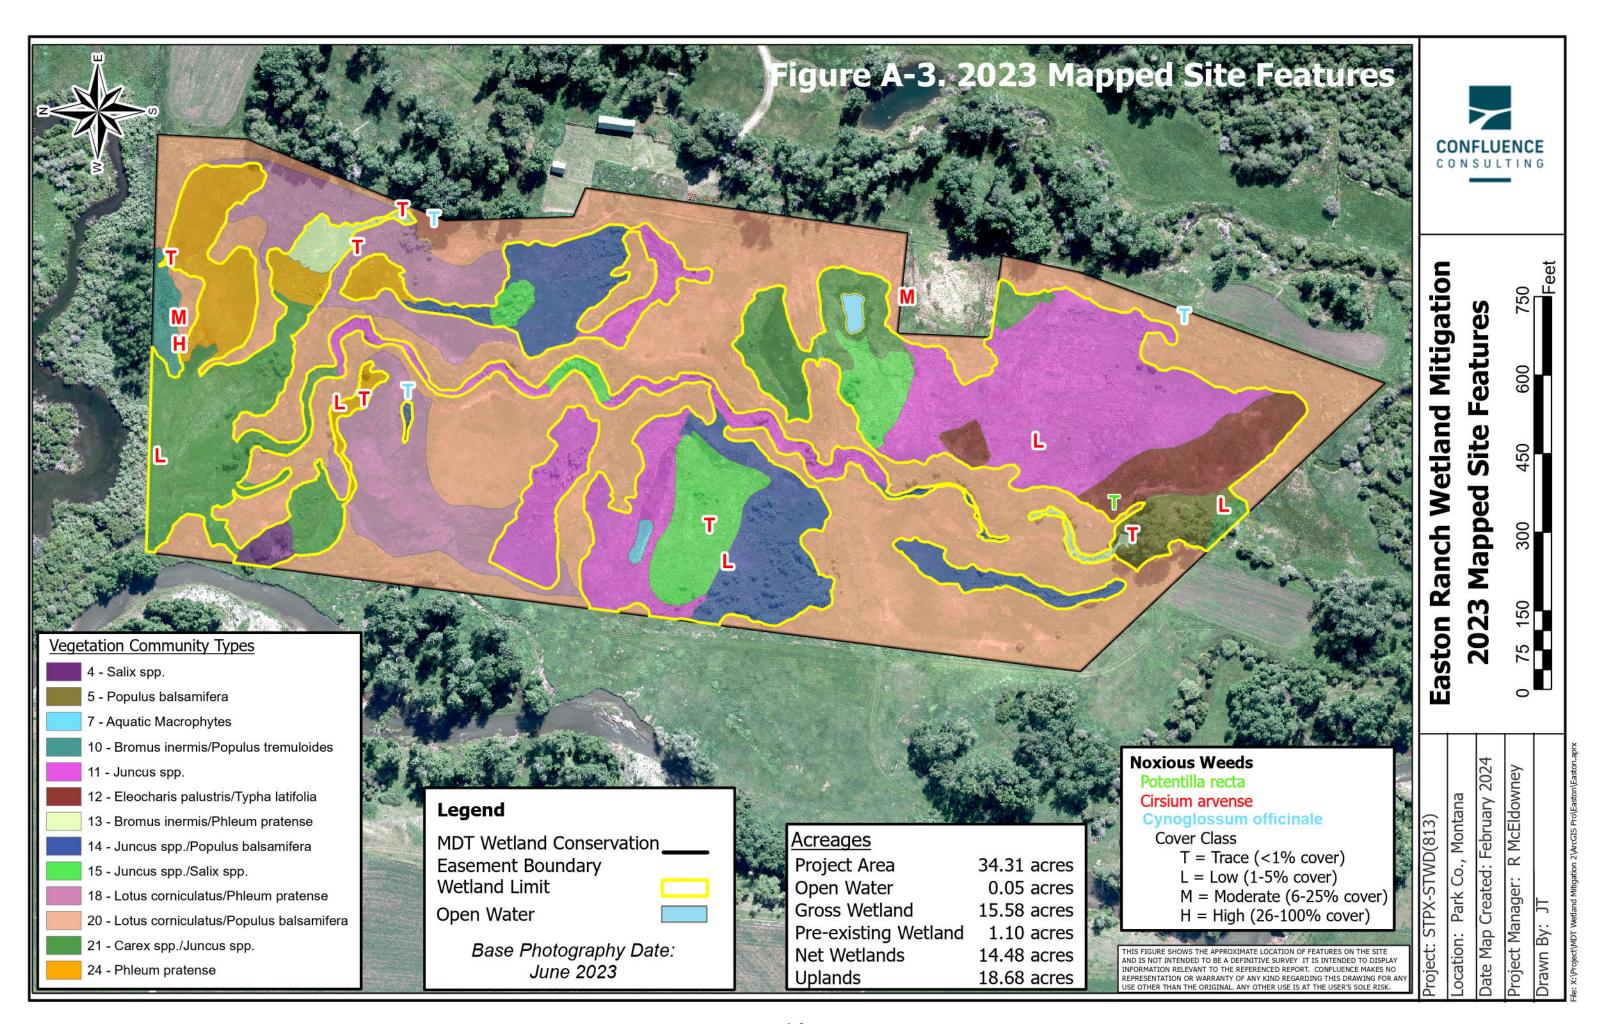
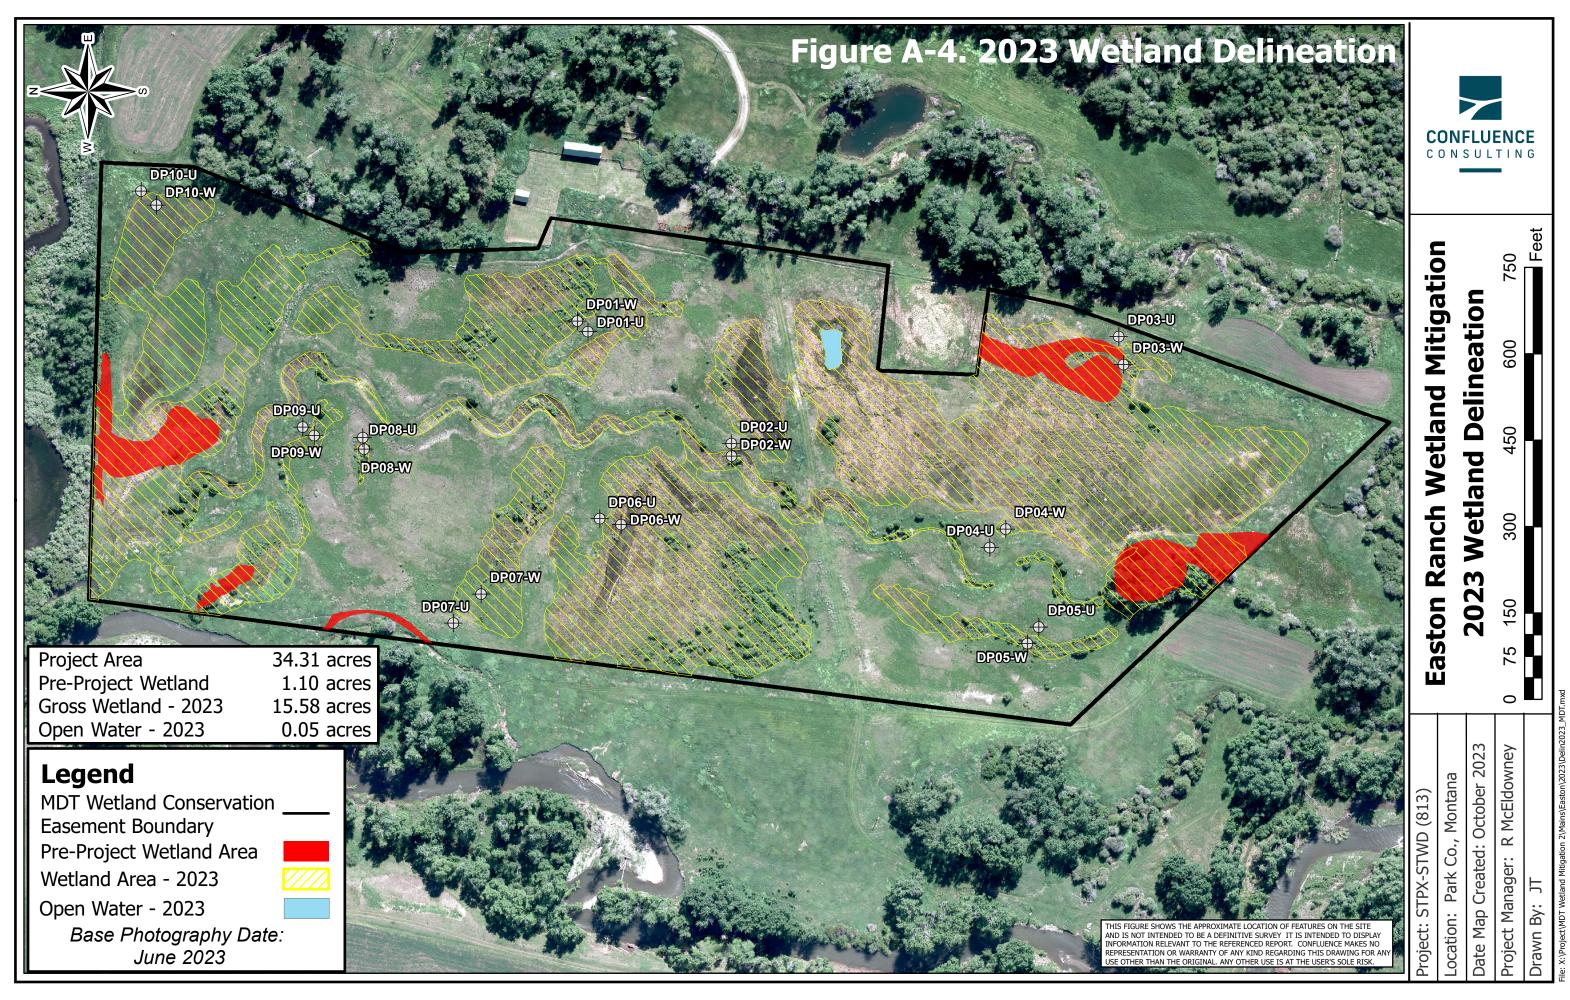
MDT Wetland Mitigation Monitoring Easton Ranch Park County, Montana

Project Area Maps/Figures: See Appendix A (Figure A-2 – 2023 Monitoring Activity Locations; Figure A-3 – 2023 Mapped Site Features; and Figure A-4 – 2023 Wetland Delineation)

During the June 2023 monitoring, new infestations of Canada thistle (*Cirsium arvense*), a Priority 2B noxious weed in Montana, were identified (Figure A-3, Appendix A). In addition, all of the Canada thistle infestations found in 2022 were also identified in 2023 for a combined total of 14 populations. All the Canada thistle infestations were less than 0.1-acre in size. Several of the population's cover class was rated as trace (< 1 percent), other populations were rated low (1–5 percent), two populations were rated moderate (6-25 percent), and one population was rated high (26-100 percent). Canada thistle infestations were found in both upland and wetland habitats. Canada thistle was observed in WT's 4, 5, 11, 14, 15, 20, and 23, and UT 10.

Infestations of gypsy-flower (*Cynoglossum officinale*), a Priority 2B noxious weed in Montana, were observed in 2023 (Figure A-3, Appendix A). All gypsy-flower populations were rated as cover class trace and located in UTs 13 and 18. In addition, a new population of the noxious weed sulphur cinquefoil (*Potentilla recta*), a Priority 2B noxious weed in Montana, was found in the southcentral portion of the site. Overall, annual weed management efforts have effectively controlled the spread of noxious weed populations across the site. However, a slight increase in weed cover was observed in 2023 compared to 2022, and one new weed species was found. MDT has an ongoing weed-control program that conducted weed management in the fall of 2023 and will continue in 2024.

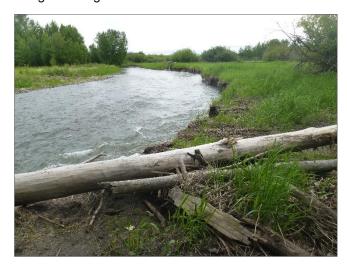
Photo Point: 4B Bearing: 20 degrees

Location: Shields Bank US Year: 2023 - 2021 location*

^{*} new (2021) photo point location due to bank loss during high flows in 2018.

Specific recommendations for any additional corrective actions: The MDT has an ongoing weed-control program and will continue weed treatments in 2024. Soil lifts and riprap installed along the bank of the Shields River in the northwestern corner of the site continue to erode. This bank area is generally dominated by shallow-rooting pasture grasses that provide little resistance to bank erosion. MDT will assess this bank erosion and discuss the potential need for adaptive management actions with the landowner and US Army Corps of Engineers. In addition, three bird boxes are not functioning and need repair.

Stream Bank Stabilization — During the spring 2013 high-flow event, significant bank erosion occurred immediately upstream of PP4B. This erosion exposed the riprap and undermined the riprap and coirwrapped soil lifts along an approximately 85-foot-long reconstructed bank, which caused significant loss of soil and willow cuttings. Photo point PP4B, located at the south end of the reconstructed bank, had to be relocated because of bank erosion and woody debris accumulation. Additional bank erosion has been noted since the dramatic lateral cutting event of 2013, and this bank section remains exposed and vulnerable. The 2018 runoff period was supported by above-average precipitation in June. From 2019 through 2023, bank erosion continued along the downstream (south) portion of the 85-foot-long bank and resulted in areas of undercutting and loss of finer textured subsoils.
