Montana Department of Transportation Wetland Mitigation Monitoring Report

KINDSFATER MITIGATION SITE

MDT Project Number: STPX 56 (56) UPN # 5034

Monitoring Year: 2023

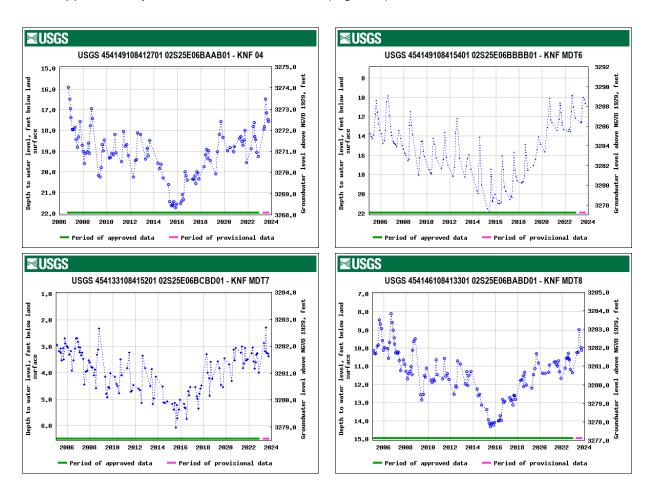
Figure 1. USGS Groundwater Well Data from 2006-2023

Long-term groundwater monitoring of four wells conducted by the US Geological Survey (USGS) at the Kindsfater site indicates that groundwater levels steadily declined from 2006 through 2015, potentially a result of prolonged drought conditions in the region and de-watering by the active gravel operation to the north of the site (Figure 1). According to the USGS, groundwater elevations in some areas of the site are also influenced by the active gravel mining operation north of the site and, to a lesser extent, by a large irrigation canal just south of the site (USGS, 2020). Groundwater levels within the site have steadily increased since 2015, which may be a result of higher-than-average precipitation in the region. Monitoring efforts completed

by the USGS in 2023 show groundwater levels have followed a similar pattern across the site and have ranged from a high of roughly 2.2 feet below ground surface (BGS) at well MDT7 to a low of approximately 22 feet BGS at well MDT6 (Figure 1).

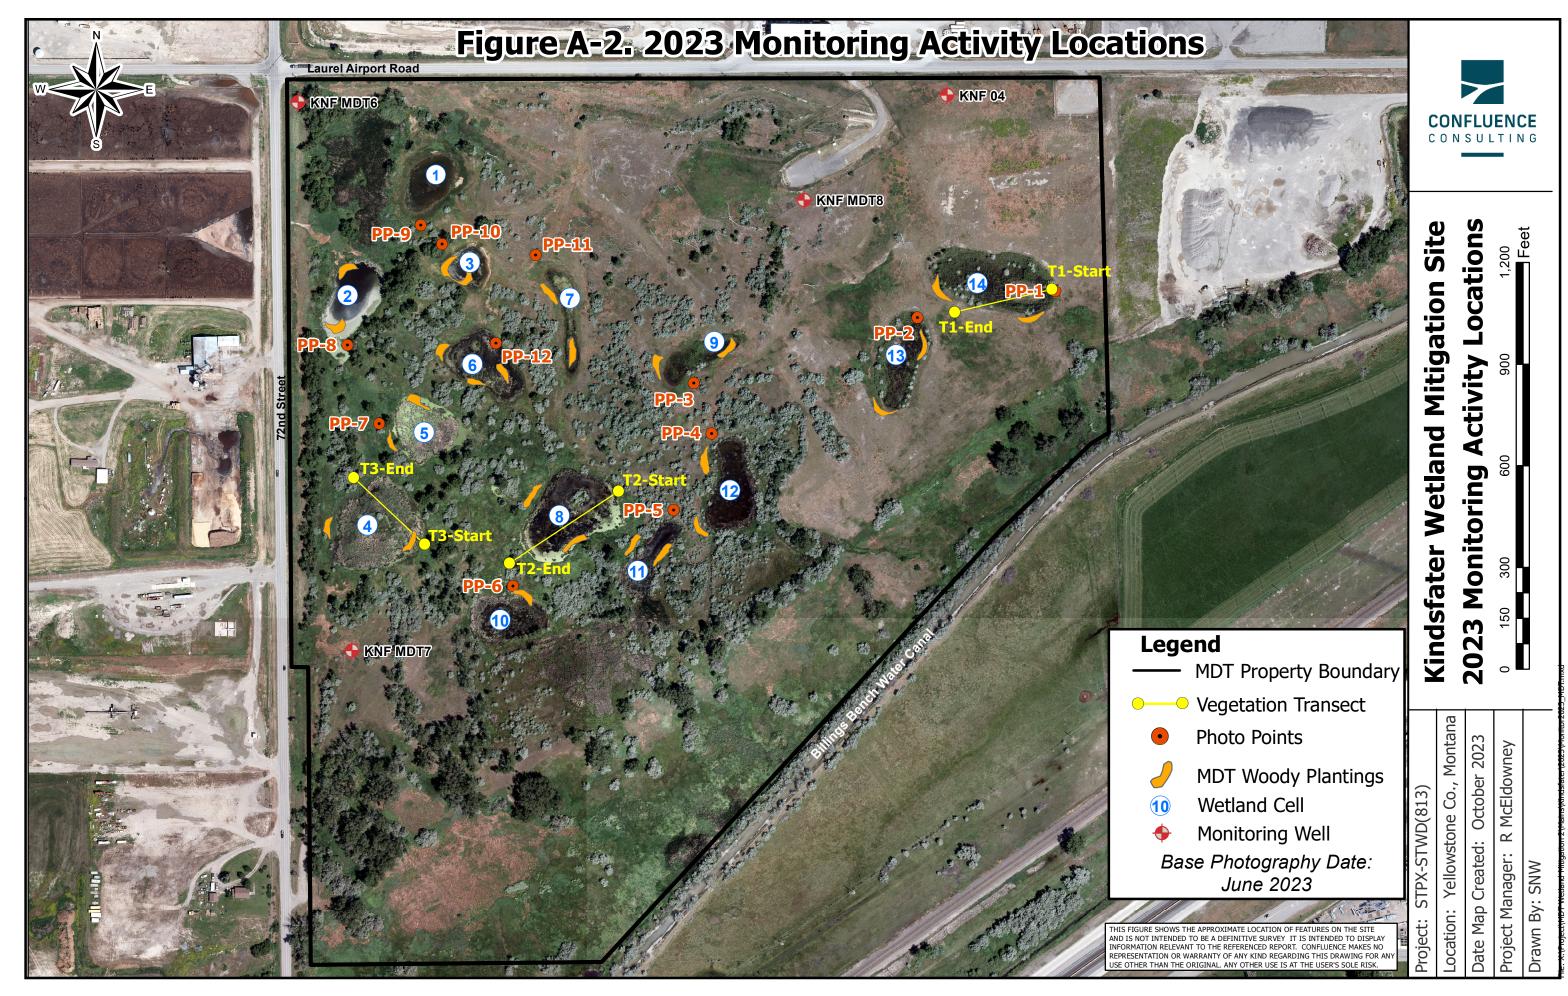
Cuttings and containerized materials were planted in approximately 27 clusters (Figure A-2, Appendix A) around the Kindsfater site following construction completion. The woody planting zones were generally located around the excavated wetland cells. The success criteria of at least fifty percent survival of woody plants after five years was not met during the fifth monitoring event in 2017. Planting clusters were observed in 2023, and the survival rate appeared to be consistent with that reported in 2022. Volunteers of Rocky Mountain juniper (*Juniperus scopulorum*), Woods' rose (*Rosa woodsii*), and silver buffalo-berry (*Shepherdia argentea*) were observed in the mitigation site. Additionally, Eastern cottonwood (*Populus deltoides*), narrow-leaf willow (*Salix exigua*), and yellow willow (*Salix lutea*) in wetland cells 9, 13, and 14 are thriving and expanding. The planted and surviving species are listed on the Wetland Mitigation Site Monitoring form (Appendix B).

Approximately 27 woody planting areas were mapped by MDT in 2013, generally located around the excavated basins. Locations for the planted vegetation are shown on Figure A-2. Survival of woody plantings was not quantitatively assessed during the 2023 monitoring event because the success criteria is tied to survival after a five year period. However, volunteer woody species (Salix spp. and Populus spp.) are observed across the site, particularly in the excavated wetland cells in the east portion of the site. The woody vegetation provides important structural and habitat diversity for birds and other wildlife.
