Experimental Feature Evaluation December 2022

Experimental Feature:	Chip Seal Comparison: CRS-2p and CHFRS-2p
Location:	Great Falls District, Hill County, US Hwy 2, RP 354.60 –
	RP 372.14
MDT Project Name:	Gildford – East
MDT Project Number:	NH 1-6(123)355[9393]
Experimental Project Number:	MT-20-02
Principle Investigator:	Chad DeAustin, Experimental Project Manager (ExPM)
Technical Contact:	MDT Surfacing
Construction Date:	Paved August 2019, Chip Seal June 2020
Date of Inspections:	September 2021, June 2022

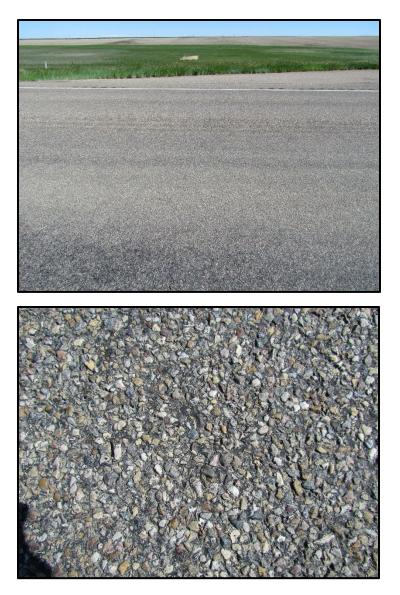
← Transverse surface view near RP 354.6. West end of the project, CRS-2p emulsion with CSS-1h fog seal. Normal wear was noticed.

← Close-up views of the chip seal surface and texture.

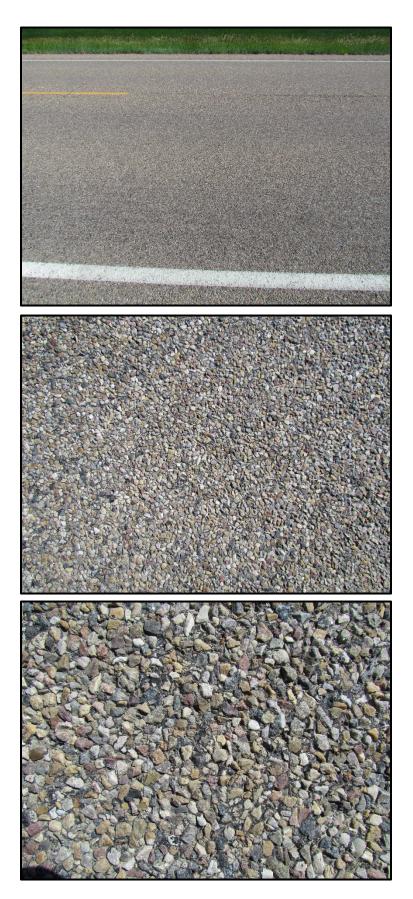
← Transverse view near RP 359. CRS-2p emulsion without fog seal section. This section experienced some chip loss at the centerline. See next page for examples.

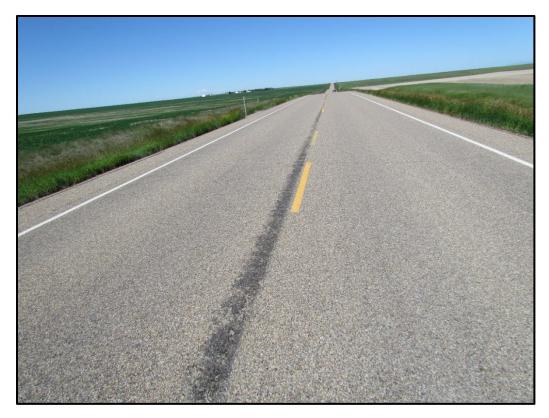
Section 1 with CRS-2p and a CSS-1H fog seal, showed no change in condition from 2021 and normal wear a was noticed. The CSS-1H was still noticeable. Section 2 also showed little change from 2021 with a small section of centerline chip loss near RP 361. Section 3 had the most chip loss. It was seen mostly between RP 367 and RP 368 only at the centerline. The driving lanes of all three sections showed no mentionable change or discernable differences.

♠ View of centerline chip loss near RP 361.

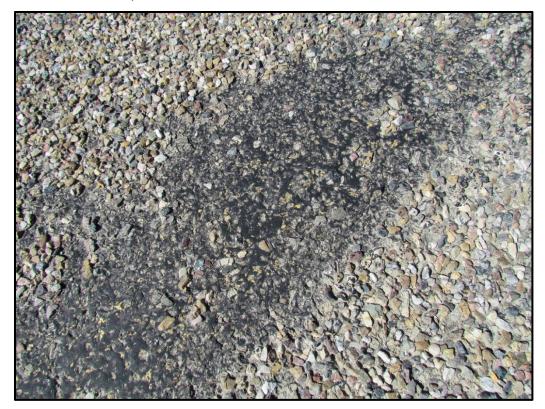
↑ Close-up of centerline chip loss.

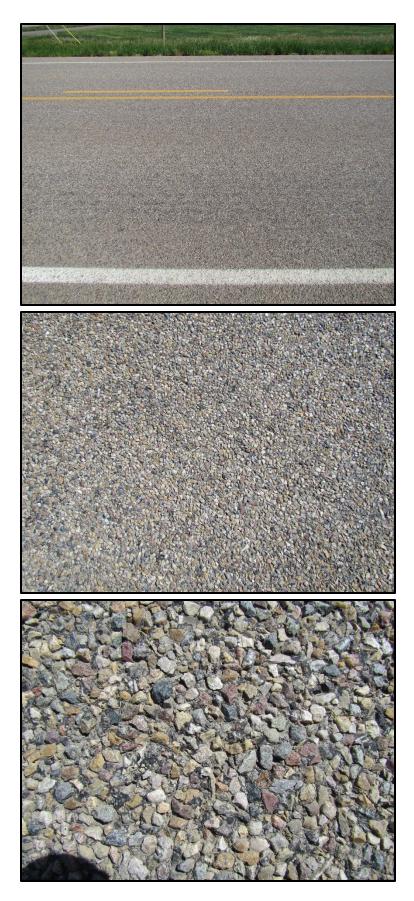
← Transverse view near RP 359. CHFRS-2p emulsion without fog seal section. This section also experienced some chip loss at the centerline. See next page for examples.

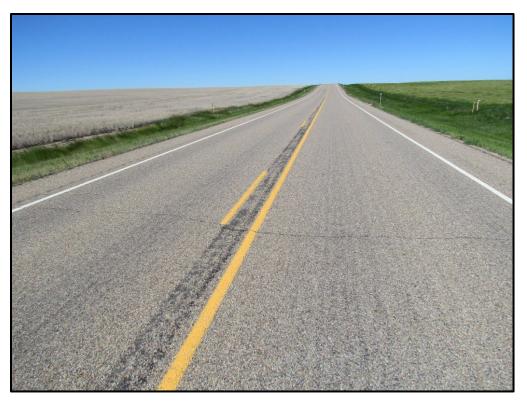
↑ View of centerline chip loss near RP 367. This loss occurred mostly between RP 367-368 and covered almost the entire mile.

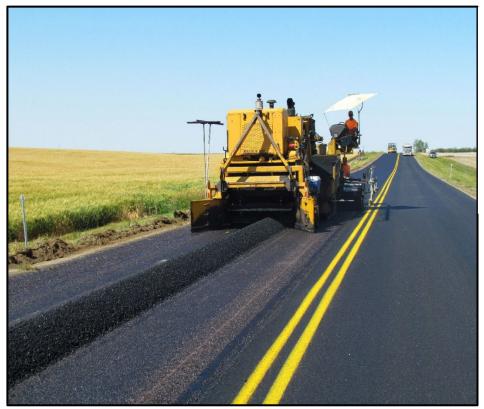
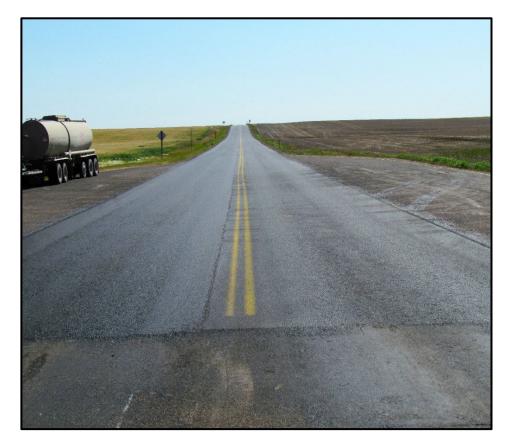
← ♥ Representative images of paving using ½ inch Grade S PMS with PG 64-28 binder.

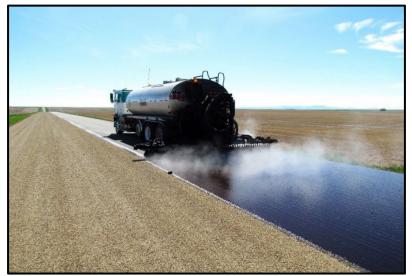
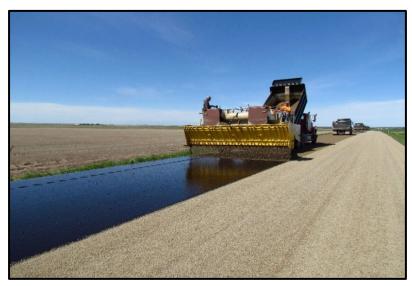
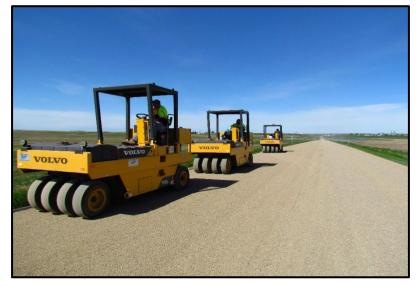
← ♥ Representative images of project CRS-2P emulsion application, chipping phase with type 1 chips, and pneumatic nine-wheel compaction.

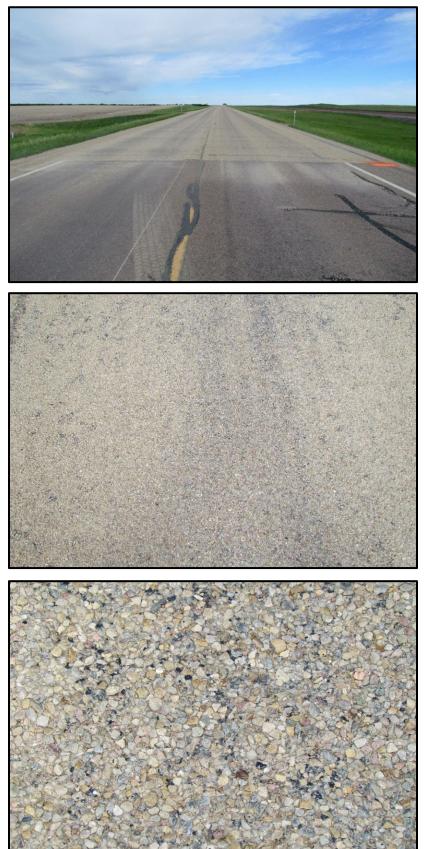
← Completion of CHFRS-2p section after sweeping. View is at east end of project at RF 372, view west.

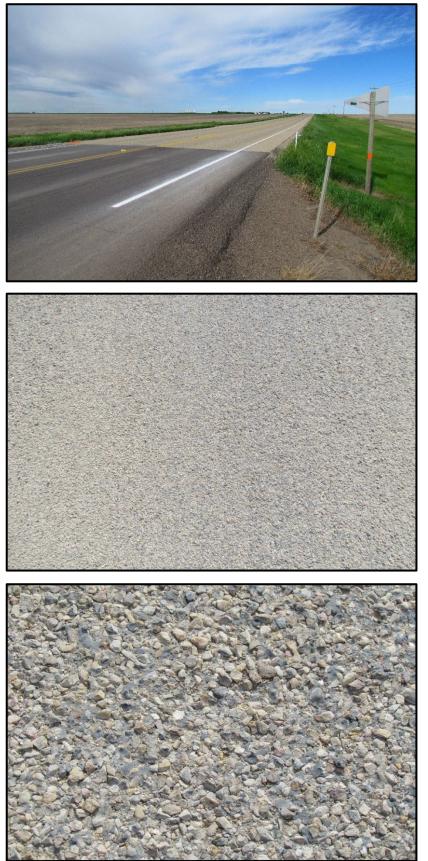
← Completion CRS-2p without fog seal section after sweeping. View is at RP 363, view west.

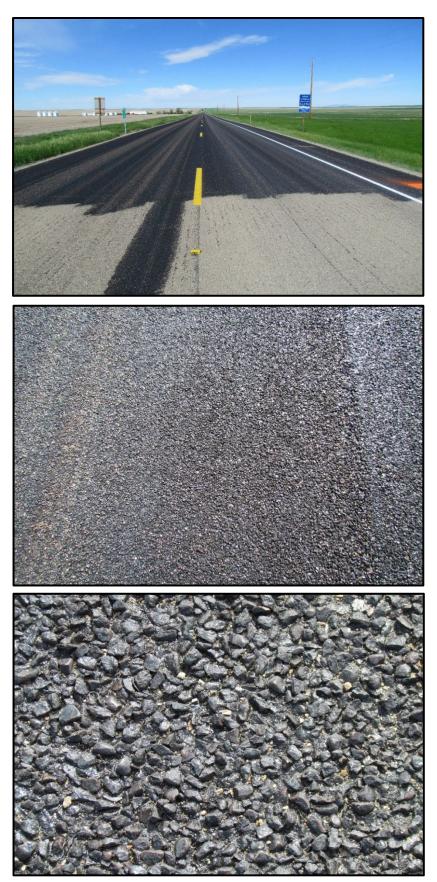
← Begin of CSS-1H fog application on CRS-2p section at RF 359 view west.

←♥ Several images of fog seal and chip texture.

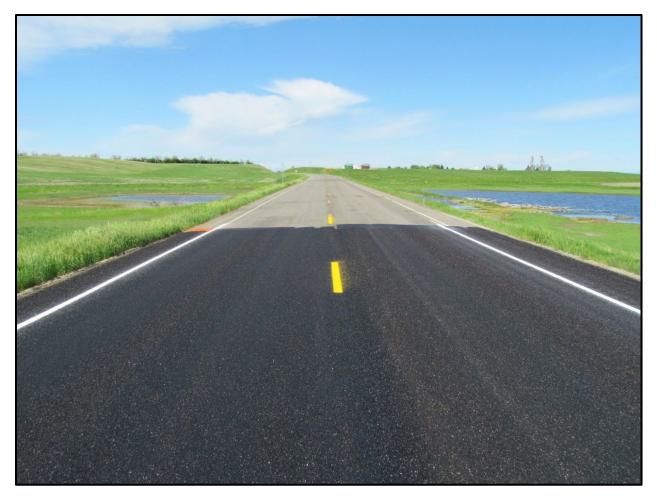
♠ End of CSS-1H fog seal over CRS-2p project section; west end, view west at approximate RP 355.
