RELATIVE OPERATIONAL  
PERFORMANCE OF GEOSYNTHETICS USED  
AS SUBGRADE STABILIZATION

FHWA/MT-14-002/7712-251

*Final Report*

Western Transportation Institute  
Montana State University - Bozeman

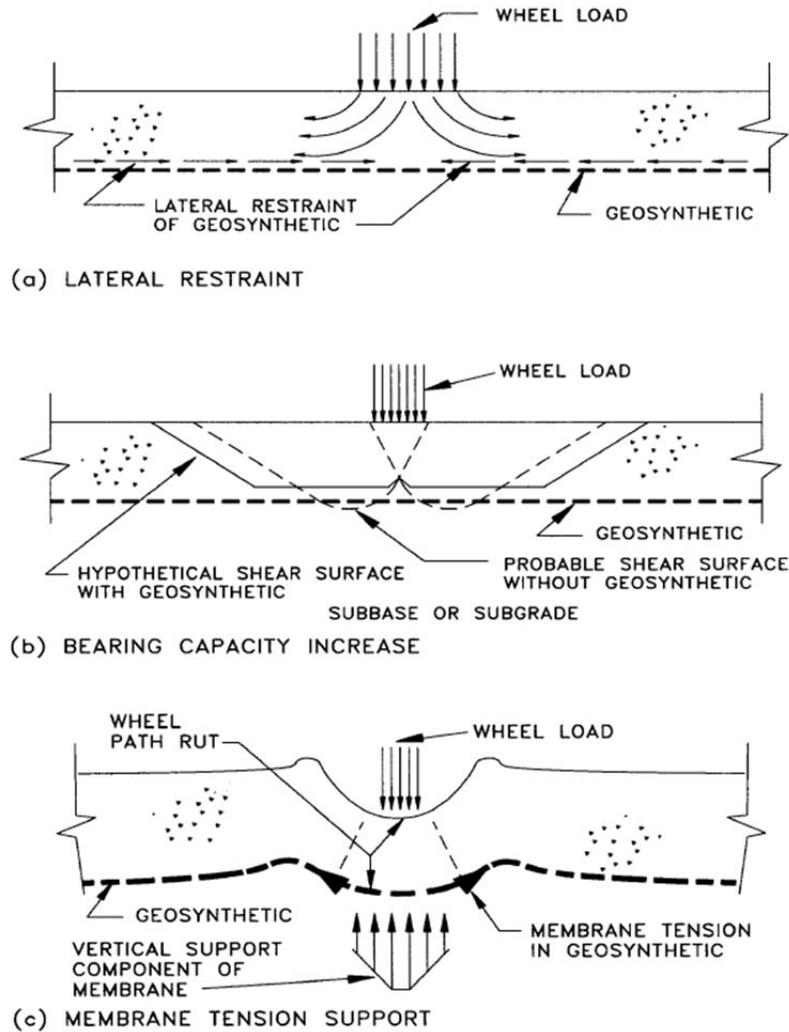
**Figure 1: Possible reinforcement functions provided by geosynthetics in subgrade stabilization applications (from Haliburton et al., 1981).**

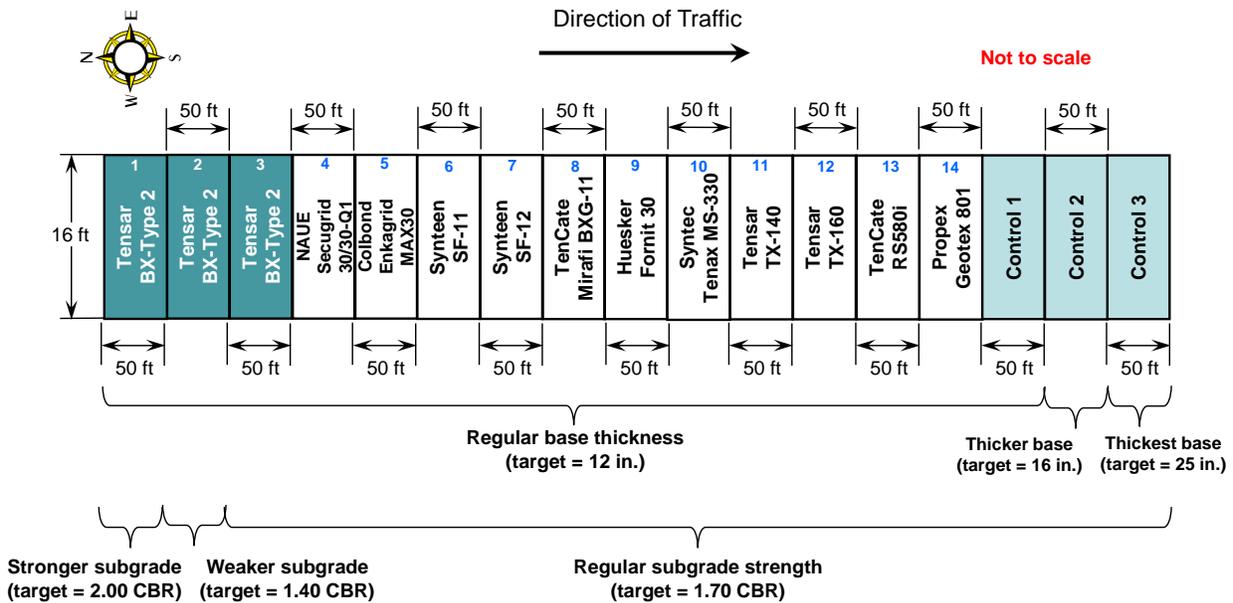
**Figure 2: General layout of test sections with target construction parameters.**

Design of this project is based on a single-lane, gravel road that is built on 3 ft. of soft subgrade above a strong, stable substrate. A trench was excavated so the final grade of the test site was similar to the surrounding grade (i.e., the existing taxiway). The size of the excavation was 16 ft. wide by 3 ft. deep to sufficiently minimize boundary affects from the trench walls and foundation. A length of 860 ft. was necessary to evaluate 14 geosynthetic test sections and three control sections. The bottom of the test pit was tapered at the ends to facilitate movement of the construction equipment into and out of the pit. The tapered area was in addition to the 860 ft and was not included in the experiment.

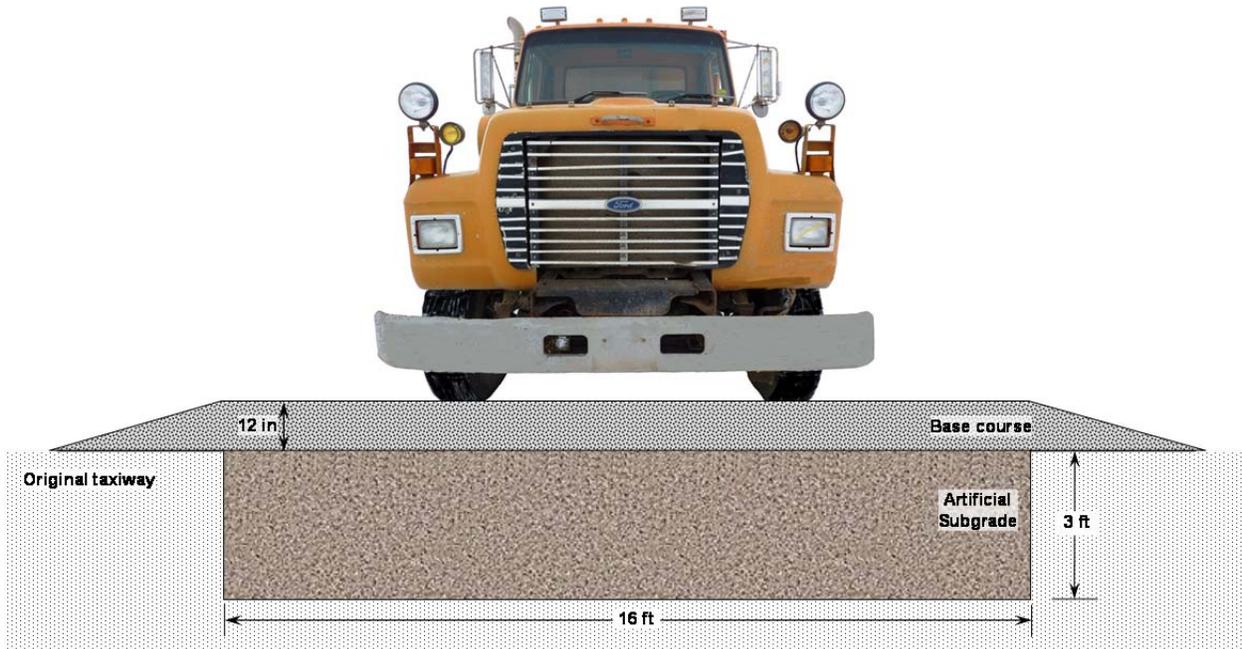
**Figure 3: Cross-section of field test section with truck (truck scaled to approximate size).**

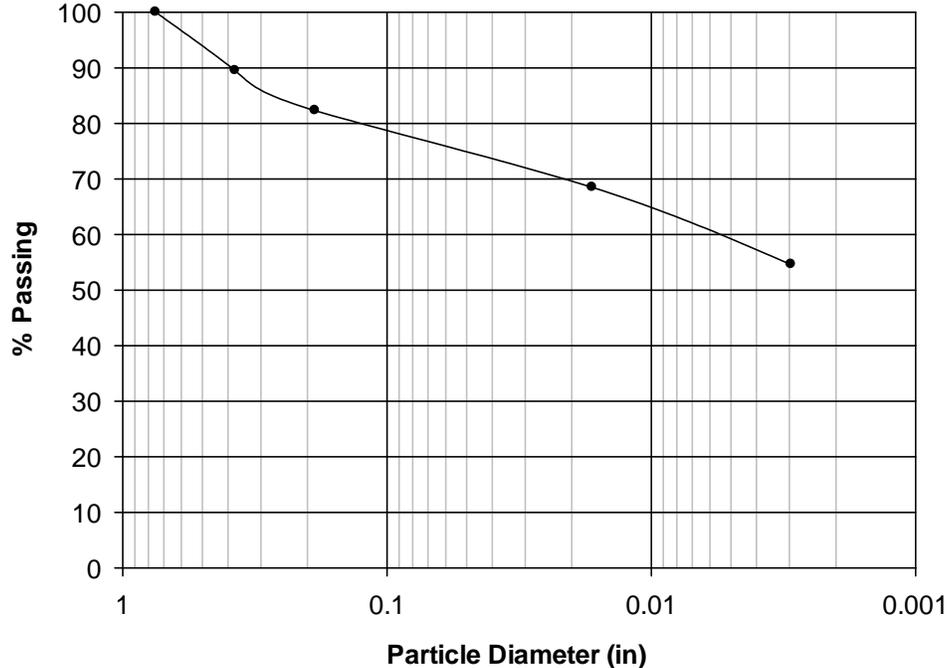
**Figure 4: Grain-size distribution of the artificial subgrade soil.**

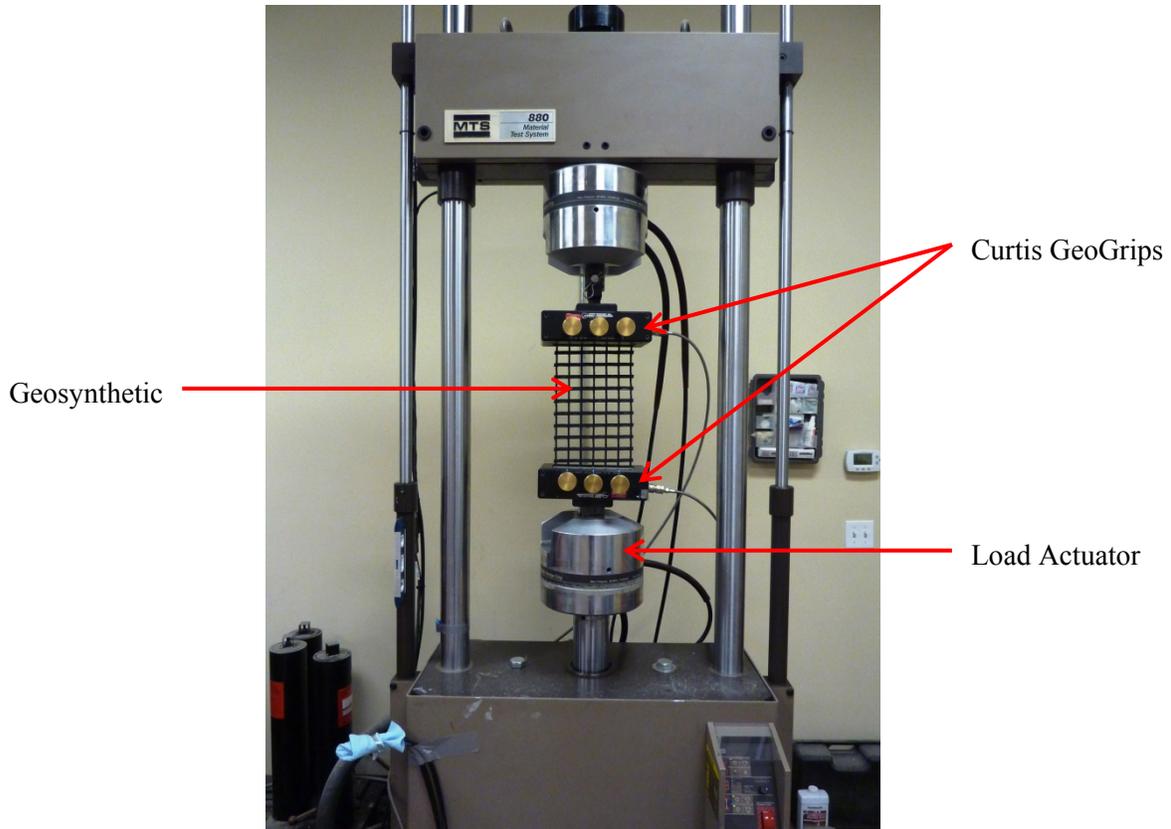
**Figure 8: Wide-width tensile strength test setup.**

The wide-width tensile strength test is used to determine the force-elongation curve of the geosynthetic in its two principal directions. A MTS servo-hydraulic load frame was used to conduct the wide-width tensile testing. The geosynthetics were held on both ends by Curtis Sure-Grip Geosynthetic Grips which apply pressure to the geosynthetics using a pneumatically driven hydraulic system. The grips can accommodate a sample up to 8 inches wide and have a capacity of 10,000 lbs. The setup for a typical wide-width tensile test is shown in Figure 8.

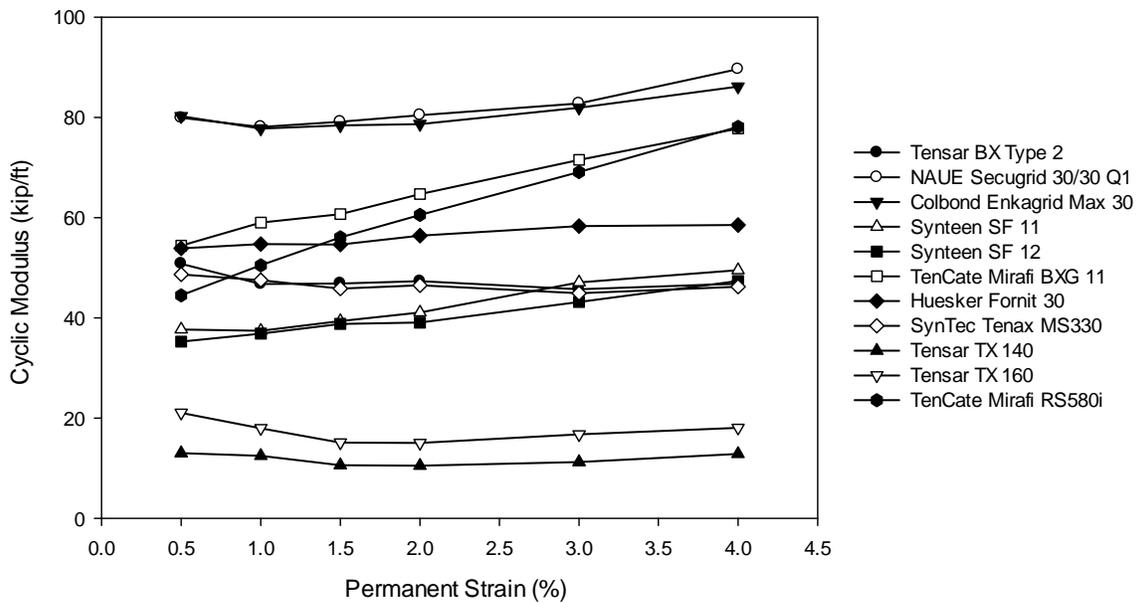
Figure 9: Cyclic tensile modulus summary - machine direction.

The equivalent force per unit width is calculated for the last 10 cycles of each cyclic load step and averaged together to determine a single cyclic tensile modulus for each load step. The Propex Geotex 801 material was not tested because it has low strength at small strains and would not yield a representative cyclic tensile modulus. The results from the cyclic tensile modulus tests conducted by WTI are summarized in Figure 9 and Figure 10. Representative load-displacement results in the machine and cross-machine directions are shown for each geosynthetic in Appendix B.

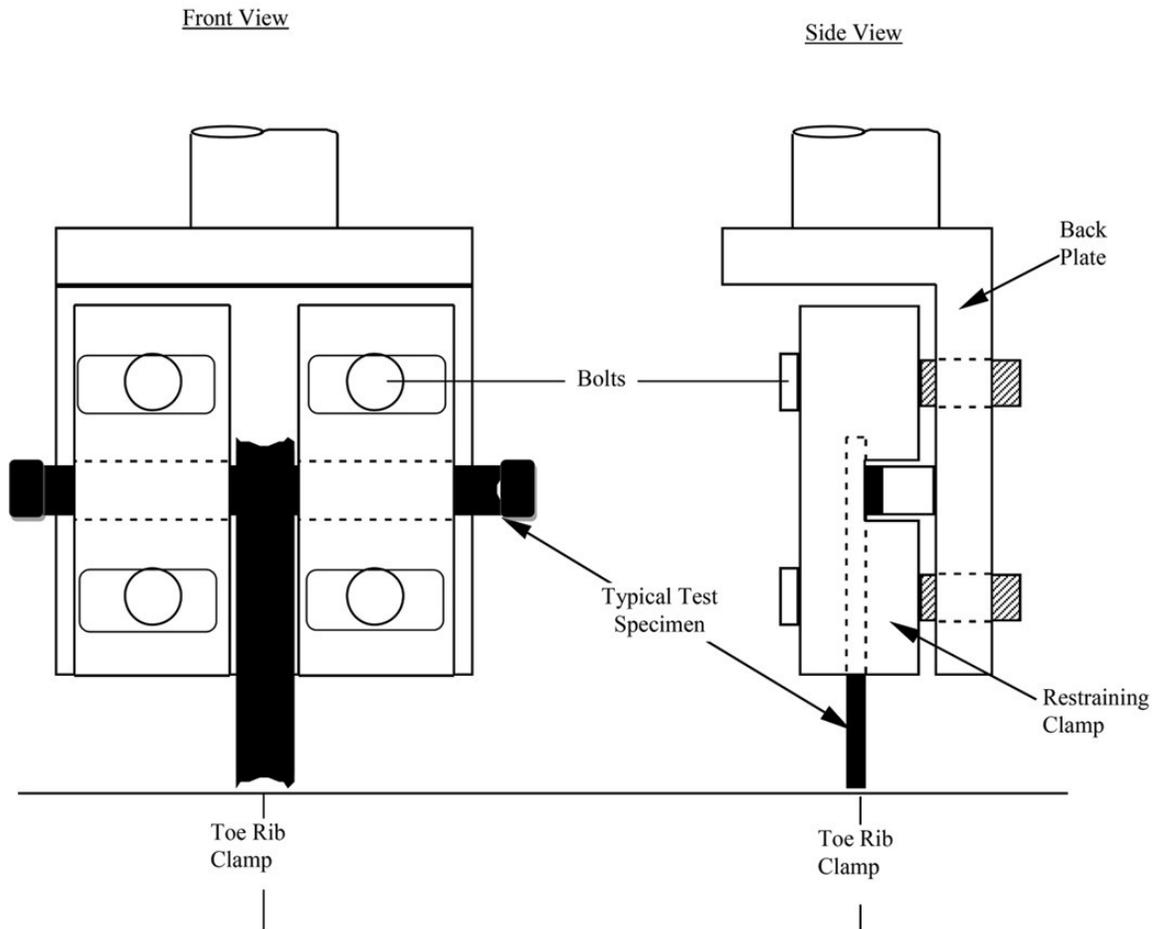
**Figure 13: Typical junction strength test specimen setup (from ASTM D 7737).**

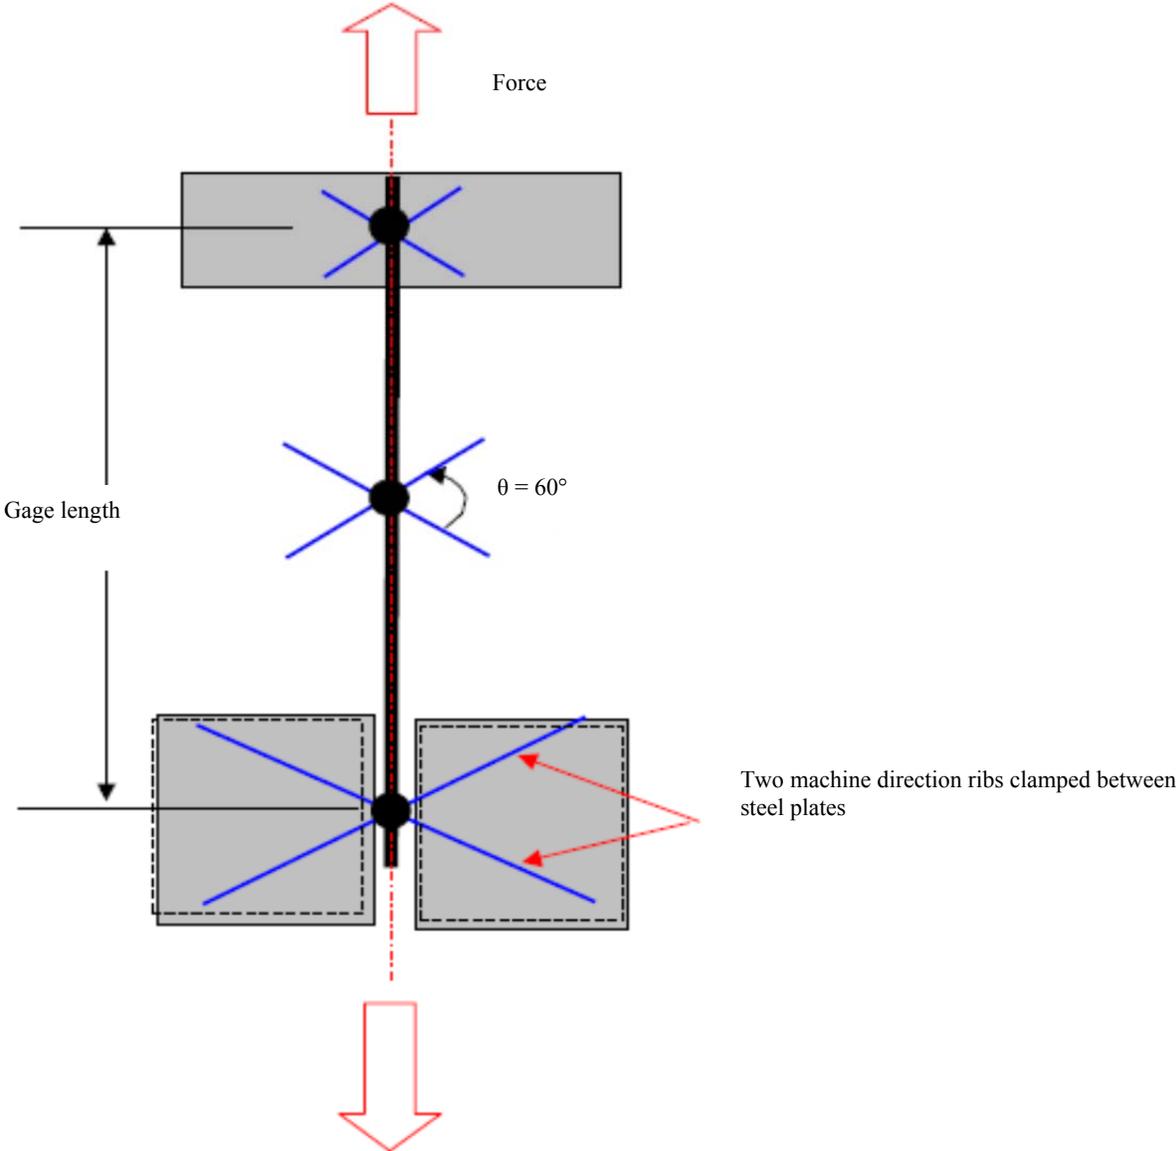
Figure 14: Modified junction strength specimen setup for Tensar TX140 and TX160 geogrids.

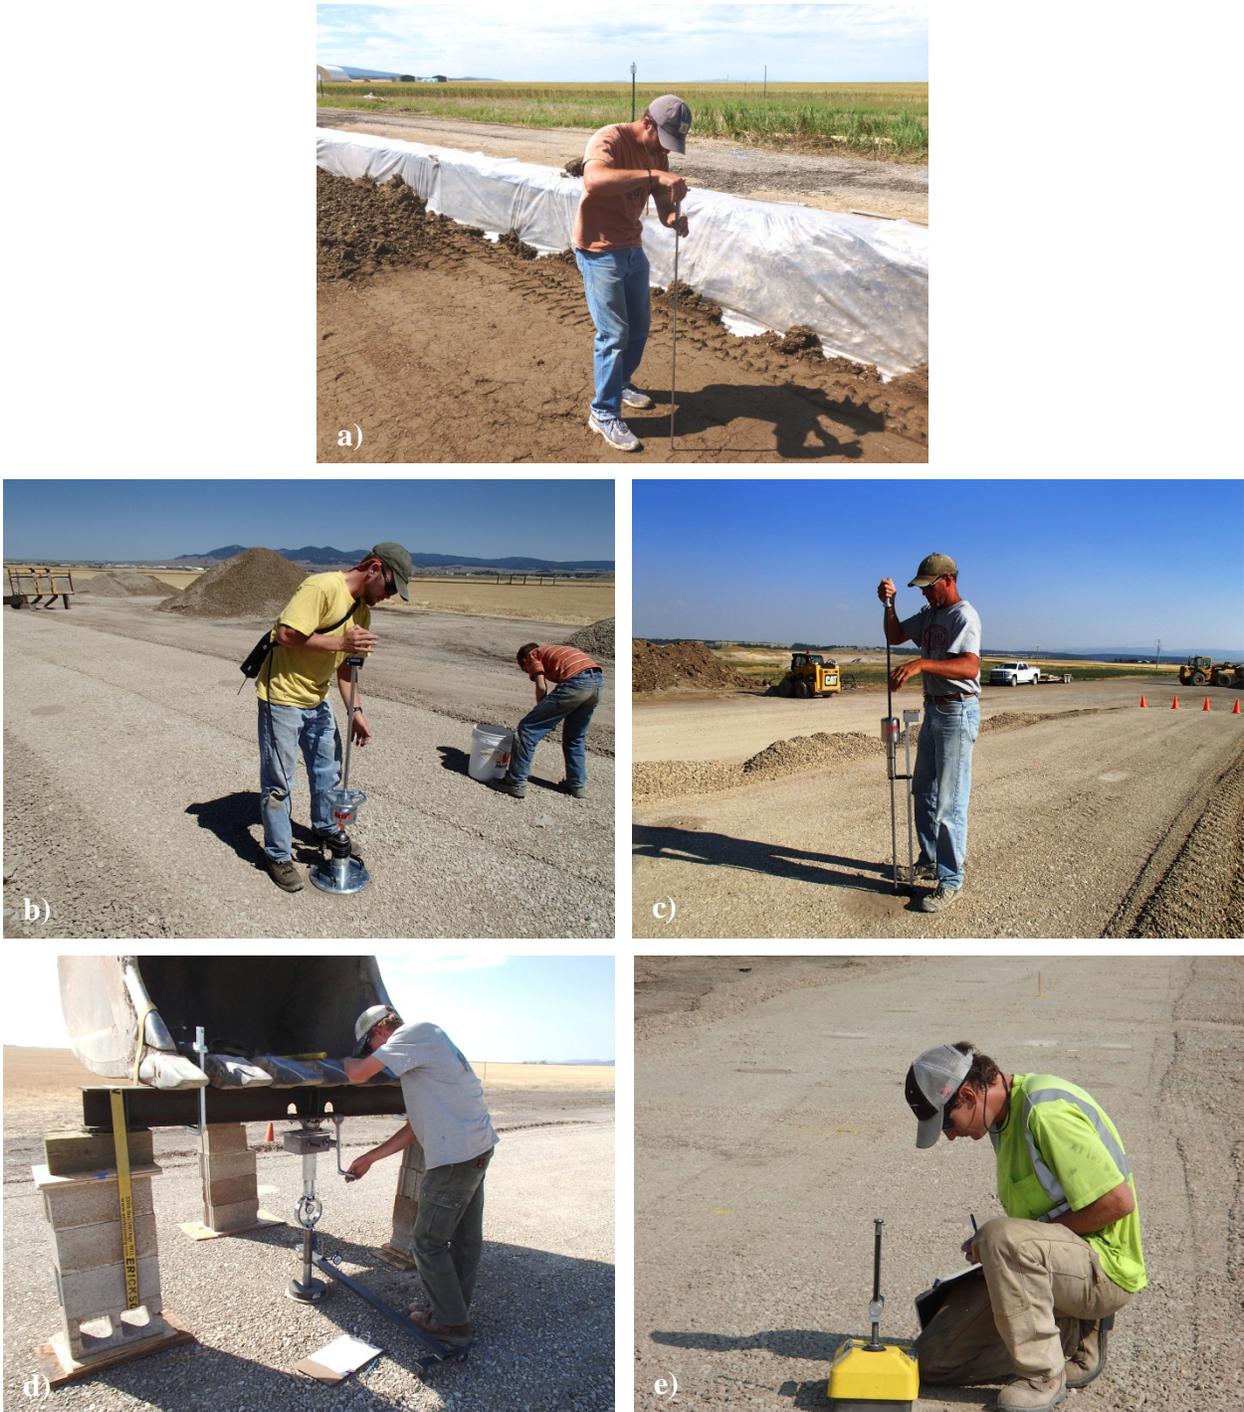
**Figure 17: Construction quality measuring devices: a) vane shear, b) LWD, c) DCP, d) in-field CBR, and e) nuclear density.**

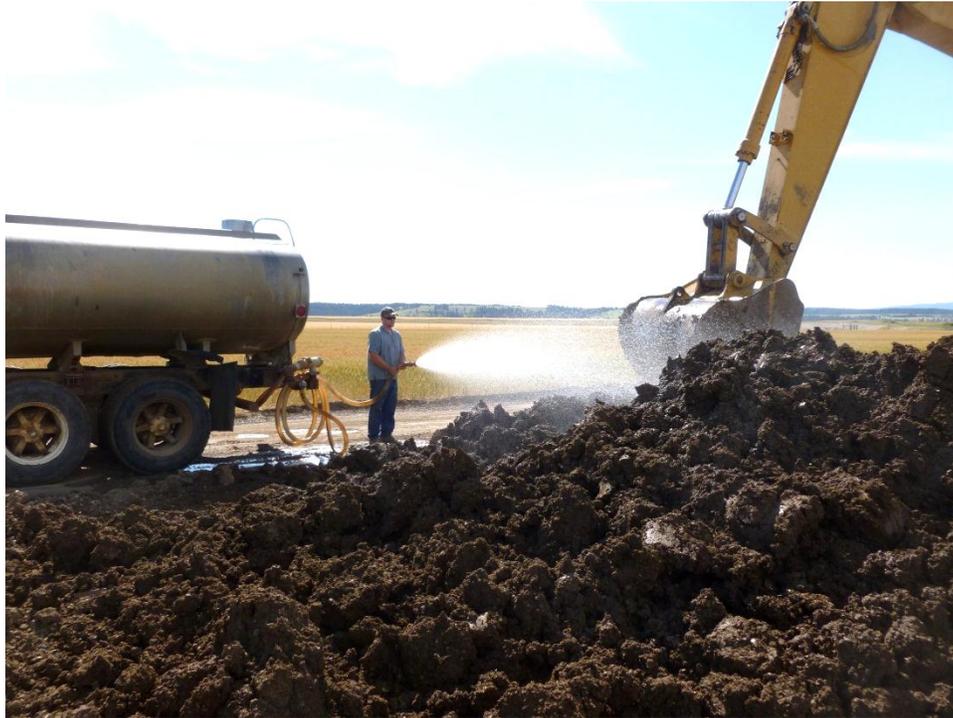
**Figure 20: Watering and mixing subgrade with excavator.**

The subgrade was built in 6 lifts that were approximately 6 inches deep for a total depth of about 3 feet. The subgrade was delivered adjacent to the test pit (refer to Figure 19) and was processed to reach the target strength by adding water from a water truck and fire hose (Figure 20). Water was added until the portion of the pile being prepared reached the target moisture content (e.g., 23 percent for test Sections 3 through C3). Processing was accomplished using a large excavator (Caterpillar 345B). The operator used the bucket to move and mix the material as water was being added (Figure 20). Sufficient material was processed to construct a single 6-inch deep layer over two test sections at a time (about 30 yd<sup>3</sup>). The subgrade was then placed in the trench using the excavator and a track-mounted skid-steer tractor was used to level and initially compact the subgrade (Figure 21). A smooth, single-drum, vibratory roller (66-inch wide, 15,500 lb) was used to compact the subgrade by making two passes of the roller in three longitudinal paths of the freshly placed subgrade (Figure 22). The moisture in the top surface of the subgrade was maintained during construction by periodically wetting the surface and keeping it covered with plastic until the next layer of subgrade or the base course could be placed. Prior to placement of the base course, the top surface of the subgrade was smoothed and screeded to the height of the adjacent pavement surface. This was accomplished by tilling the top of the subgrade and pushing a large metal trench box along the surface to remove excess material (Figure 23). The top surface was then re-compacted using a smaller single-drum, vibratory roller. This was done from the side to minimize ruts in the subgrade surface during final

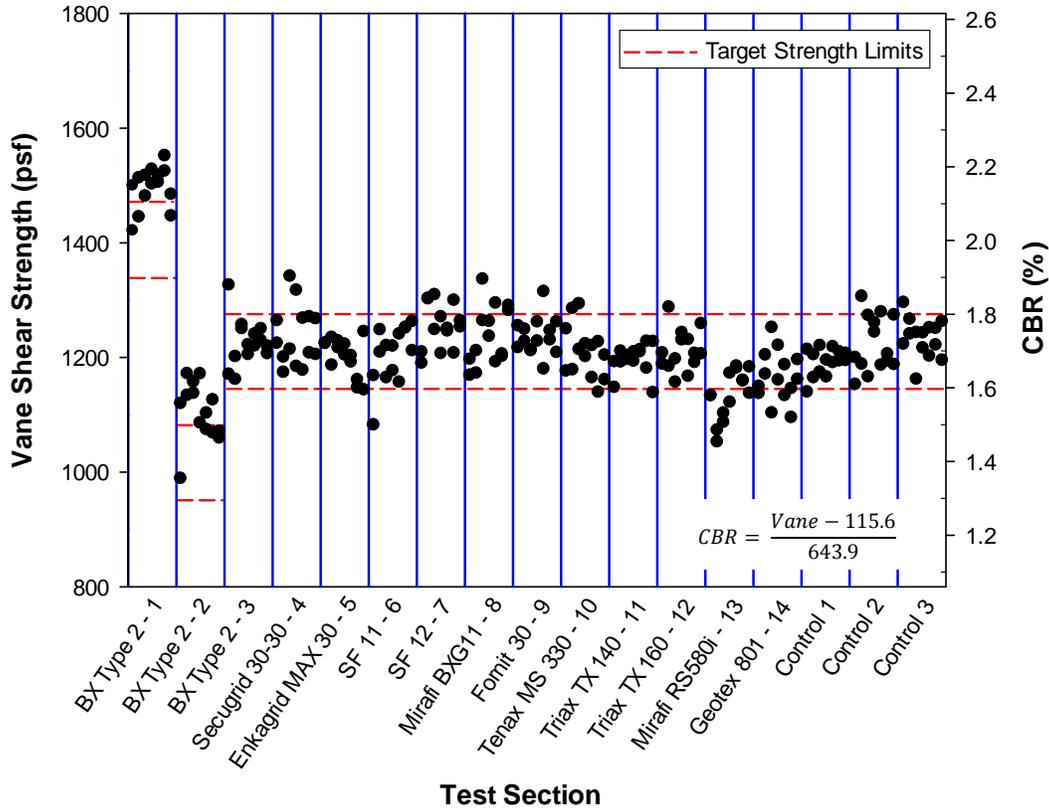
**Figure 24: Composite vane shear strength of the constructed subgrade in regions A–G (west and east rut paths).**

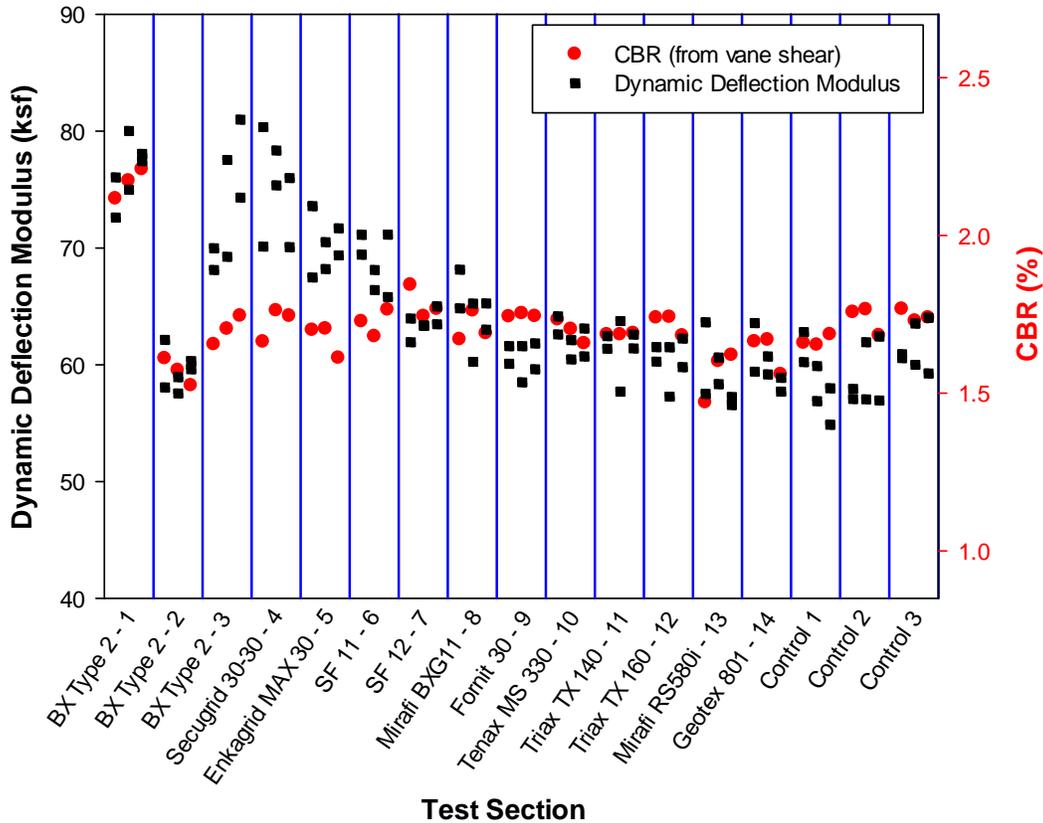
**Figure 25: Composite dynamic deflection modulus in regions *B*, *D*, and *F* (west and east rut paths) of the constructed subgrade and composite CBR from vane shear in regions *B*, *D*, and *F* (average of west and east rut paths).**

A Zorn ZFG 3000 Light Weight Deflectometer (LWD) was used to measure stiffness within regions B, D, and F of each layer of each test section during subgrade construction. The LWD has a 1 ft diameter plate, 22 lb drop weight, and provides the dynamic deflection modulus ( $E_{vd}$ ). The depth of influence for the LWD is about 1 ft, thus measurements on the bottom two layers were neglected due to the presence of the densely compacted fill under the artificial subgrade. Similar to the analysis of vane shear data, a composite  $E_{vd}$  was calculated by assigning weights to individual layers using Boussinesq’s theory and taking into consideration the measurement depths and base course thickness at individual measurement points. The composite  $E_{vd}$  for points within each test section are shown in Figure 25 in comparison to the composite CBR from the vane shear. (A correlation between  $E_{vd}$  and CBR was not developed, and the two ordinate axes in Figure 25 are not related.) About half of the test sections show similar behavior regarding  $E_{vd}$  and CBR, although there are notable differences for test sections 3–6 where the LWD indicated stiffer subgrade than what was measured by the vane shear.

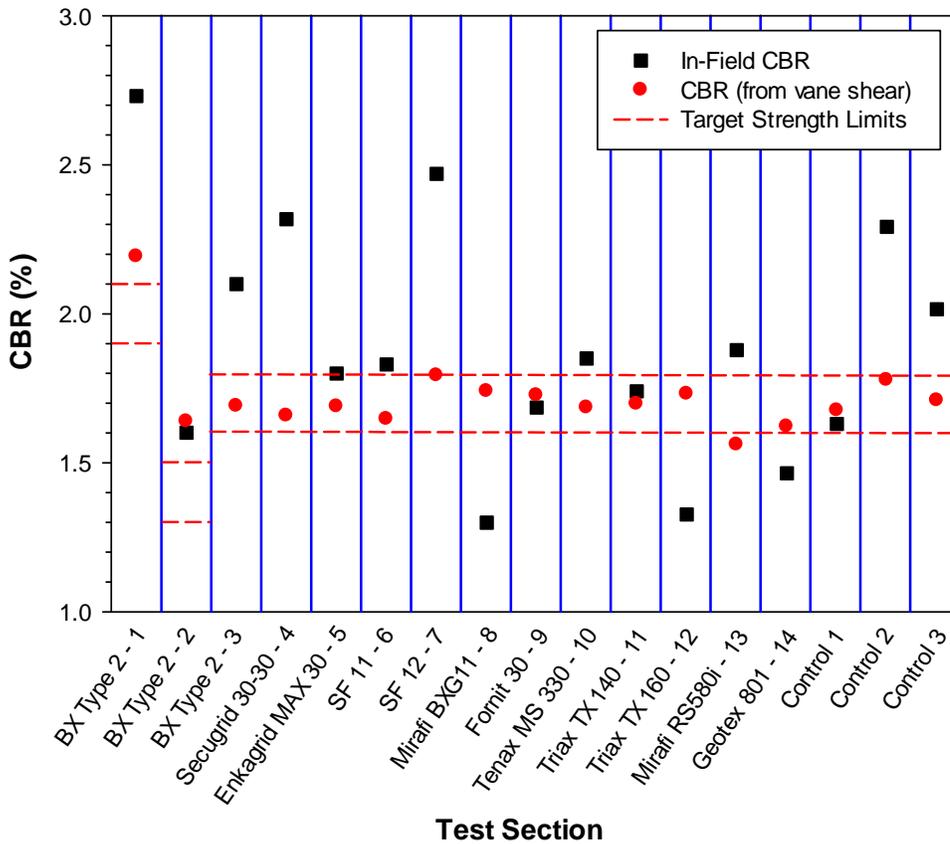
**Figure 28: Comparison of subgrade strength from in-field CBR tests and composite CBR from vane shear in region *D* west rut path.**

In-field CBR tests were conducted on the final layer of the subgrade in substantial accordance to ASTM D 4429 with 60 lbs. of surcharge, representative of approximately 10 in. of gravel at 135 pcf. One test was conducted in each test section, located in region *D* in the west rut. The in-field CBR and the composite CBR determined from vane shear measurements located in region *D* (west rut) are shown in Figure 28. The in-field CBR data is limited and variable, but generally shows that the artificial subgrade is weak (ranging from about 1.3 to about 2.7).

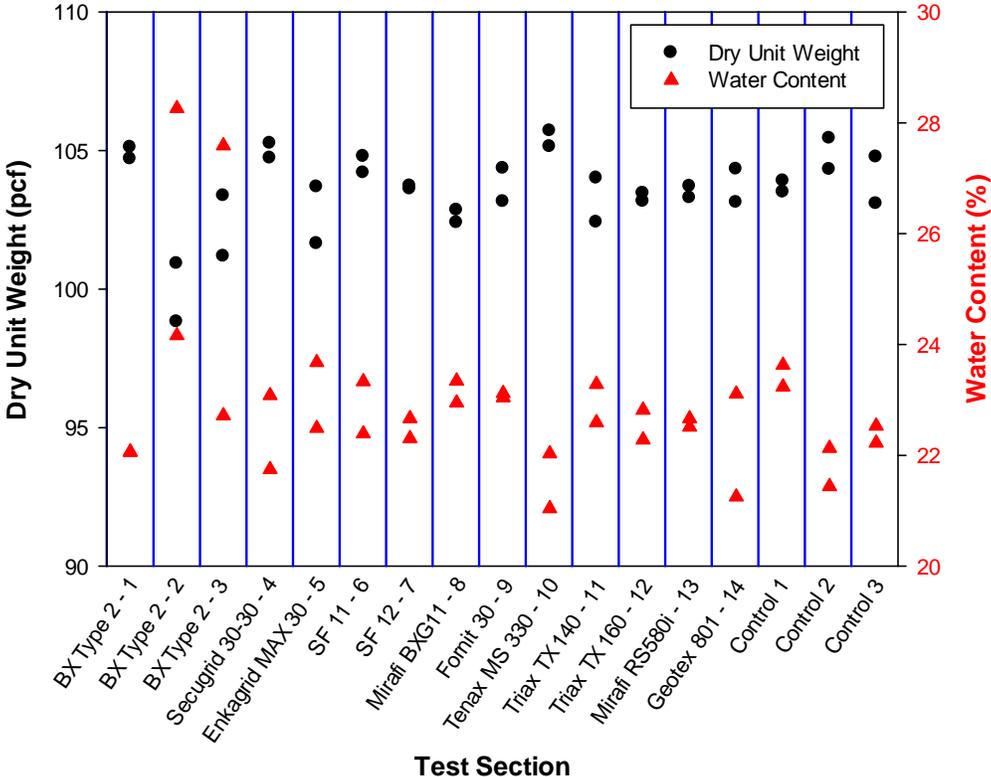
Figure 29: In-place density and water content of the subgrade in region D (west and east rut paths).

Density of the subgrade was measured with a nuclear densometer in region *D* after the subgrade was constructed. Moisture samples were collected near the density measurements and microwave-dried to determine water content. Test Section 2 had the lowest dry unit weight and the highest water content. Moisture contents at the surface ranged from about 21 to 28 percent, and the dry unit weight ranged from about 100 to 106 pcf (Figure 29). The maximum dry density of the subgrade was 112 lb/ft<sup>3</sup> and optimum moisture content was 16 percent, as determined using the Standard Proctor test. The in-place density and moisture content of the subgrade is plotted with respect to the Standard Proctor curve in Figure 30.

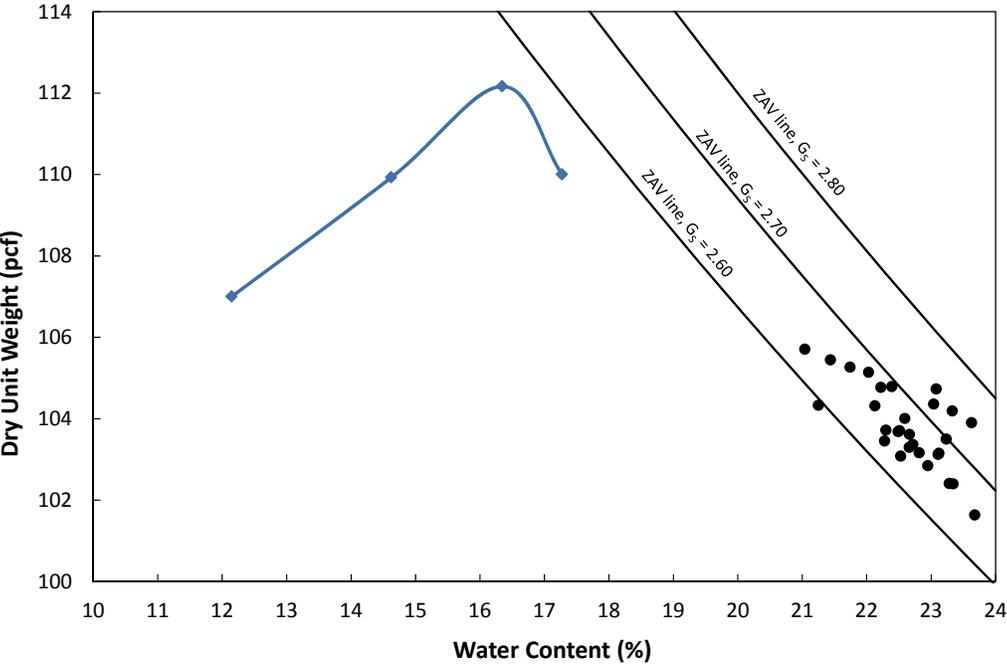
Figure 30: In-place density and moisture of the subgrade plotted with respect to Standard Proctor curve.

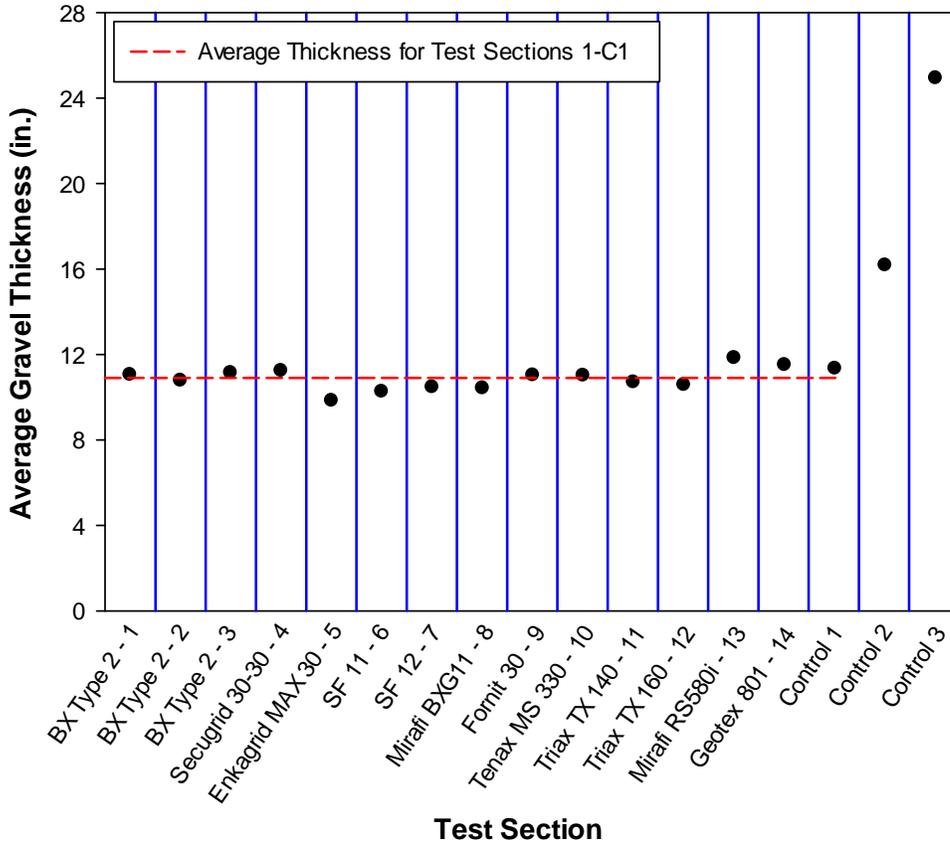
**Figure 33: Average base course thickness.**

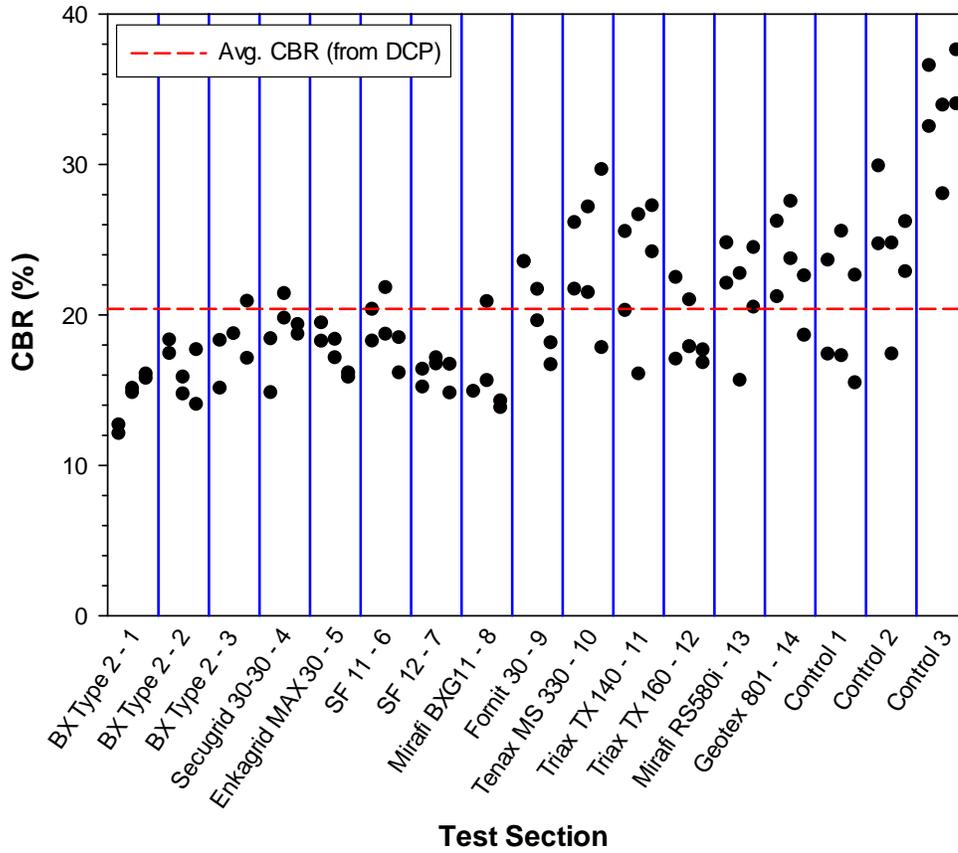
**Figure 34: Base course CBR strength from DCP measurements in regions B, D, and F (west and east rut paths).**

DCP measurements were taken with the dual mass DCP (drop hammer weight of 17.6 lbs.) on the finished surface of the base course in regions *B*, *D*, and *F* in the west and east rut paths. A correlation equation recommended by the US Army Corps of Engineers for granular soils was used to convert the DCP data to CBR strength (Equation 13, where *DCP* is penetration rate in mm/blow). Penetration data from the upper and lower 2 in. of the base were not used in the calculation of average CBR for each region—granular materials near the surface of the gravel were more easily disturbed, being unbound and the lower 2 in. was close enough to the weak subgrade soil to influence DCP measurements. The variation of CBR along the test plot (as determined from the DCP measurements) is shown in Figure 34. Test sections 1–8 generally showed lower CBR strength than other test sections. The average CBR of the base course was about 20.

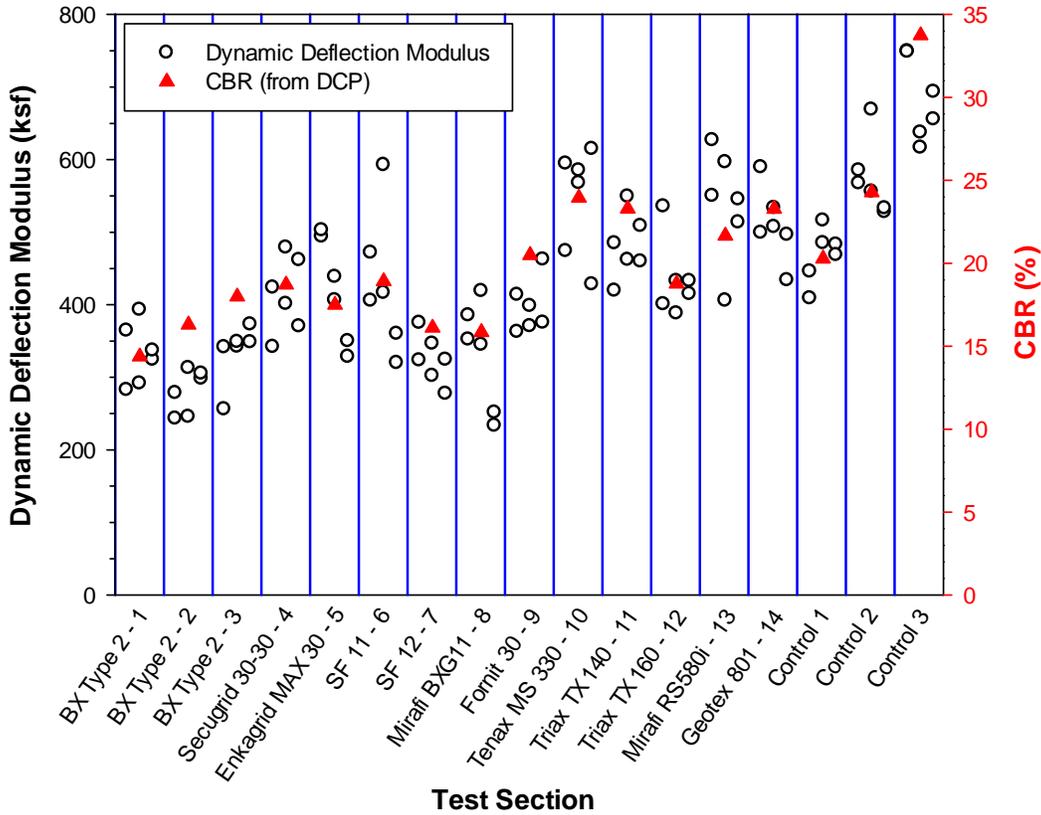
Figure 36: LWD (regions *B*, *D*, and *F*, west and east rut paths) and average CBR from DCP measurements of the completed base course.

The dynamic deflection modulus from the final set of LWD measurements after the base course was fully constructed exhibits similar behavior in comparison to the average CBR of the base course as determined from DCP measurements (Figure 36). The southern test sections are consistently stiffer than the northern test sections.

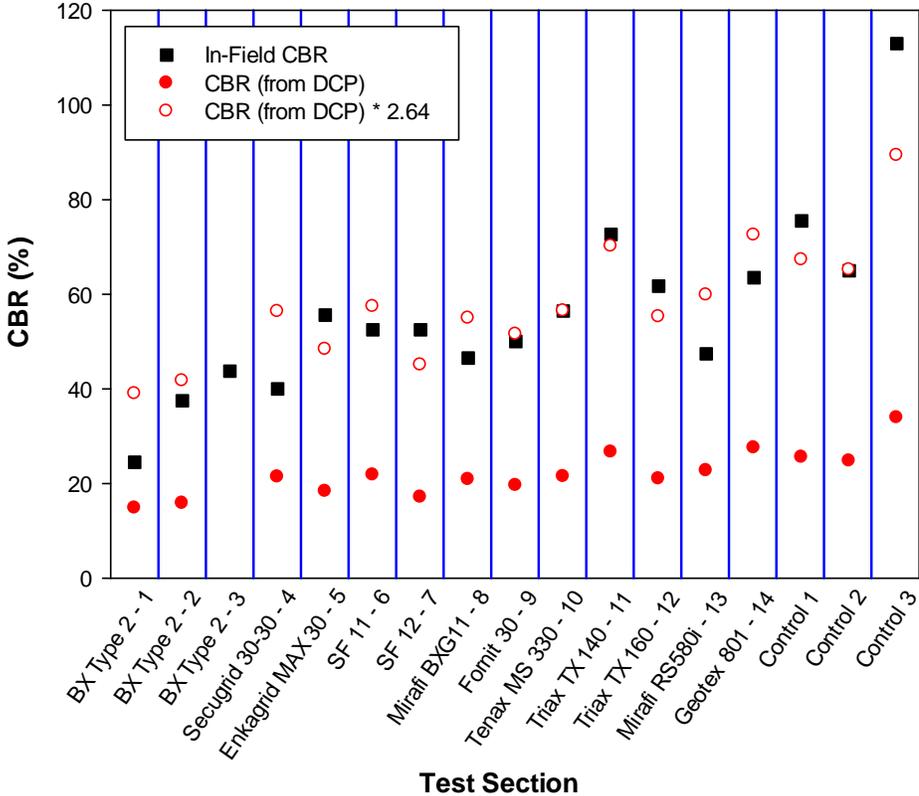
Figure 37: Comparison of base course strength from in-field CBR tests and CBR from DCP in region D (east rut path).

In-field CBR tests were conducted after construction of the base course, in substantial accordance to ASTM D4429 using the minimum recommended surcharge of 30 lb. One test was conducted in each test section, located in region *D* in the east rut. The in-field CBR for each test section is shown in Figure 37. The in-field CBR test results demonstrate a similar trend to the LWD and DCP measurements in that the southern test sections are generally stronger and stiffer than the northern test sections. The in-field CBR results were about 2.64 times greater than the CBR calculated from DCP data. Since only one test was conducted on the final subgrade surface in each test section, the in-field CBR data is not considered as reliable an indicator of overall strength or variability. The rutting behavior was not adjusted based on the stiffness and strength of the base course aggregate layer for two reasons: 1) test sections were not intentionally constructed with different base stiffnesses in order to determine their effect on rut performance, and 2) the stiffness of the base course correlated well with its thickness, as illustrated in Figure 38, and rut performance was adjusted to correct for varying thicknesses, as described in the Analysis and Results section.

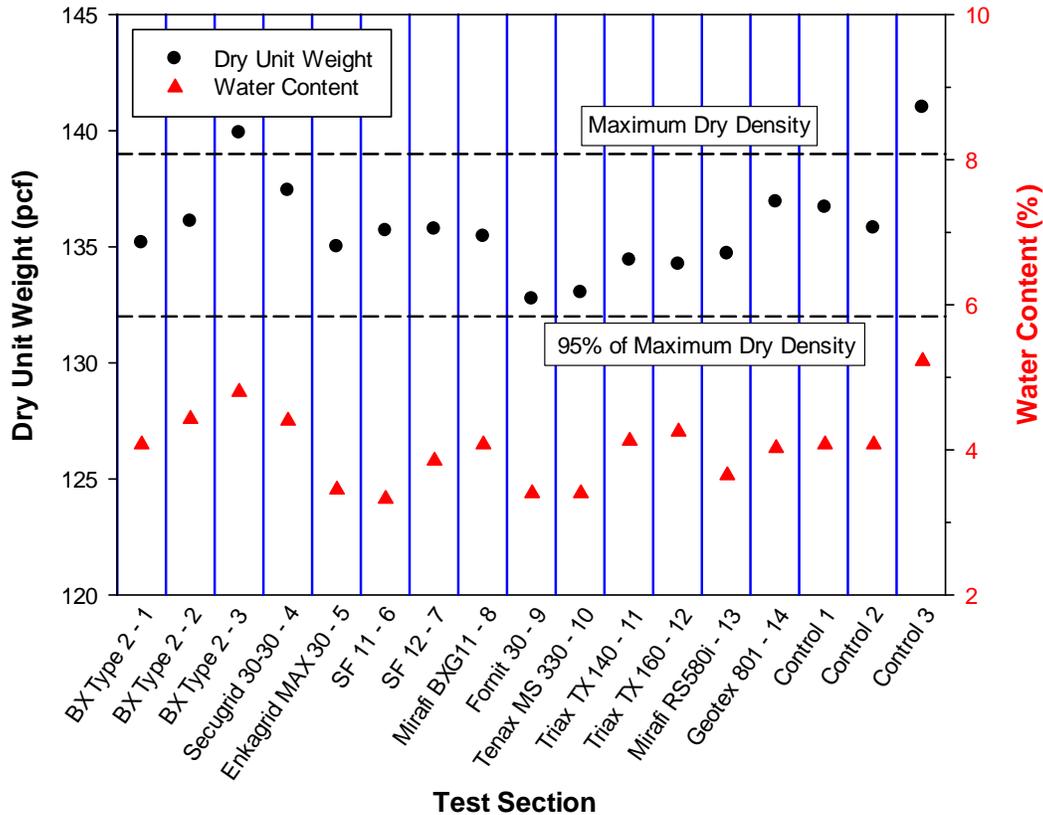
Figure 39: In place density and water content of the base course.

A nuclear densometer was used to measure density and water content during and after construction of the base course in region *D* in both the east and west rut paths. The average dry unit weight and water content in region *D* of the constructed base course of each test section is shown in Figure 39. All test sections achieved the minimum compaction specification of 95 percent of maximum dry density (determined according to ASTM D 1557, modified Proctor).

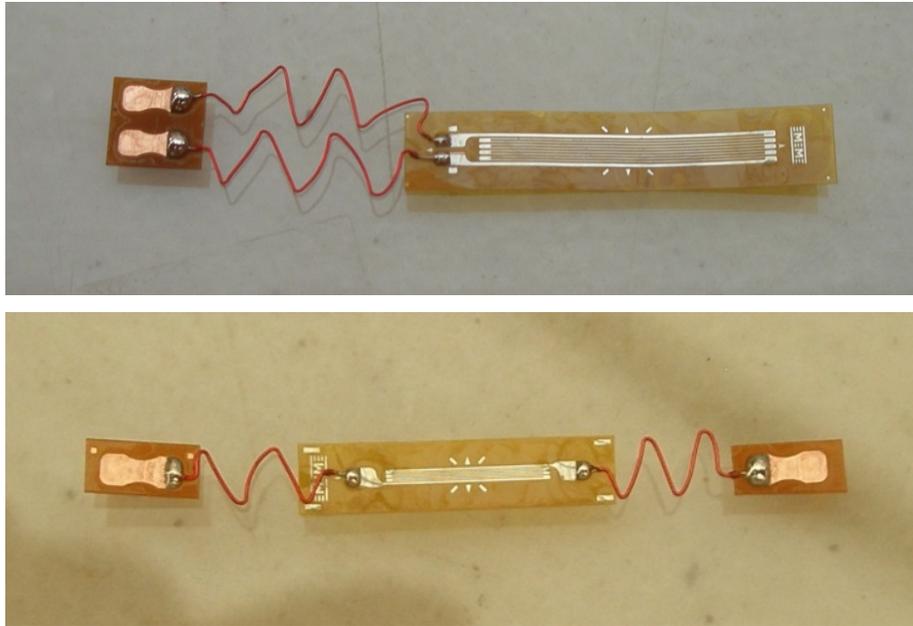
**Figure 44: Jumper wires attached to strain gages.**

Preparation of the strain gages consisted of attaching wires from the strain gage to bondable terminals. The reason for this step is to prevent potential forces transmitted along the instrumentation wire from damaging the strain gage or affecting its performance during installation and trafficking. Two examples of a typical setup of the gage with jumper wires attached are shown in Figure 44. Special solvents were used to clean the strain gages after this step to remove any foreign matter or solder residues prior to bonding.

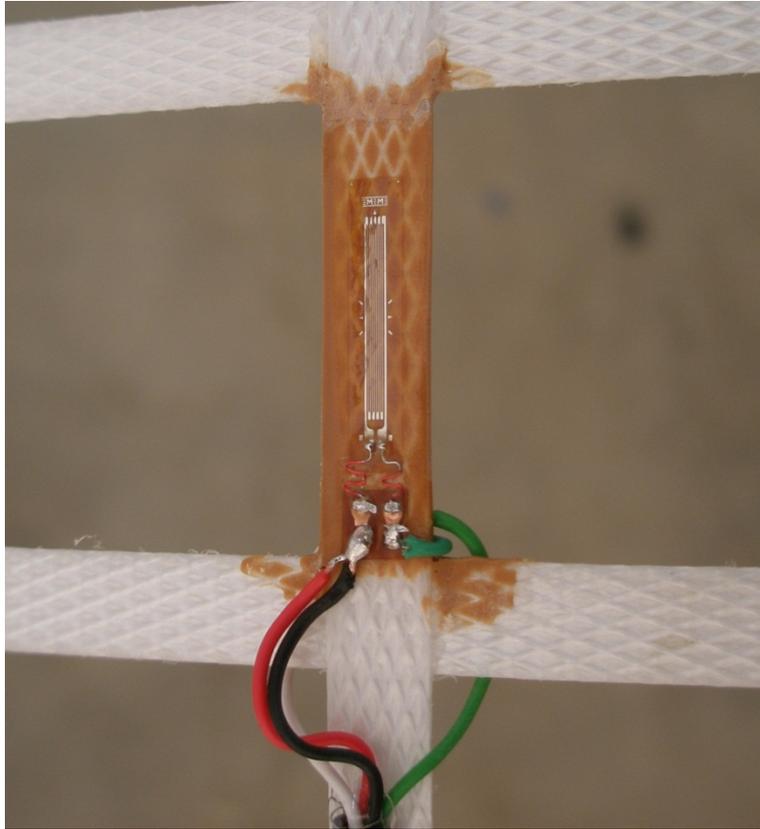
**Figure 45: Completed placement and wiring of a strain gage.**

The strain gages are positioned on the material, the adhesive is applied, and pressure is applied to the gages to create an optimum bond. Two gages were attached to the material at a single location (one on the top of the geosynthetic and one on the bottom) to negate the effects of local bending of the gaged area. Strain gages were attached to the transverse ribs of the geogrids, or in the transverse direction of the geotextile to measure strain in the transverse direction during trafficking. Curing of the adhesive was achieved by elevating the temperature to 150 °F for 6 hours in the gage area. Excess glue was carefully removed using a dremel tool and the lead wires were attached. A strain gage bonded to a geogrid is shown in Figure 45.
