RELATIVE OPERATIONAL  
PERFORMANCE OF GEOSYNTHETICS USED  
AS SUBGRADE STABILIZATION

FHWA/MT-14-002/7712-251

*Final Report*

Western Transportation Institute  
Montana State University - Bozeman

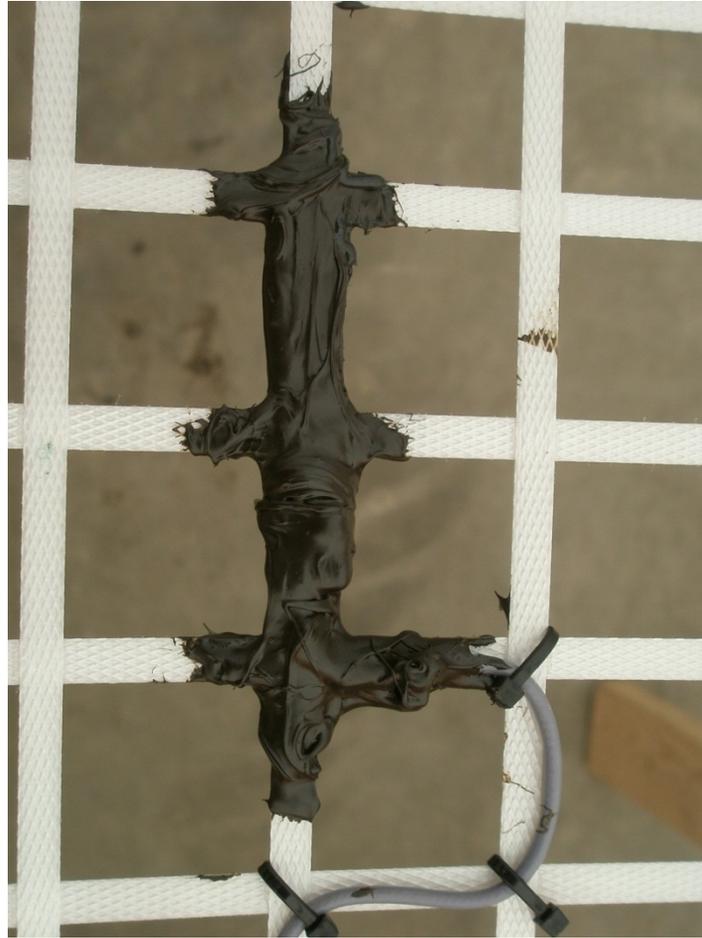
**Figure 46: Completed strain gage installation with protective coating.**

A protective coating is then applied to keep water from entering the gaged area and to protect it from physical damage during construction and trafficking. M-Coat J from MicroMeasurements Group (Raleigh, NC) was used for this purpose. A thin piece of Teflon™ is used to separate the exposed gage surface from the coating material, as recommended by the manufacturers. Curing of the protective coating was accelerated by heating the gage area to 125 °F for 2.5 hours. A finished strain gage location is shown in Figure 46.

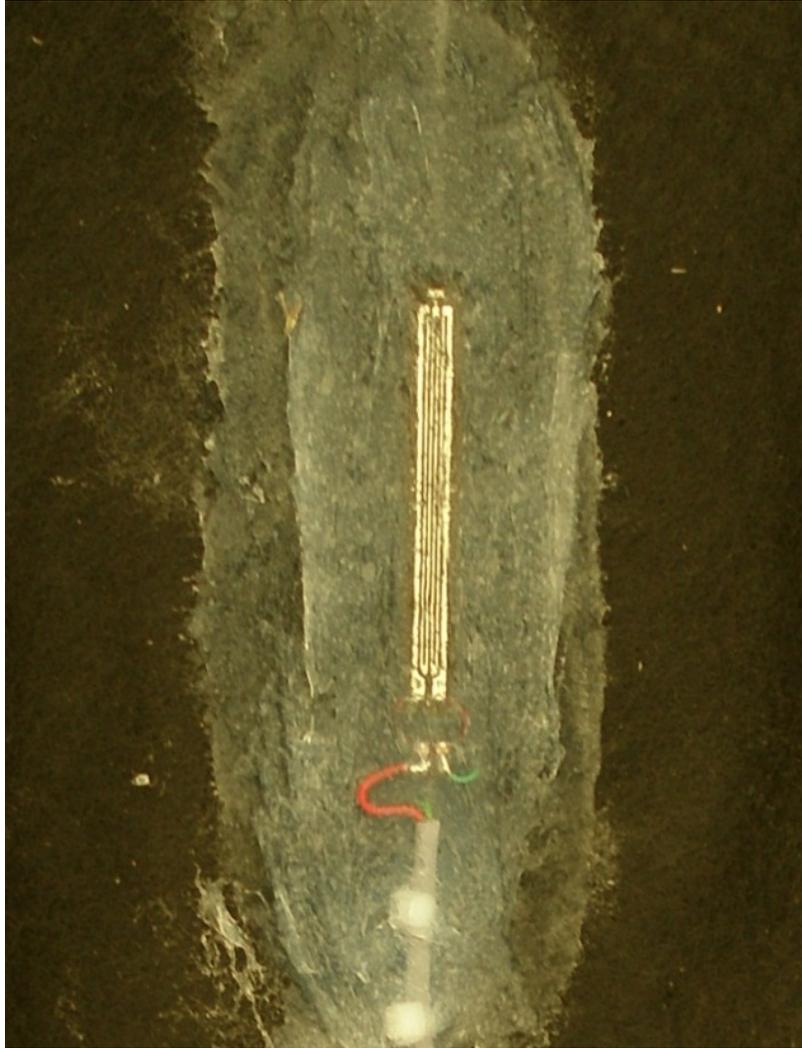
**Figure 47: Completed strain gage installation on a non-woven geotextiles.**

The procedure used to bond strain gages to geotextiles was similar, but modified slightly to accommodate the unique surface structure of the materials. To minimize stiffening of the gaged area, a different adhesive (a non-conducting silicone) was used to bond the strain gages to the textiles and also act as the protective coating. A completed strain gage installation on the geotextiles is shown in Figure 47.

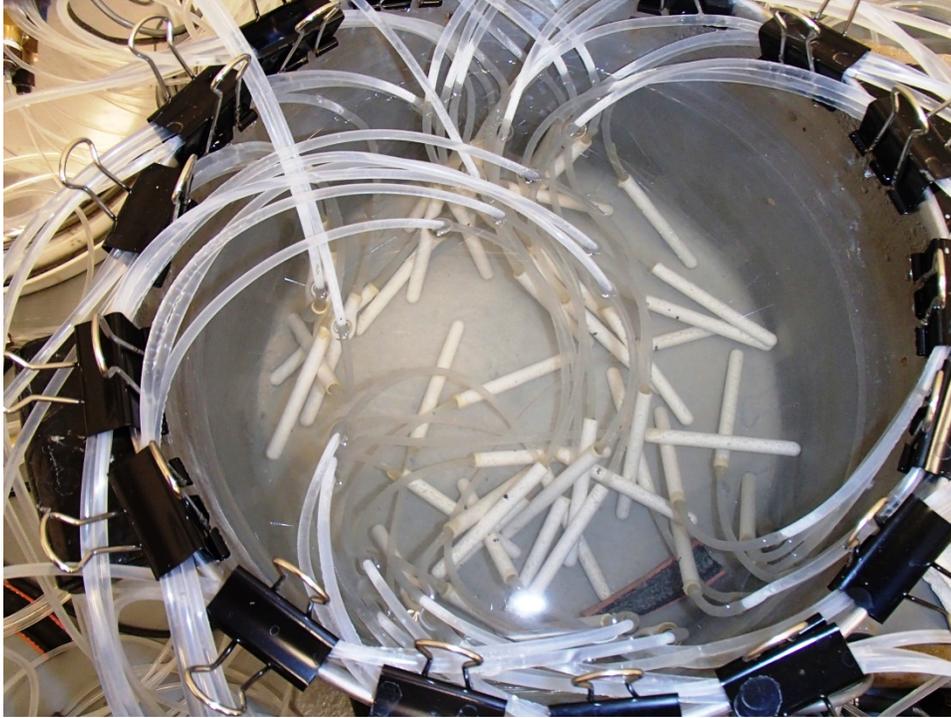
**Figure 48: Saturation of ceramic porous stones.**

also saturated by boiling them (Figure 48). Vacuum pumps were used to pull the de-aired water through the saturated stone and into the flexible tubing. A brass fitting was used to attach the open end of the flexible tubing to the sensor. This was done under water to prevent any air from penetrating into the system during assembly. This procedure was used to prepare all of the pore-water pressure sensors used in this research project. Great care was given to the de-airing and preparation process to ensure that no bubbles were present in the flexible tubes during installation and use.

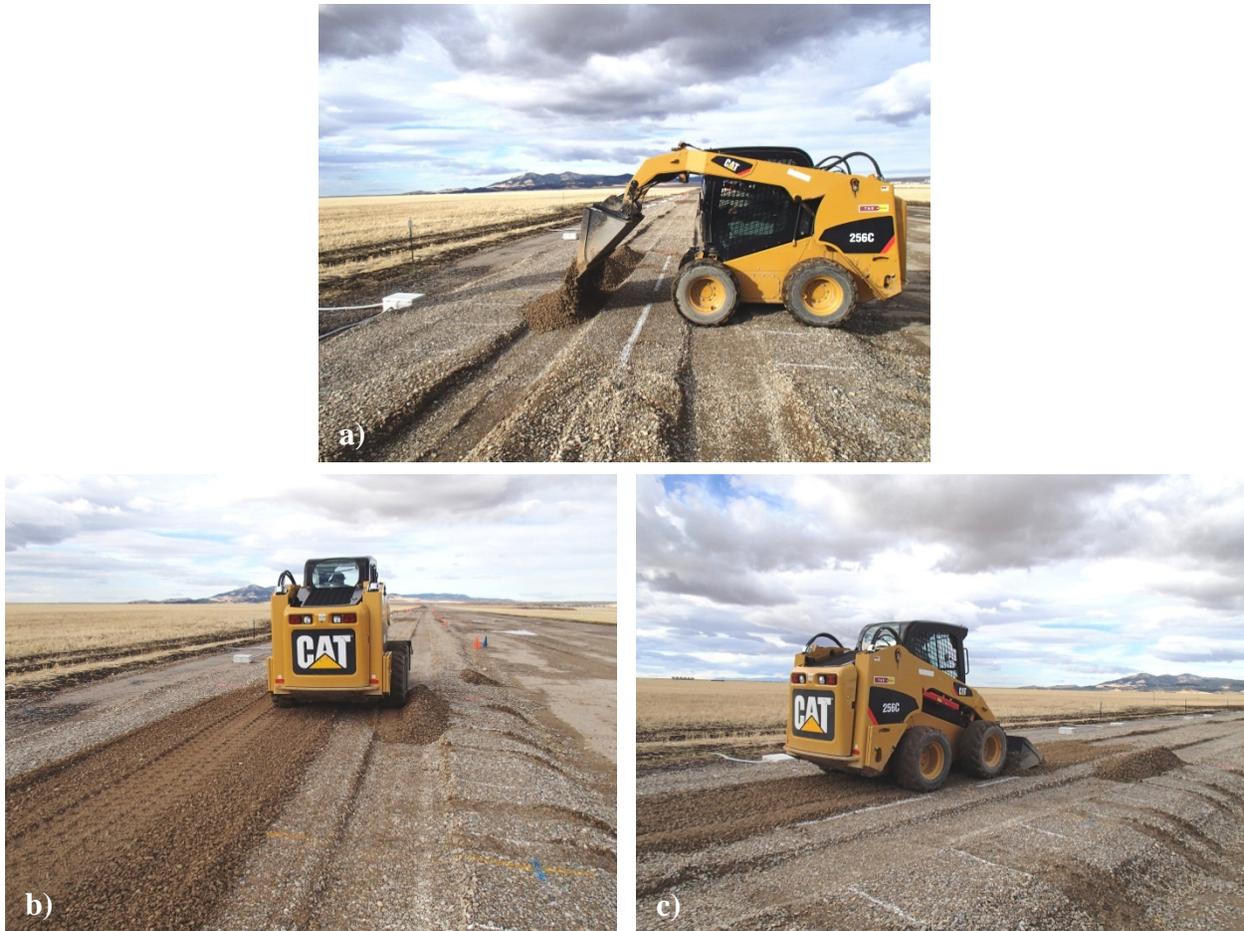
**Figure 58: Rut repair: a) adding gravel to the rutted area, b) compacting the new gravel with the skid-steer tractor, and c) final smoothing.**

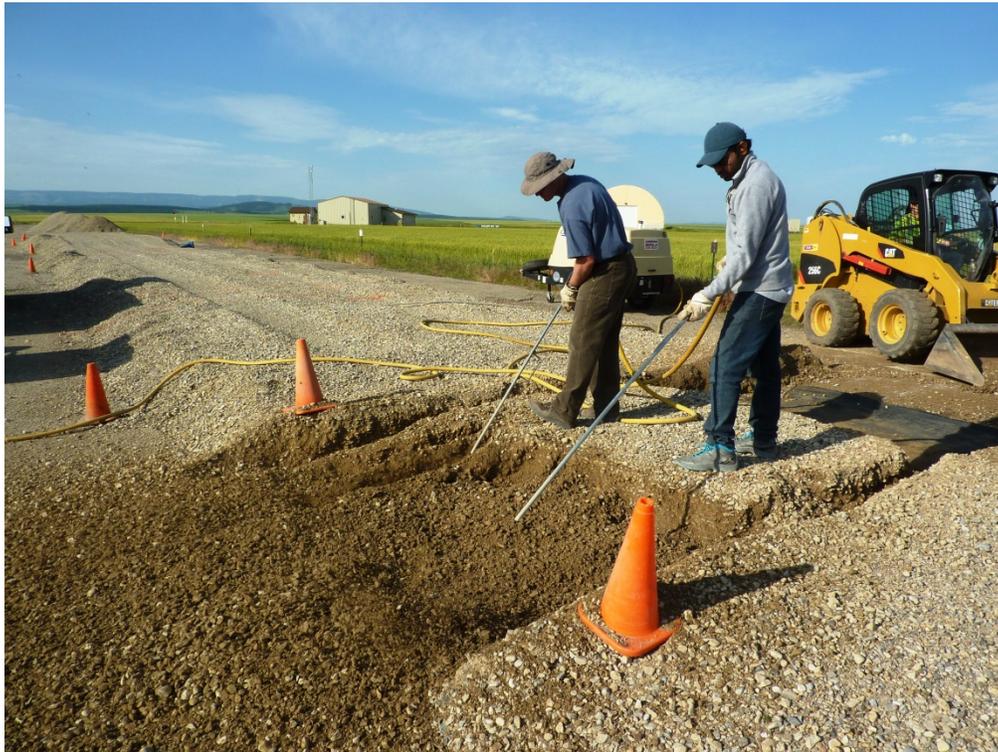
**Figure 60: Removal of the base course aggregate using compressed air.**

Once these areas were selected, the base course was carefully removed to facilitate extraction of the geosynthetic and assessments of the subgrade. The base course aggregate was removed using an air nozzle connected to a high-volume air compressor to clear an area approximately 6 ft wide (3 ft on either side of the point of interest), as shown in Figure 60. This method was used in order to minimize damage to the geosynthetics during excavation of the base aggregate. The geosynthetic was then carefully cut out and stored for further evaluation.

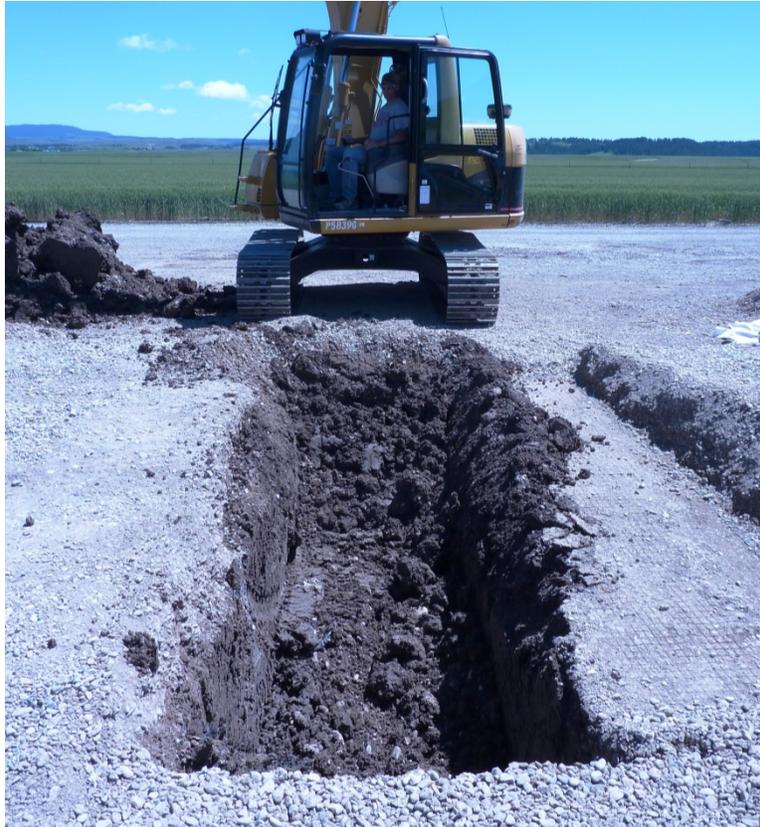
**Figure 61: Removal of subgrade from forensic location.**

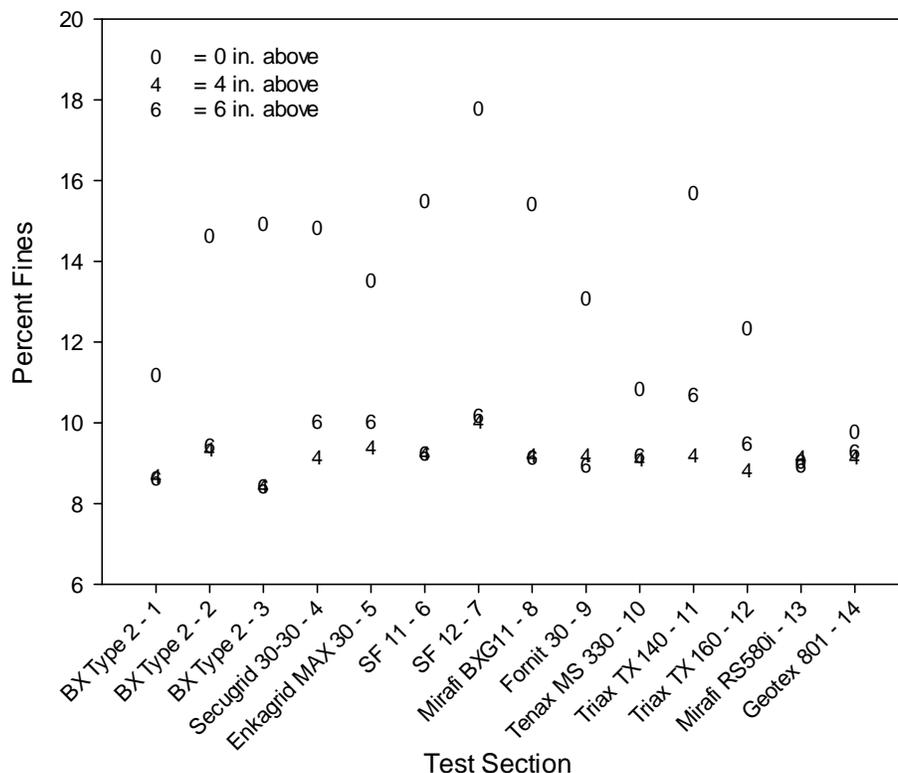
Figure 62: Percent fines in base aggregate samples above geosynthetics.

Samples of base aggregate were extracted from the reinforced test sections during the second forensic visit to evaluate migration of fines in to the base layer from construction and trafficking. Three samples were taken from each wheel path (west and east) in each test section (a total of 6 samples per test section). The samples were removed from immediately on top of, at 4 inches above, and at 6 inches above the geosynthetic. This analysis was not conducted on the control test sections because it was too difficult to determine the exact location of the transition between the subgrade and base layers. The volume of material removed for each sample was the same, each being about 1 inch thick by 10 inches wide by 10 inches long. A washed sieve analysis was conducted to determine the amount of fines (percent passing the #200 sieve), and the results are shown in Figure 62. Aggregate samples removed from 4 and 6 inches above the geosynthetic had very similar amounts of fines (around 8.5 and 10 percent). This was similar to the fines content of the stockpile of virgin base aggregate, which was 10 percent. Fines contents in samples from just above the geosynthetic were generally about 5 percent greater. The greatest increase was in Test Section 7 (Synten SF12) and the smallest increase was in Test Section 13 (TenCate Mirafi RS580i).

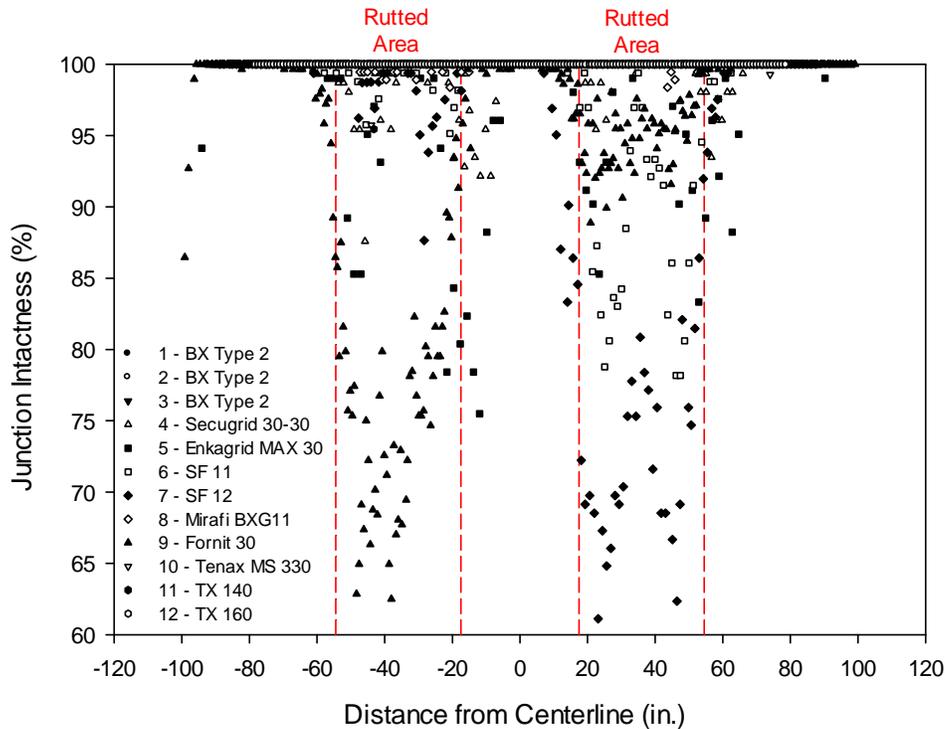
**Figure 63: Geogrid junction intactness.**

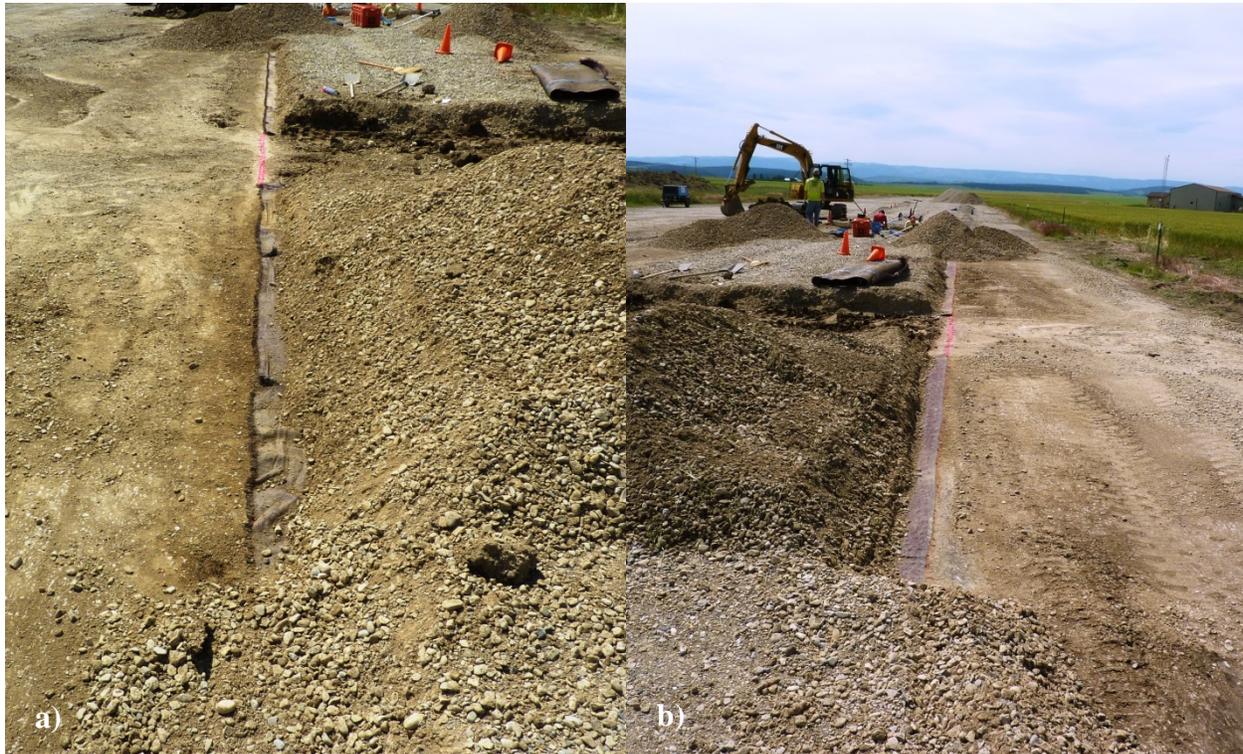
**Figure 66: Edges of Mirafi RS580i geotextile showing no pullout a) east edge, b) west edge.**

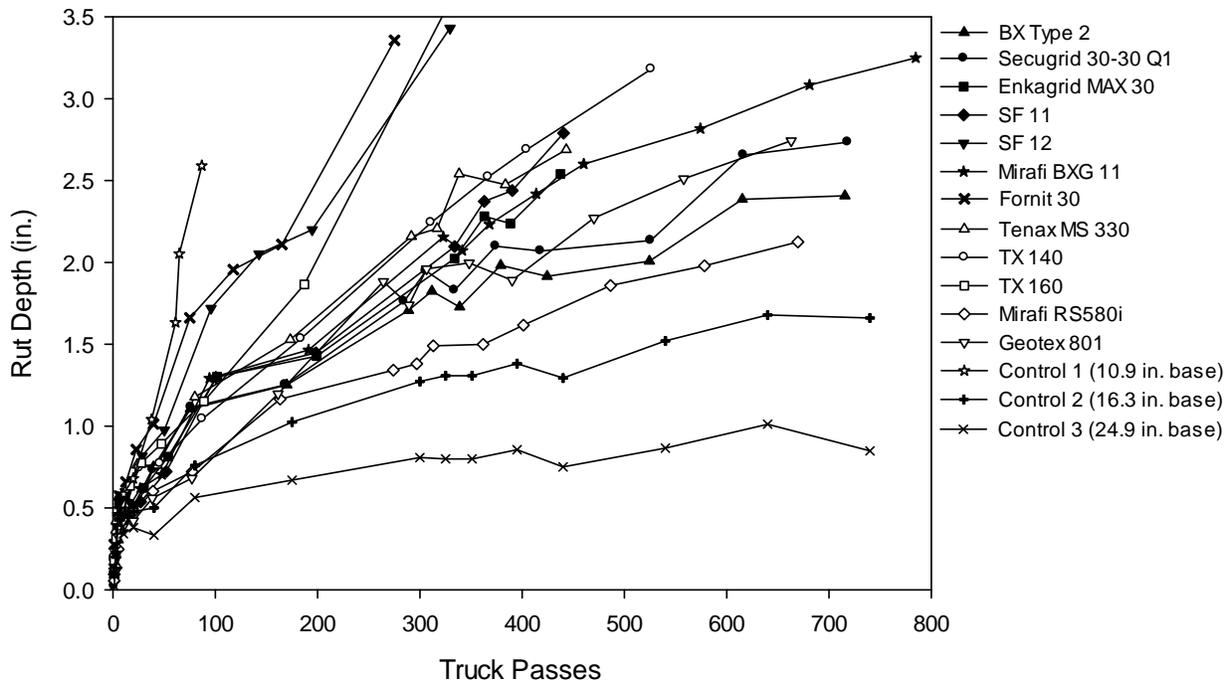
**Figure 77: Corrected rut response for all test sections.**

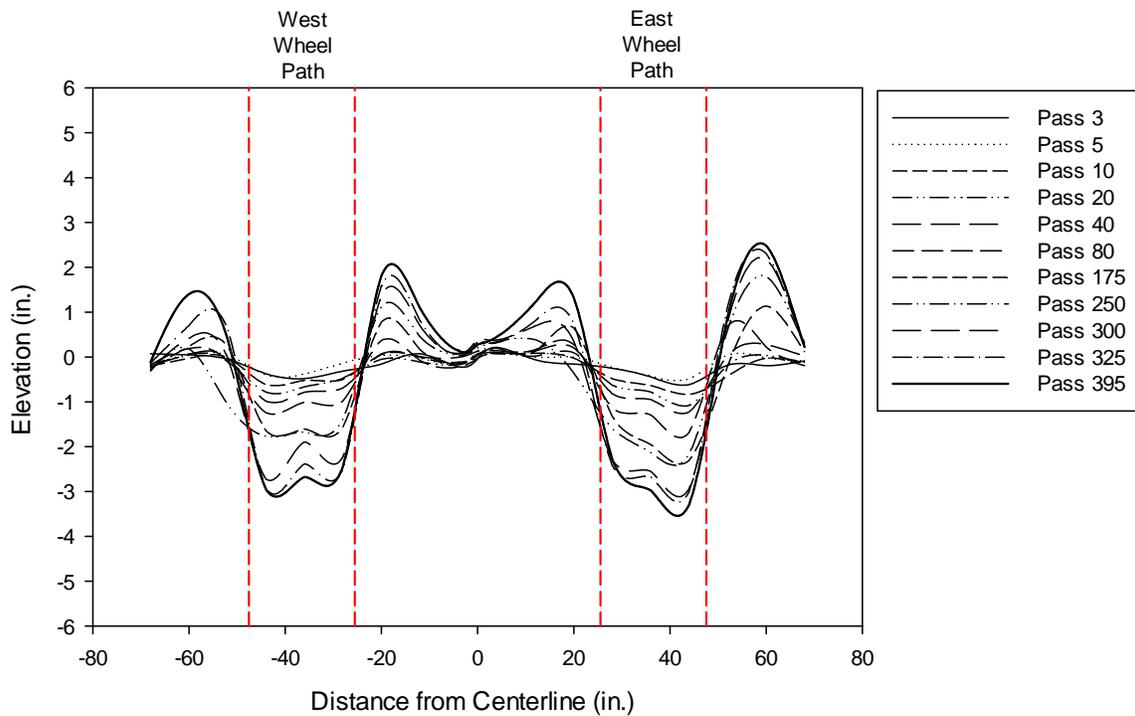
Figure 79: Transverse rut profiles for Test Section 10 (Tenax MS 330), north location.

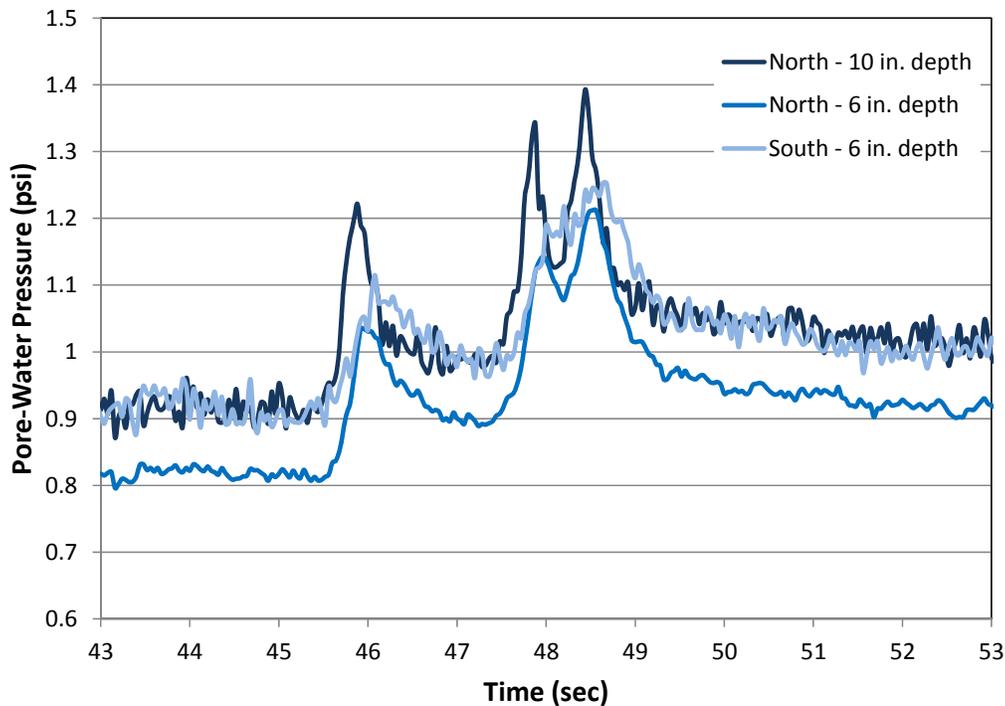
**Figure 88: Dynamic pore-water pressure response in Test Section 3, truck pass 9.**

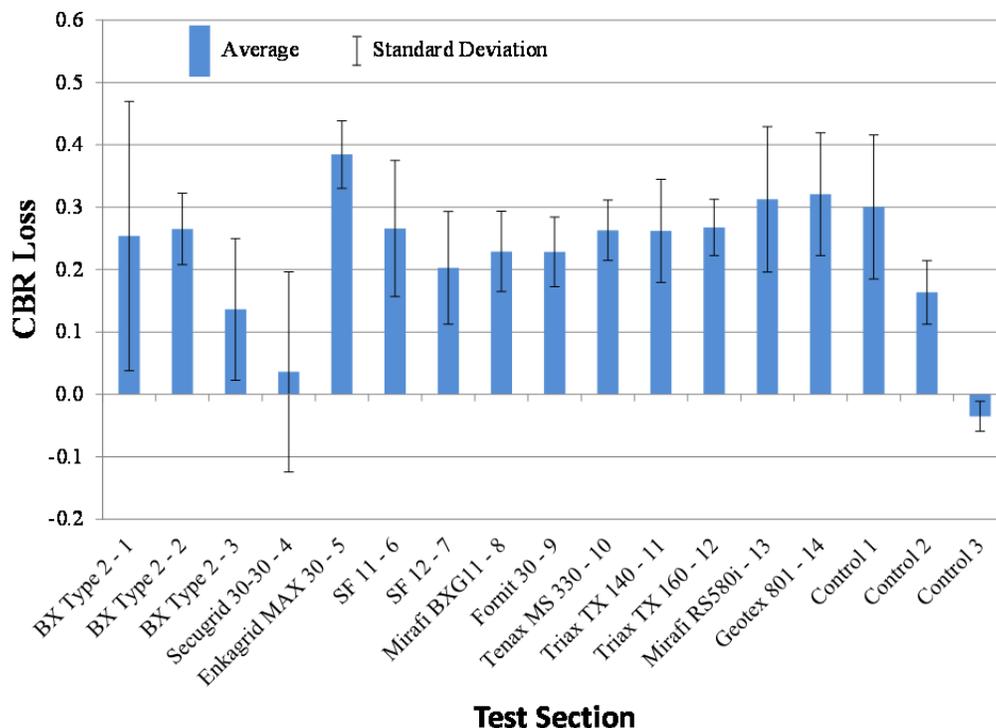
**Figure 94: Predicted change in subgrade CBR in each test section due to pore-water pressure accumulation by truck pass 175.**

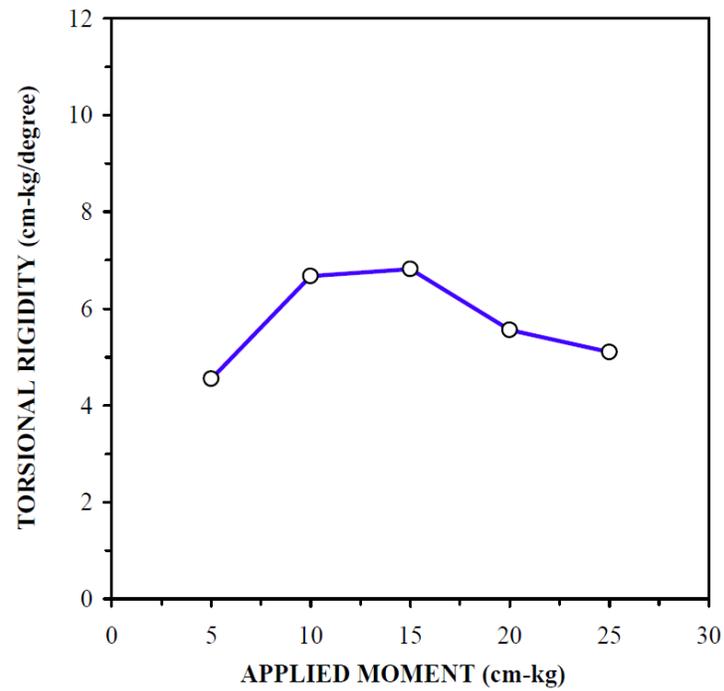
**Figure E-10: Aperture stability modulus for Tensar TX 160.**

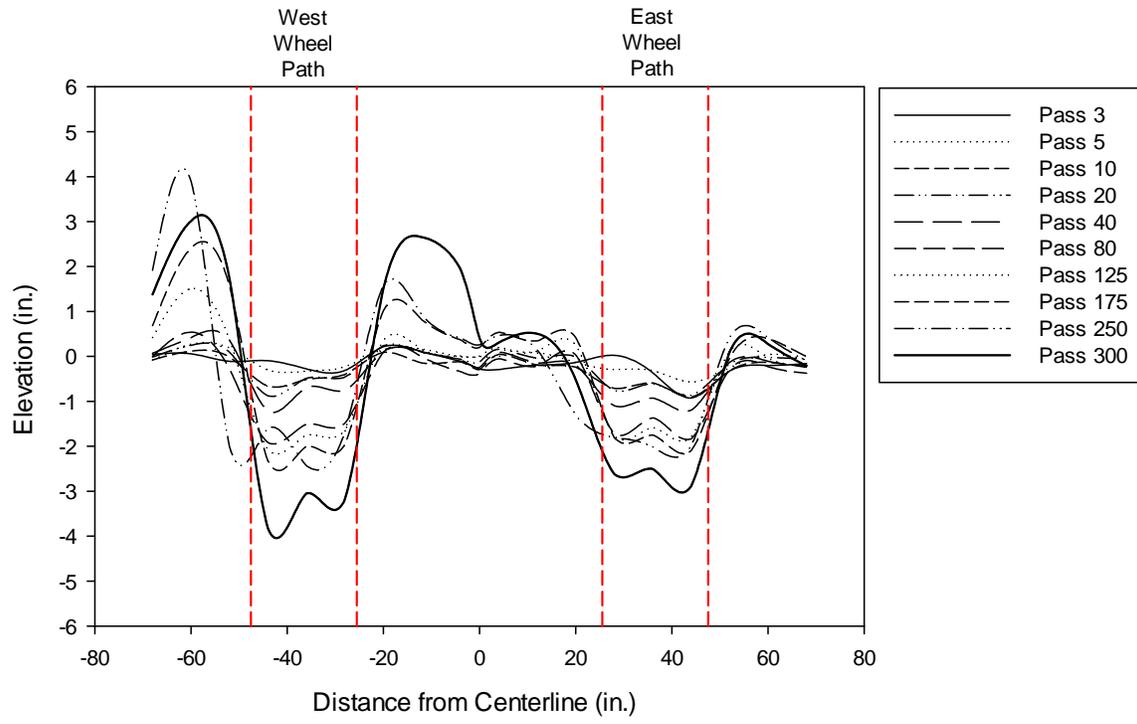
**Figure L-13: Transverse rut profiles for Test Section 7, north (Synteen SF12).**
