EVALUATION OF WILDLIFE CROSSING STRUCTURES ON US 93 IN MONTANA'S BITTERROOT VALLEY

FHWA/MT-17-003/8194

Final Report

prepared for
THE STATE OF MONTANA
DEPARTMENT OF TRANSPORTATION

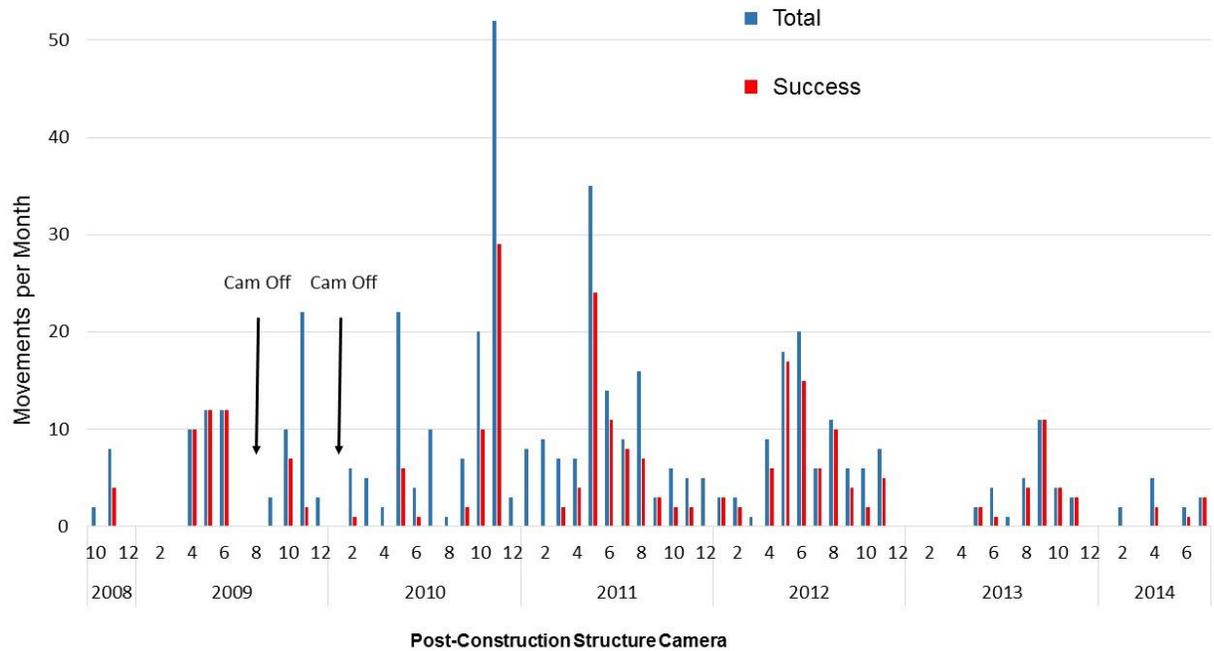
Figure 2. Bass Creek North Bridge, mp 71, White-Tailed Deer Monthly Use, 2008-2014.

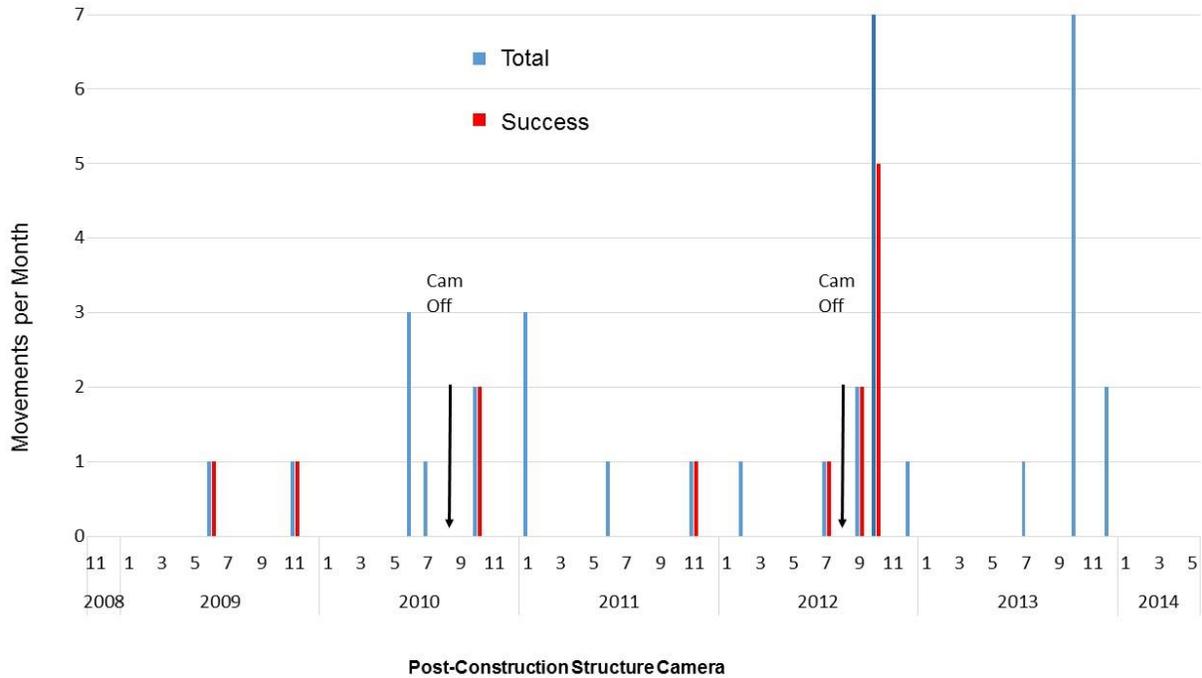
Figure 3. Bass Creek South Bridge, mp 70, White-Tailed Deer Monthly Use, 2008-2014.

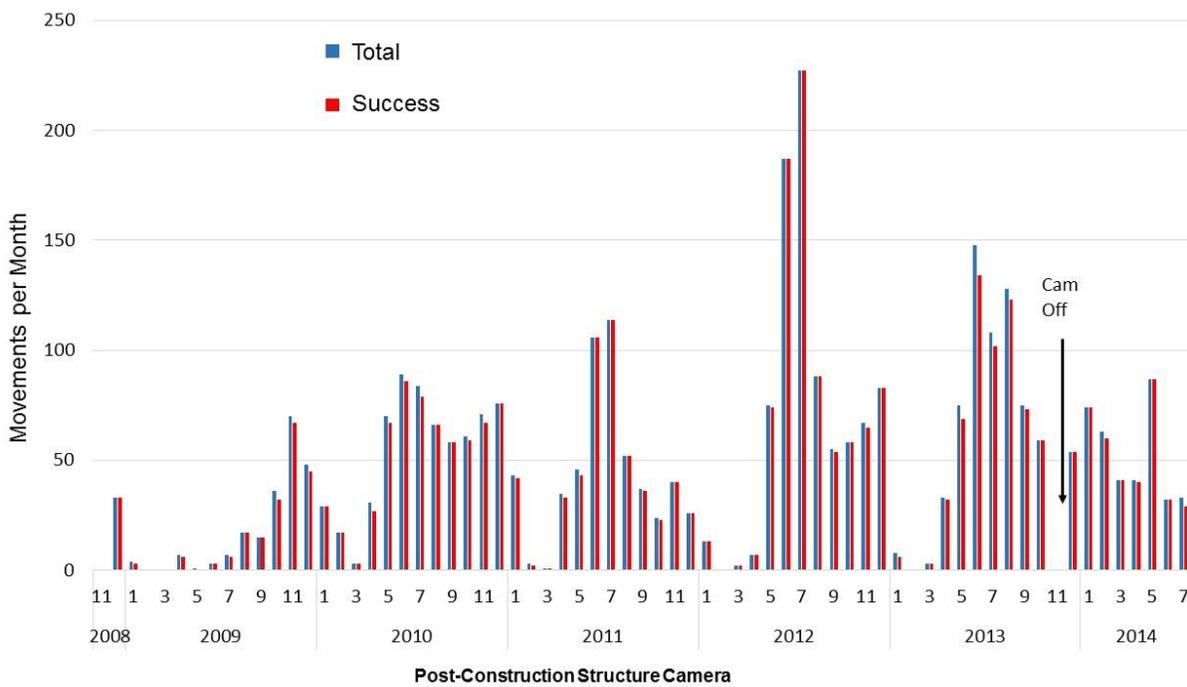
Figure 4. Bass Fishing Access Culvert, mp 70, White-Tailed Deer Monthly Use, 2008-2014.

Creek south had a very large decrease in white-tailed deer abundance during post-construction (Table 4). Fence length was not related to structure use rates (section 3.3.1), however, extensive wildlife fence and continuous fence between structures may be associated with reduced crash rates. One example that contradicts this hypothesis was observed at Bass Creek Fishing Access-Dawns Crossing. This pair of structures had extensive wildlife fence and continuous fence between them. Both structures were rated “highly positive” yet the relative WVC crash rate increased at these structures (Figure 40). One explanation is that white-tailed deer abundance greatly increased at Bass Creek Fishing Access and Dawns Crossing during post-construction monitoring (Figure 4 and Figure 5).

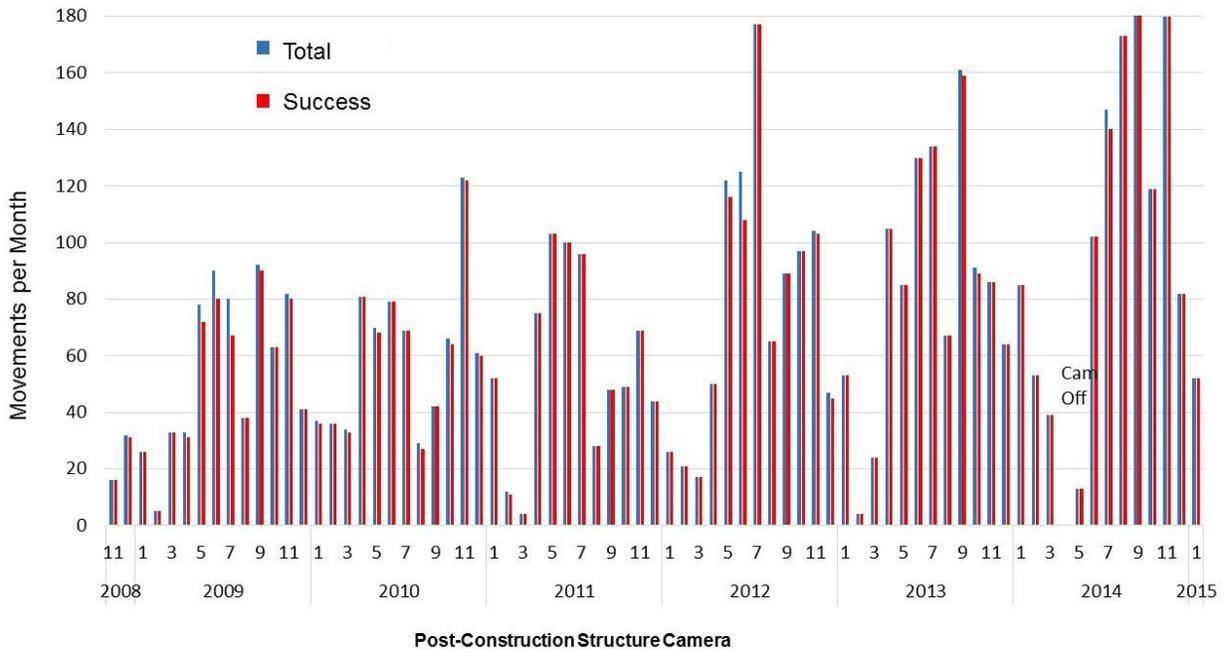
Figure 5. Dawns Crossing Bridge, mp 70, White-Tailed Deer Monthly Use, 2008-2015.

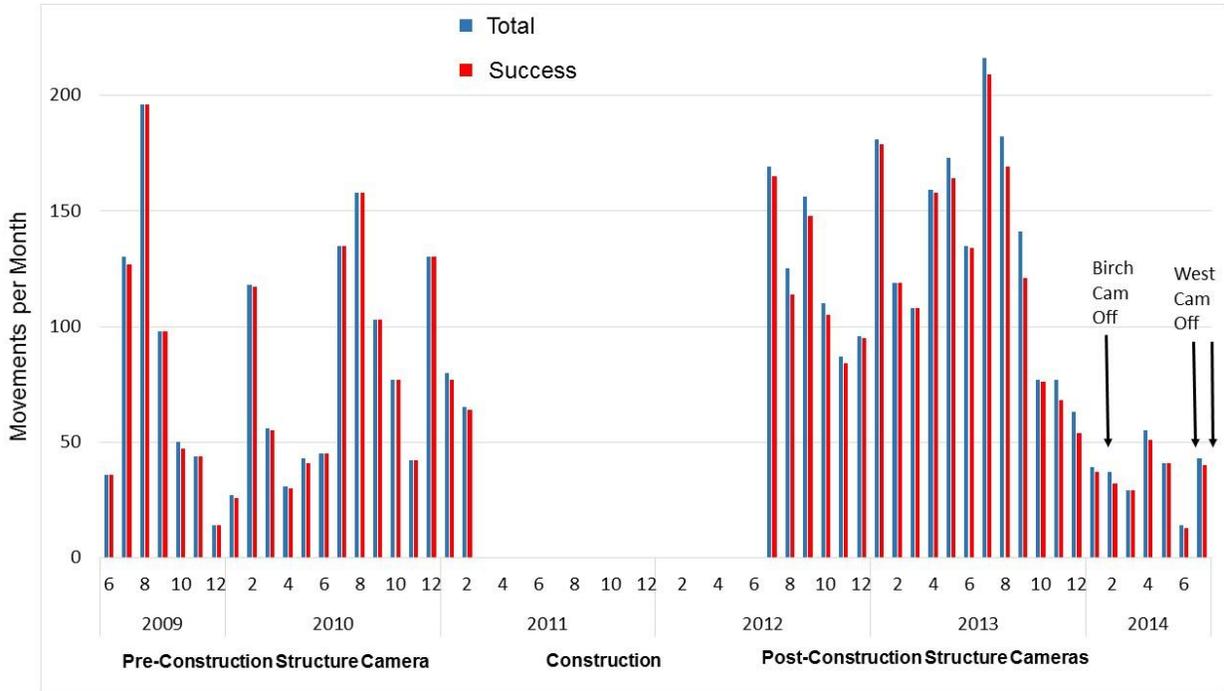
Figure 15. Bear Creek South Bridge, mp 57, White-Tailed Deer Monthly Use, 2009-2014.

Post-construction total movements and success movements peaked in 2013 and declined sharply in 2014 (Figure 15). This decline may have been artificial, the result of camera failures and a camera theft. In addition, a landowner east of the structure was observed feeding wildlife in 2013, and moved away in 2014. Post-construction success rate (95 percent) and rate of repellency (1 percent) greatly exceeded the performance measures established in section 2.2.3. Pre-construction monitoring included a structure camera at the original bridge and a right of way camera. Pre-construction success per camera day at the original bridge (2.6) and the right of way (0.3) were lower than post-construction success per camera day (3.7). Pre-construction success rates at the original bridge (98 percent) and right of way (68 percent) were similar to and lower than, respectively, the post-construction success rate. Pre-construction abundance at the original bridge (2.7) and the right of way (0.4) was lower than post-construction abundance at the structure (3.9). The overall post-construction effect of this structure on white-tailed deer attempting to move from one side of US 93 to the other was highly positive. This structure ranked first for success per camera day and third for success rate among the 19 wildlife crossing structures. There were 2,554 success movements by white-tailed deer during nearly two years of post-construction monitoring.

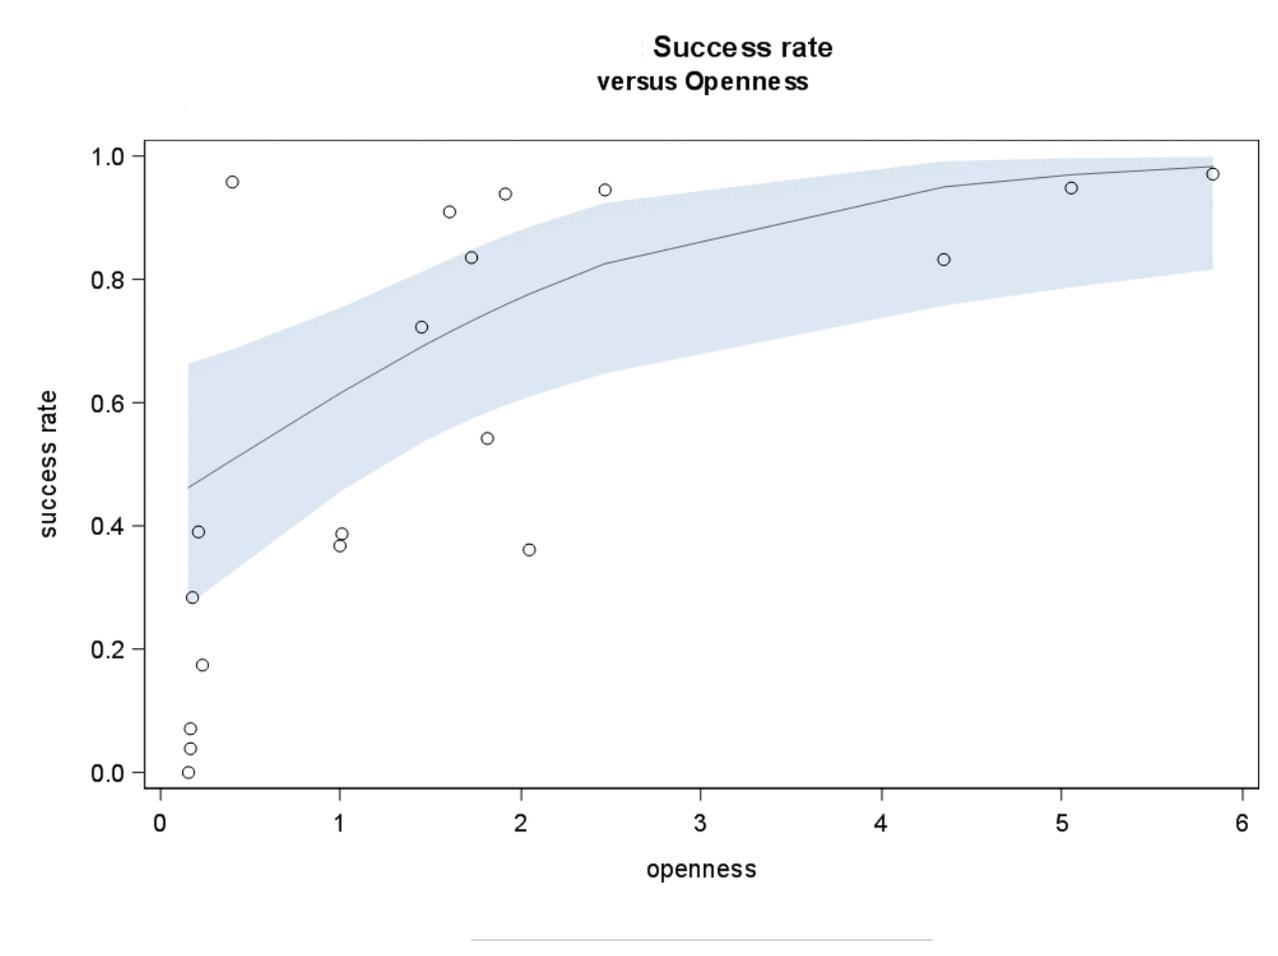
Figure 21. White-Tailed Deer Success Rate Plotted Against Openness.

- There were very strong relationships between openness ratio (height multiplied by width (span) divided by length, in meters) and use rates in this study. Wildlife crossing structures should be designed to maximize openness ratio. We choose not to recommend a minimum openness ratio for wildlife crossing structures. High openness ratios are easier to achieve with bridges than with culverts.

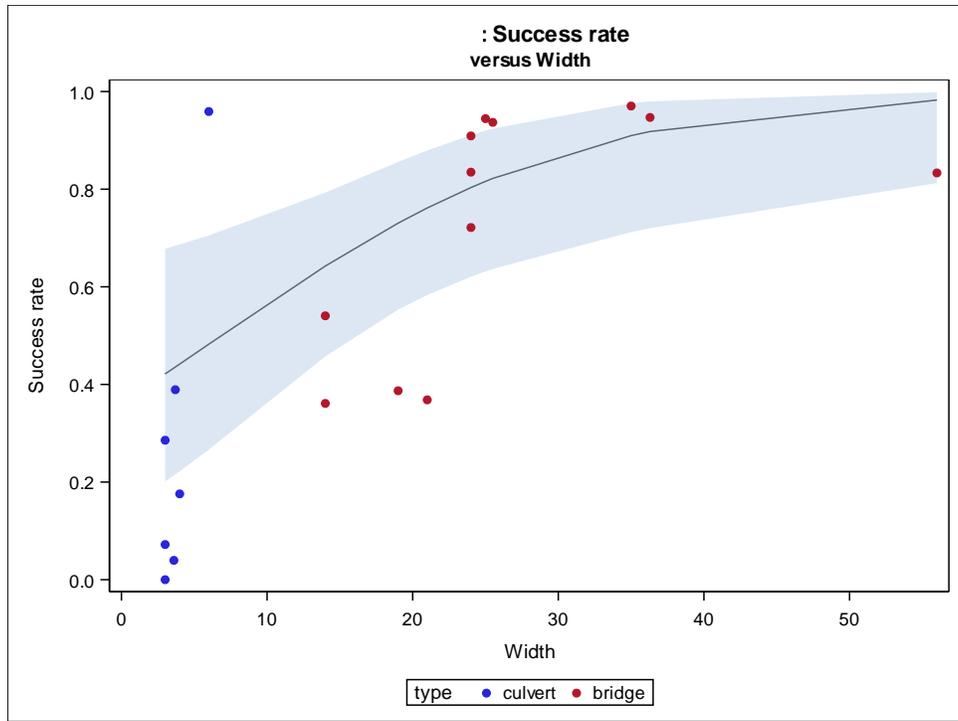
Figure 22. White-Tailed Deer Success Rate Plotted Against Width.

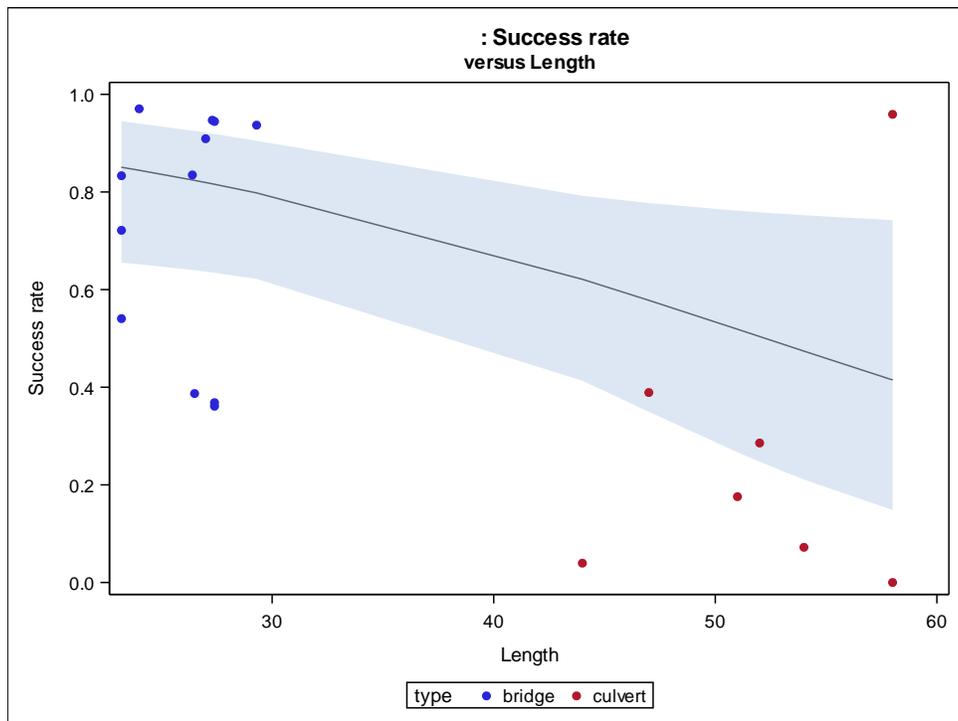
Figure 23. White-Tailed Deer Success Rate Plotted Against Length of Structure.

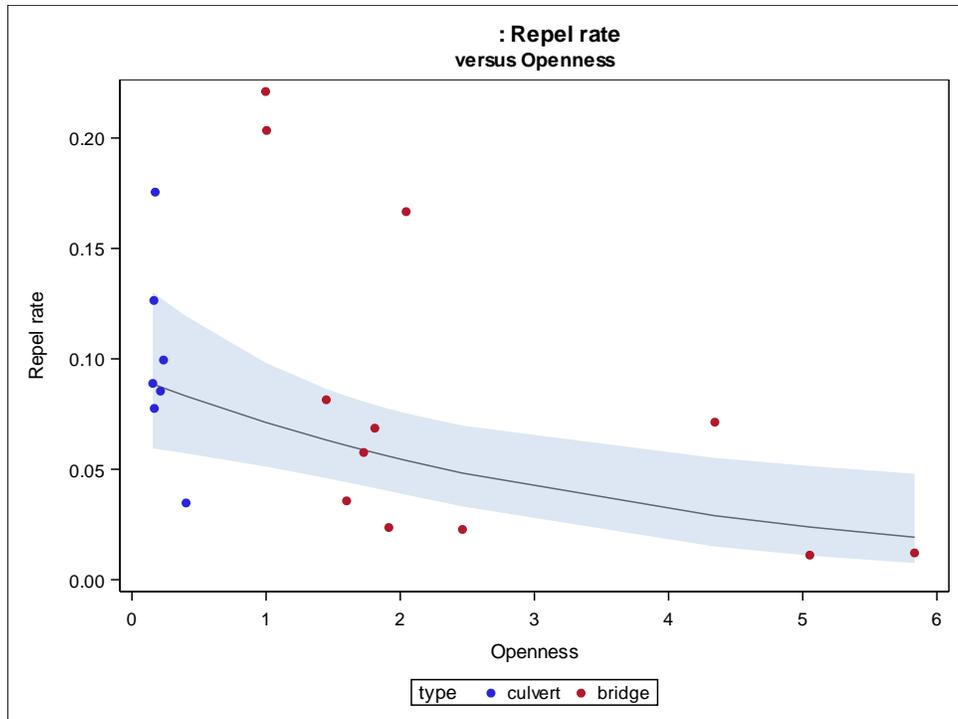
Figure 24. White-Tailed Deer Rate of Repellence Plotted Against Openness.

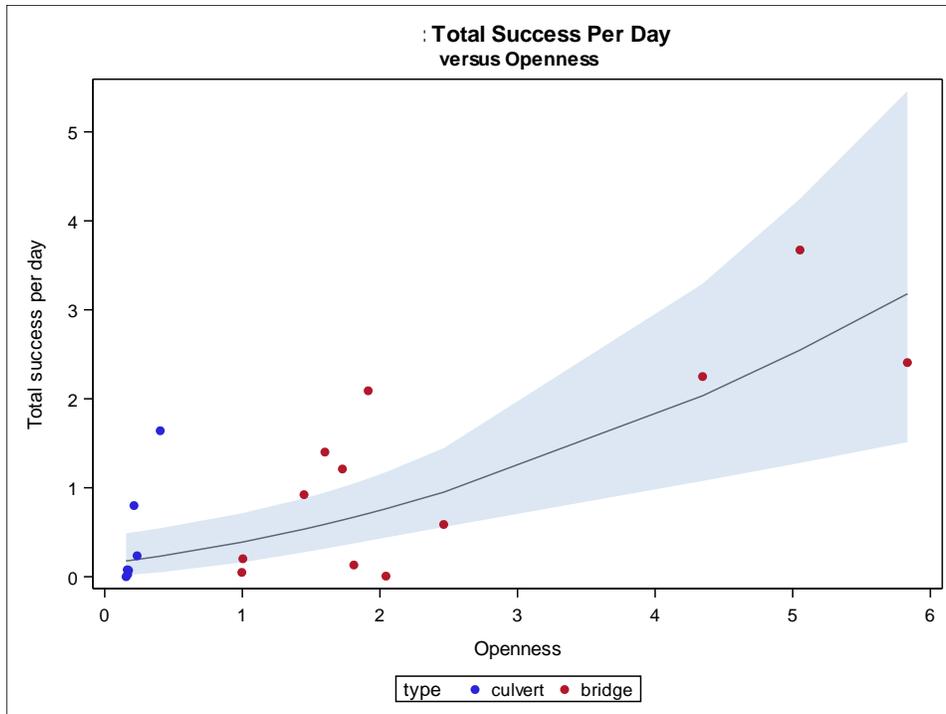
Figure 25. White-Tailed Deer Success Per Day Plotted Against Openness.

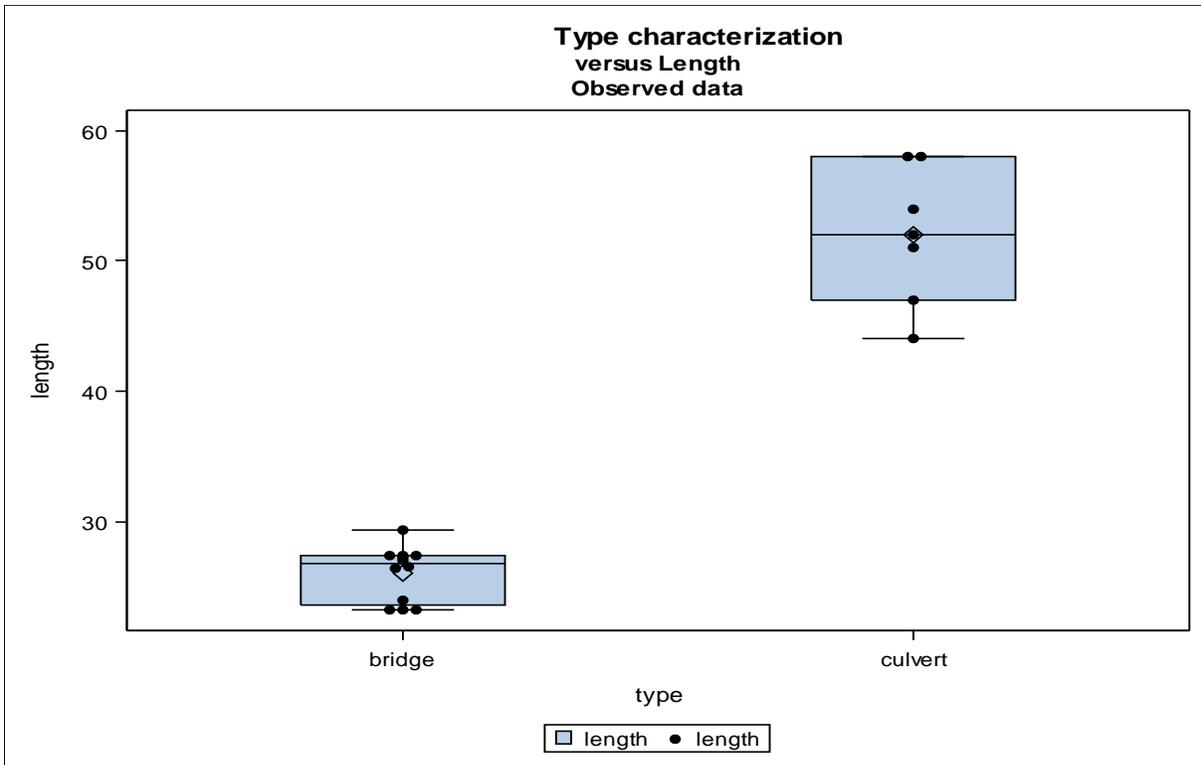
Figure 26. Wildlife Crossing Structure Type and Length of Structures.

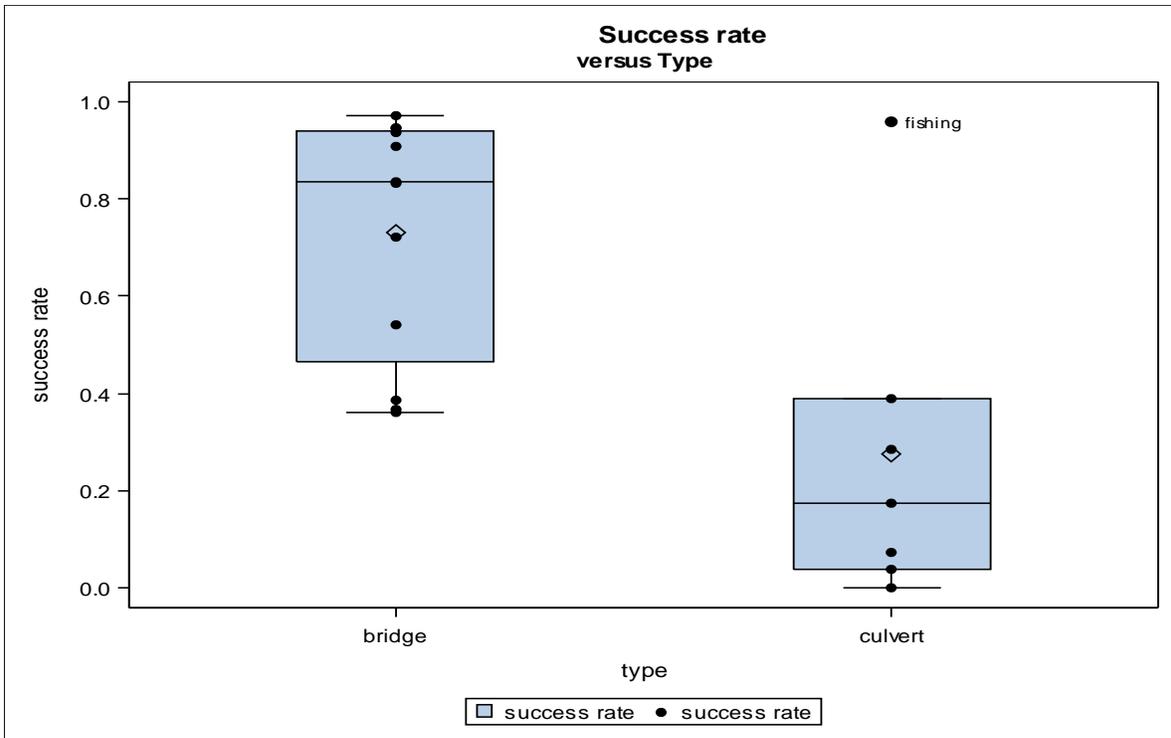
Success rate was higher for bridges than for culverts (Figure 27). Counterbalancing this difference in success rate, parallel rate was lower for bridges than for culverts, whereas no difference was observed in rate of repellency. A notable exception to this pattern was Bass Creek Fishing Access Culvert, which was as successful as the most successful bridges and appreciably more successful than any other culvert (Table 3, Section 2.3.3). Bass Creek Fishing Access Culvert had height, width, and openness nearly twice as large as other culverts. White-tailed deer success per camera day was higher for bridges than for culverts (Figure 28).

Figure 27. White-Tailed Deer Success Rate for Bridges and Culverts.

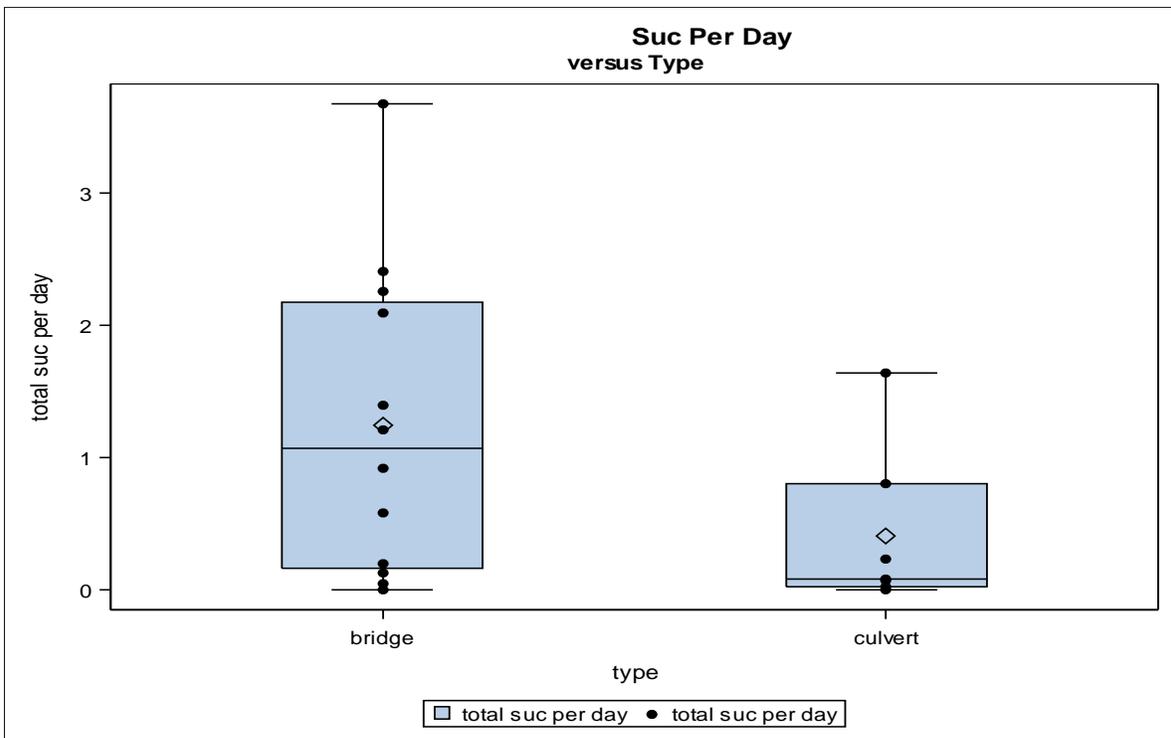
Figure 28. White-Tailed Deer Success per Day for Bridges and Culverts.

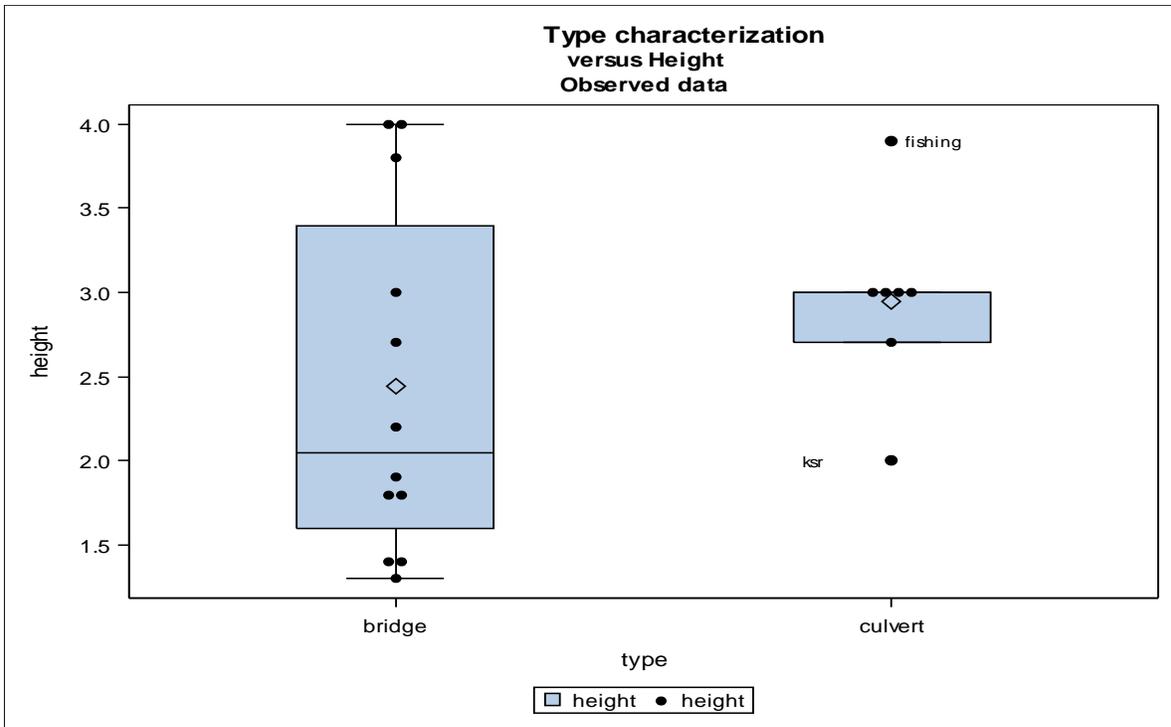
Figure 29. Heights of Bridges and Culverts.

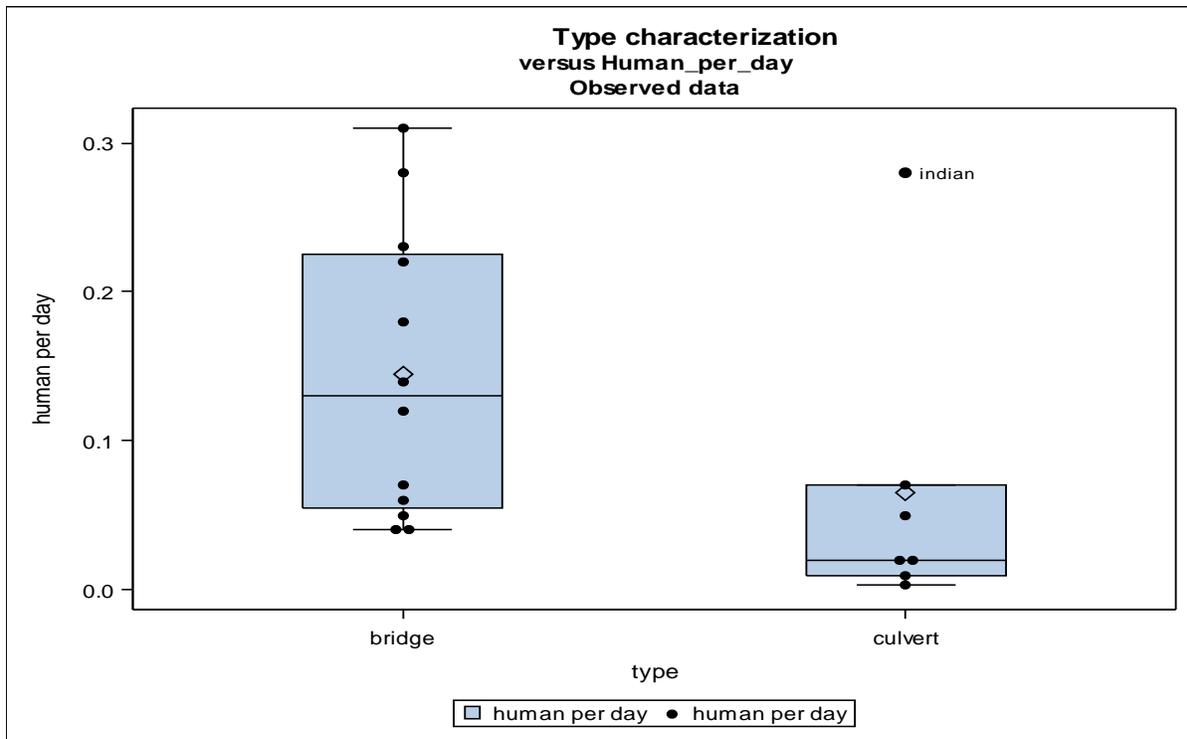
Figure 30. Human Use Per Day for Bridges and Culverts.

Bridges and culverts were distinctly different in their design characteristics of width, length, and openness. There was no overlap in width, length, and openness values between bridges and culverts. For example, the widest culvert was 6 meters (20 feet) and the narrowest bridge was 14 meters (46 feet). Consequently, the effects of width, length, and openness on use rates cannot be distinguished from the effect of structure type on use rates. Height values overlapped for bridges and culverts (Figure 29). There was no evidence of a difference between the bridge mean and the culvert mean for height. Bridges typically had more human use than culverts. The exception was Indian Prairie Culvert (Figure 30).

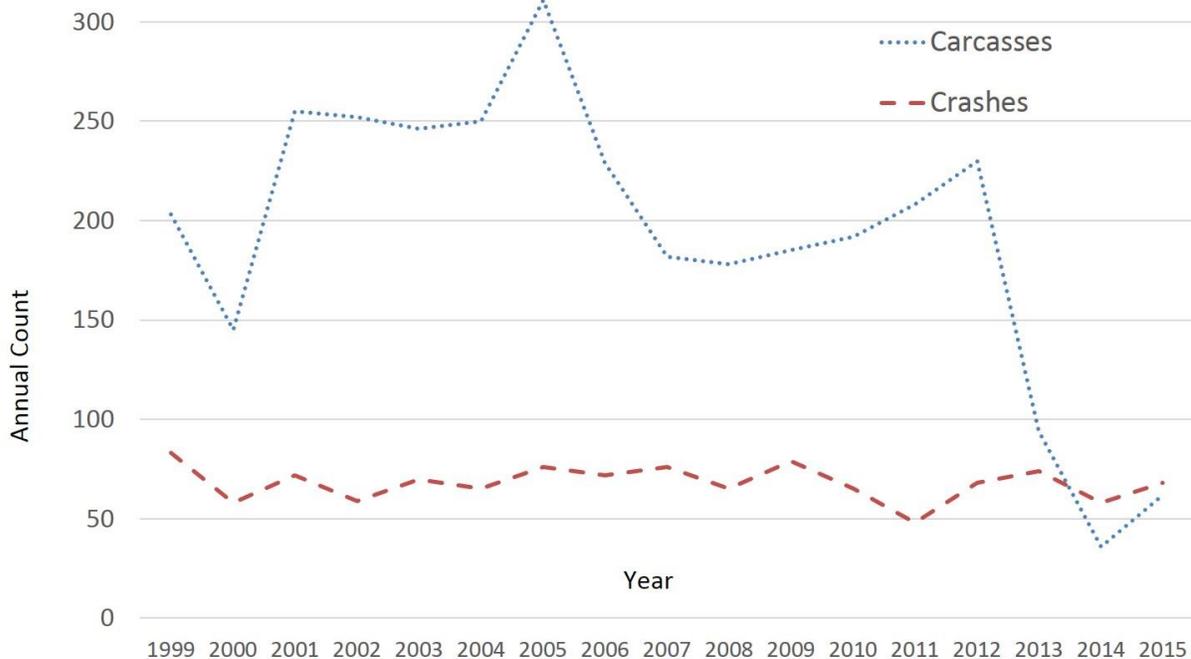
The plot of annual white-tailed deer WVC carcasses and annual WVC crashes are presented in Figure 31. The annual number of WVC carcasses fluctuated greatly compared to the annual number of WVC crashes. The number of WVC carcasses decreased 59 percent from 2012 to

2013, and decreased 84 percent from 2012 to 2014. The lowest number of WVC carcasses (36) occurred in 2014 when WVC carcasses were less than WVC crashes (58). From 2000 through 2012, WVC crashes averaged 32 percent of WVC carcasses.

Figure 31. WVC Carcass and Crash Data Comparison, in the Study Area, mp 48 to mp 85, from 1999 through 2015.

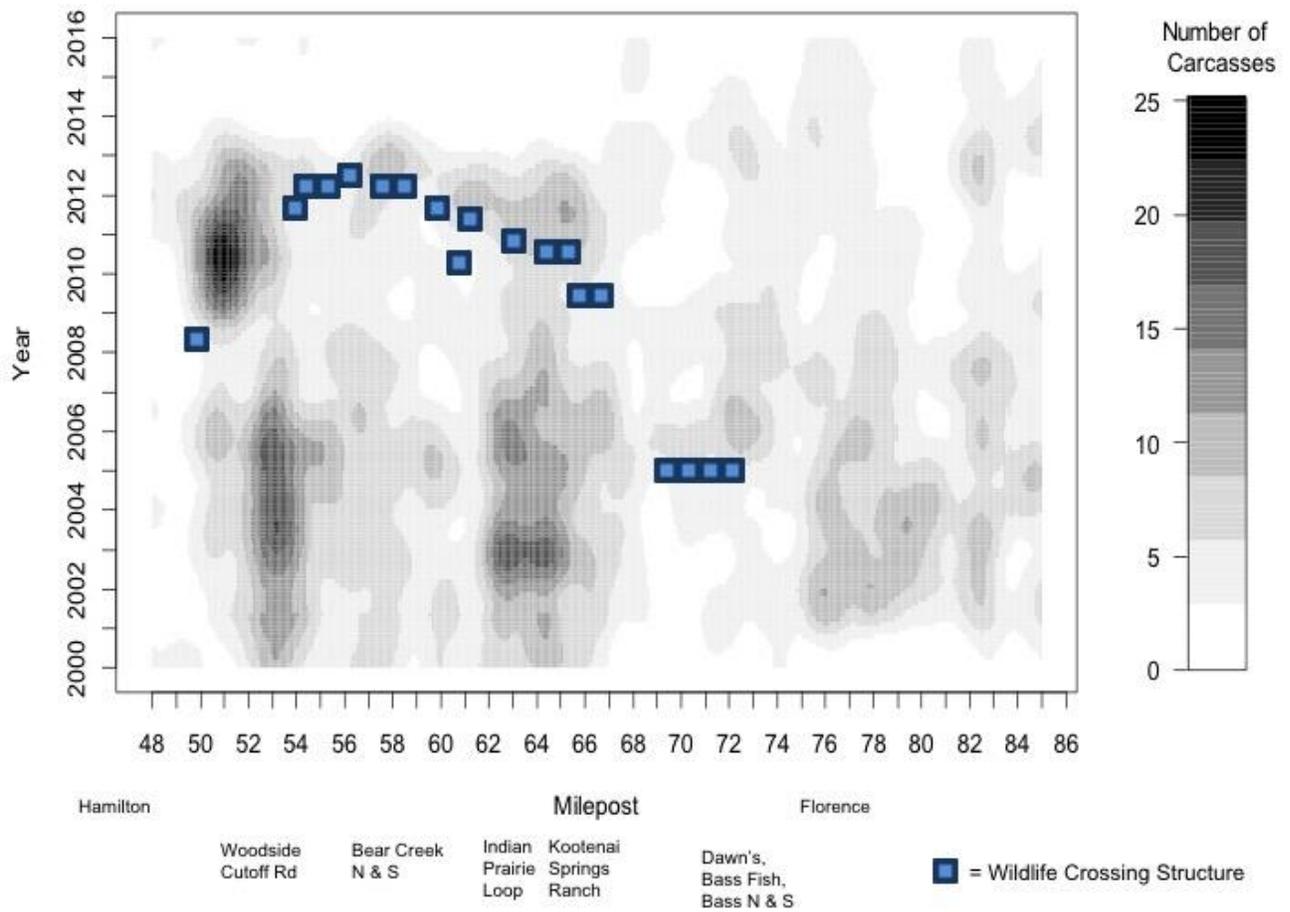
Kernel2d representations of white-tailed deer WVC carcass and WVC crash intensities are presented in Figure 32 and Figure 33. The figures visually demonstrate the discrepancy between WVC carcass and crash intensities from 2013 through 2015. Figure 32 reveals a general increase in WVC carcass intensity from 2011 to early 2013 following the construction of wildlife crossing structures between mp 55 and mp 65. WVC carcass intensity decreased from mp 55 to mp 65 in the second half of 2013 and remained low through 2015. A temporary increase in WVC carcass intensity also occurred in 2005 and 2006 between mp 69 and mp 72 following the construction of wildlife crossing structures. A similar pattern of temporary increases in WVC crash intensities near mp 54 through 57, mp 61, mp 63, mp 65, and mp 70 through mp 72 following construction of wildlife crossing structures was also observed in Figure 33.

Figure 32. Kernel2d Representation of WVC Carcass Intensity, US 93, mp 48 to 85, 2000 Through October 2015.

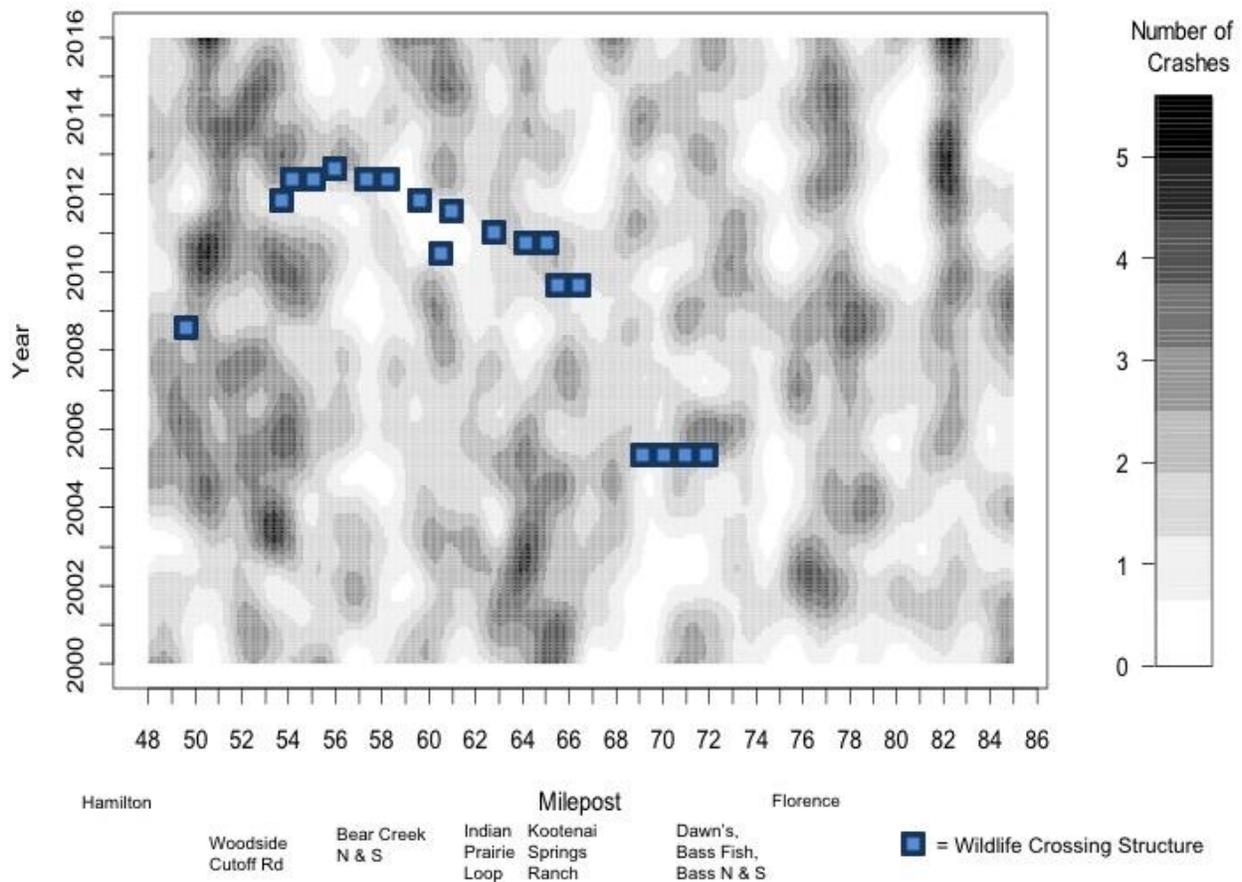
Figure 33. Kernel2d Representation of WVC Crash Intensity, US 93, mp 48 to 85, 2000 Through 2015.

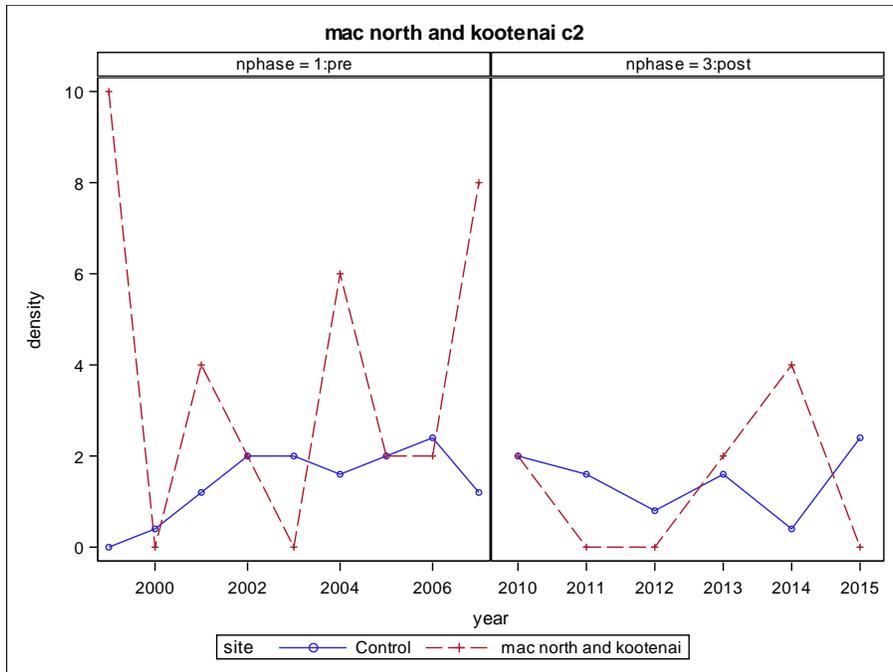
The BACI design analysis is presented in Table 6. Wildlife crossing structures had no statistically significant effect of WVC crash rates. The smallest p -value (0.11) was computed for Kootenai Creek Bridge and McCalla Creek North Bridge (mp 66.4 to mp 65.9). This location had the largest WVC crash rate reduction relative to a control section (-2.6 crashes per year per mile), and is clearly observed in Figure 34. The BACI analysis computed a p -value of 0.22, not statistically significant, for McCalla Creek South Bridge and Kootenai Springs Ranch Culvert (mp 65.3 to mp 63.8). The relative WVC crash rate reduction at this location was -1.2 crashes per year per mile; and this reduction is shown in Figure 35. Other statistically insignificant but notable relative reductions in WVC crash rates (-1.8 crashes per year per mile) occurred at Big Creek Bridge (mp 61.8 to mp 61.4), Bear Creek South Bridge (mp 57.3 to 56.9), and Fun Park Culvert (mp 55.7 to mp 55.3). These relative reductions are apparent in Figure 36 through Figure 38. The largest relative increases in WVC crash rates occurred at Blodgett Creek Bridge (1.4 crashes per year per mile, mp 50.5 to 50.1) and at Bass Creek Fishing Access Culvert and Dawns

Figure 34. Changes in WVC Crash Rate at Kootenai Creek Bridge and McCalla Creek North Bridge Wildlife Crossing Structures between Pre-construction and Post-Construction Relative to a Control Section.

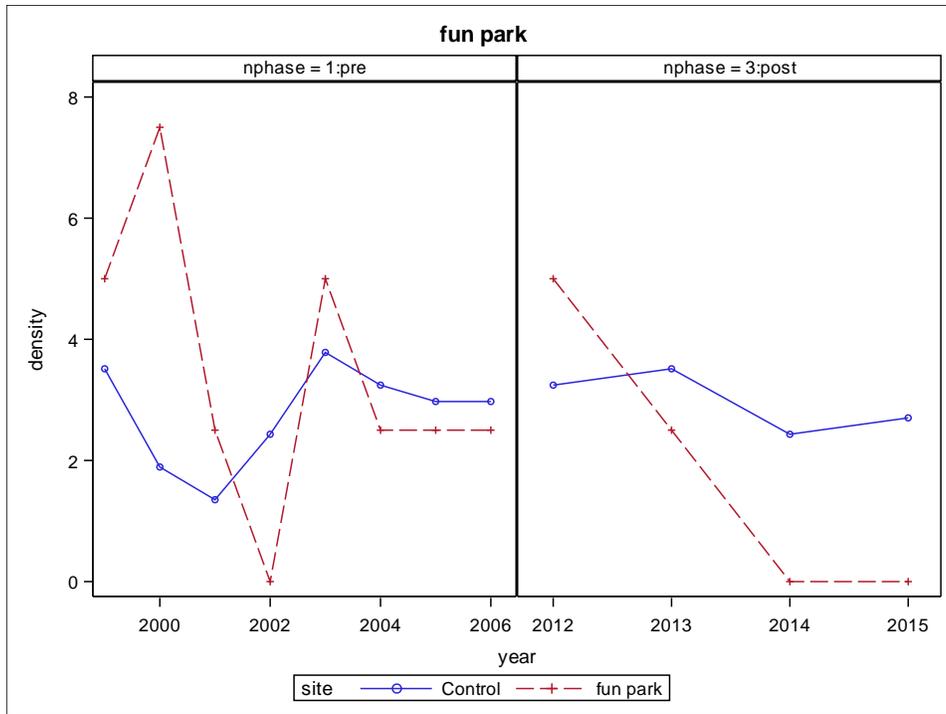
Figure 38. Changes in WVC Crash Rate at Fun Park Culvert Wildlife Crossing Structure between Pre-construction and Post-Construction Relative to a Control Section.

Another notable result from the BACI analysis was the relative reduction in WVC crash rate at the Fun Park Culvert wildlife crossing structure (Figure 38). This structure had only a small amount of wildlife fence. No white-tailed deer were observed moving through the structure during post-construction monitoring. The success rate and the success per camera day and were zero (Table 3). The explanation, once again, may be the substantial change in white-tailed deer abundance documented during pre-construction and post-construction monitoring (Figure 18). White-tailed deer were observed successfully moving across US 93 at the site on 663 occasions during pre-construction monitoring.

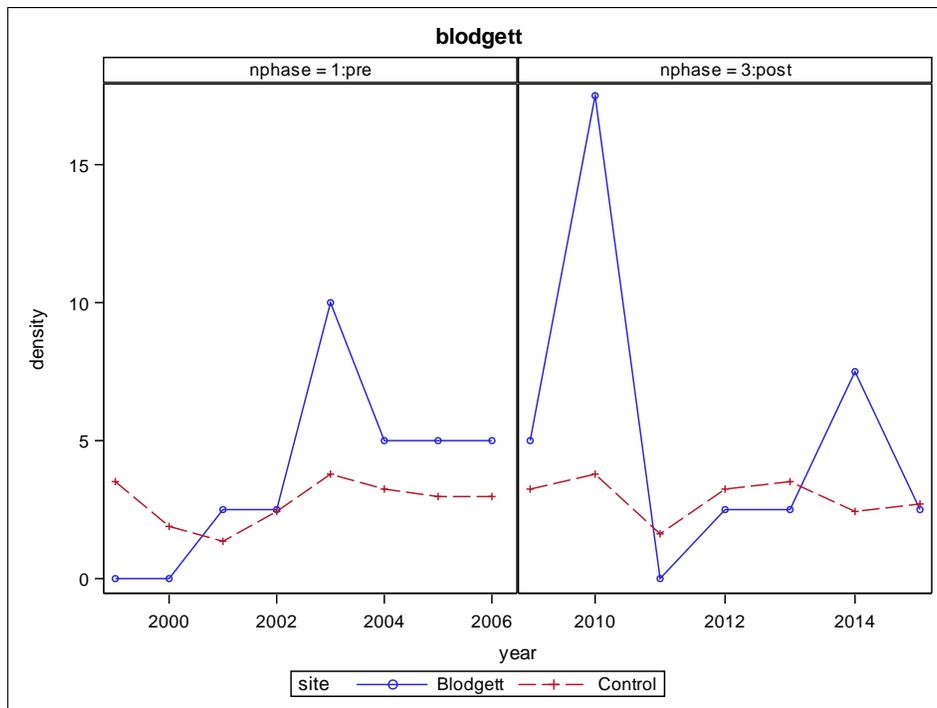
Figure 39. Changes in WVC Crash Rate at Blodgett Creek Bridge Wildlife Crossing Structure between Pre-Construction and Post-Construction Relative to a Control Section.

Crossing Bridge (1.2 crashes per year per mile, mp 70.4 to mp 69.0). These changes can be observed in Figure 39 and Figure 40.

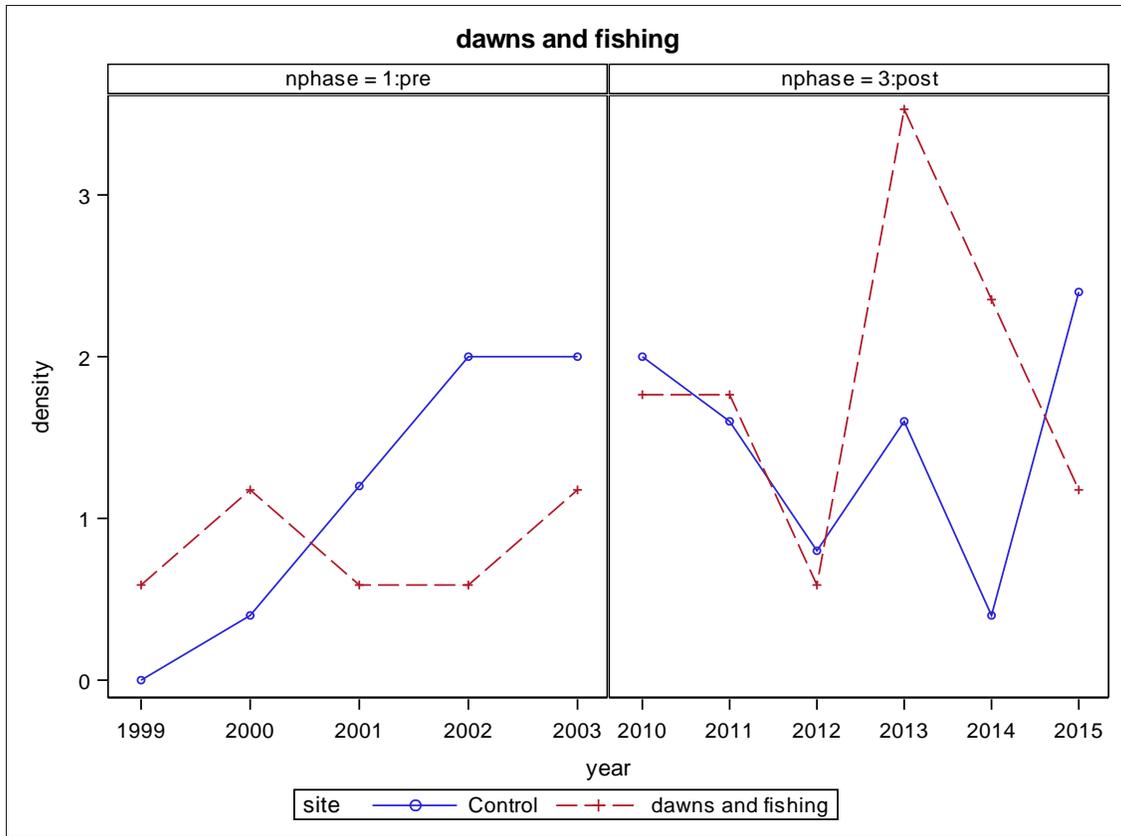
Figure 40. Changes in WVC Crash Rate at Bass Creek Fishing Access Culvert and Dawns Crossing Bridge Wildlife Crossing Structures between Pre-construction and Post-Construction Relative to a Control Section.

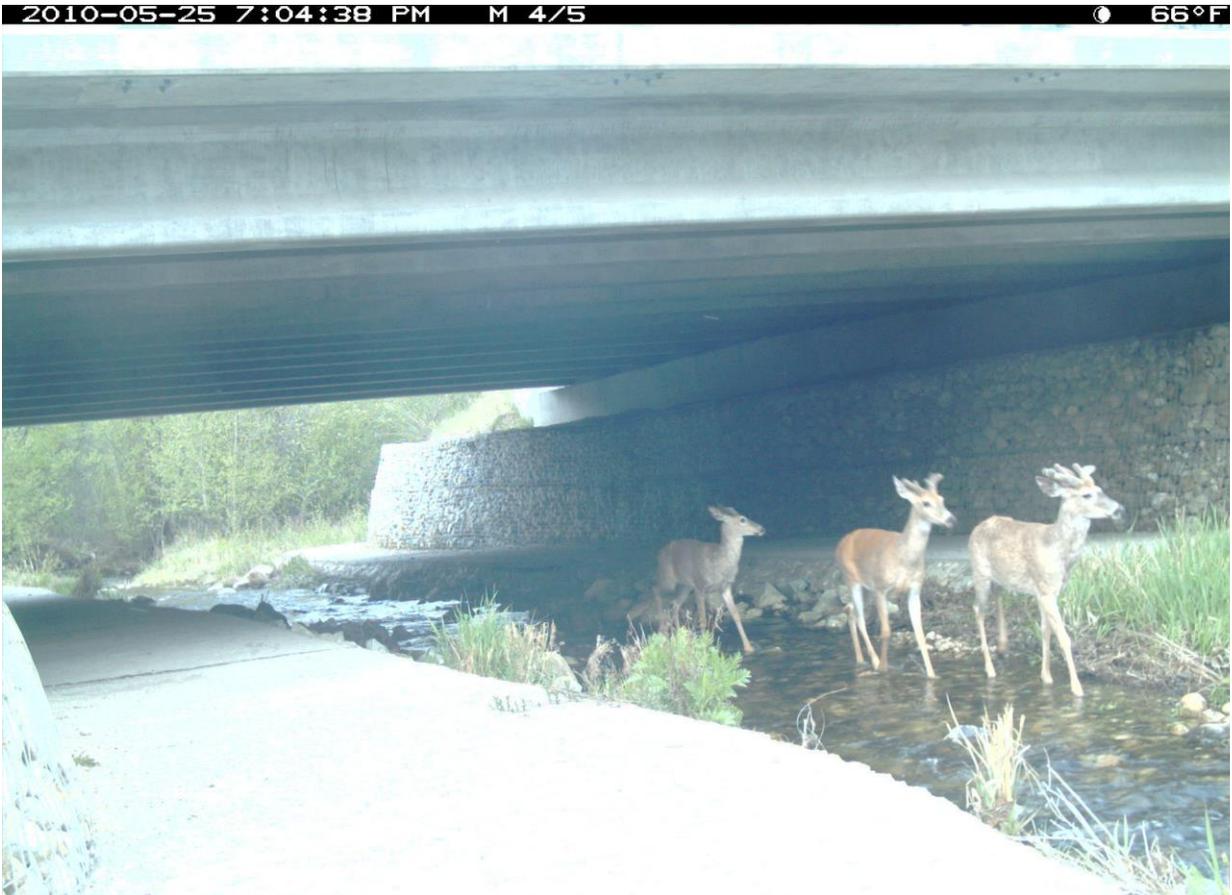
Figure 41. US 93 mp 71.1 Bass North Bridge, 3 (H) x 14 (W) x 23.2 (L) meters, 9.8 x 46 x 76 feet, Openness Ratio (meters) 1.8.

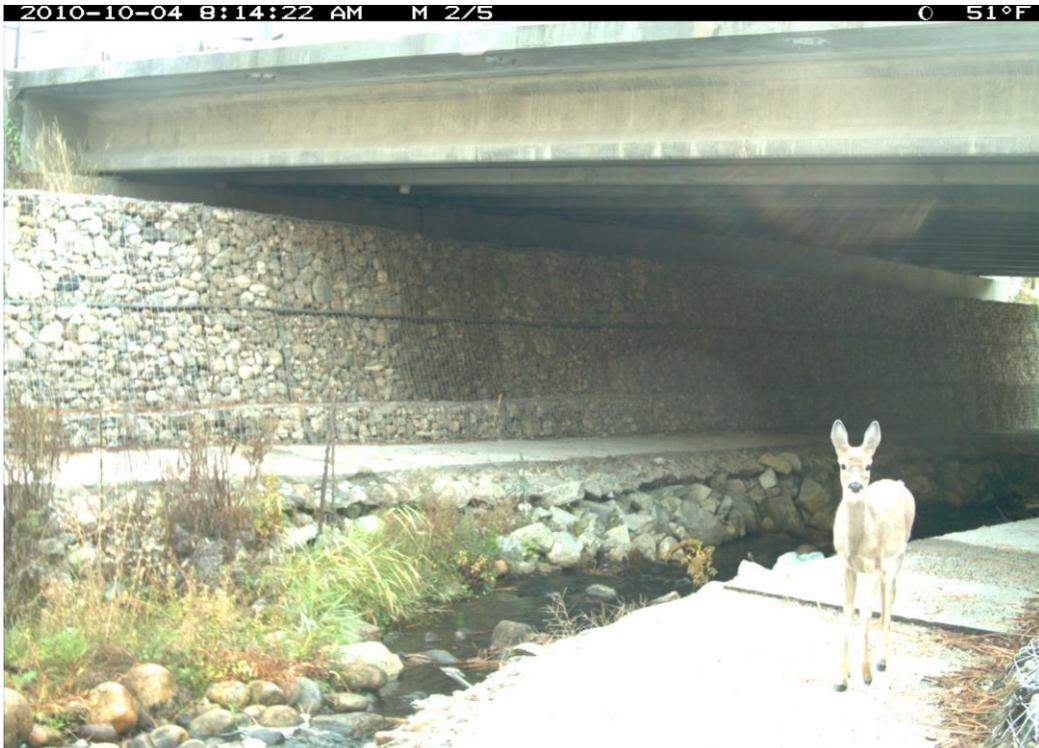
Figure 42. US 93 mp 70.5 Bass South Bridge, 4 (H) x 14 (W) x 27.4 (L) meters, 13 x 46 x 76 feet, Openness ratio (meters) 2.0.
