EVALUATION OF WILDLIFE CROSSING STRUCTURES ON US 93 IN MONTANA'S BITTERROOT VALLEY

FHWA/MT-17-003/8194

Final Report

prepared for
THE STATE OF MONTANA
DEPARTMENT OF TRANSPORTATION

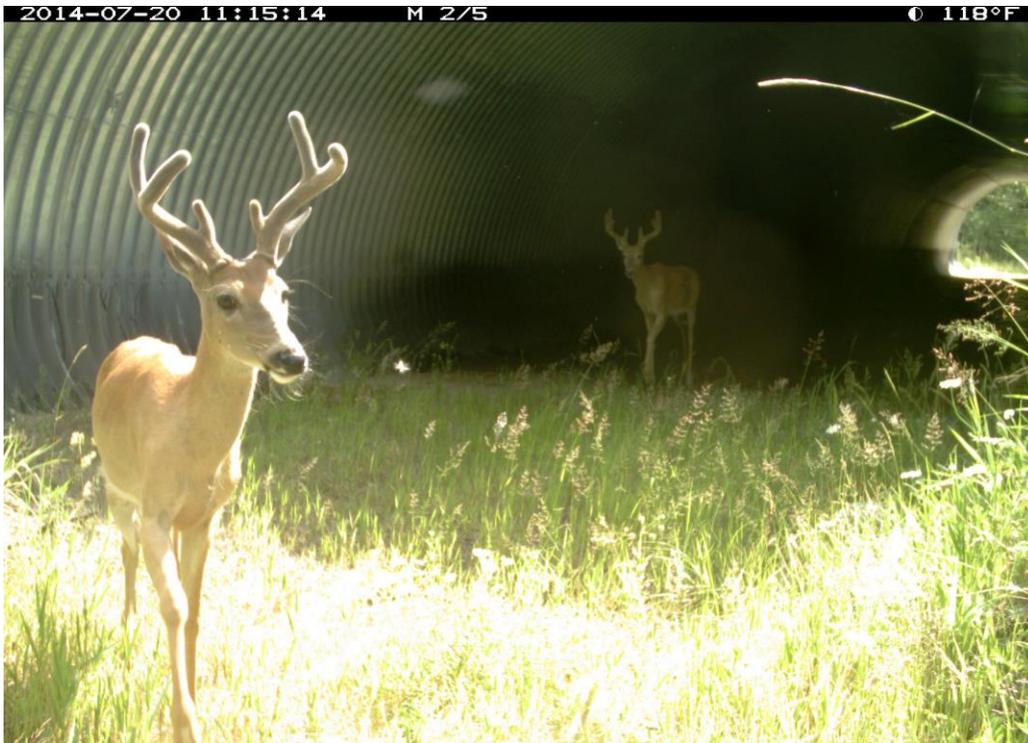
Figure 43. US 93 mp 70.1 Bass Fishing Access Culvert, 3.9 (H) x 6 (W) x 58 (L) meters, 12.7 x 20 x 190 feet, Openness Ratio (meters) 0.40.

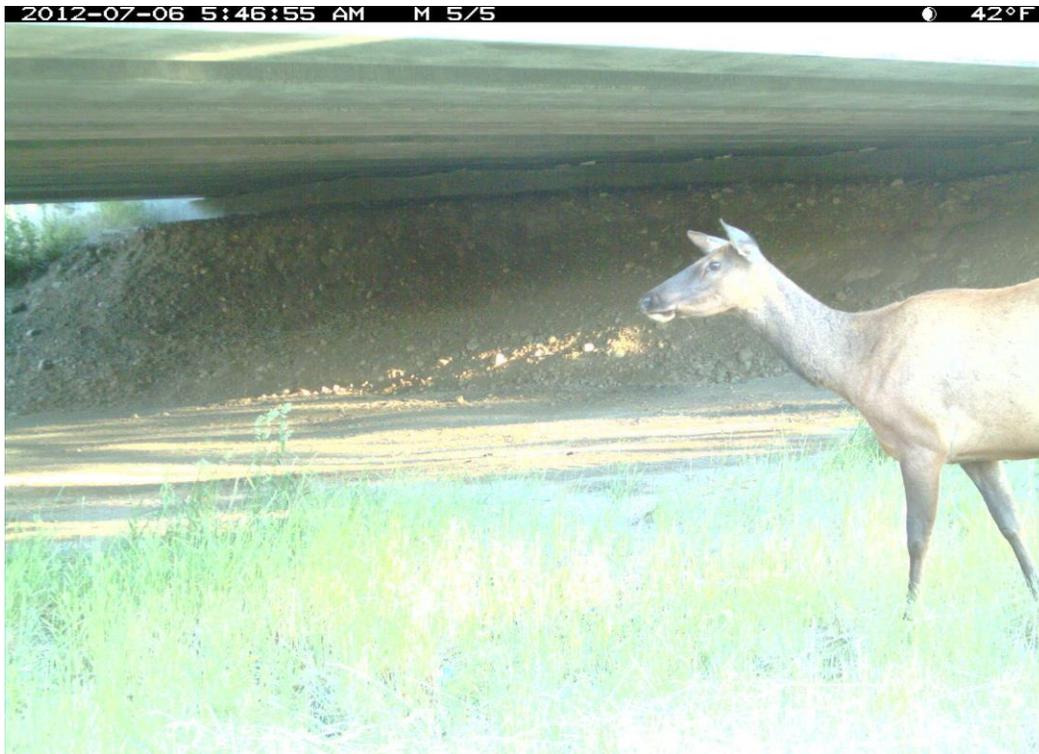
Figure 44. US 93 mp 69.7 Dawn's Crossing Bridge, 4 (H) x 135 (W) x 24 (L) meters, 13 x 115 x 79 feet, Openness Ratio (meters) 5.8.

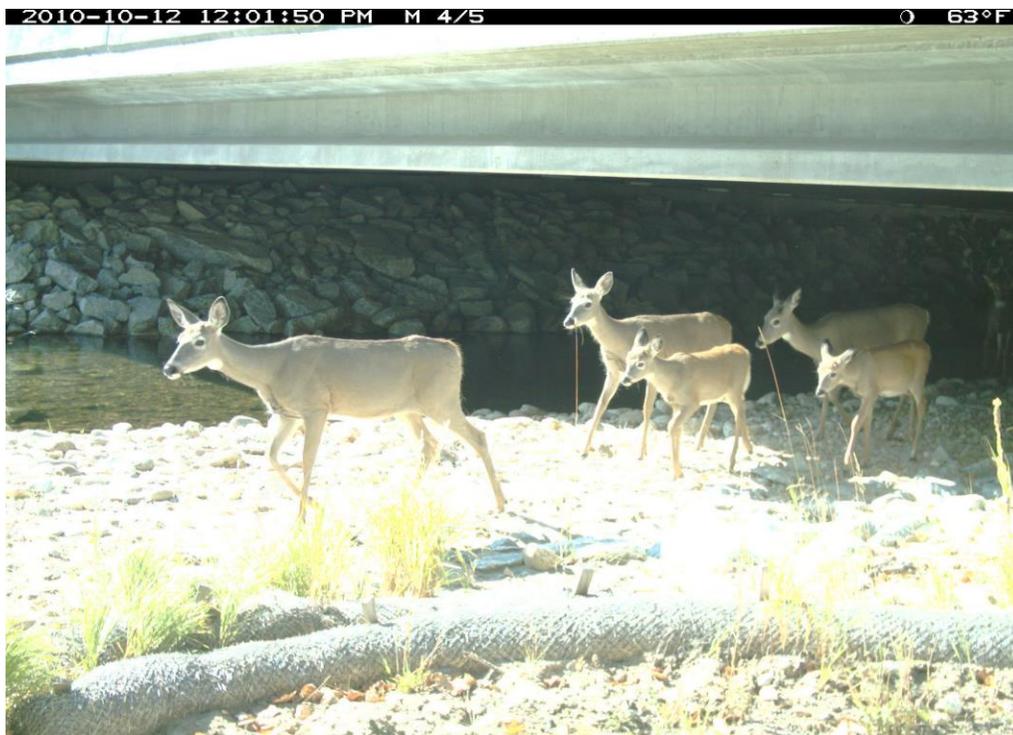
Figure 45. US 93 mp 66.2 Kootenai Creek Bridge, 1.8 (H) x 24 (W) x 27 (L) meters, 5.9 x 79 x 88.6 feet, Openness Ratio (meters) 1.6.

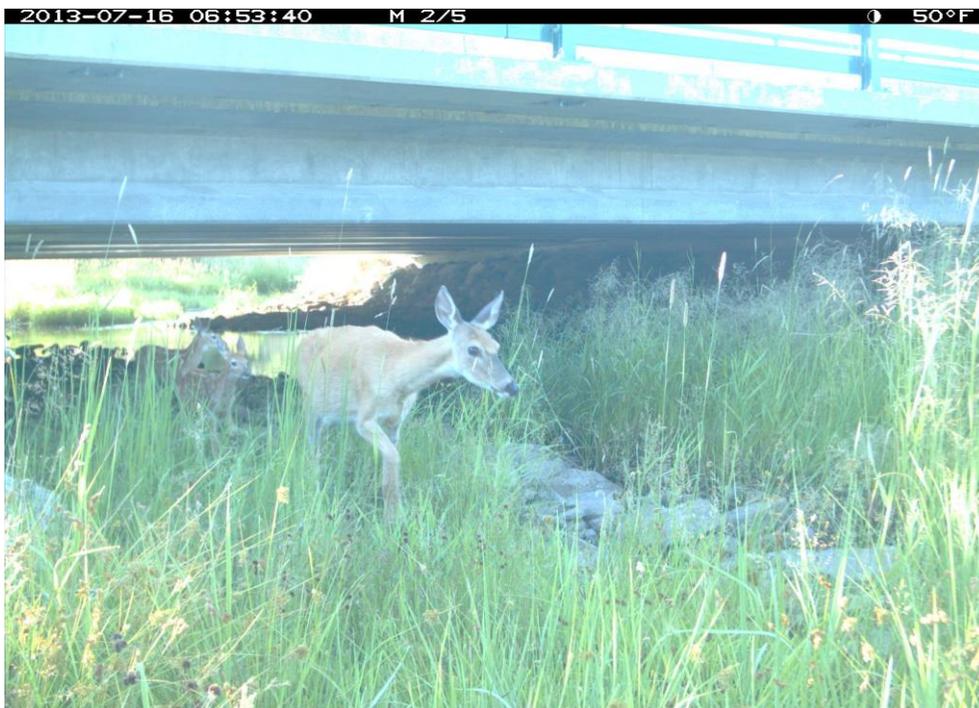
Figure 46. US 93 mp 66.1 McCalla North Bridge, 1.9 (H) x 24 (W) x 26.4 (L) meters, 6 x 79 x 86 feet, Openness Ratio (meters) 1.7.

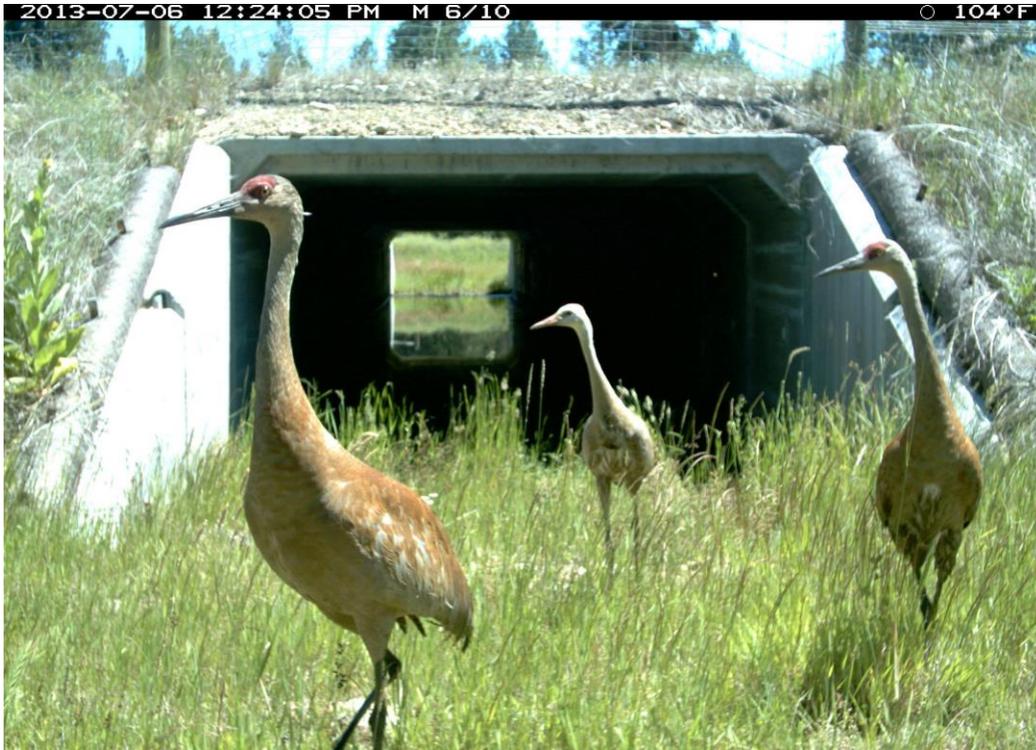
Figure 48. US 93 mp 64.6 Kootenai Springs Ranch Culvert, 2 (H) x 3.6 (W) x 44 (L) meters, 6.5 x 11.8 x 144 feet, Openness Ratio (meters) 0.16.

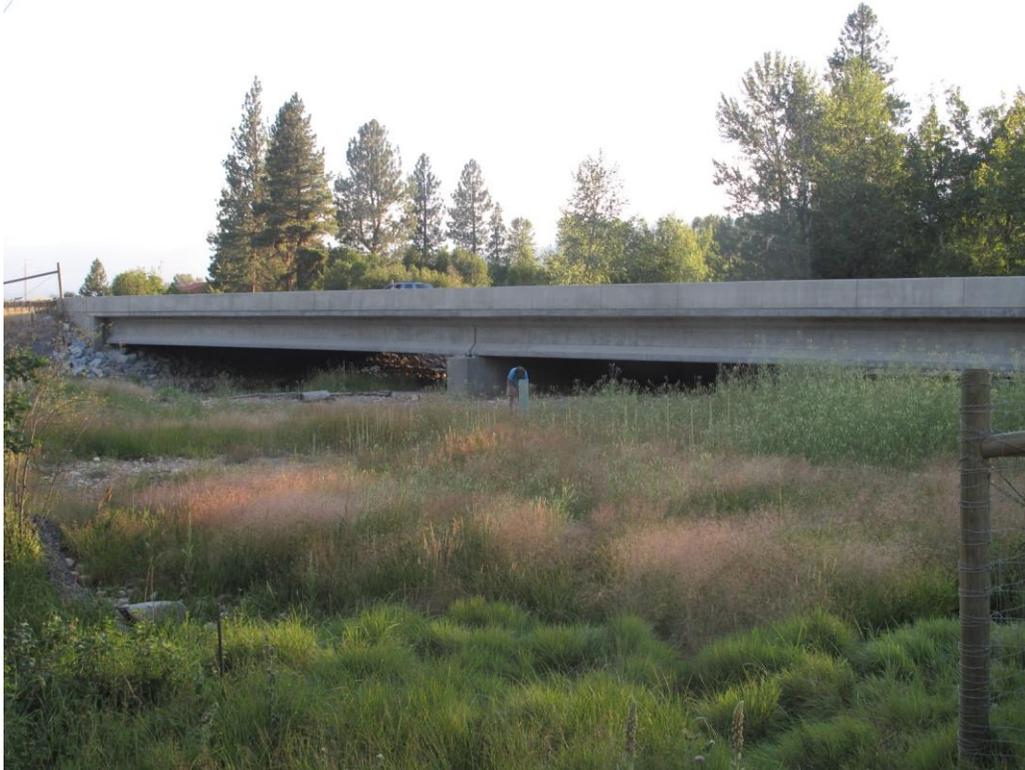
Figure 50. US mp 61.6 Big Creek Bridge, 1.4 (H) x 19 (W) x 26.5 (L) meters, 4.5 x 62 x 87 feet, Openness Ratio (meters) 4.3. View from Northeast Corner. Note Researcher Bent Over Camera Box in Foreground for Height Comparison.

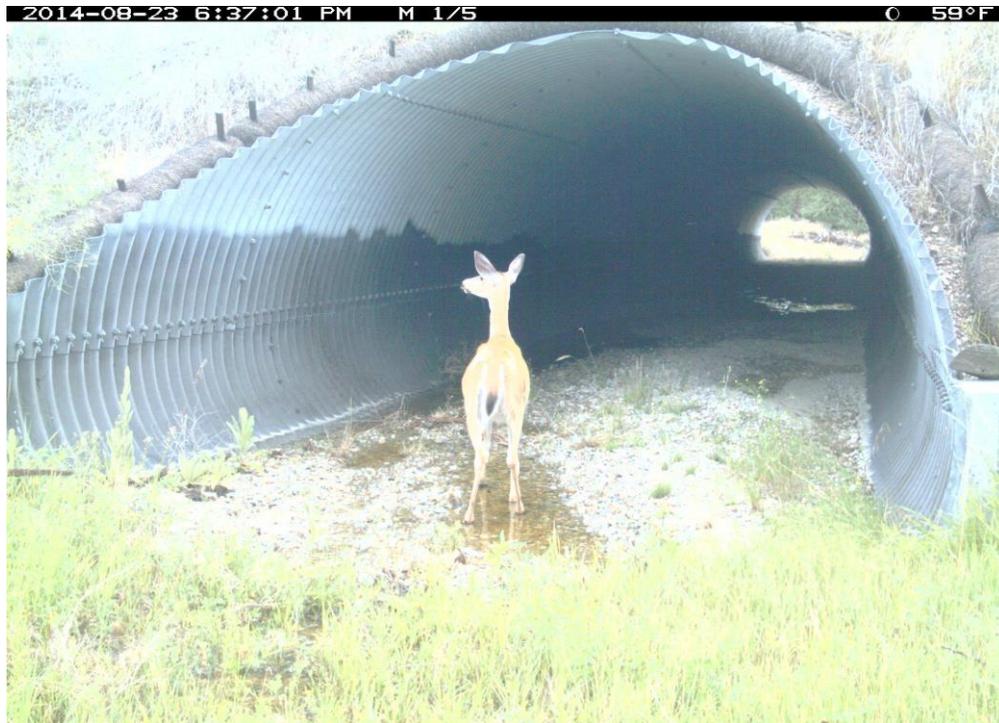
Figure 52. US 93 mp 60.7 Axmen Propane Culvert, 3 (H) x 4 (W) x 51 (L) meters, 9.8 x 13 x 161 feet, Openness Ratio (meters) 0.24.

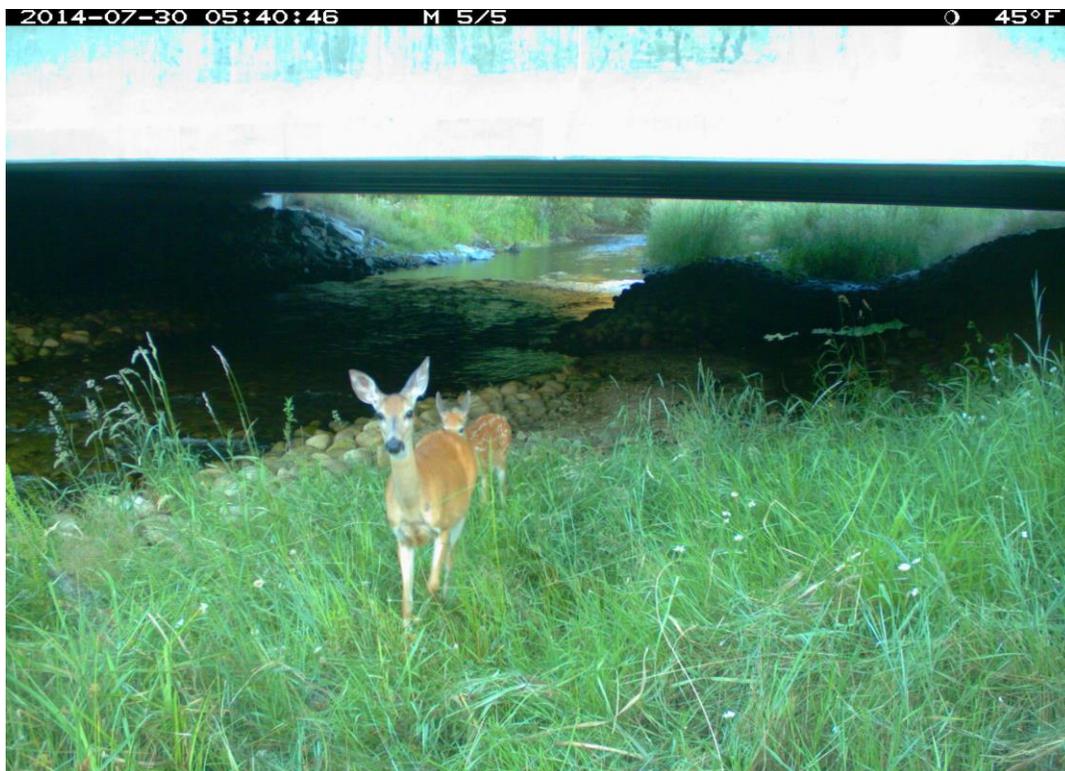
Figure 53. US 93 mp 59.7 Sweathouse Creek Bridge, 2.2 (H) x 25.5 (W) x 29.3 (L) meters, 7.2 x 84 x 96 feet, Openness Ratio (meters) 1.9.

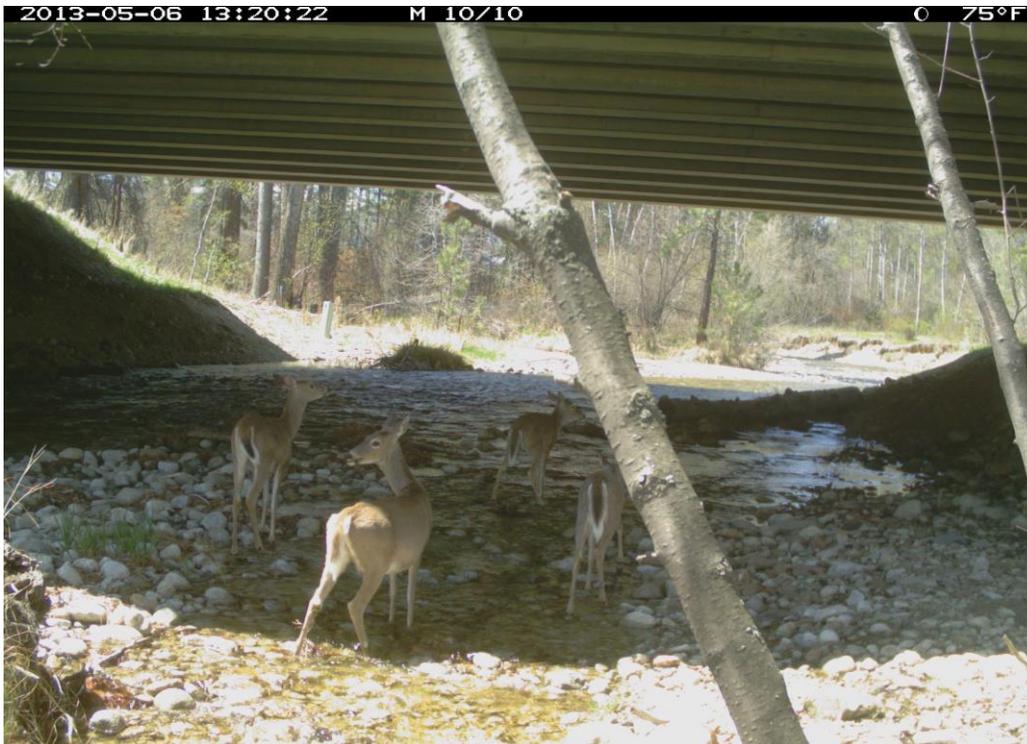
Figure 55. US 93 mp 57.1 Bear Creek South Bridge, 3.8 (H) x 36.3 (W) x 27.3 (L) meters, 12.5 x 119 x 89.5 feet, Openness Ratio (meters) 5.0.

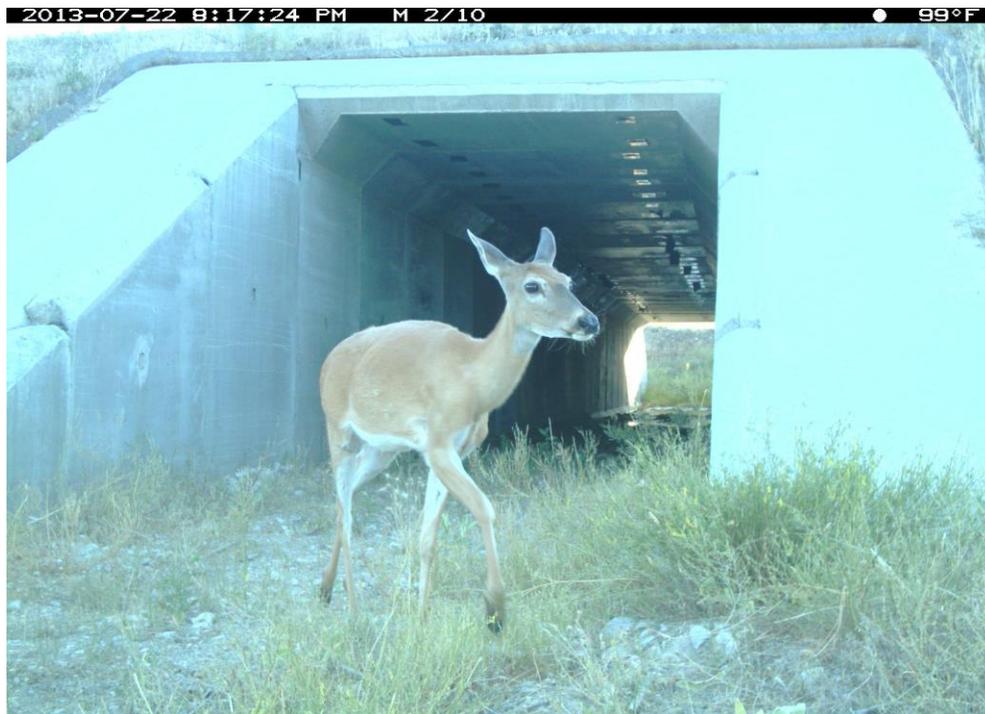
Figure 56. US 93 mp 56.7 Lupine Culvert, 2.7 (H) x 2.7 (W) x 52 (L) meters, 9 x 9 x 170 feet, Openness Ratio (meters) 0.14.

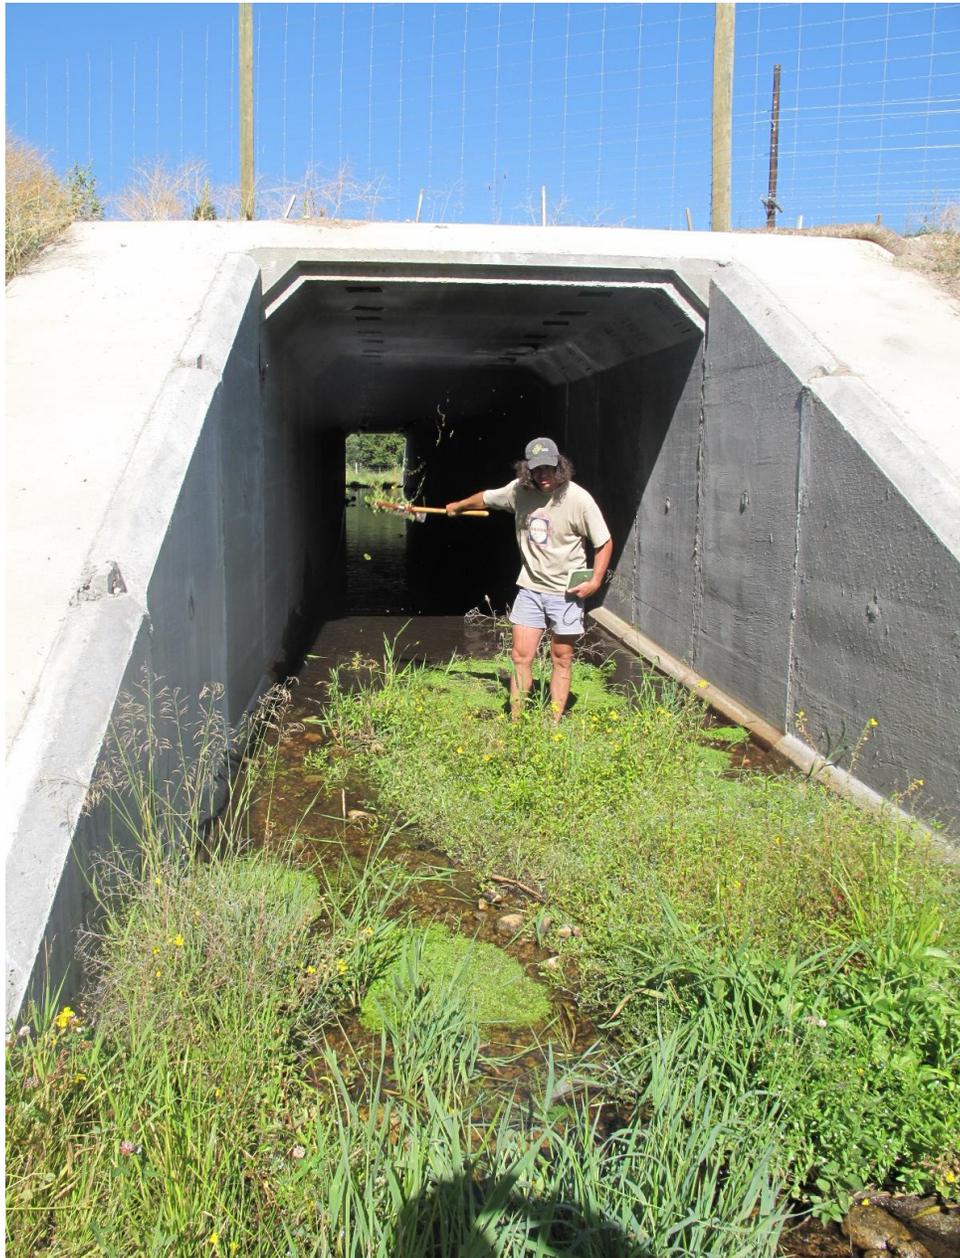
Figure 58. US 93 mp 55.5 Fun Park Culvert, 2.7 (H) x 2.7 (W) x 58 (L) meters, 9 x 9 x 190 feet, Openness Ratio (meters) 0.13.

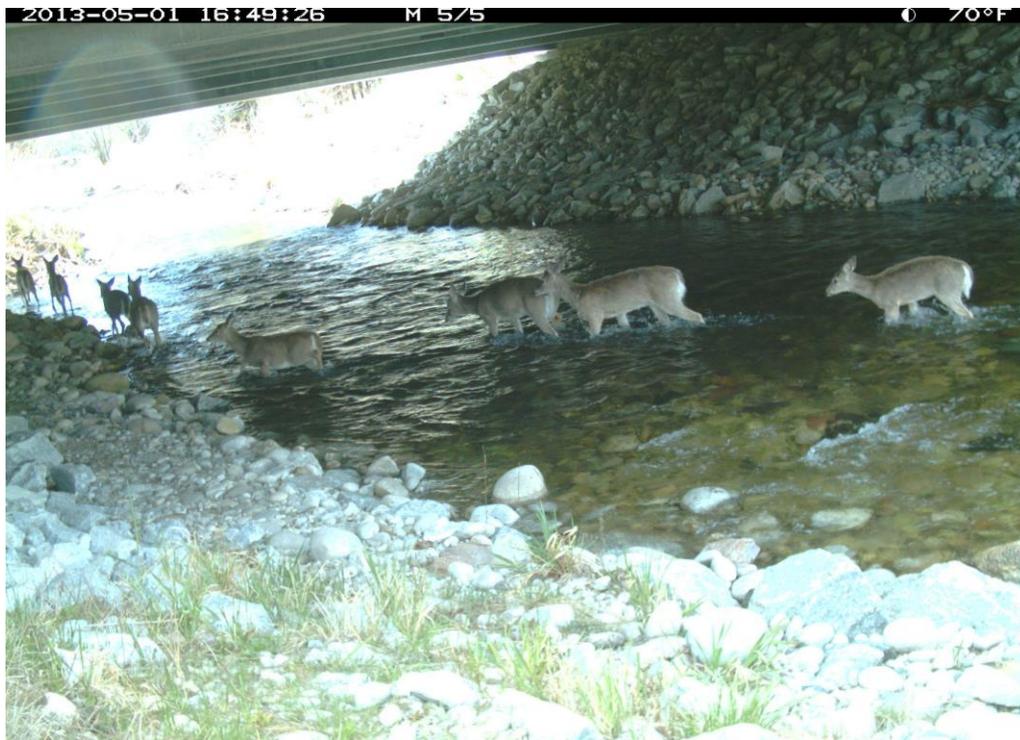
Figure 60. US 93 mp 50.3 Blodgett Creek Bridge, 2.7 (H) x 25 (W) x 27.4 (L) meters, 9 x 82 x 90 feet, Openness Ratio (meters) 2.4.
