**Montana US 93 South Wildlife Crossings Research
MDT # HWY – 308445-RP**

**Fourth Quarterly Report
April 23 - July 31, 2009**

Prepared for
Montana Department of Transportation
July 2009

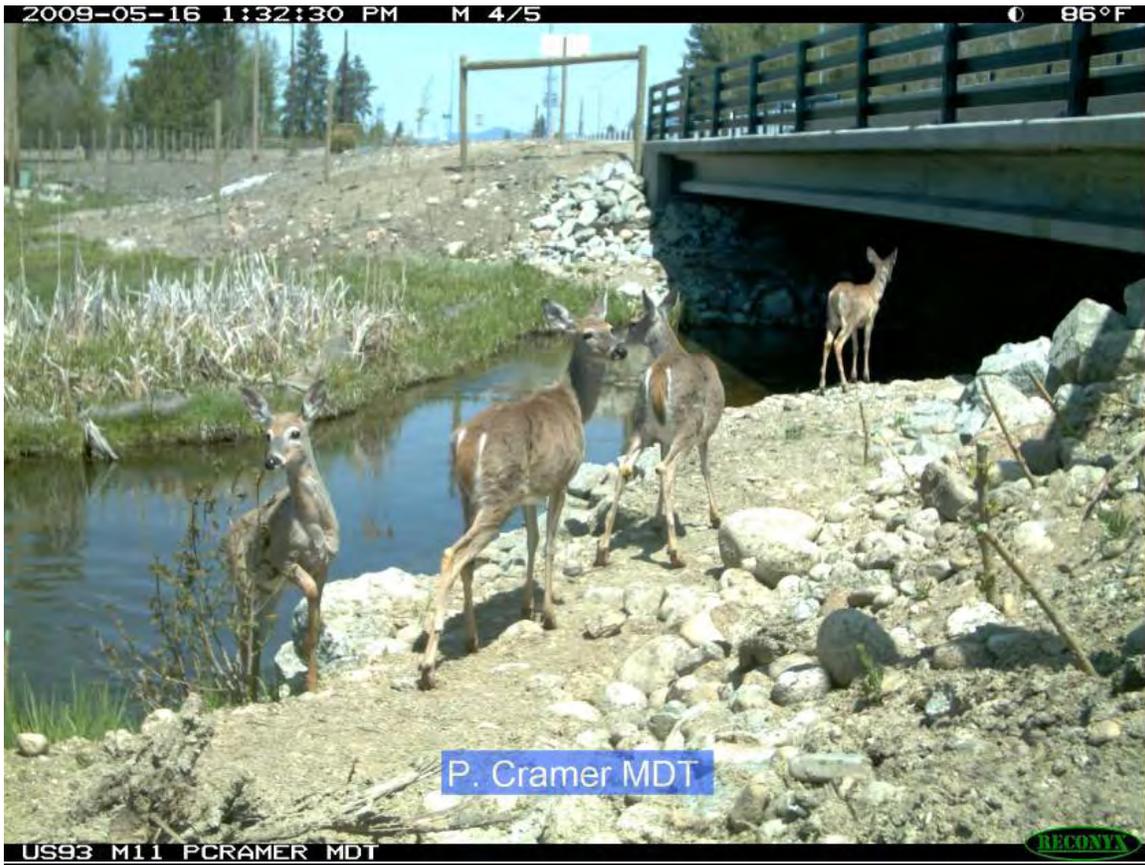
walkways, which were finished at the end of 2008, once fencing was placed to guide the animals to the crossings, white-tailed deer began using these crossings within three weeks, see cover photo. All future crossings with cameras have had deer photographed using the area. Some existing older bridges are showing to pass deer. Of special note is the deer use of a large and quite high bridge. There are not only white-tailed deer, but mule deer have been photographed using the stream area under the structure. This includes regular buck use as well see Figure 2 below. A new camera site placed at a future culvert site is proving a hot spot of deer activity. In the first 10 days of monitoring in July, there were 37 deer passes, Figure 3 below.

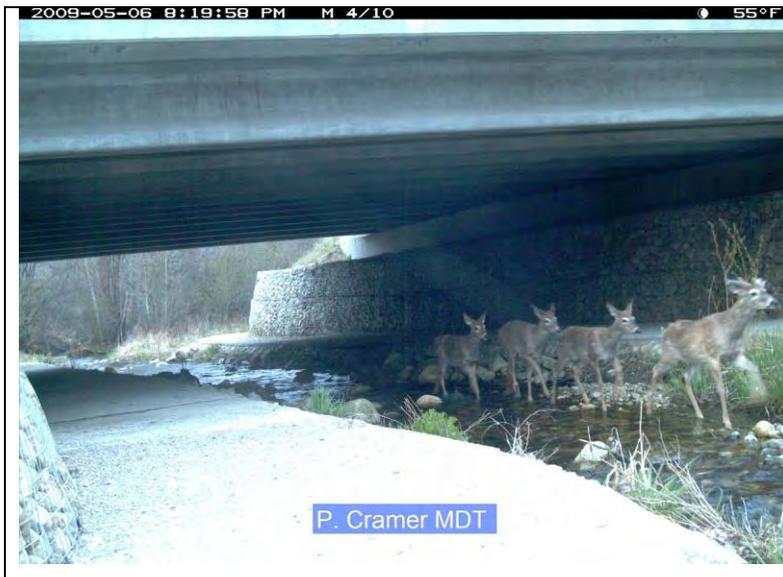
Figure 1. White-tailed deer buck leading does and buck through bridged crossing with sidewalks. In 270 days of monitoring this crossing, no deer has used the cement sidewalks to pass underneath the bridge.

In general, deer are using the existing crossings. In the north, the number of deer using the bridged crossings with sidewalks and the corrugated steel culvert are much lower than the deer using the bridged crossing at a nearby bridged crossing. All these crossings are within a mile and 3/4 of each other. An interesting development at a bridged crossing with sidewalks is that the two white-tailed deer bucks that were using the stream bed to move through began leading two does through the crossing and now the four of them can be seen using this stream, see Figure 1 below. At two bridged crossings with natural bed

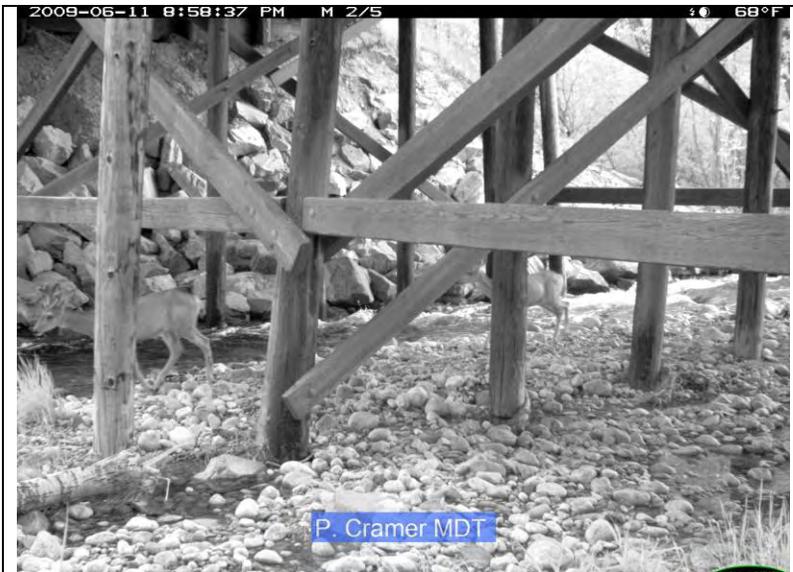
Figure 2. Old bridge with mule deer bucks moving underneath. This is the first site to record mule deer.

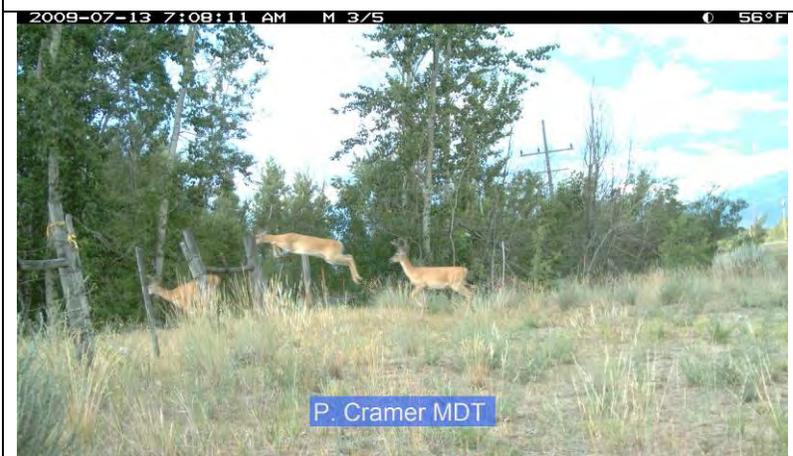
Figure 3. A trio of deer at a new camera location where there is to be a future culvert. This site had 37 deer events in the 1st 10 days of monitoring.
