Photo Plate 4: Flathead River Bridge (24FH463)

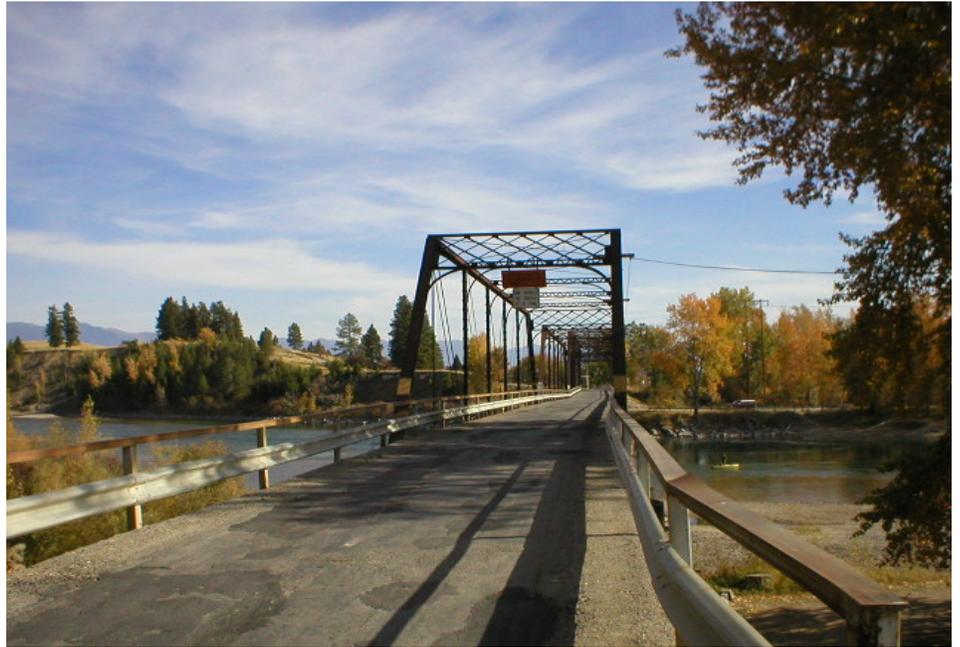
Photograph 1:

Looking eastward across the existing bridge. The present structure does not meet MDT's optimal width for two-lane bridges and has a limited vertical clearance. The bridge's deteriorated conditions have resulted in the posting of a 3-ton load limit for vehicles using the structure.
