MISSOULA BRIDGES

PLANNING STUDY

EXISTING AND PROJECTED CONDITIONS REPORT

August 21, 2013

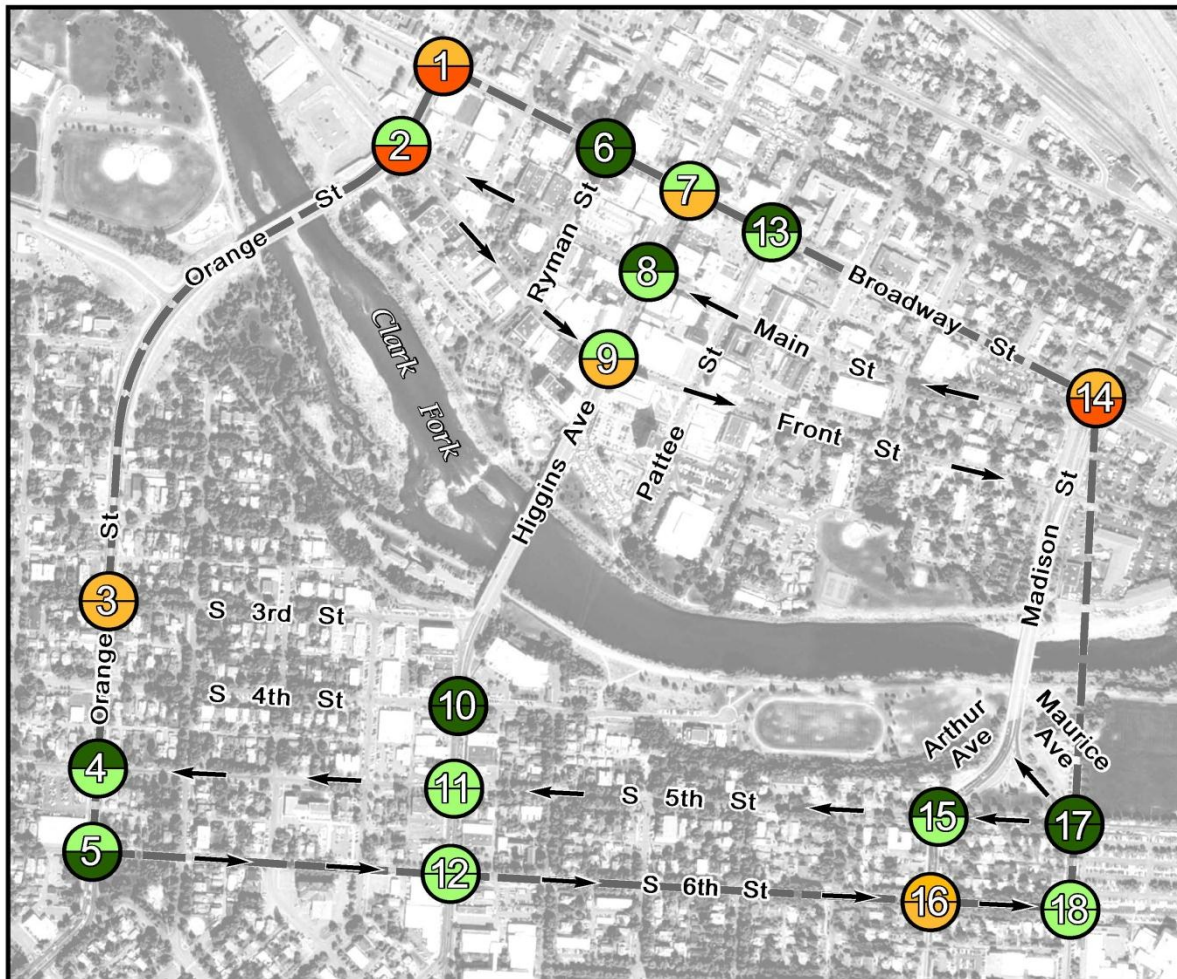
Figure 2-9 Intersection Level of Service (2013)

Table 2.8 and Figure 2-9 present the results of the signalized and unsignalized LOS analysis.

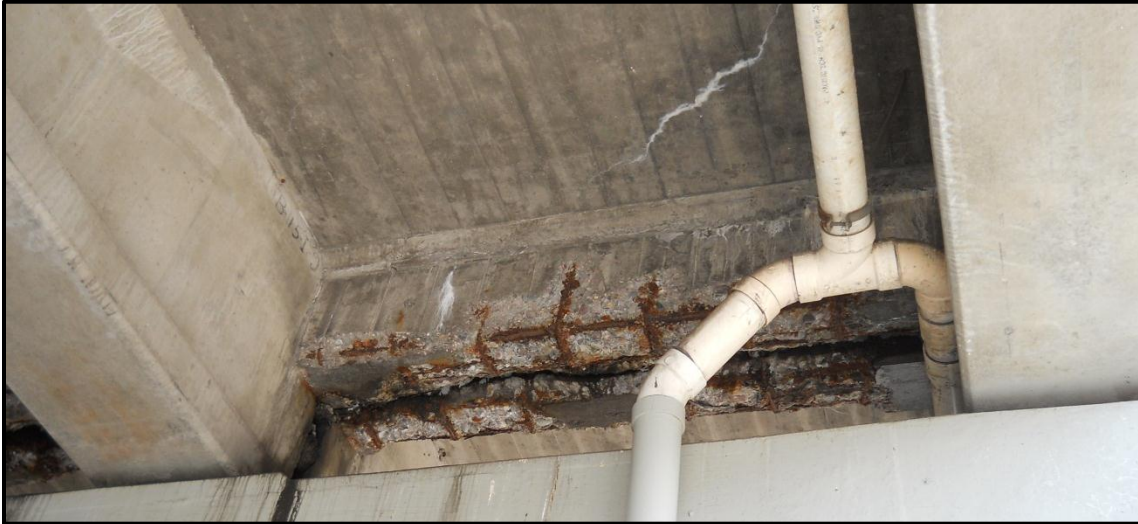
Photo 1. Cracking concrete with efflorescence and corroded rebar is visible on the Higgins Avenue Bridge diaphragms at the intermediate bents.

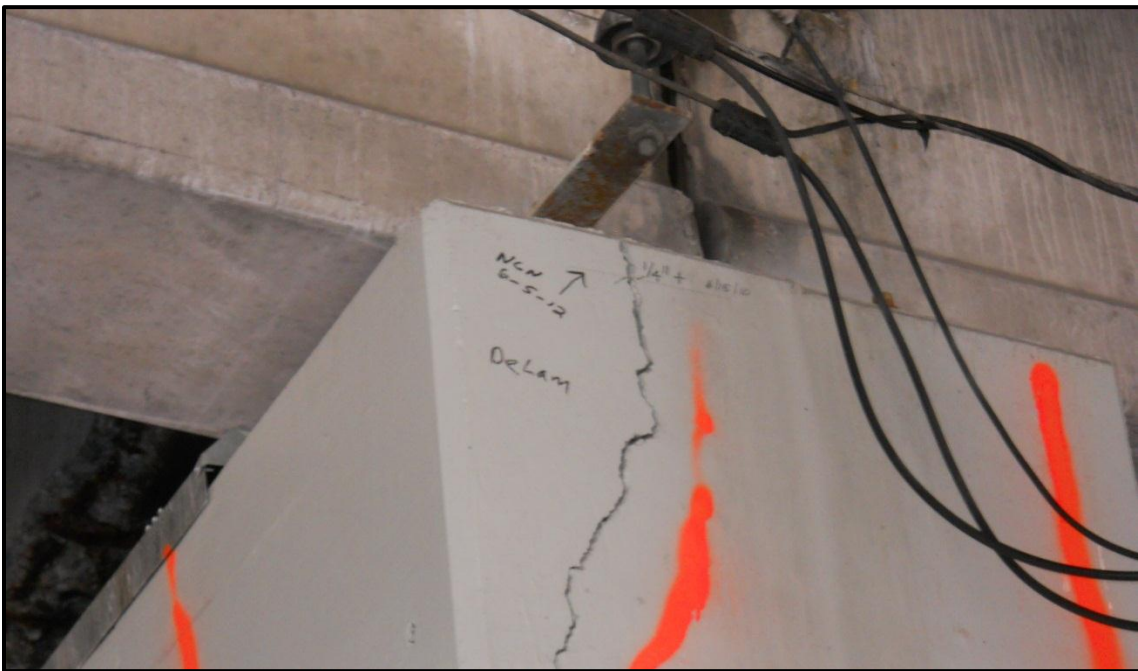
Photo 2. Cracking concrete delineated by orange paint on a Higgins Avenue Bridge pier.

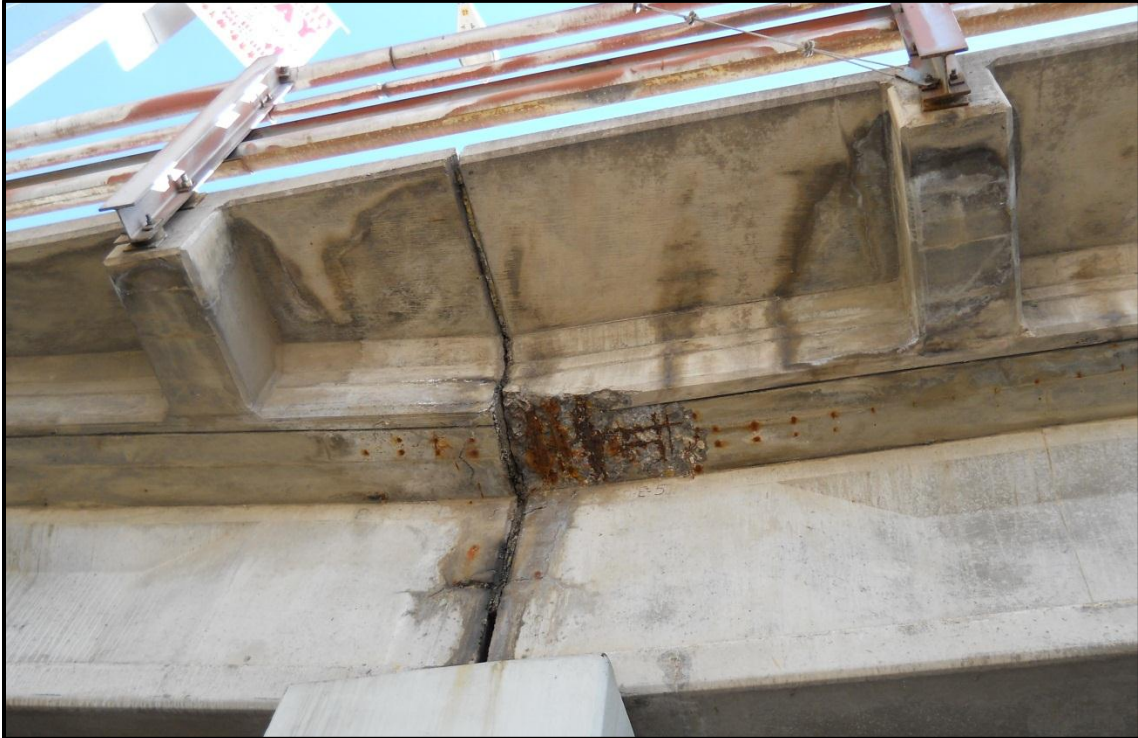
Photo 3. Spalled concrete and corroded rebar in the soffit under the Higgins Avenue Bridge pedestrian sidewalk.

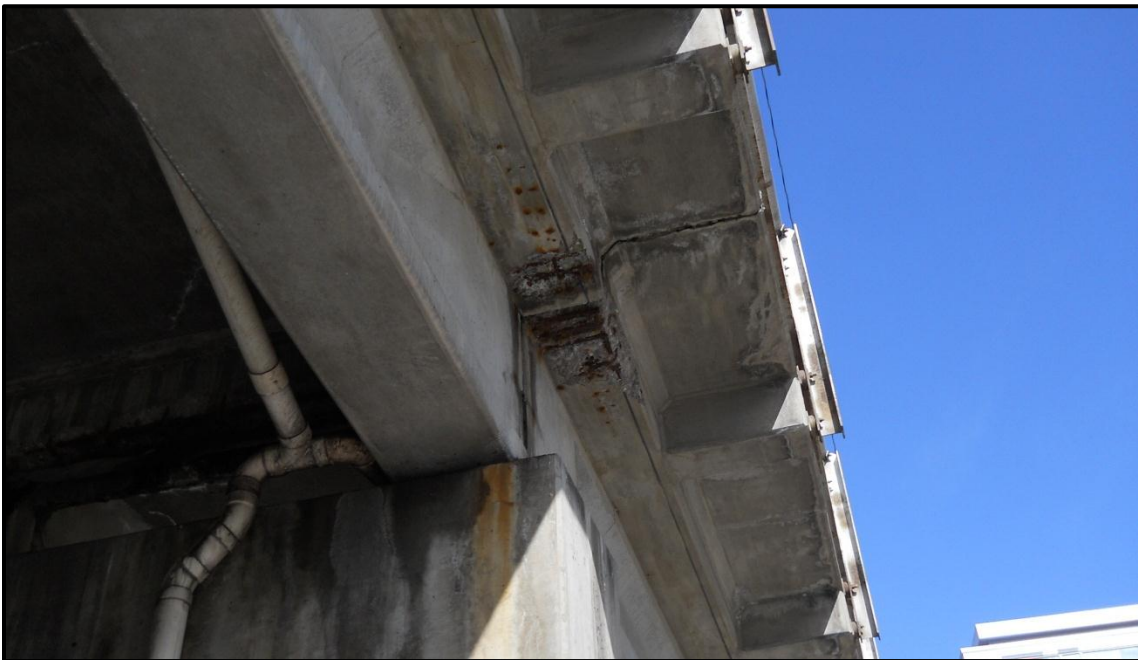
Photo 4. Cracking concrete with efflorescence and steel corrosion on the Higgins Avenue Bridge.

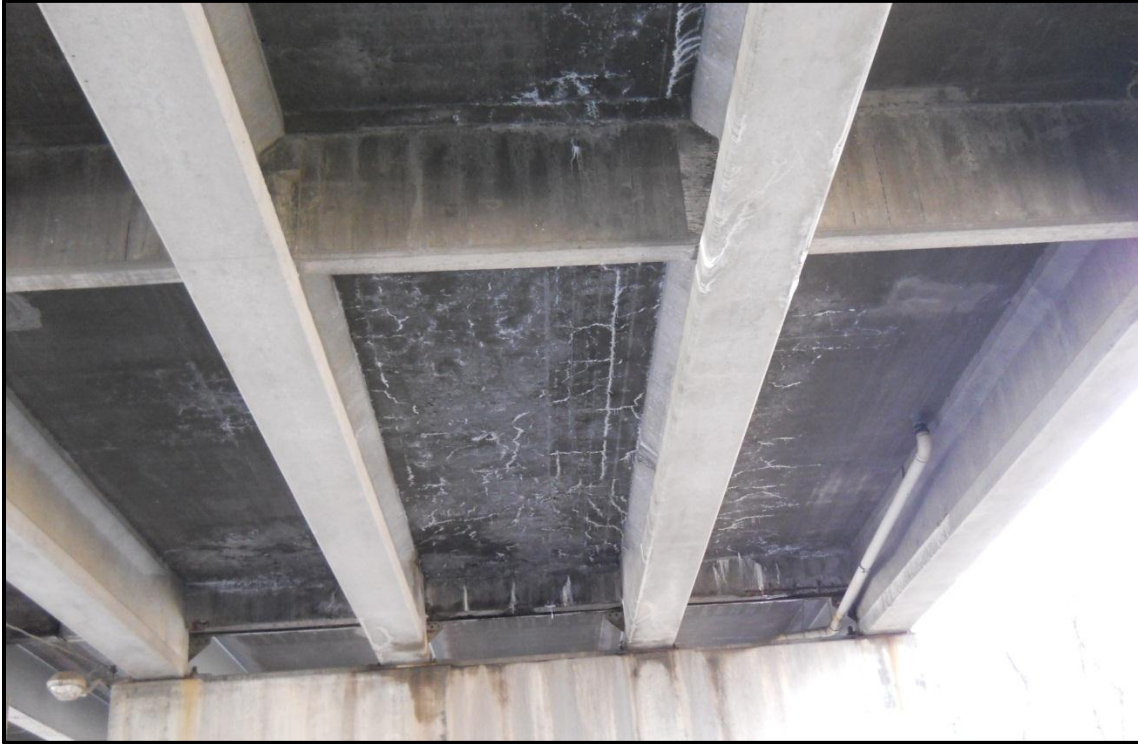
Photo 5. Cracking concrete with efflorescence on the Higgins Avenue Bridge. Photo 6 shows this area from the top side of the bridge.

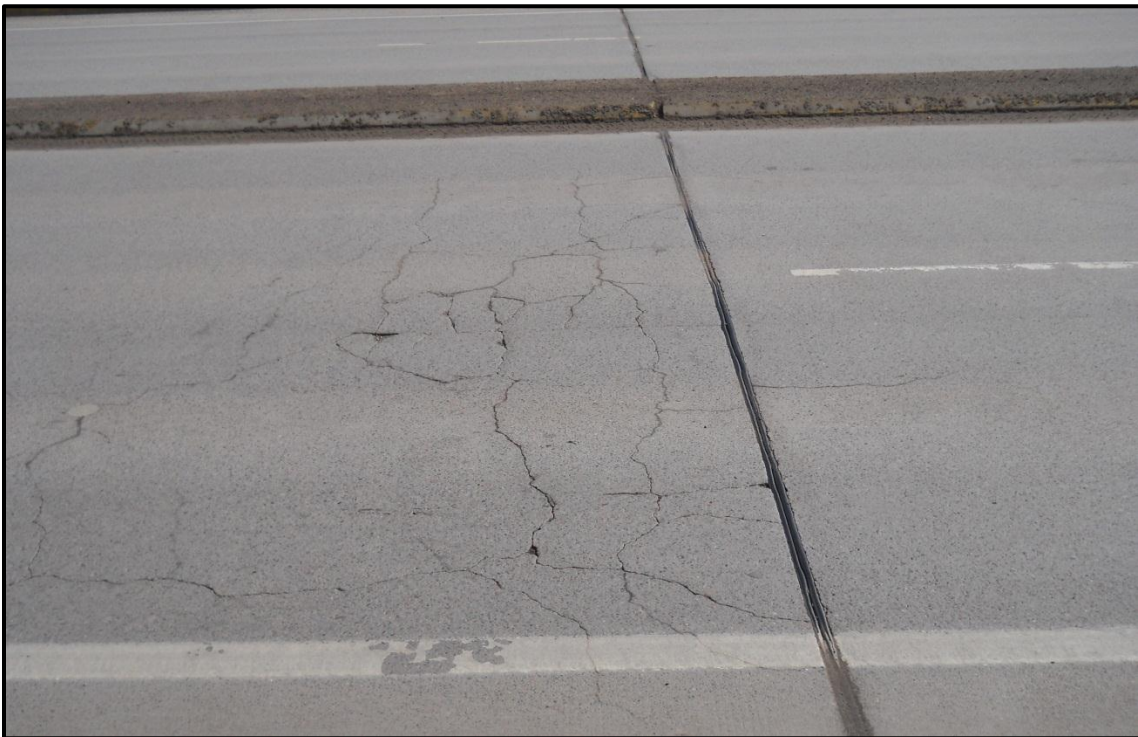
Photo 6. Cracking concrete on the Higgins Avenue Bridge top decking. Photo 5 shows this area from underneath the bridge.

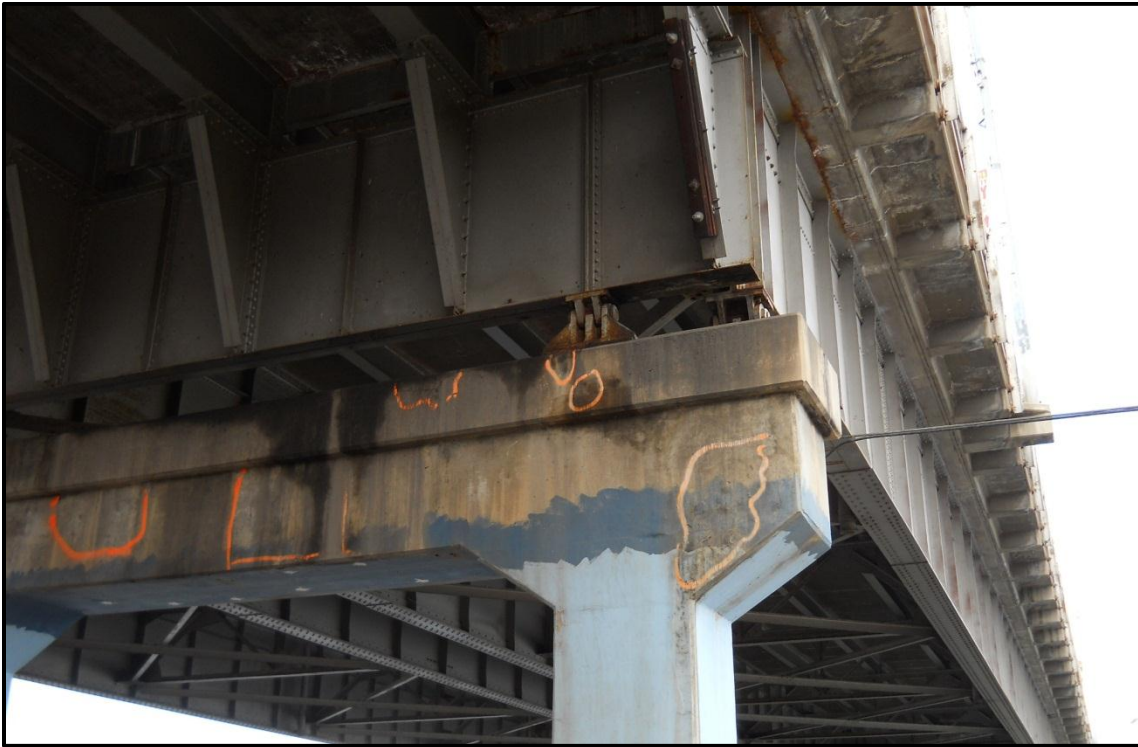
Photo 7. Concrete bent delamination delineated by orange paint and moderately corroded structural steel on the Higgins Avenue Bridge.

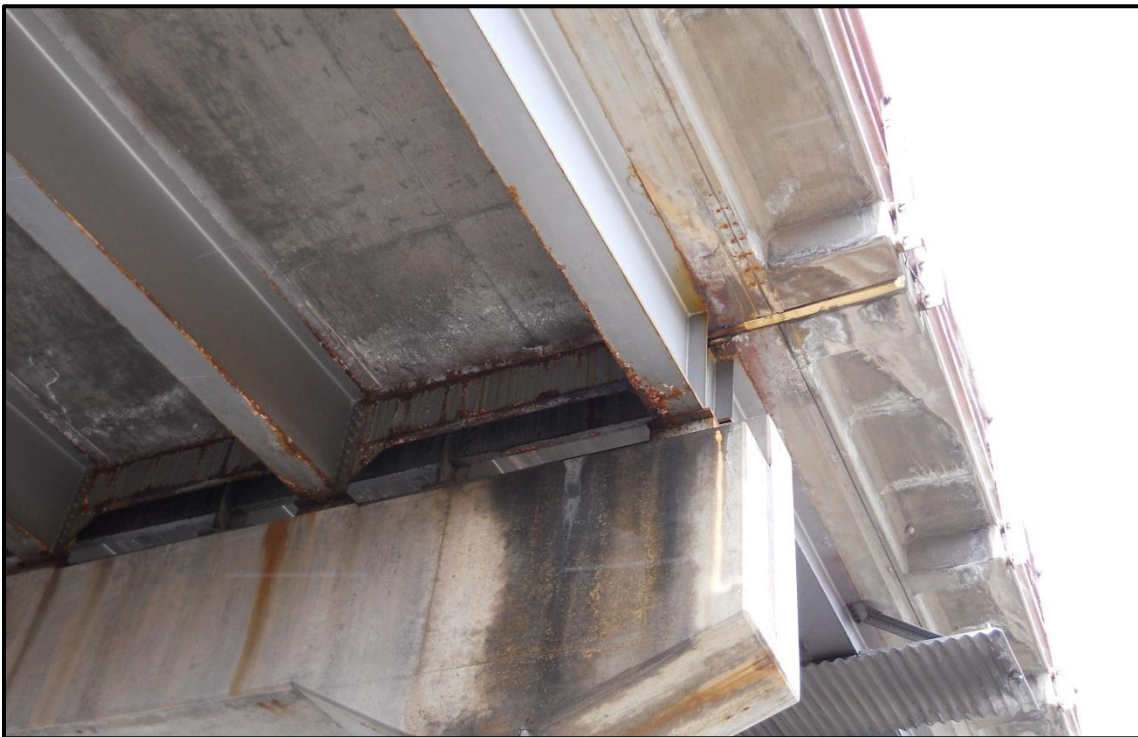
Photo 8. Corroded steel and dark staining of concrete on the Higgins Avenue Bridge.

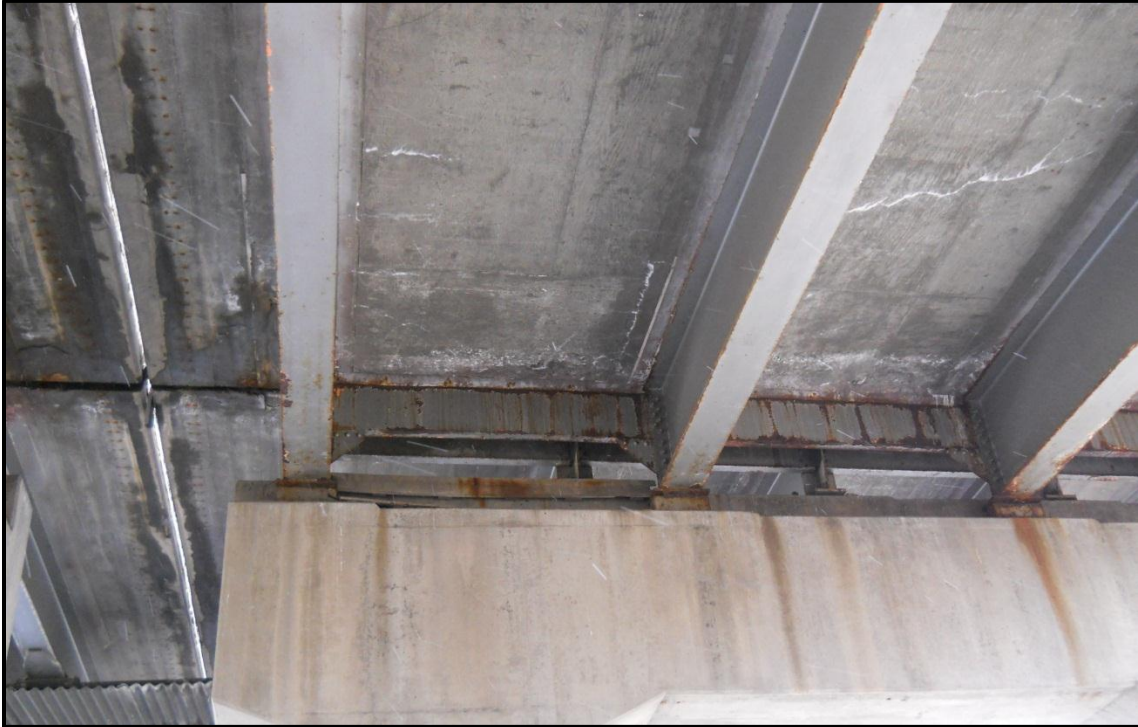
Photo 9. Staining and cracking concrete with efflorescence on the Higgins Avenue Bridge. The white line on the left side of the photo is daylight filtering through the bridge median.

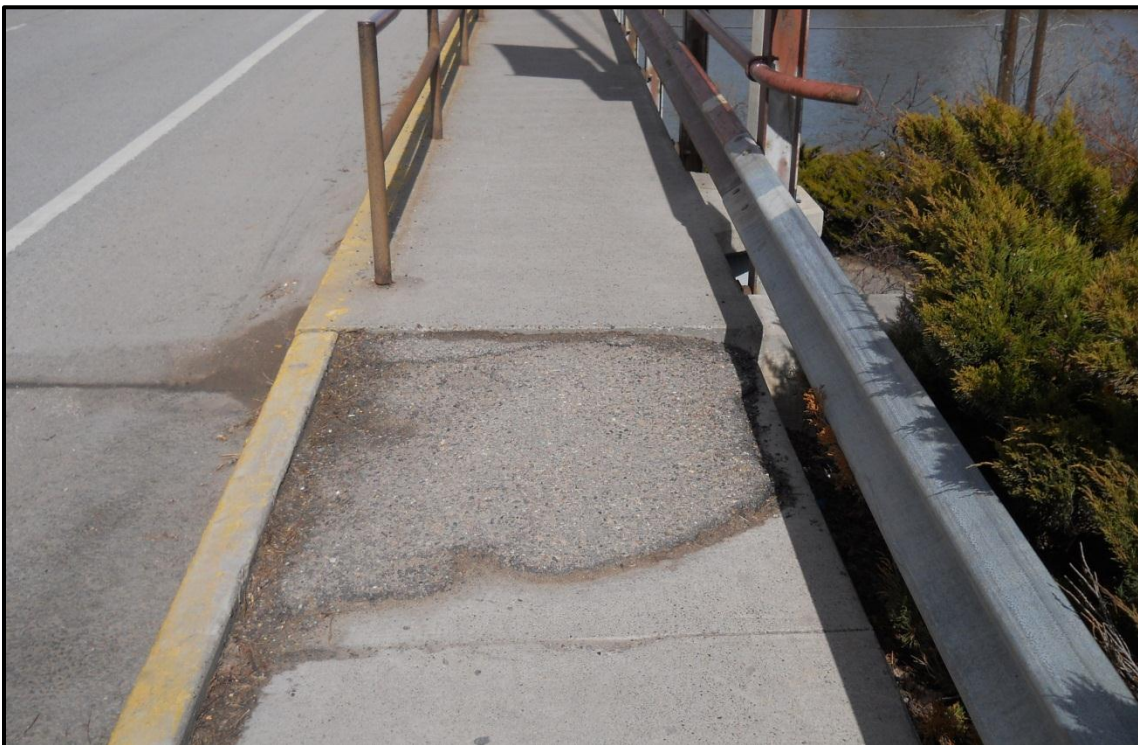
Ramp transitions from the roadway sidewalks to the Higgins Avenue Bridge sidewalks are not compliant with the Americans with Disabilities Act (ADA) due to vertical surface discontinuities (i.e., trip hazards).

Photo 10. A modified ramp transition area from the roadway sidewalk to the Higgins Avenue Bridge sidewalk. This ramping would not be considered compliant with the Americans with Disabilities Act (ADA).

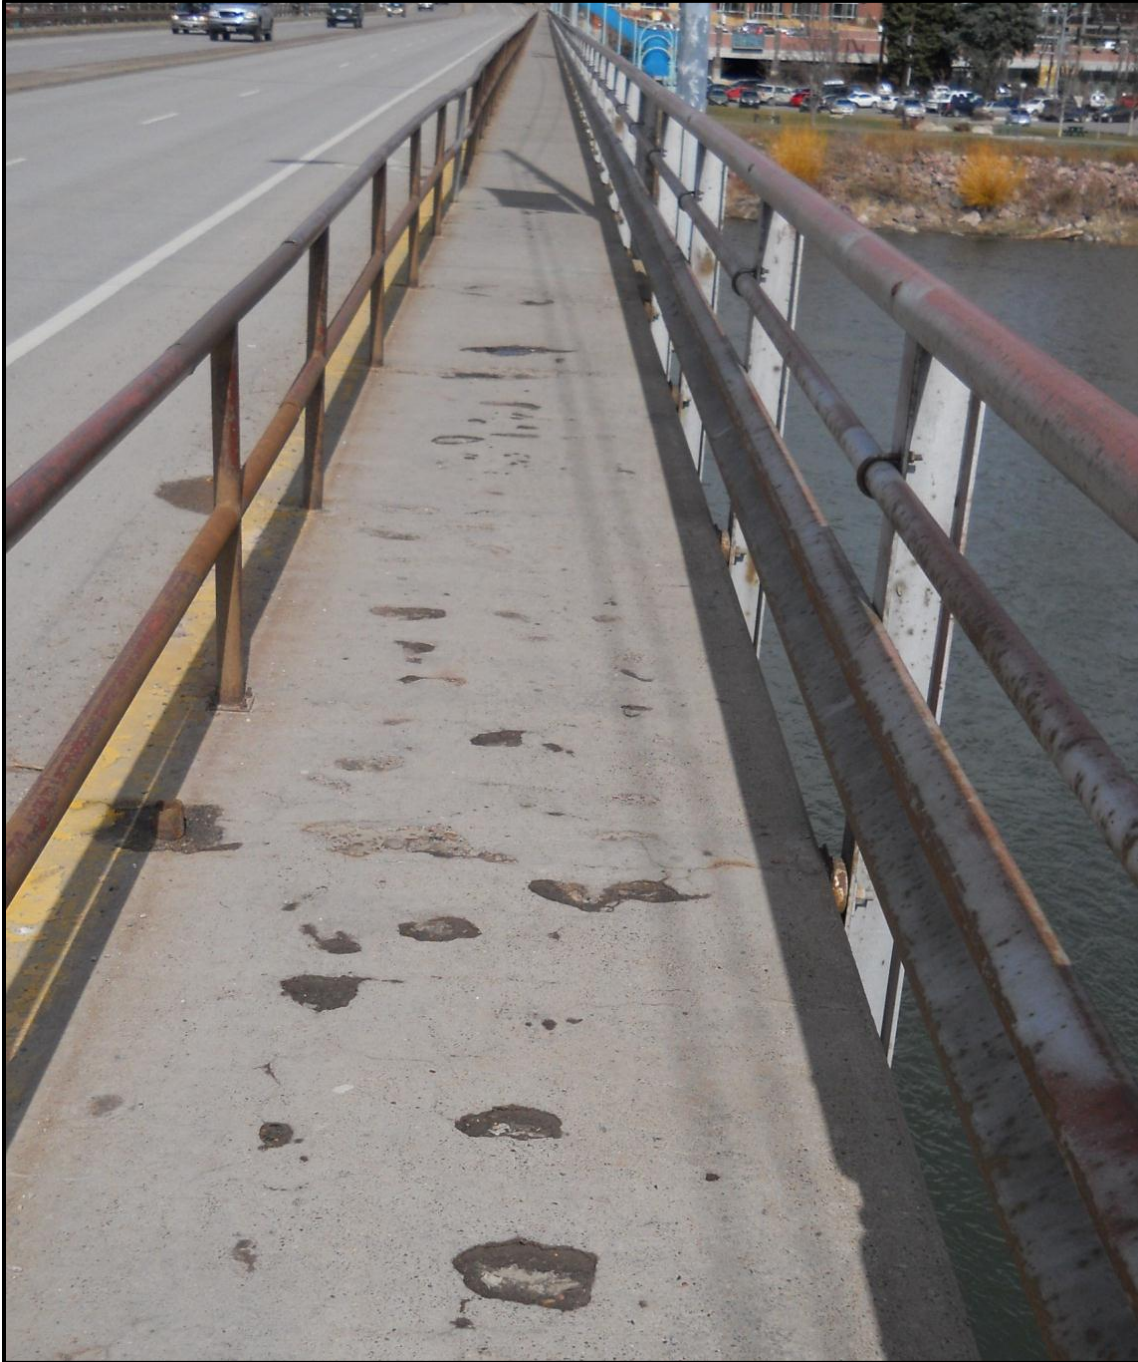
Photo 11. Delamination and spalling concrete along the Higgins Avenue Bridge sidewalk.

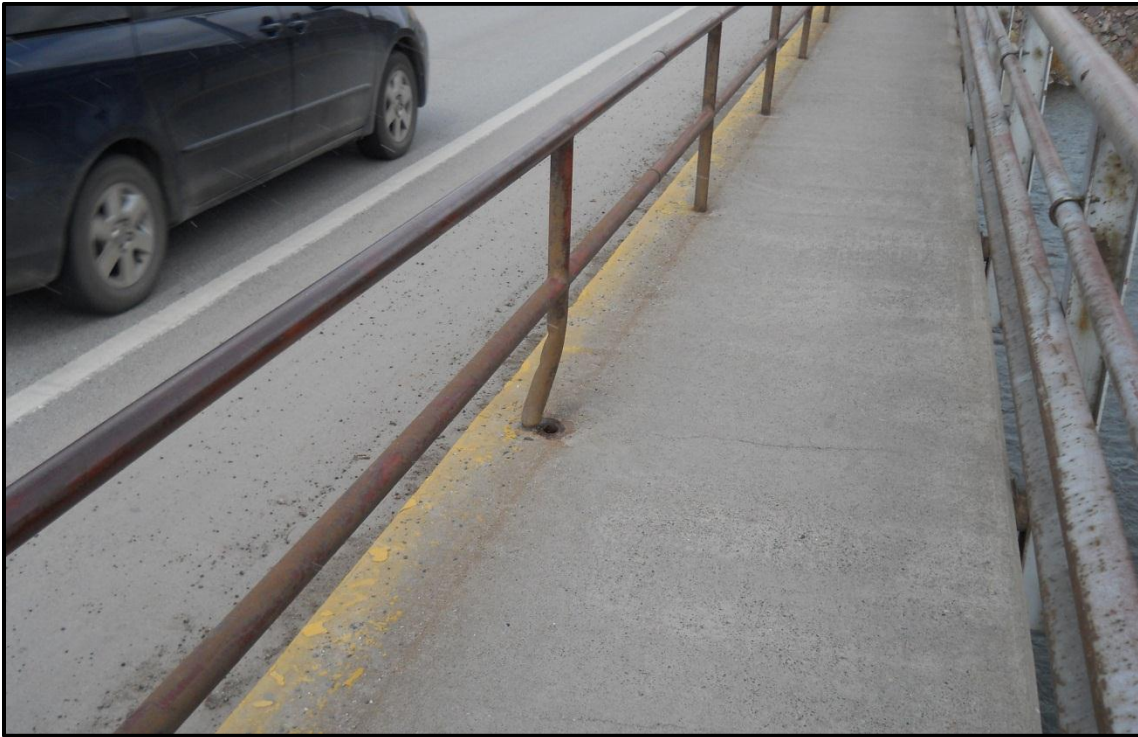
Photo 12. Cracking concrete along the Higgins Avenue Bridge sidewalk and collision damage to the bridge sidewalk railing.

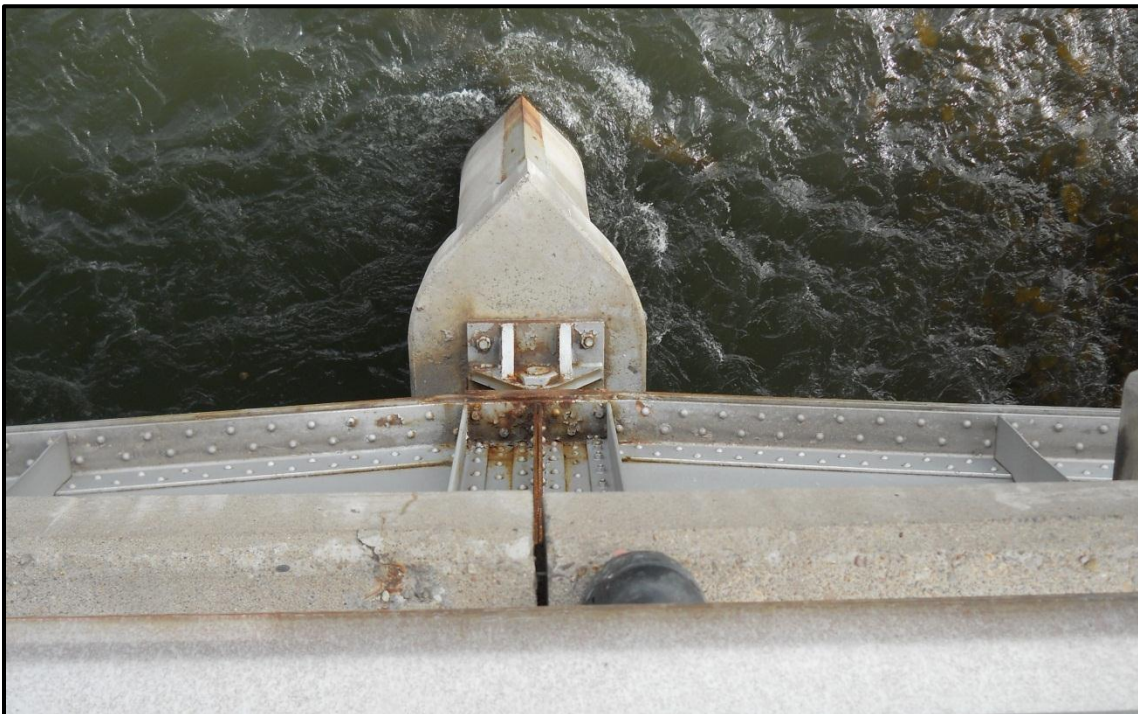
Photo 13. Steel corrosion at a Higgins Avenue Bridge pier and bridge bearing connection.

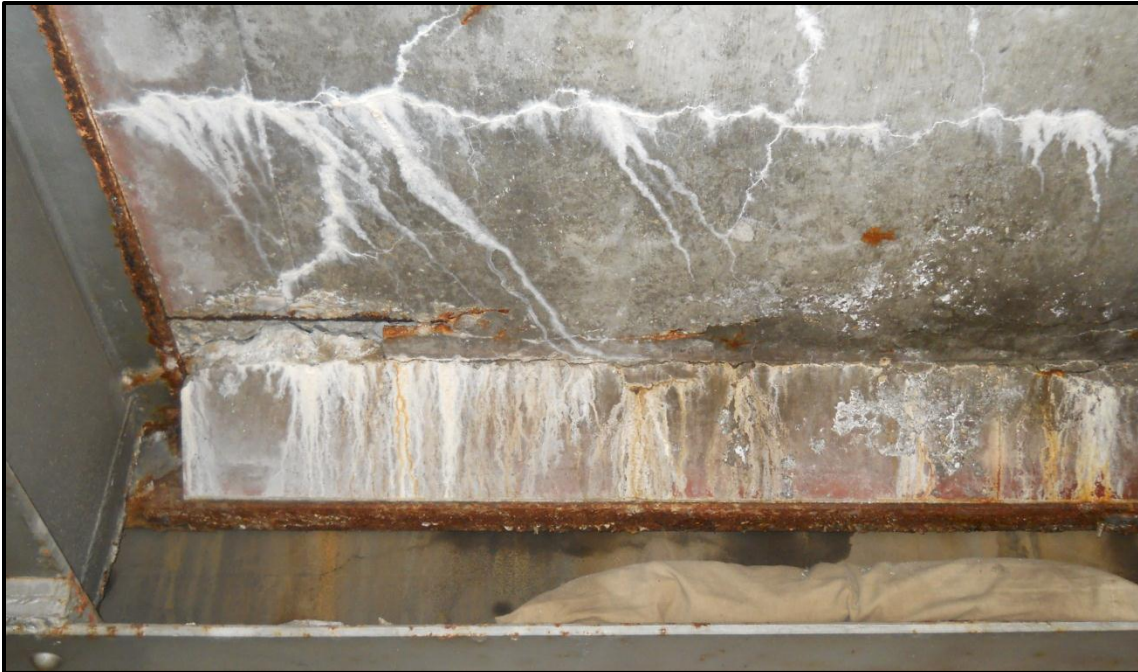
Photo 14. Degradation on the north Madison Street Bridge abutment, including corroded steel, cracking concrete with efflorescence, and concrete staining indicating rebar corrosion.

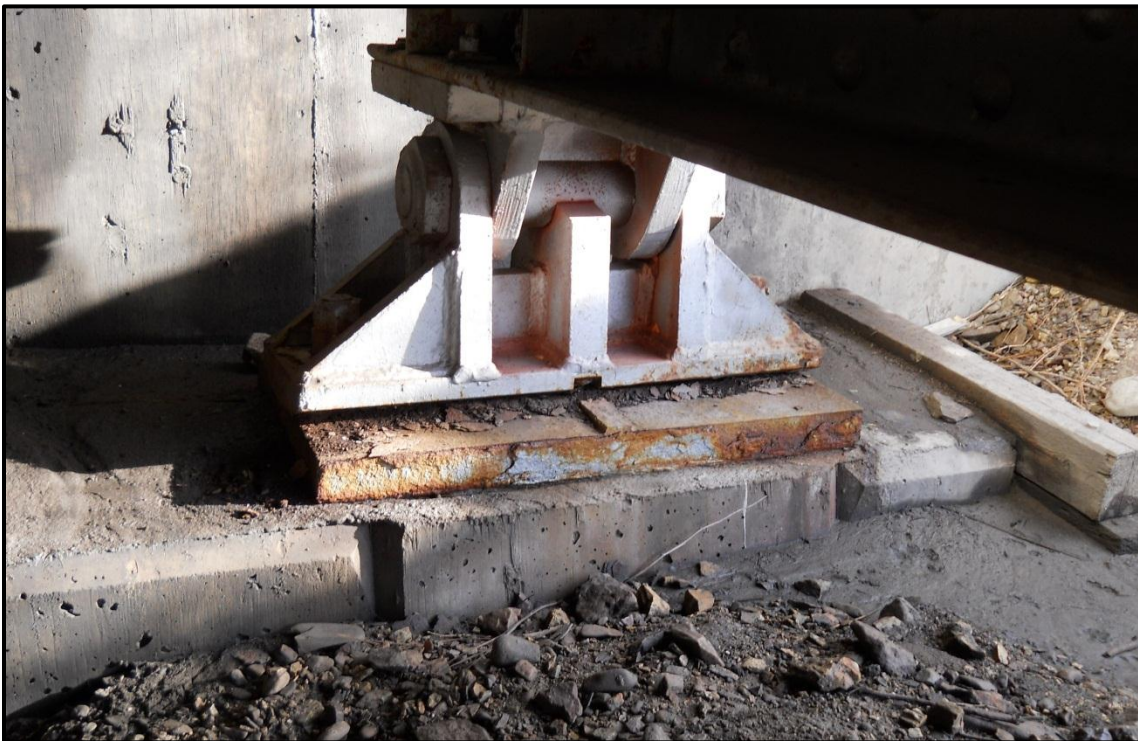
Photo 15. View of girder bearing at the north abutment exhibiting debris/pack rust between the built-up rocker assembly and bearing plate, which may limit the movement of this joint on the Madison Street Bridge.

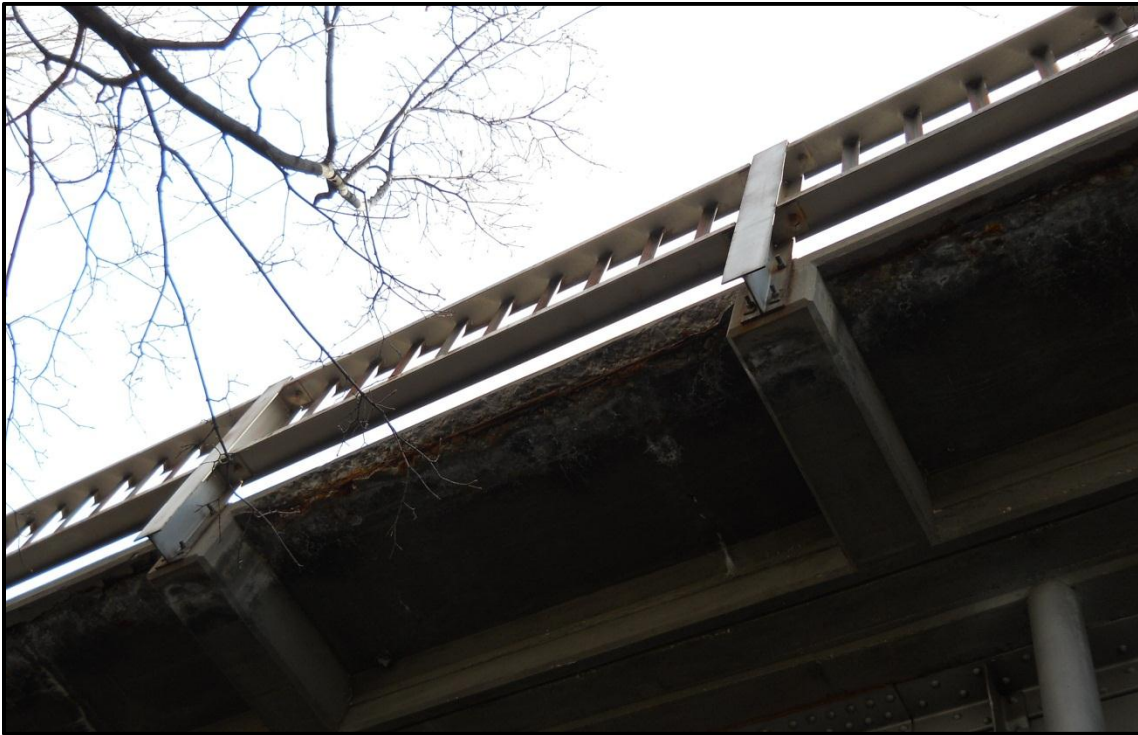
Photo 16. Concrete spalling and corroded rebar at the edge of the Madison Street Bridge. This condition was observed extending over the length of both sides of the bridge.

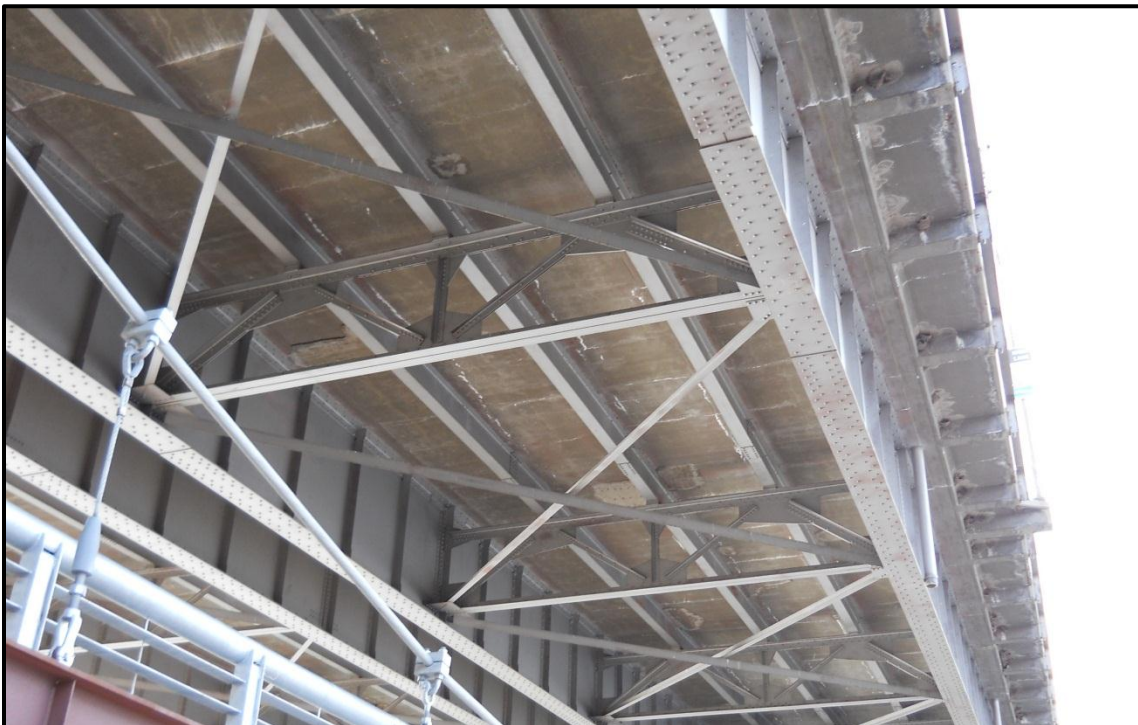
Photo 17. Cracking concrete with efflorescence and patches to concrete sections on the Madison Street Bridge.

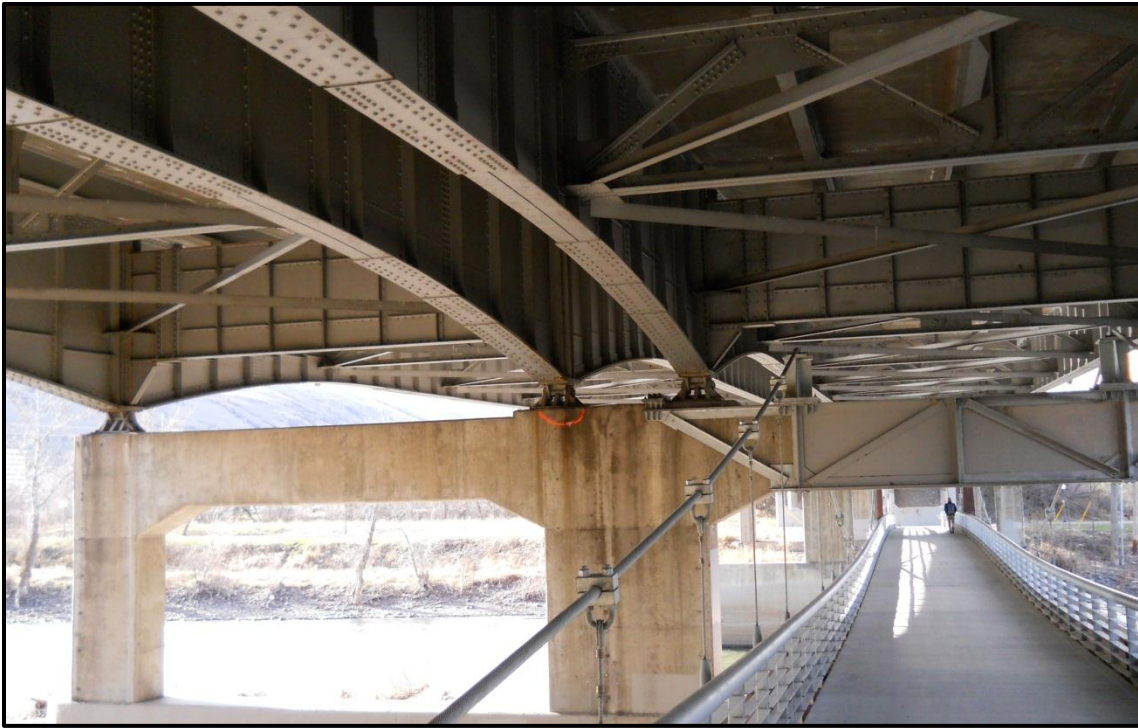
Photo 18. Orange paint delineating steel corrosion and concrete delamination on the Madison Street Bridge.

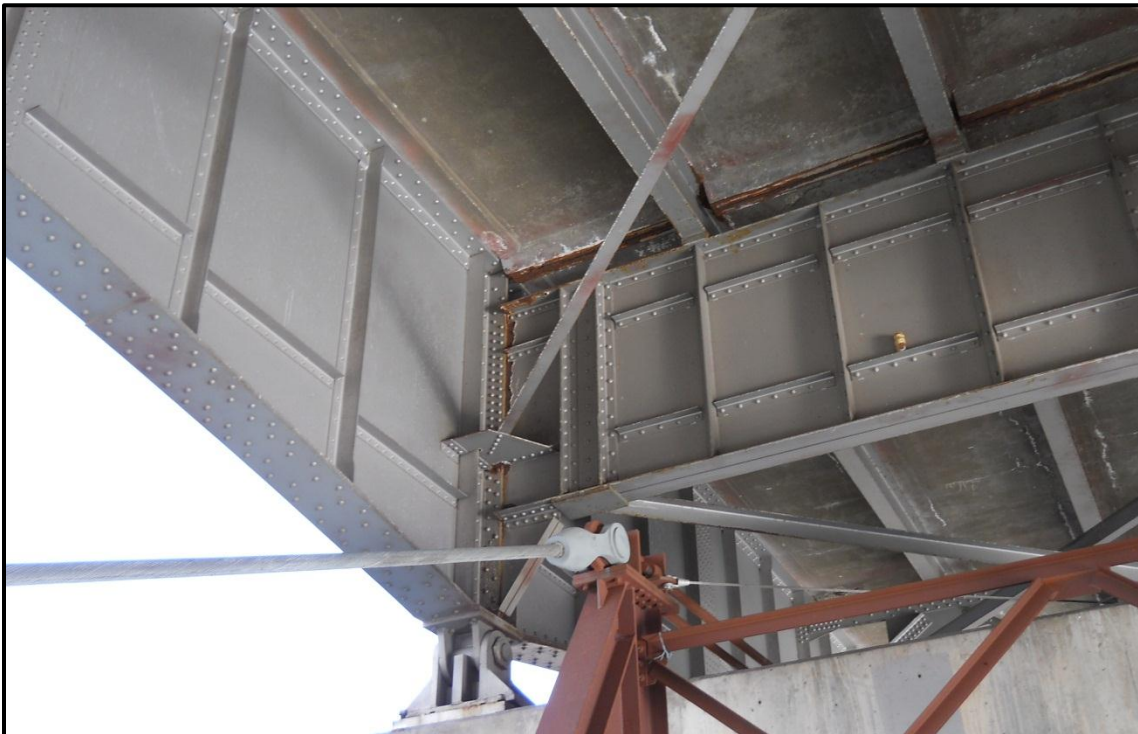
Photo 19. Corroded steel on the Madison Street Bridge.

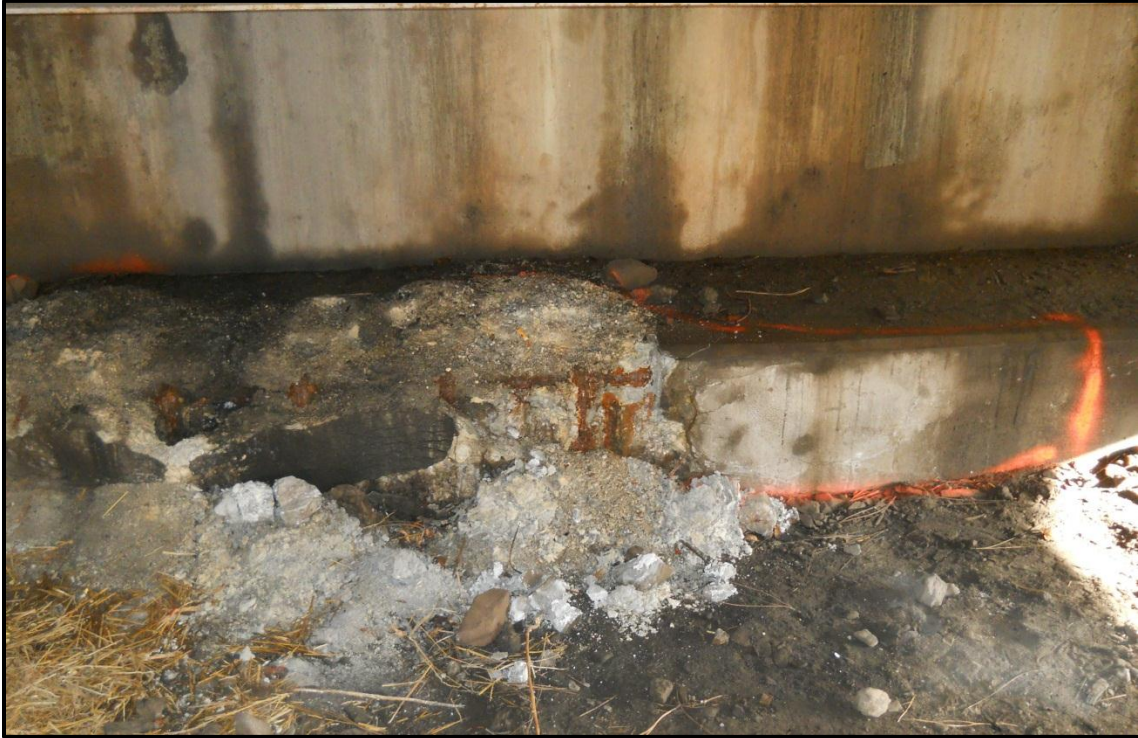
Photo 20. Spalled concrete beam at the north abutment of the Madison Street Bridge

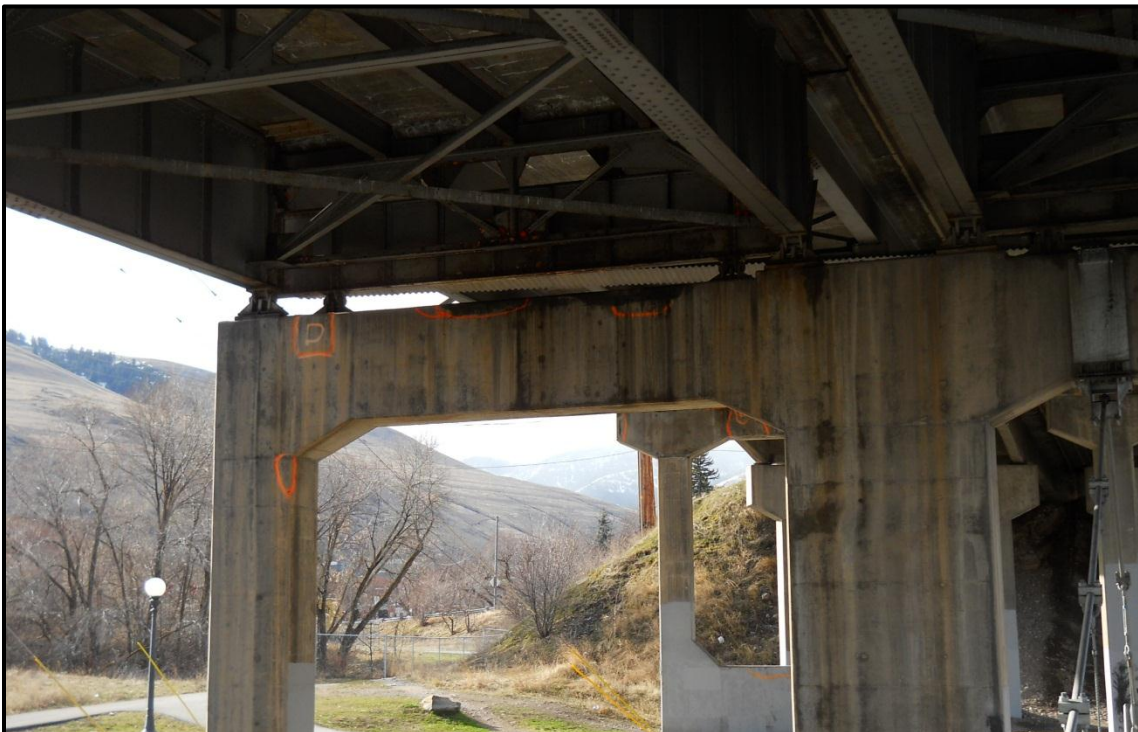
Photo 21. Corroded steel and concrete delamination on a Madison Street Bridge bent.

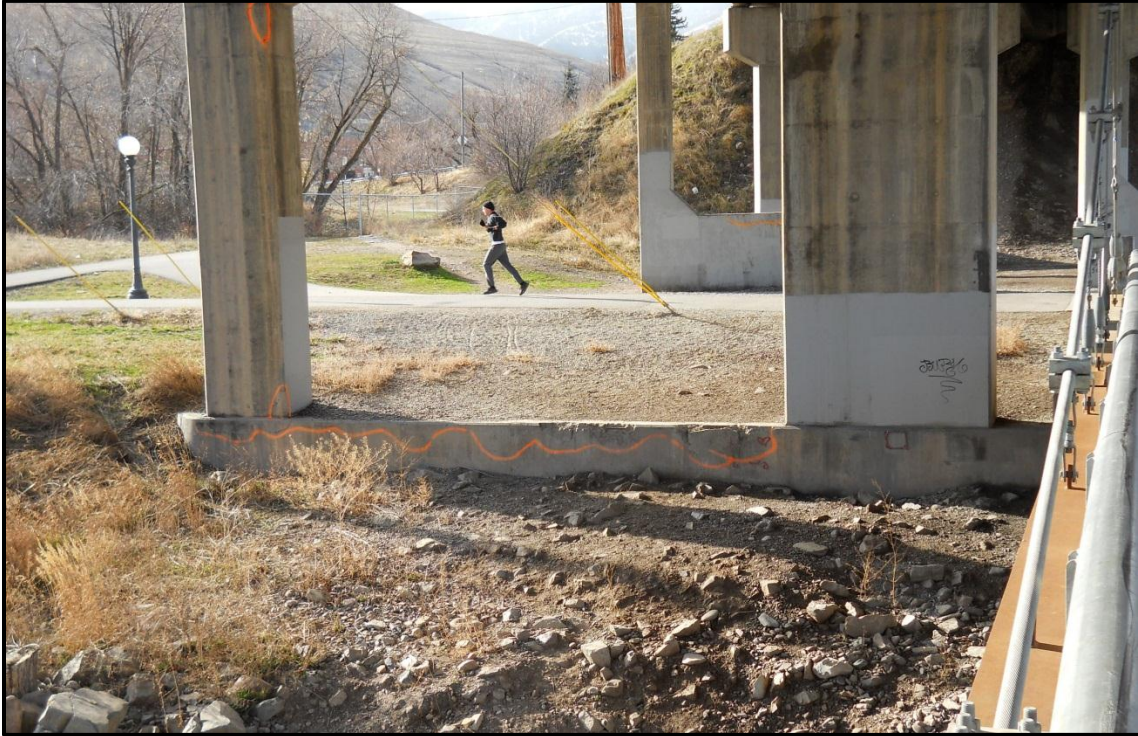
Photo 22. Deterioration of the Madison Street Bridge bent near the ground, including concrete delamination and spalling.

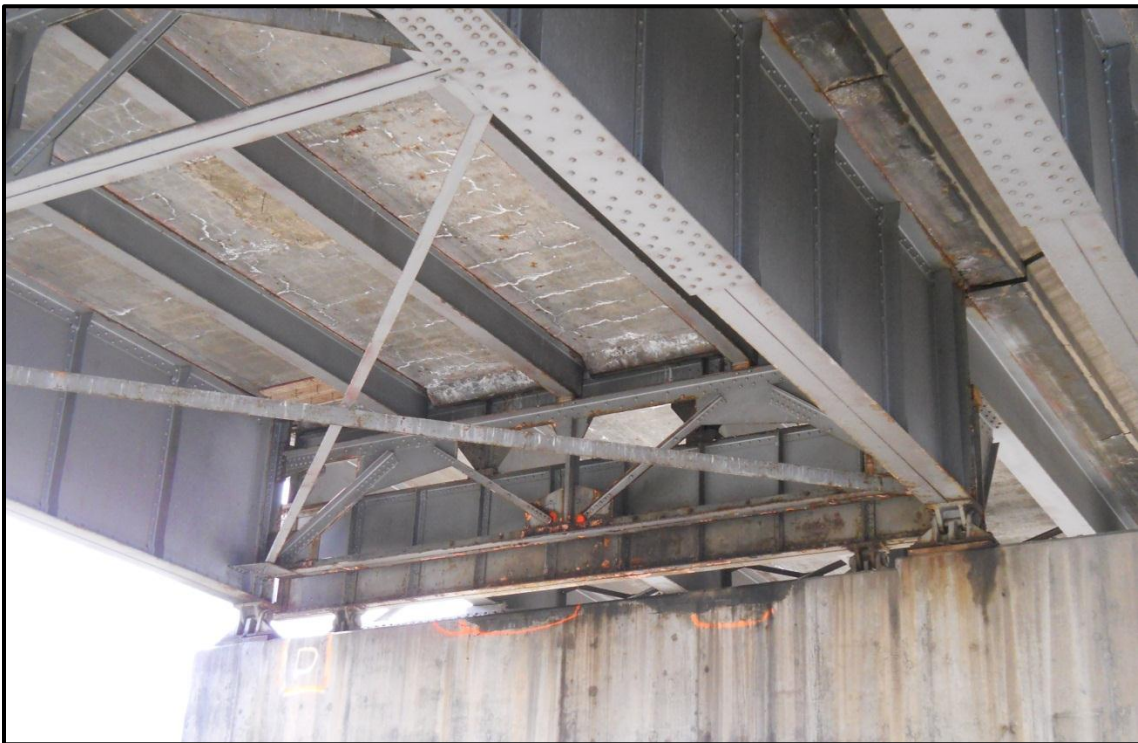
Photo 23. Deterioration of the Madison Street Bridge bent, including corroded steel, cracking concrete with efflorescence, and stains from corroded rebar.

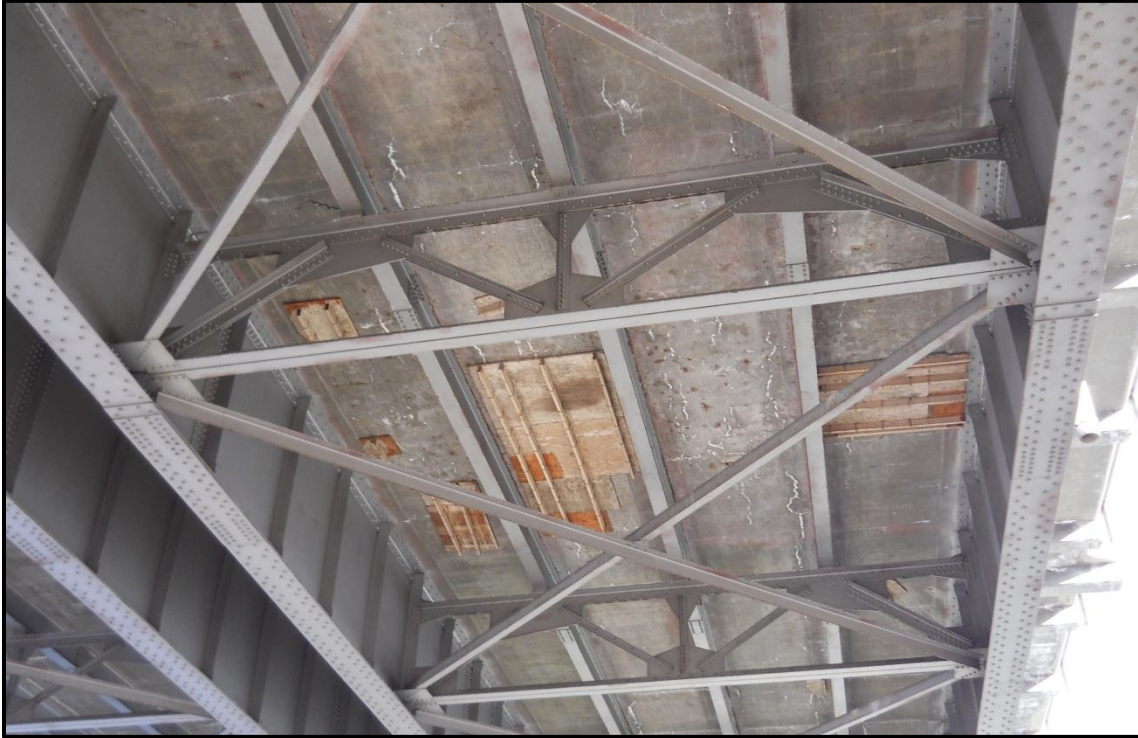
Photo 24. Cracking concrete with efflorescence and concrete deck patching with formwork left in place on the Madison Street Bridge.

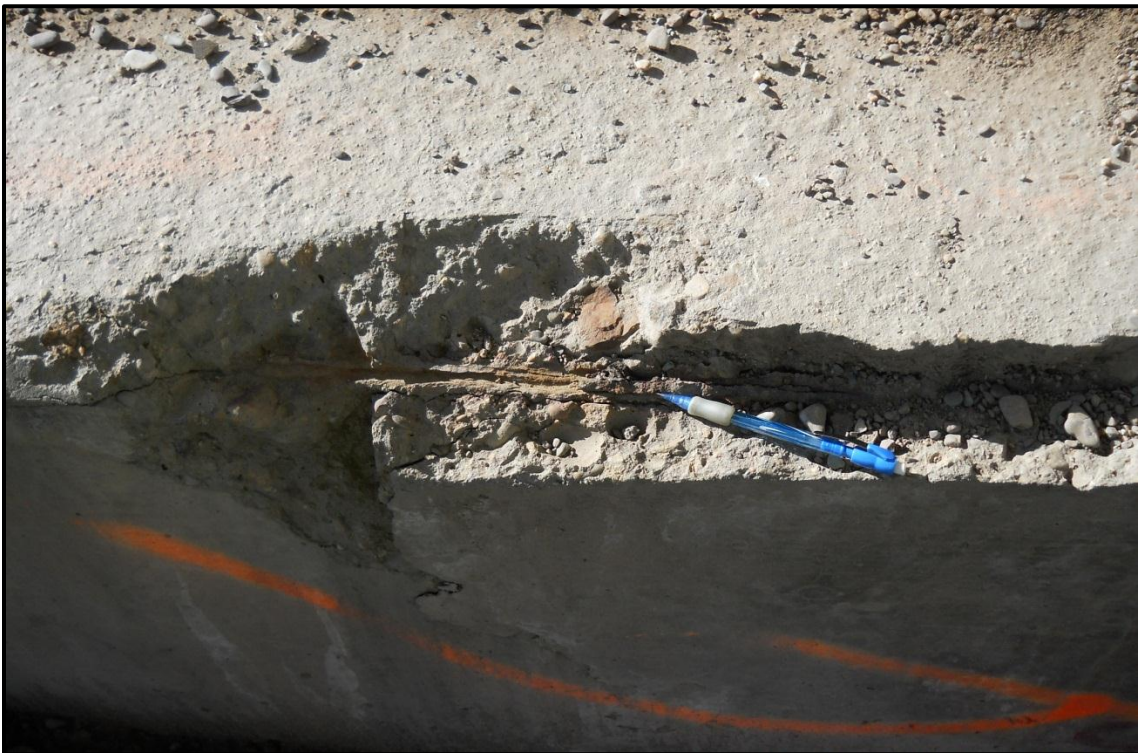
Photo 25. Delaminated/spalled concrete and corroded rebar on the Madison Street Bridge.
