MISSOULA BRIDGES

PLANNING STUDY

EXISTING AND PROJECTED CONDITIONS REPORT

August 21, 2013

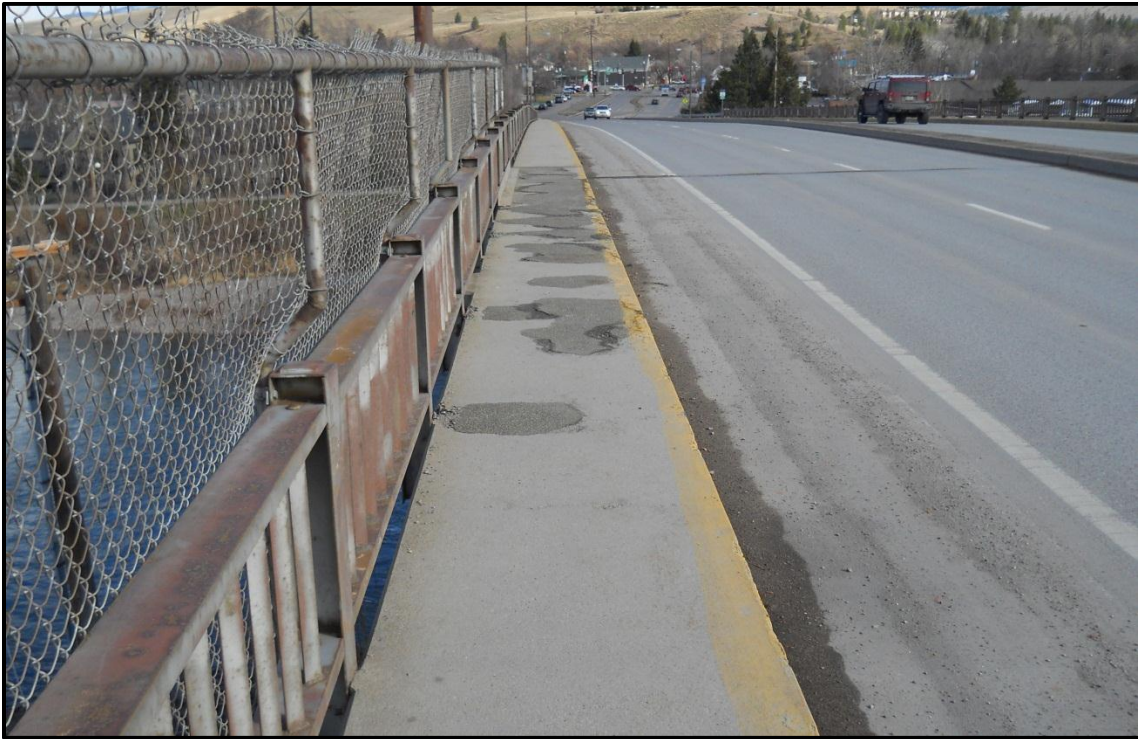
Photo 26. Delaminated and patched sidewalk on the Madison Street Bridge.

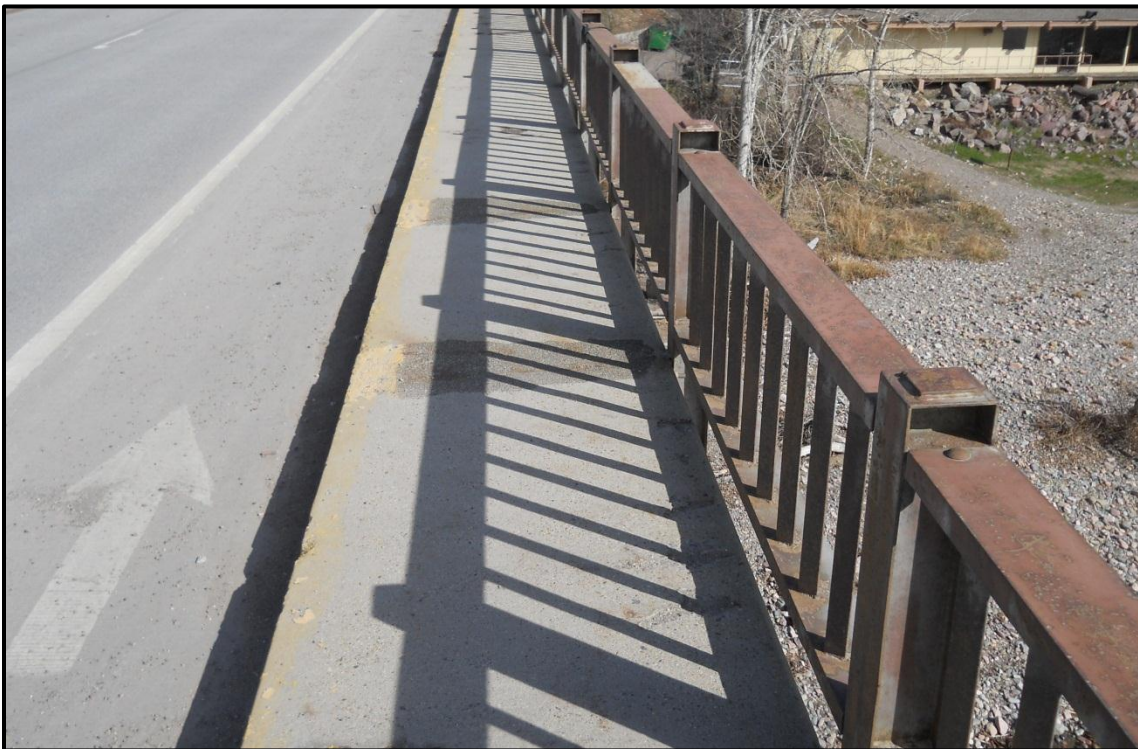
Photo 27. Delaminated and patched sidewalk on the Madison Street Bridge. The railing measures 32 inches in height, which does not meet current standards.

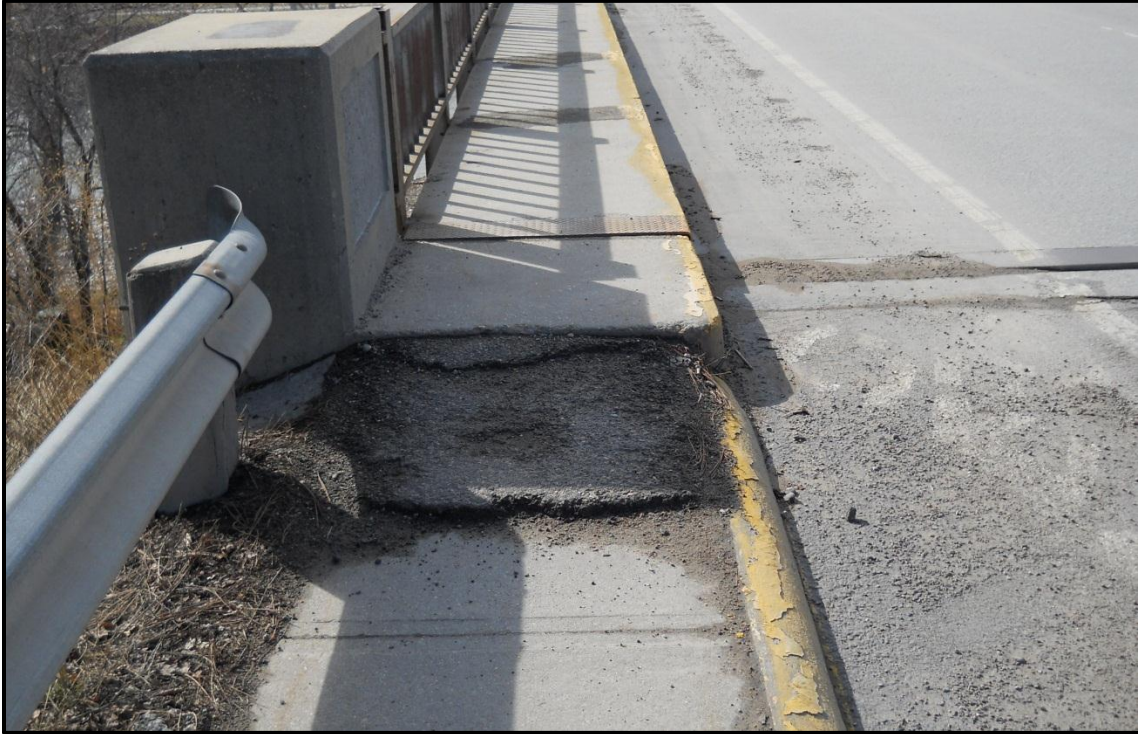
Photo 28. A modified ramp transition area from the roadway sidewalk to the Madison Street Bridge sidewalk. This ramping would not be considered ADA compliant.

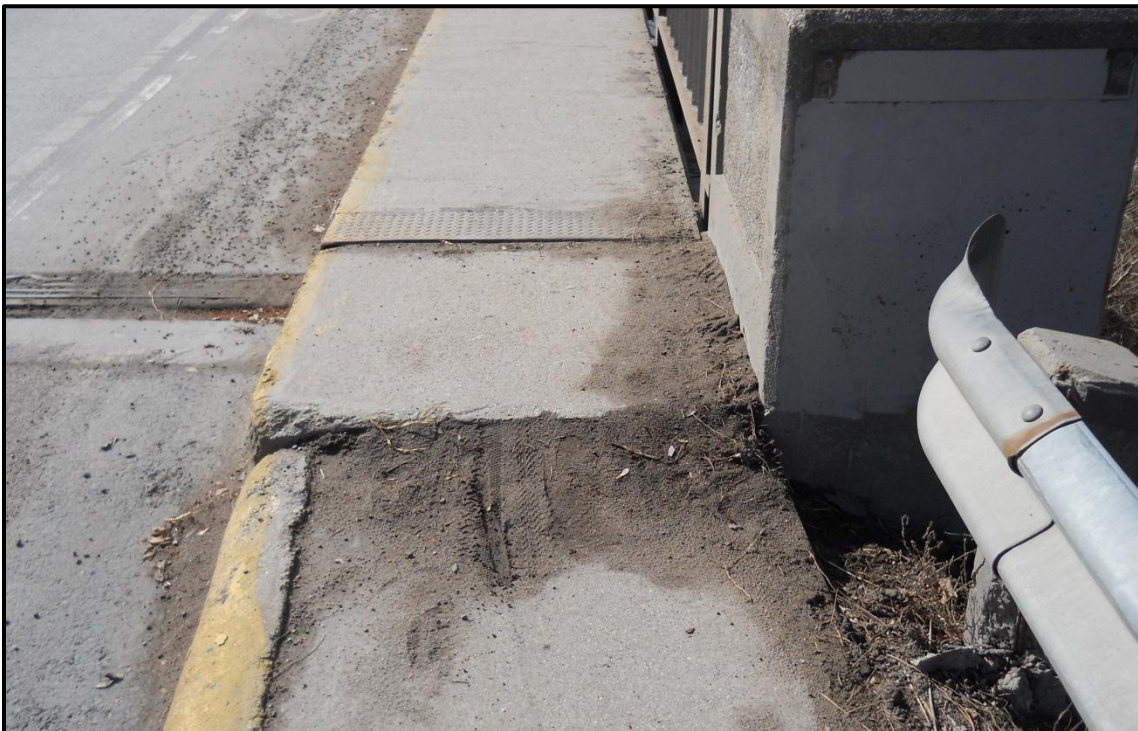
Photo 29. A modified ramp transition area from the roadway sidewalk to the Madison Street Bridge sidewalk. This ramping would not be considered ADA compliant.

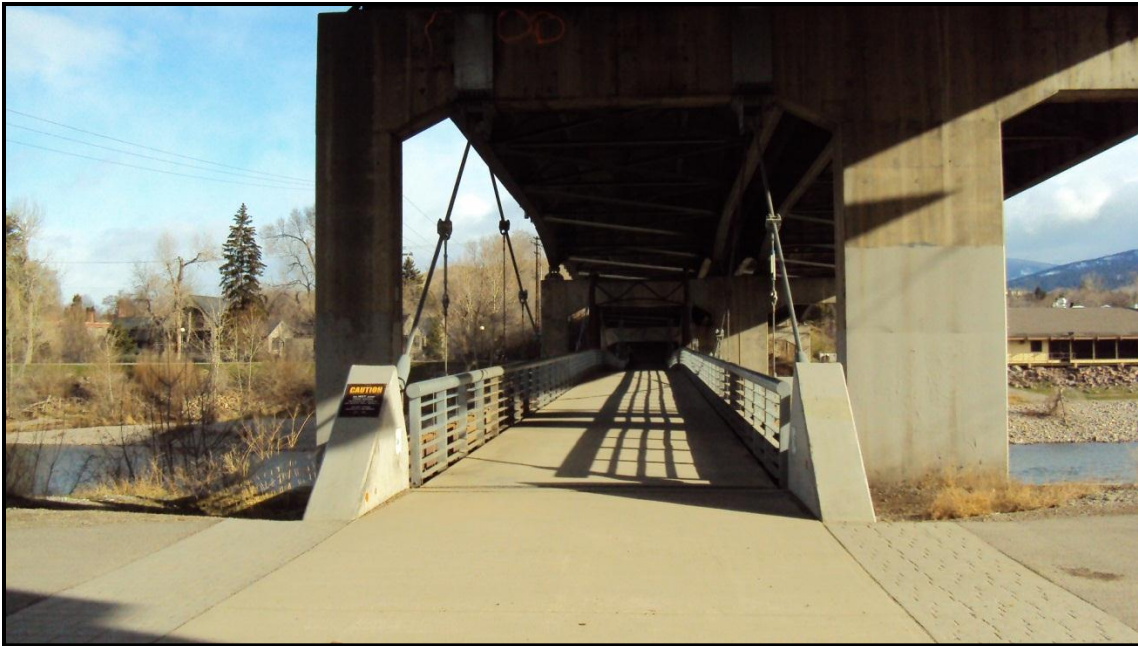
Photo 30. Looking north on the south side of the Madison Street Bridge bicycle/pedestrian underpass.

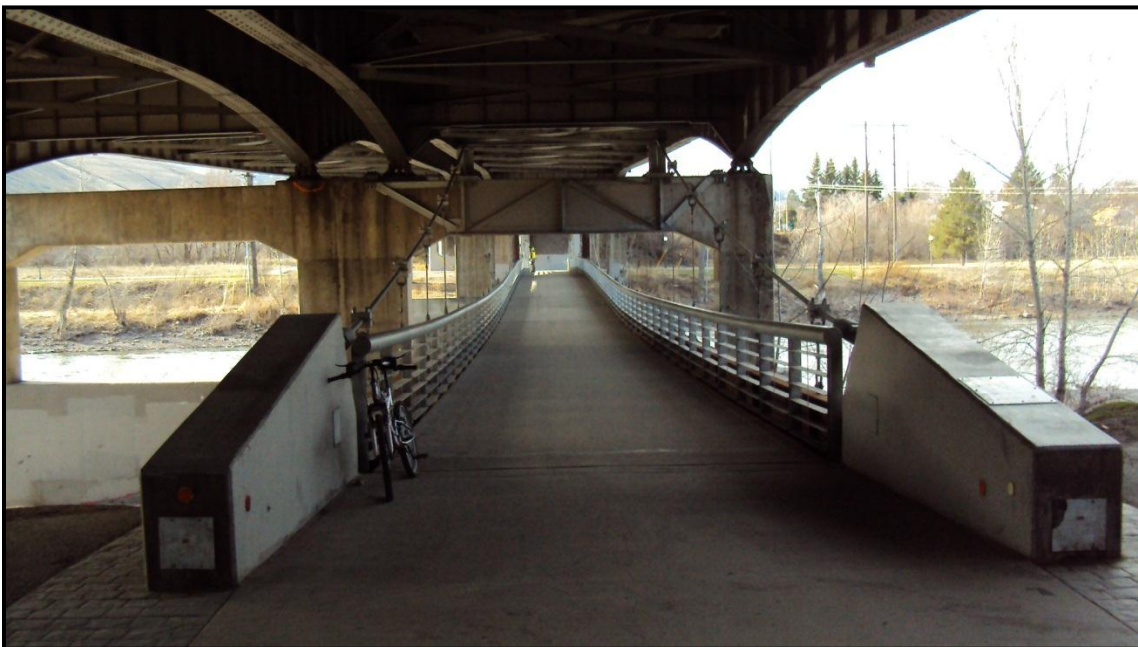
Photo 31. Looking south on the north side of the Madison Street Bridge bicycle/pedestrian underpass.

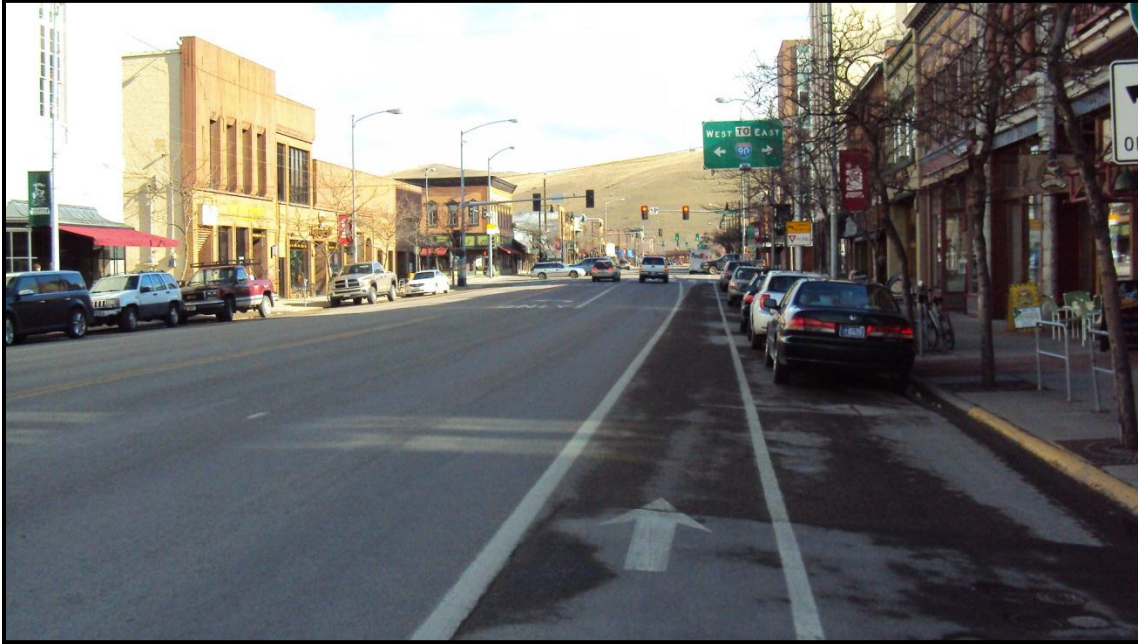
Photo 32. Looking north on the south leg of the Higgins Avenue and Broadway Street intersection. Dedicated bicycle lanes run north and south along Higgins Avenue. Bicycle racks can be seen in the photo along the east side of Higgins.

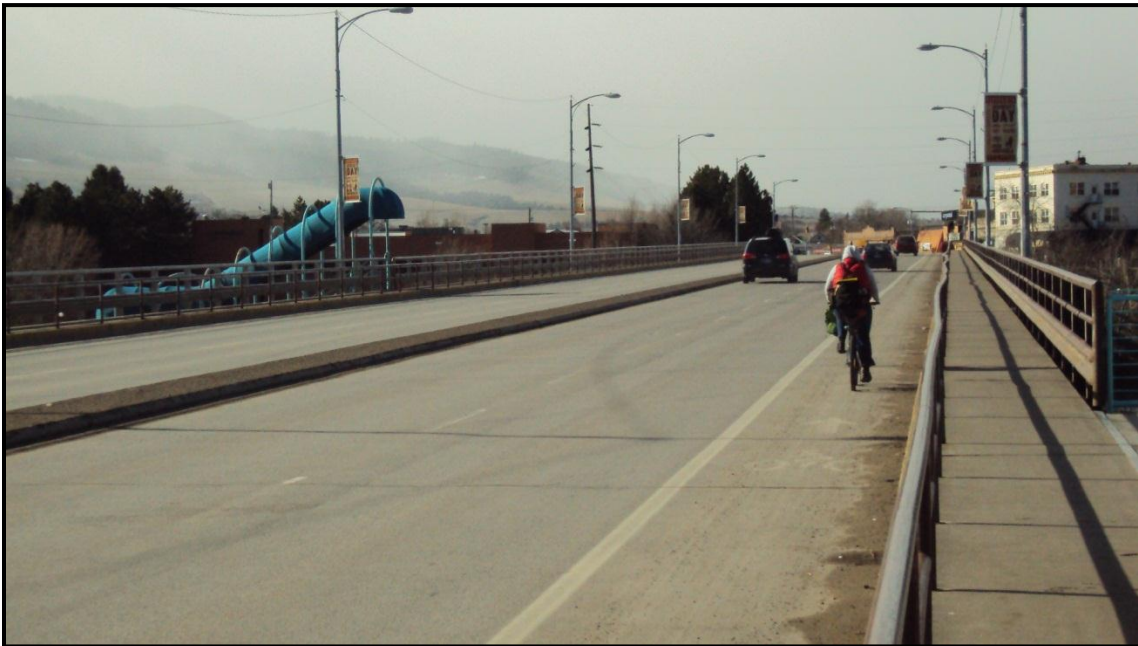
Photo 33. Looking south on the Higgins Avenue Bridge. Dedicated bicycle lanes run north and south along the bridge. A cyclist is using the southbound dedicated bicycle lane in the photo.

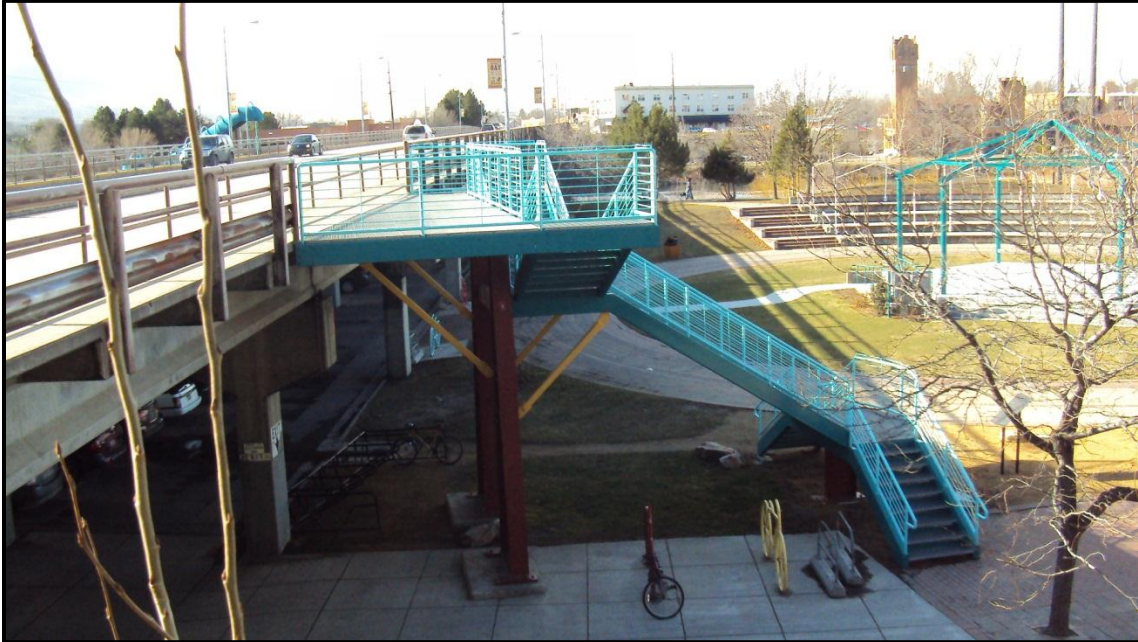
Photo 34. Looking south on the Higgins Avenue Bridge. A stairway is located on the west side of the Higgins Avenue Bridge with bicycle racks underneath.

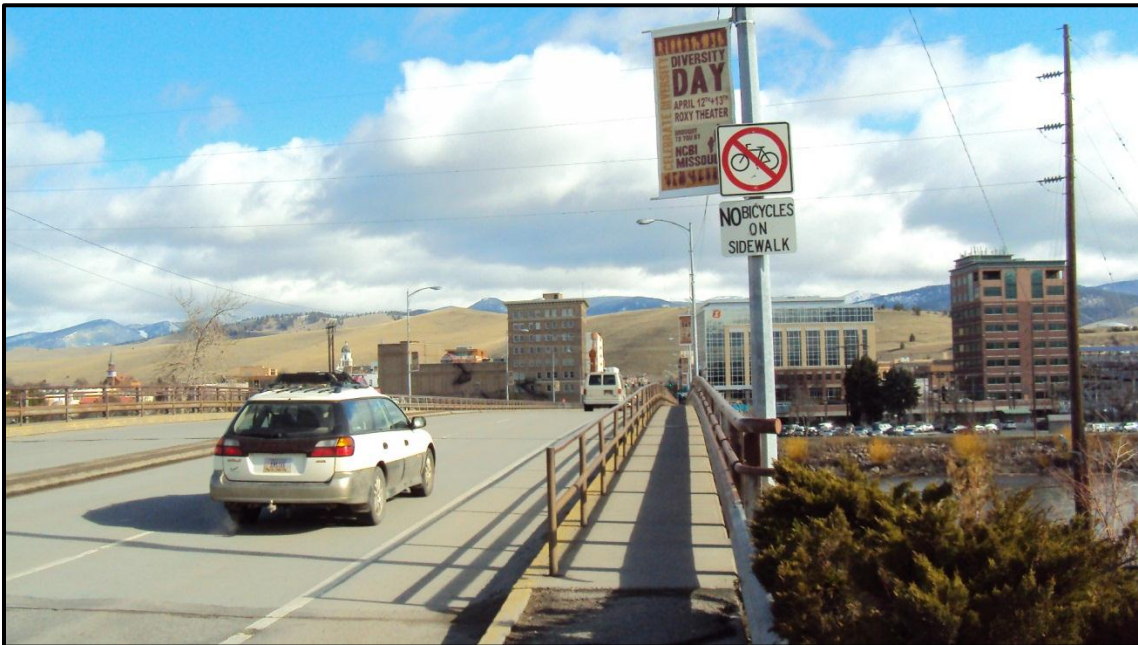
Photo 35. Looking north on the south side of the Higgins Avenue Bridge. Bicycles are prohibited on the sidewalks as indicated by signs placed on either side of the bridge.

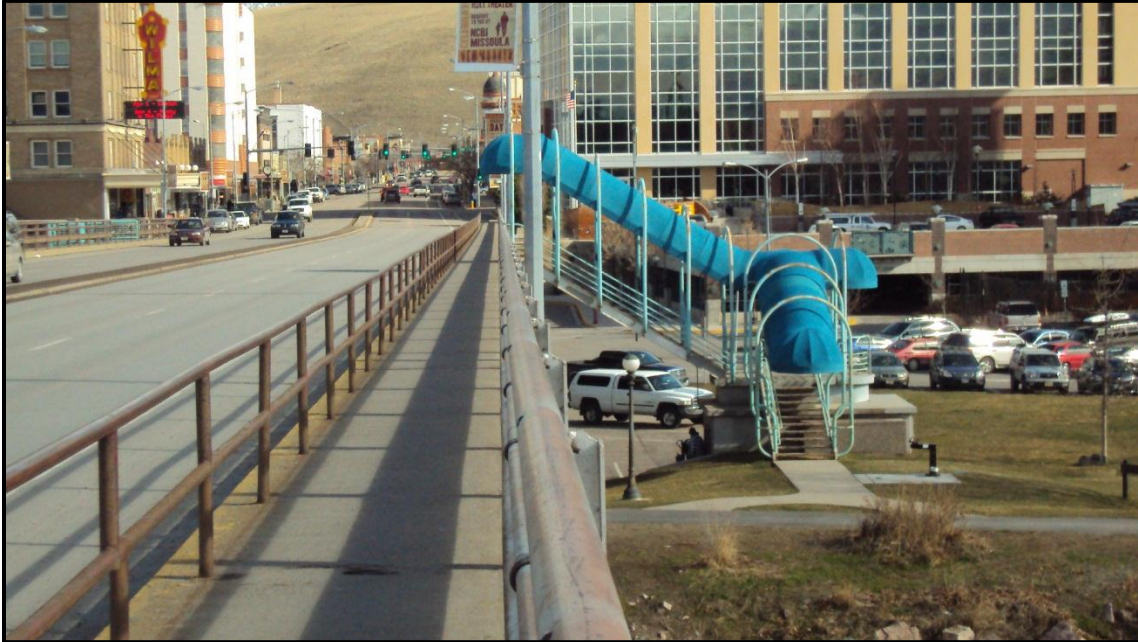
Photo 36. Looking north on the Higgins Avenue Bridge. A stairway is located on the east side of the bridge.

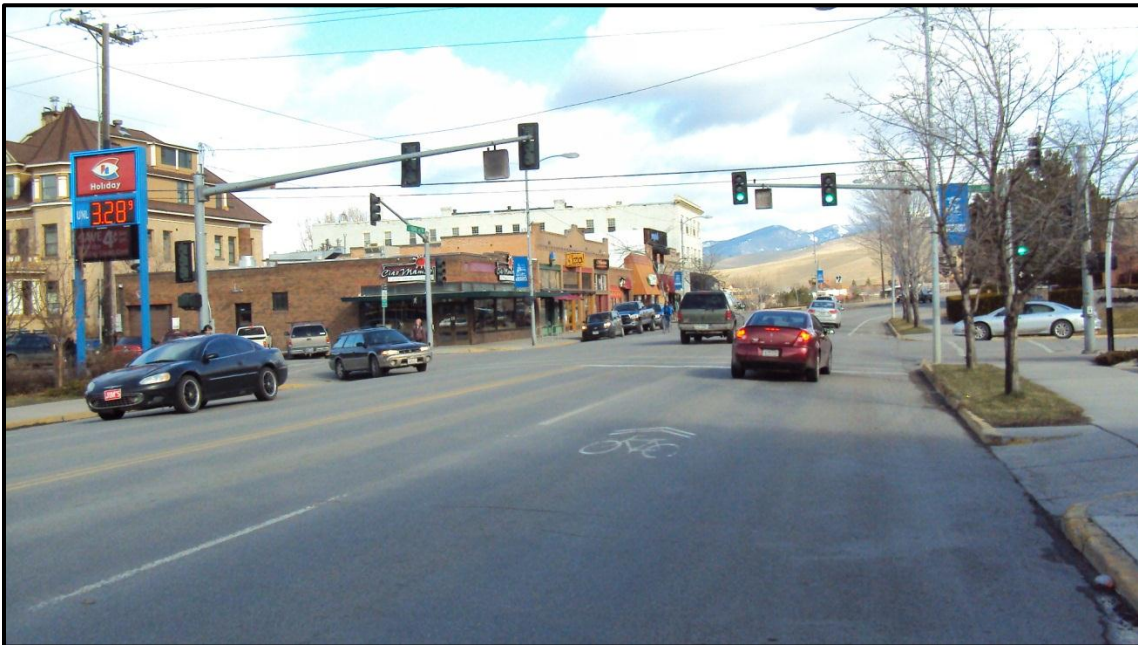
Photo 37. Looking north on the south leg of the Higgins Avenue and 4th Street intersection. A bicycle sharrow can be seen on the east side of Higgins Avenue.

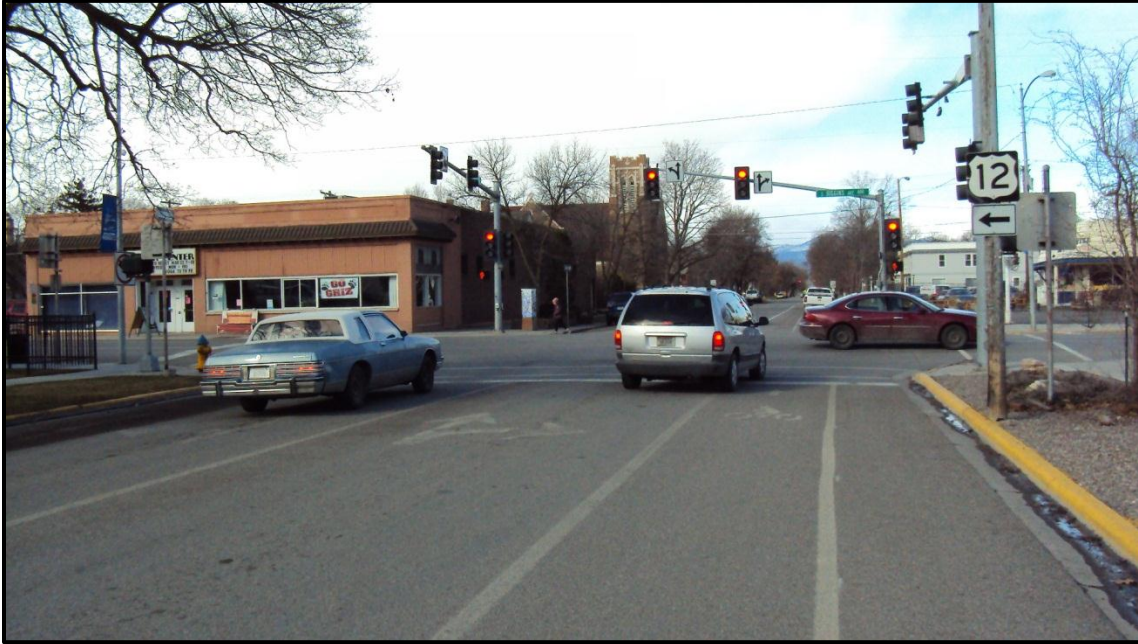
Photo 38. Looking west on the east leg of the Higgins Avenue and 5th Street intersection. A dedicated bicycle lane is provided on the north side of 5th Street.

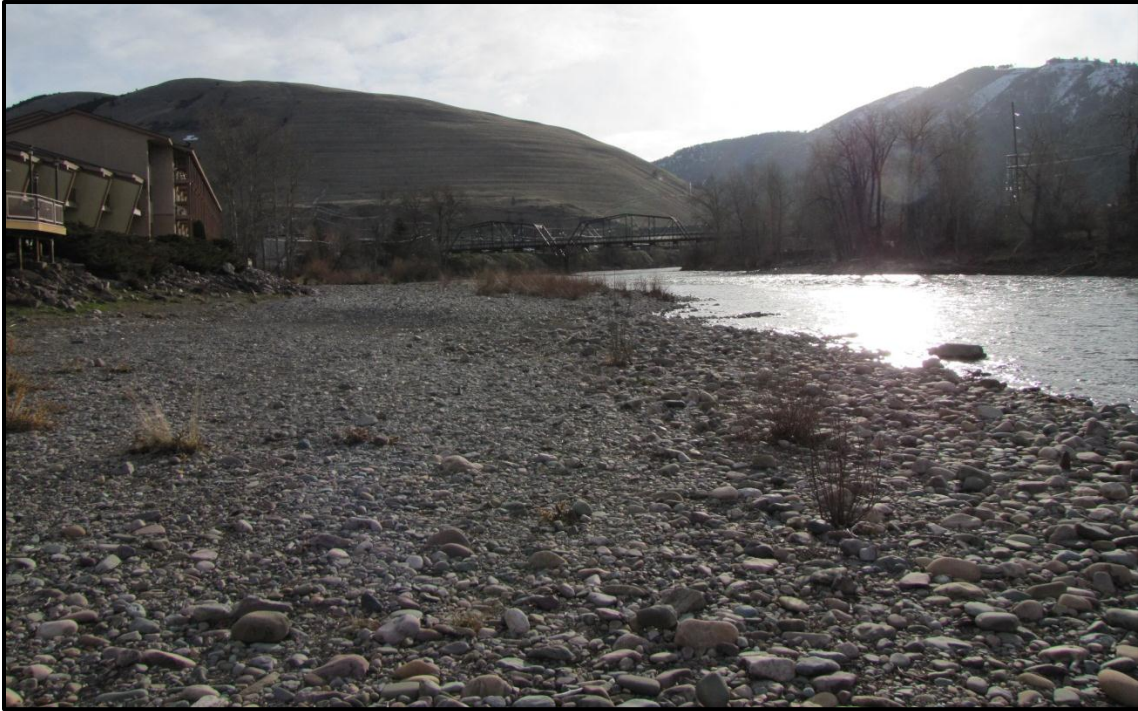
Photo 42. Looking upstream (east) at the Clark Fork River corridor from the Madison Street Bridge. A gravel bar is located on the northern side of the channel, while the south banks are steeply vegetated with cottonwood and willow.

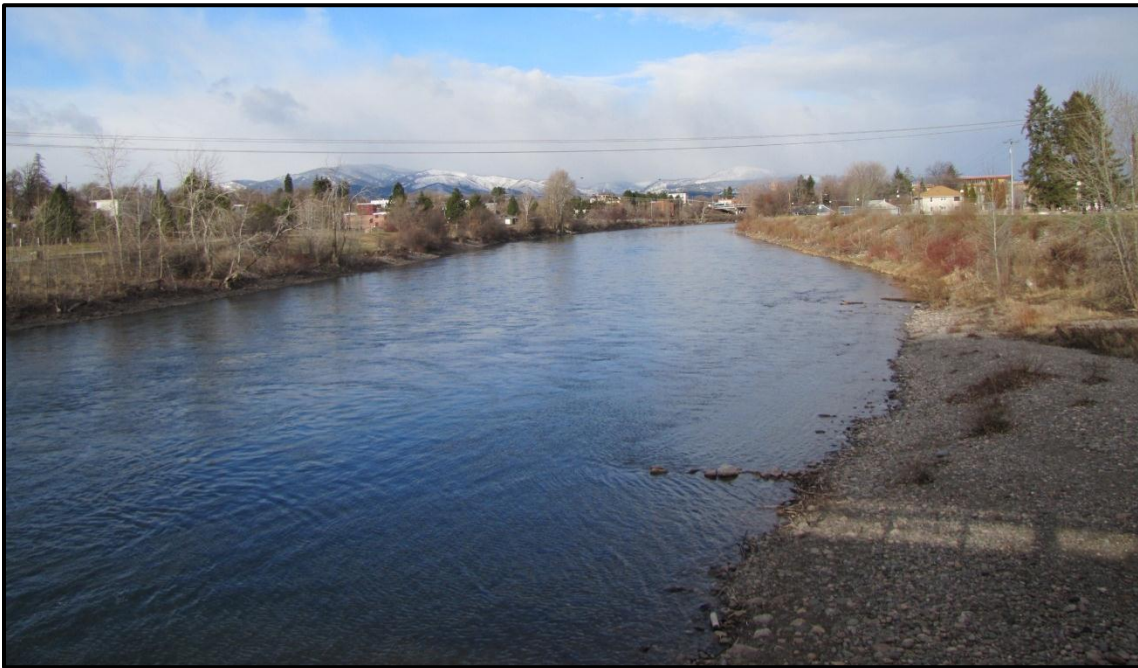
Photo 43. Looking downstream (west) at the Clark Fork River corridor from the Madison Street Bridge. Both the north and south sides of the river have steeply vegetated banks.

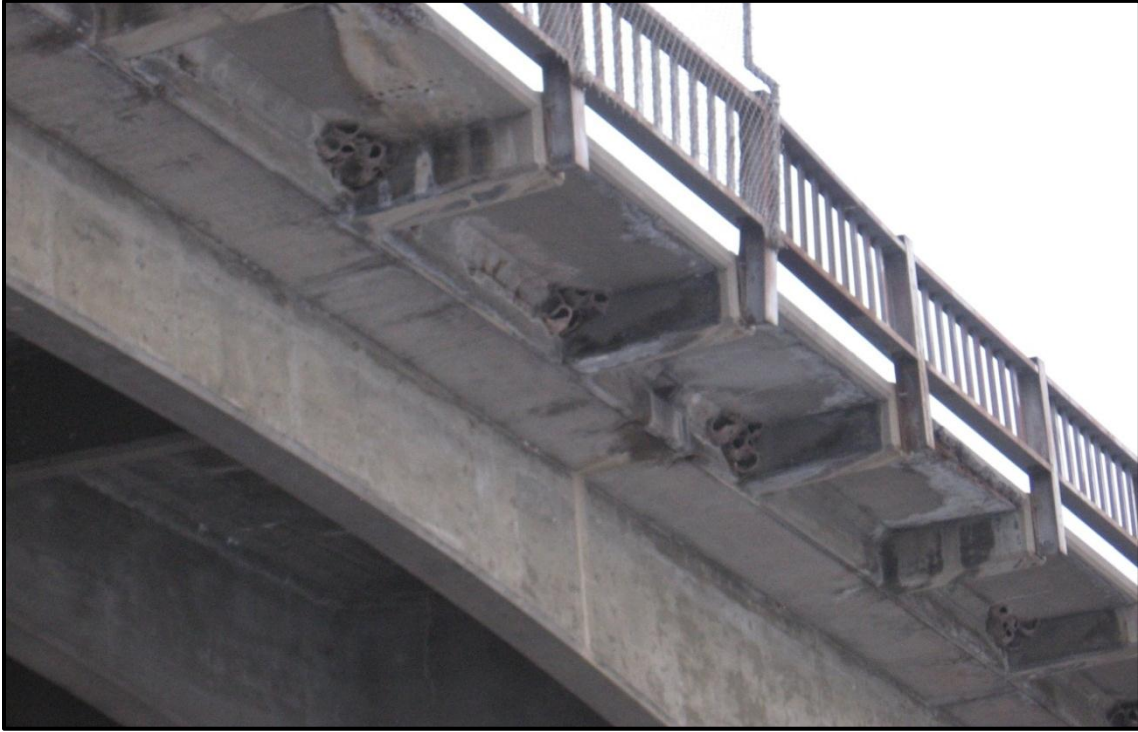
Photo 46. Swallow nests on the east side of the Madison Street Bridge.

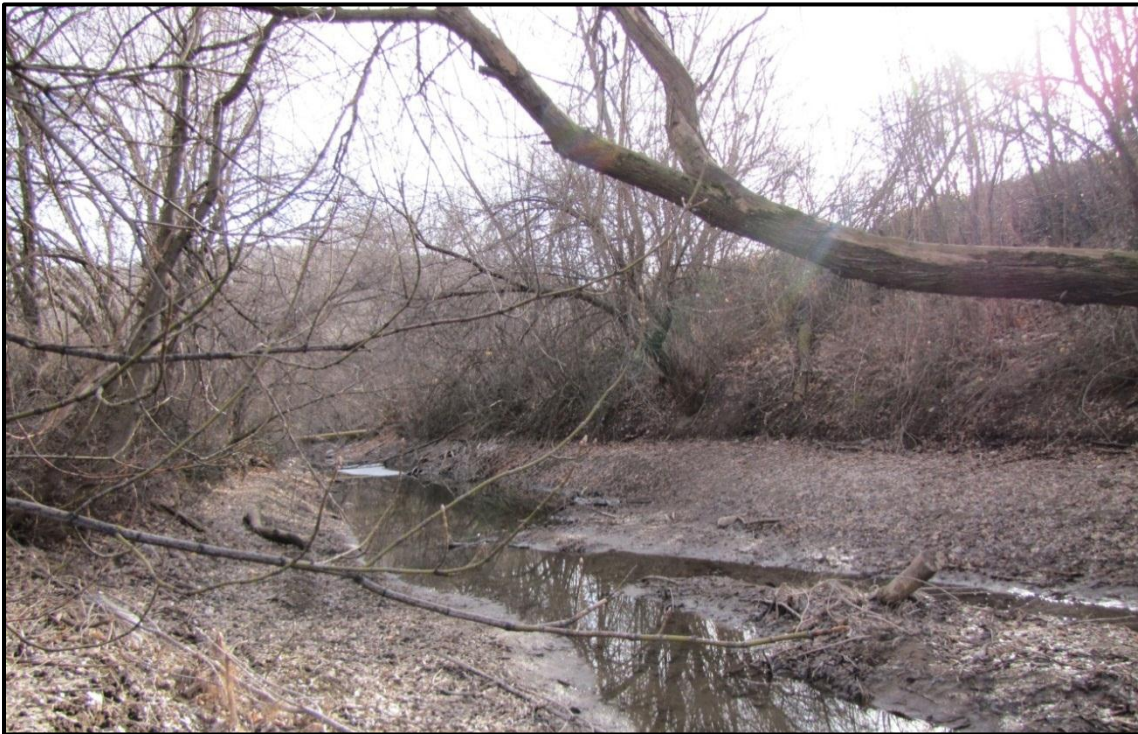
Photo 47. Looking east at a canal which crosses underneath the Madison Street Bridge south approach.

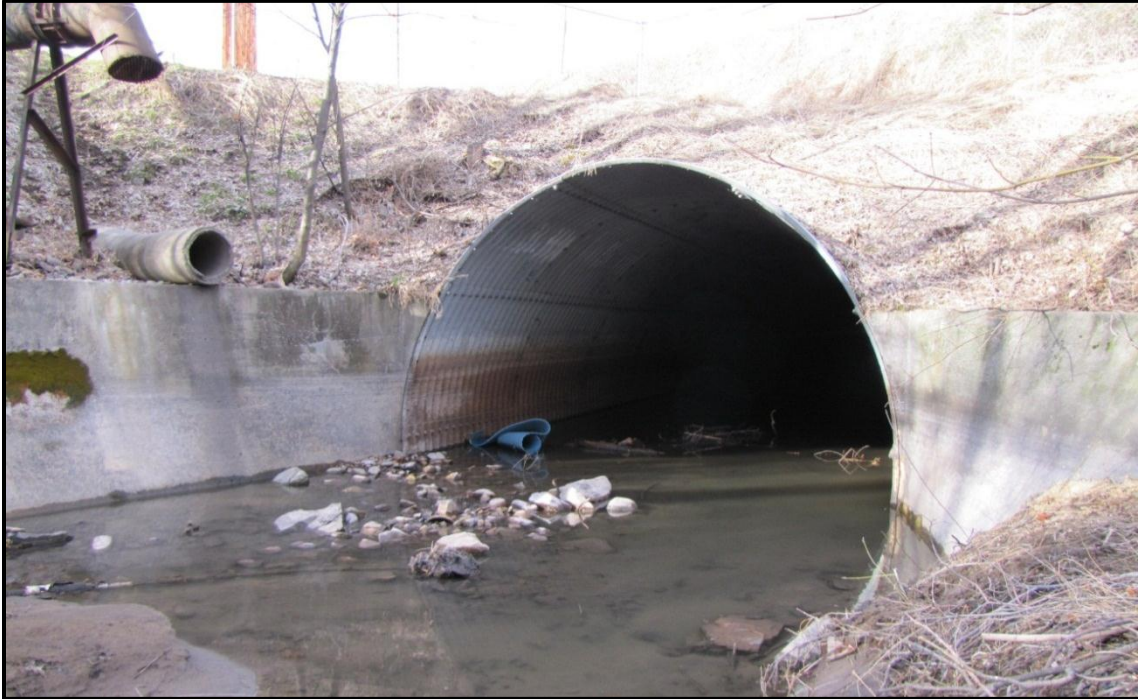
Photo 48. Looking west at canal culvert crossing underneath the Madison Street Bridge south approach.

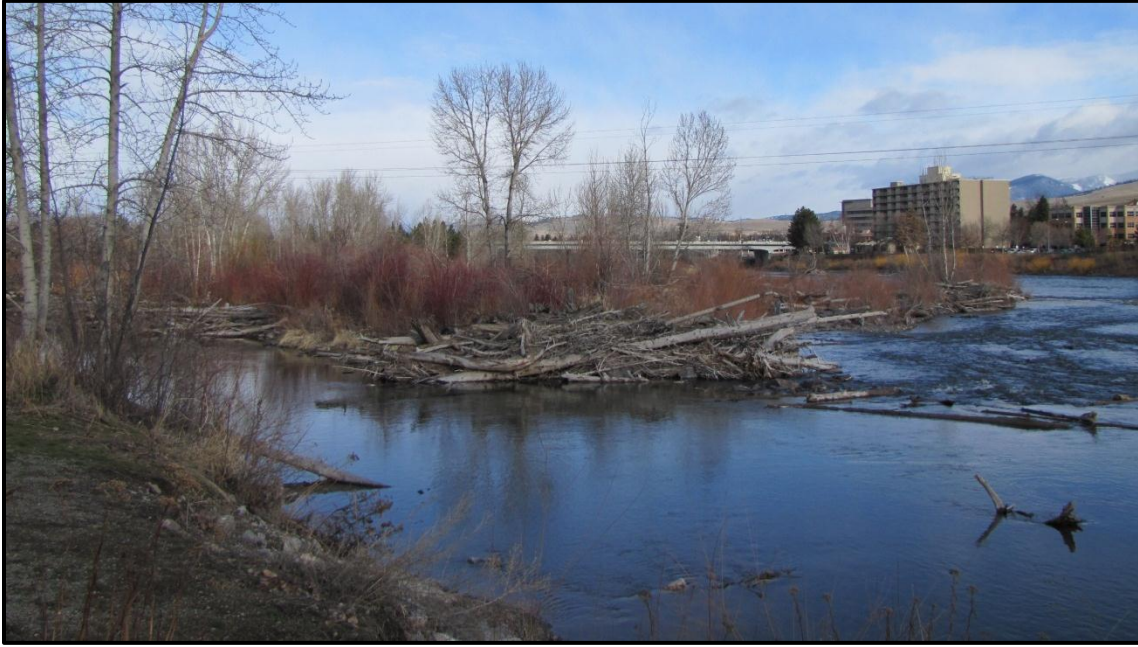
Photo 54. Looking west at palustrine freshwater forested/shrub wetland located downstream (west) of the Higgins Avenue Bridge.

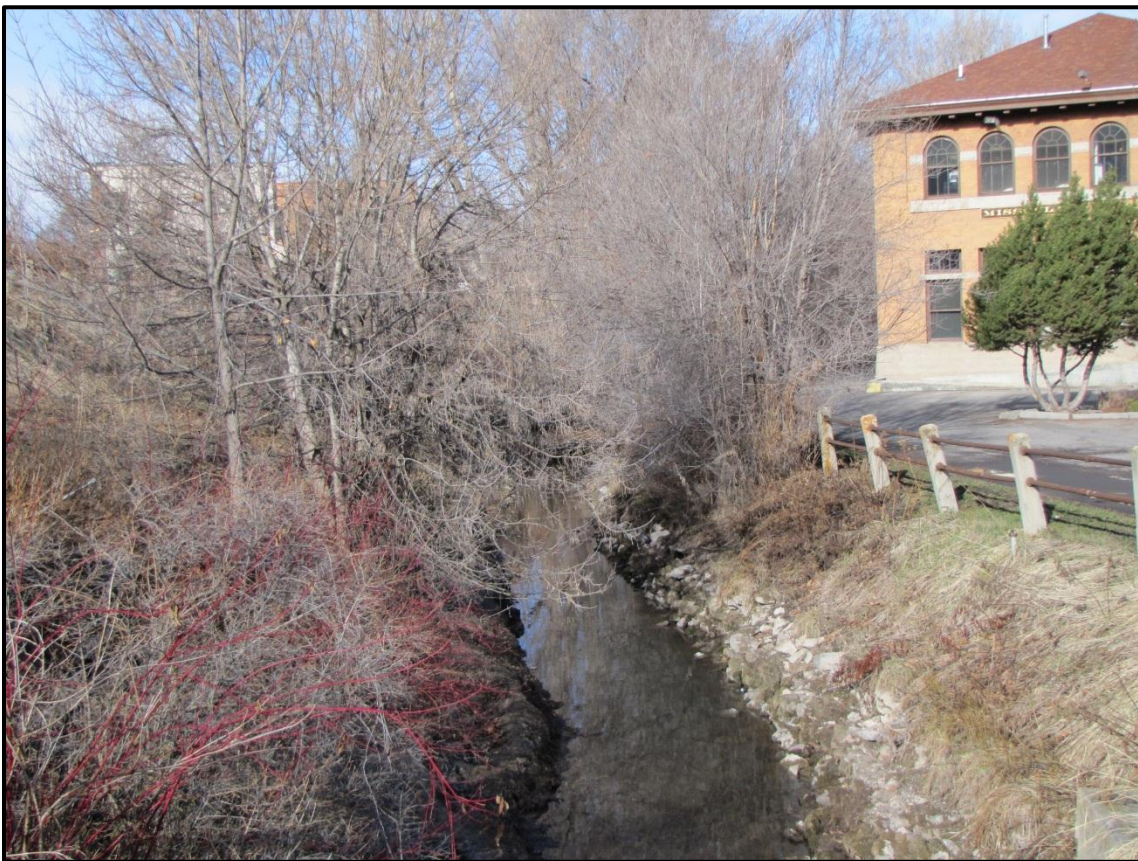
Photo 55. Looking west at the canal which crosses underneath the Higgins Avenue Bridge south approach.
