Prepared for:

Montana Department of Transportation
2701 Prospect Avenue
PO Box 201001
Helena, MT 59620-1001

Confluence Consulting Inc.
1289 Stoneridge Drive
Bozeman, MT 59718

Stone Creek - North
MT. Dept. of Transportation
BEAVERHEAD AND
MADISON COUNTIES,
MONTANA

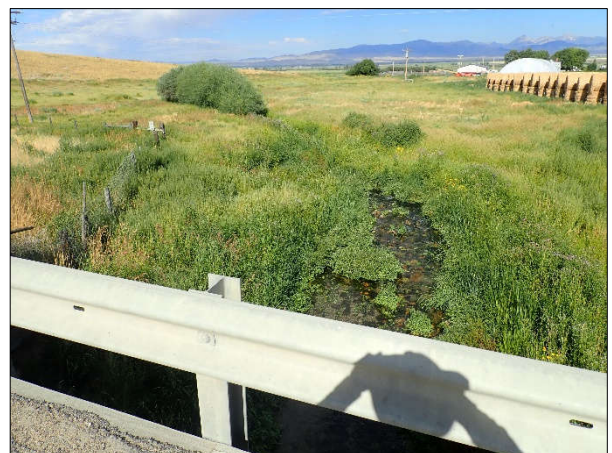
Photo 104: Facing west at Stone Creek (NWW-01) underneath bridge.

Photo 105: Facing downstream on west side of bridge over Stone Creek (NWW-01).

The riparian corridor along the creek has been reduced to a thin band of pasture grasses and sparse woody shrubs. Crops have been planted up to the edge of the channel and have replaced much of the native riparian vegetation upstream of the bridge. Downstream of the bridge, the channel is incised and includes a narrow band of grasses and forbs along the immediate channel fringe. Approximately twenty mature narrow-leaf willows have established along roughly 100 feet of the left bank downstream of the bridge, and provide the only source of shade and cover within a half mile of the bridge (photograph in Appendix C).

The existing Stone Creek timber bridge will be removed and replaced. The new structure will be a double cell, reinforced concrete box (RCB) culvert with each cell 12 ft wide x 10 ft high. The west side box culvert will be partially backfilled with riprap and native streambed material and carry Stone Creek under the highway. The east side box culvert will also be partially backfilled with native material and used as an underpass for livestock to cross under the highway. The current bridge does not create a floodplain constriction or impede Stone Creek's flood flows and the new structure is not expected to either. The channel was previously manipulated to align perpendicular to the highway, and has remained in this configuration. A temporary detour on the east (upstream) side of the highway will be installed to maintain traffic flow during the construction process. Impacts to the stream channel and adjacent wetlands will occur at this site and will be quantified by MDT when the designs have been finalized.

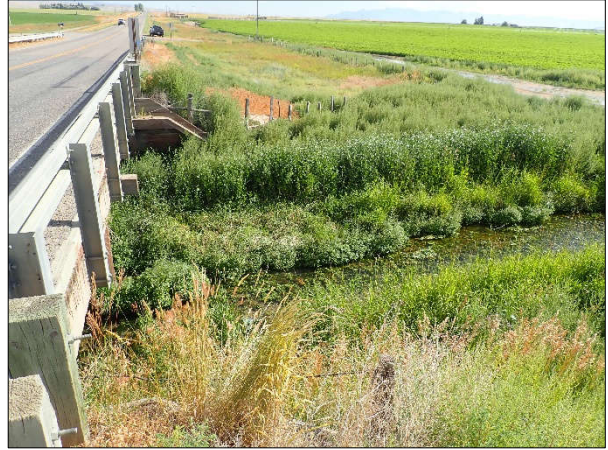
Photo 106: View to the south on west side of bridge over Stone Creek (NWW-01).

Photo 107: View to the north on east side of bridge over Stone Creek (NWW-01).

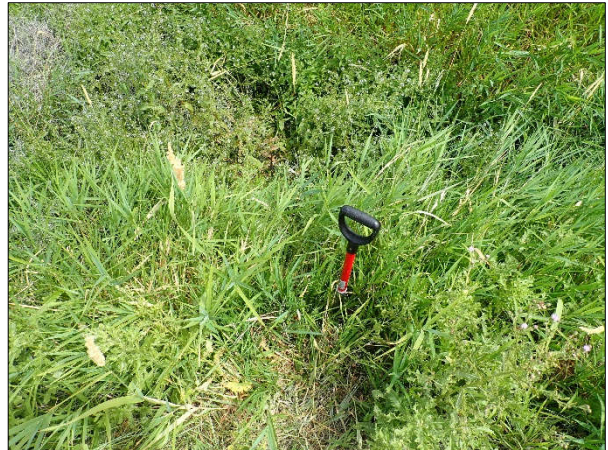
Photo 108: Unnamed spring creek (NWW-02/W03-a) is impounded south of highway.

Photo 109: Vegetated channel of unnamed spring creek (NWW-03/W03-b) north of highway.

With the exception of the artificially constructed online pond features, the relatively steep channel consists of riffle habitat features only. No pool features were observed within 500 feet upstream and downstream of the highway. The spring hydrology of the channel does not produce enough discharge to scour deeper pool habitat; therefore, deeper pool formations are not present in the vicinity of the highway.

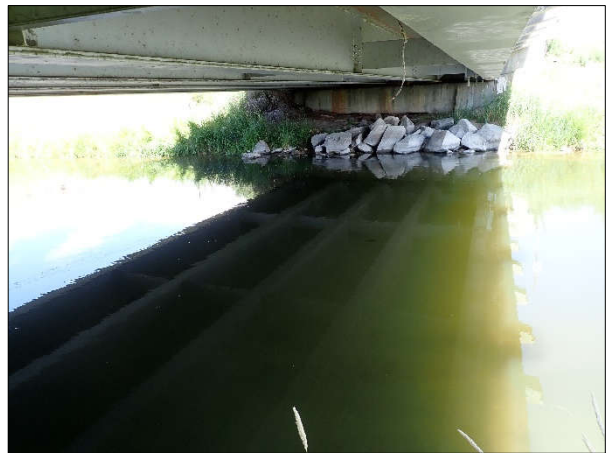
Photo 110: Facing upstream at right bank of Beaverhead River (NWW-03) under bridge.

Photo 111: Facing north across river at left bank of Beaverhead River (NWW-03) under the bridge.

Discharge in the Beaverhead River is regulated by the Clark Canyon Dam, completed in 1964 and approximately 33 miles upriver from the project site. The regulated nature of the Beaverhead below Clark Canyon Dam is reflected in dam-releases, which provide irrigation water throughout the summer months to several large diversions. The Clark Canyon dam also provides flood control downstream, therefore the Beaverhead River does not exhibit a natural flood regime. The regulated nature of the river has caused vegetation to encroach upon the channel in several locations, including just upstream of the Highway 41 bridge.

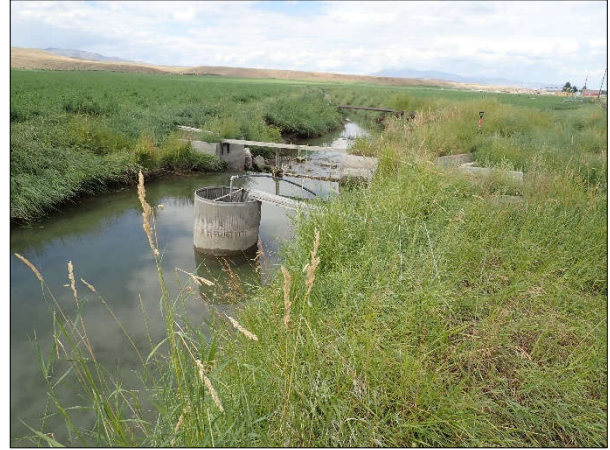
Photo 117: Facing south (upstream) towards bridge over Co-op ditch (IR-01).

Photo 118: Facing north towards irrigation infrastructure on Co-op Ditch (IR-01).

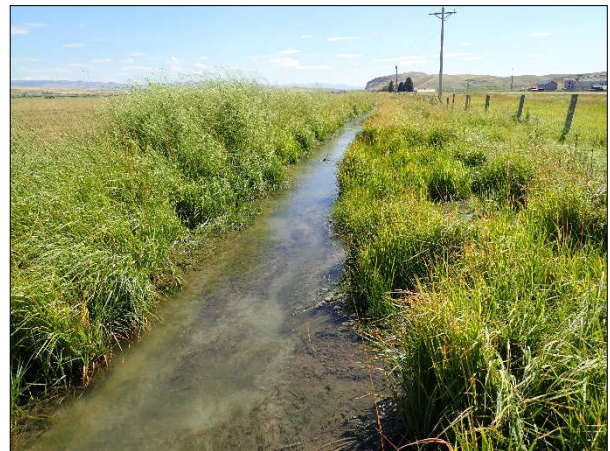
Photo 121: Facing north at Warm Springs Irrigation Ditch (IR-02) at culvert adjacent to entrance to cropped field.

Photo 122: Facing south at Warm Springs Irrigation Ditch (IR-02) from northern project boundary.
