Montana Department of Transportation

Subject: Speed Limit Recommendation
US 93 (N-7) - Hamilton to Missoula

SPEED STUDY RECOMMENDATIONS

Speed Study Recommendations

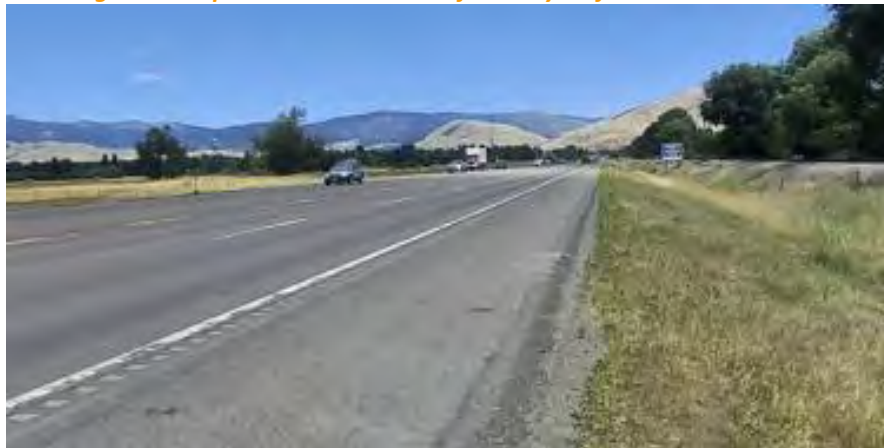
Figure 2 - Representative Section of US Hwy 93 from RP 87.7 to 90.0

The typical cross section for this study section consists mainly of four bituminous traveling lanes (outside lanes are 12-ft wide, the inside lanes are 14-ft wide), one 16-ft bituminous TWLTL in the center, and two 10-ft bituminous shoulders. The pavement is generally in good condition. The shoulders are wide enough for safe parking of disabled vehicles.

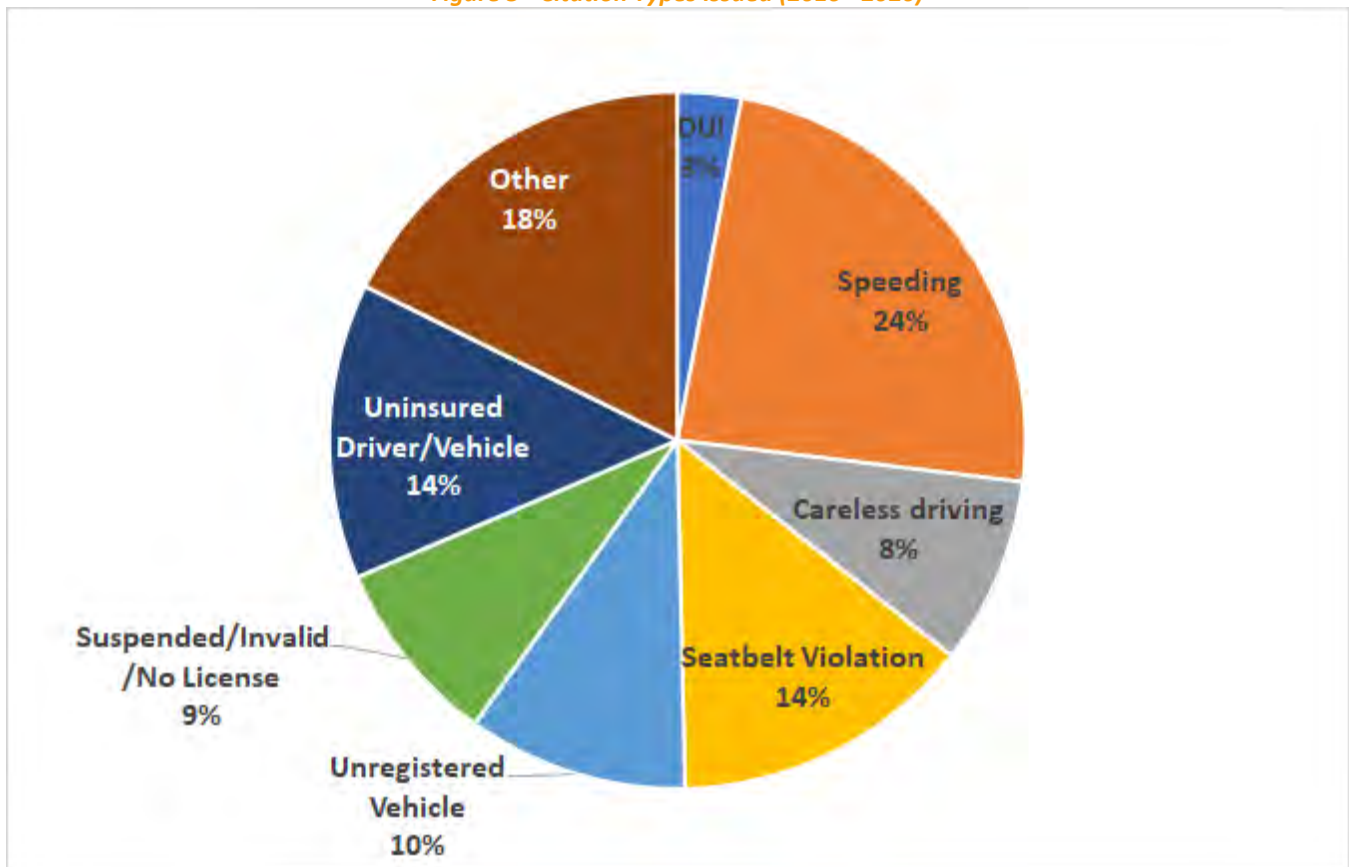
Figure 5 - Citation Types Issued (2016 - 2020)

The greatest number of citations were given in the month of March (12%). The types of citations issued in this segment are shown in **Figure 5**. Speeding (24%) was the most prominent type of traffic violation in the study area.

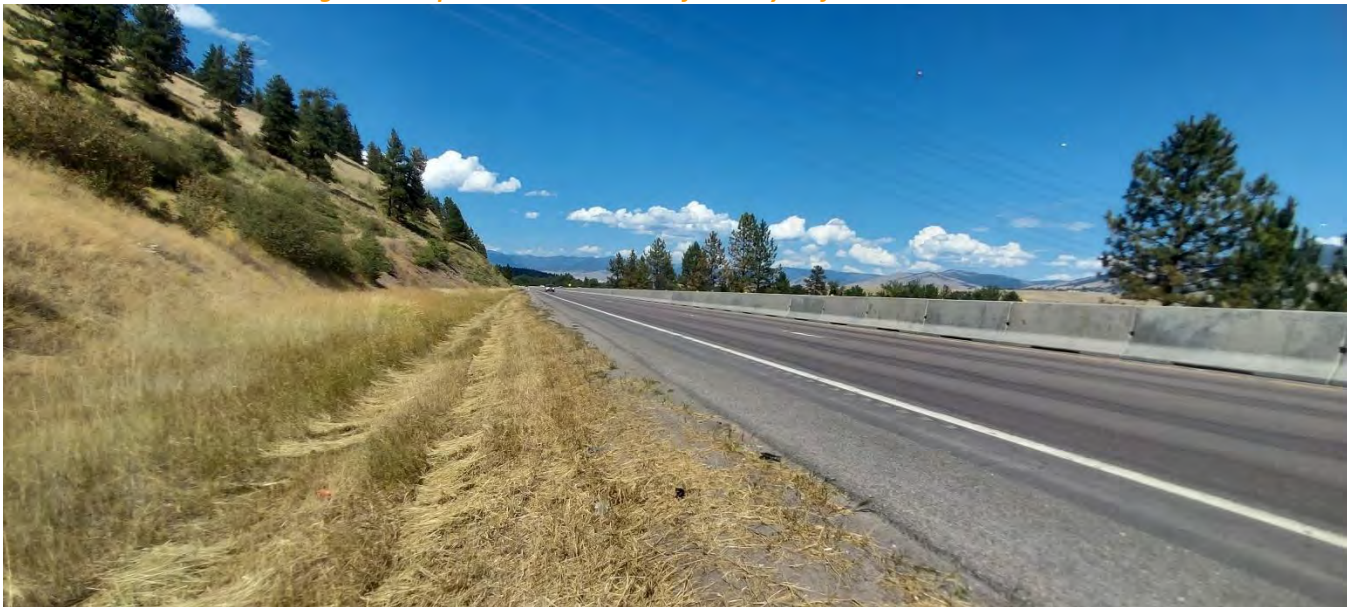
Figure 2 - Representative Section of US Hwy 93 from RP 85.6 to 87.7

The typical cross section for this study section consists mainly of four 12-ft wide bituminous traveling lanes divided by a concrete median, and two seven-ft bituminous shoulders. The pavement is generally in good condition. The shoulders are wide enough for safe parking of disabled vehicles.

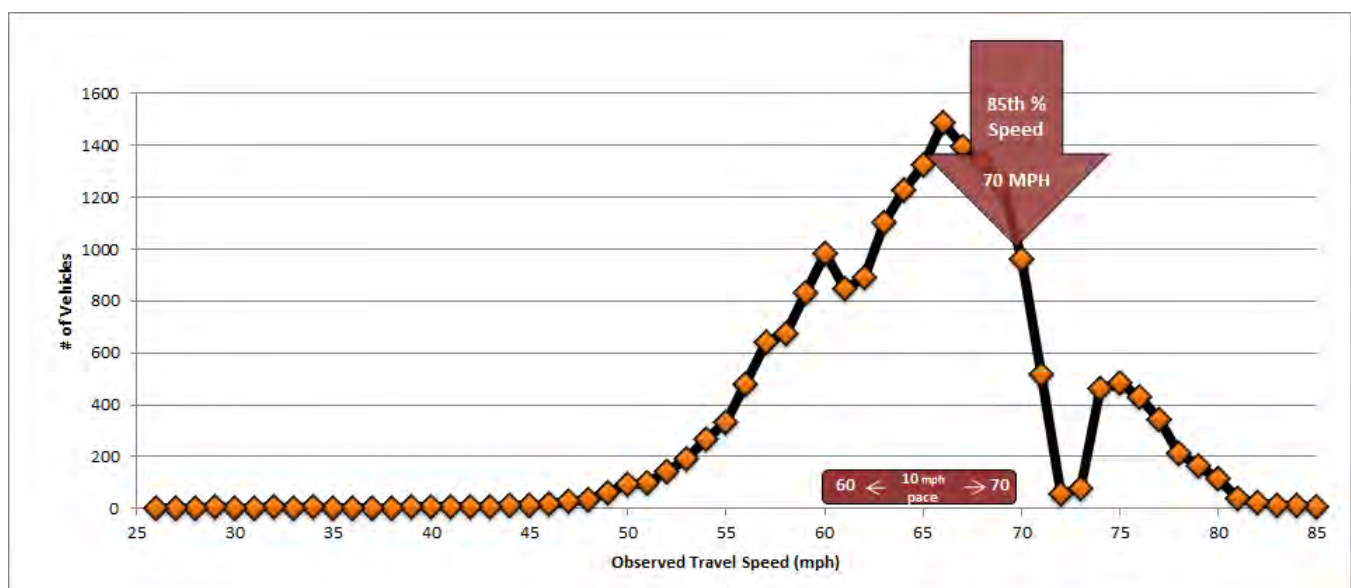
Figure 6 - Speed Profile for All Vehicle Types in Both Direction of Travel

Vehicle Type	Direction	10-mph Pace	% In Pace	85 th Percentile Speed	50 th Percentile Speed
Small to Mid-size	Northbound	62-72 mph	69%	75-mph	68-mph
	Southbound	57-67 mph	70%	66-mph	61-mph
	Both	61-71 mph	60%	71-mph	65-mph
Large	Northbound	62-72 mph	68%	70-mph	66-mph
	Southbound	56-66 mph	72%	64-mph	60-mph
	Both	59-69 mph	63%	68-mph	63-mph
All	Northbound	62-72 mph	69%	75-mph	68-mph
	Southbound	57-67 mph	70%	66-mph	61-mph
	Both	60-70 mph	60%	70-mph	65-mph

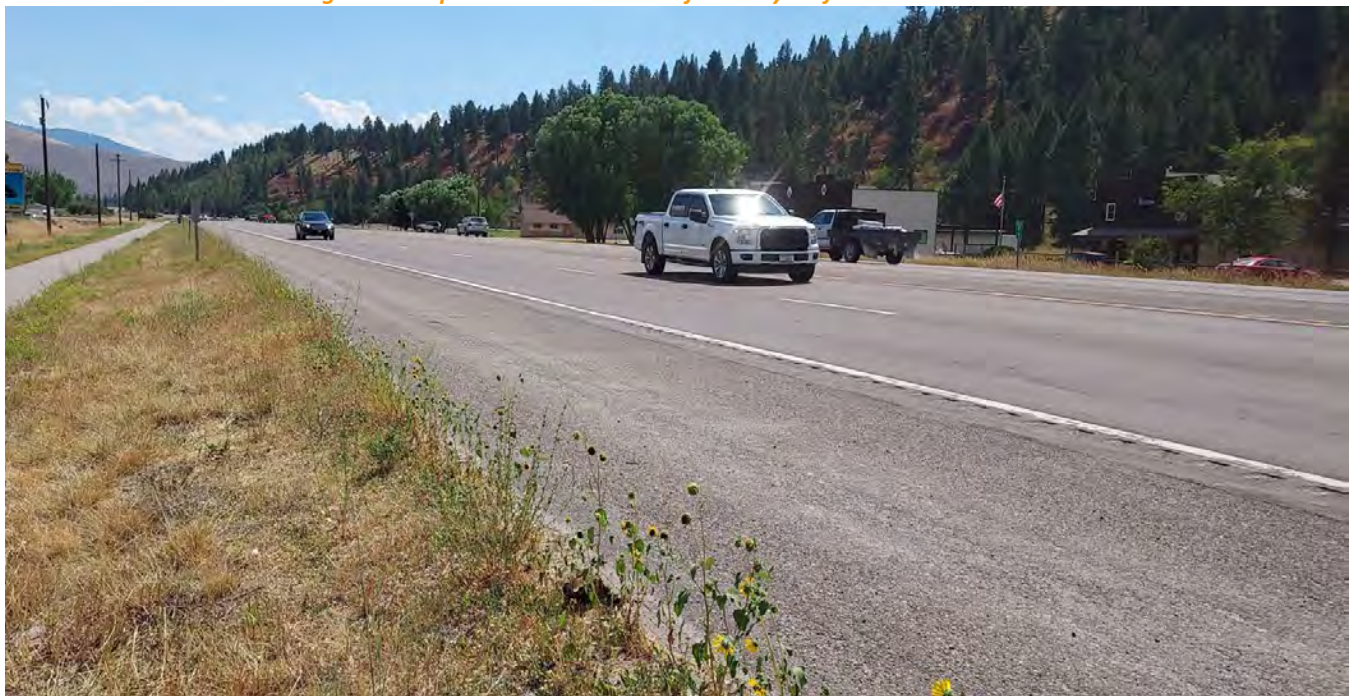
Figure 2 - Representative Section of US Hwy 93 from RP 84.0 to 85.6

The typical cross section for this study section consists mainly of four 12-ft wide bituminous traveling, one 16-ft TWLTL in the center, and two 12-ft bituminous shoulders. The pavement is generally in good condition. The shoulders are wide enough for safe parking of disabled vehicles.

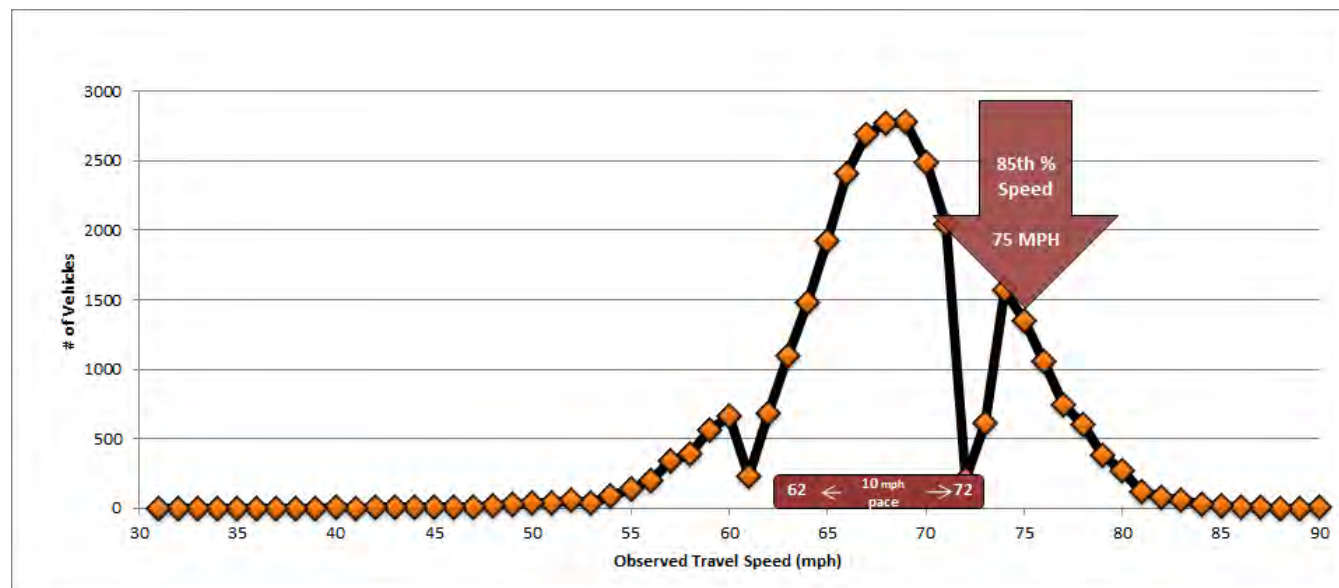
Figure 6 - Speed Profile for All Vehicle Types in Both Direction of Travel

Vehicle Type	Direction	10-mph Pace	% In Pace	85 th Percentile Speed	50 th Percentile Speed
Small to Mid-size	Northbound	62-72 mph	65%	75-mph	69-mph
	Southbound	62-72 mph	68%	74-mph	68-mph
	Both	62-72 mph	67%	75-mph	68-mph
Large	Northbound	62-72 mph	73%	69-mph	66-mph
	Southbound	59-69 mph	70%	69-mph	65-mph
	Both	62-72 mph	70%	69-mph	65-mph
All	Northbound	62-72 mph	66%	75-mph	68-mph
	Southbound	62-72 mph	68%	74-mph	68-mph
	Both	62-72 mph	67%	75-mph	68-mph

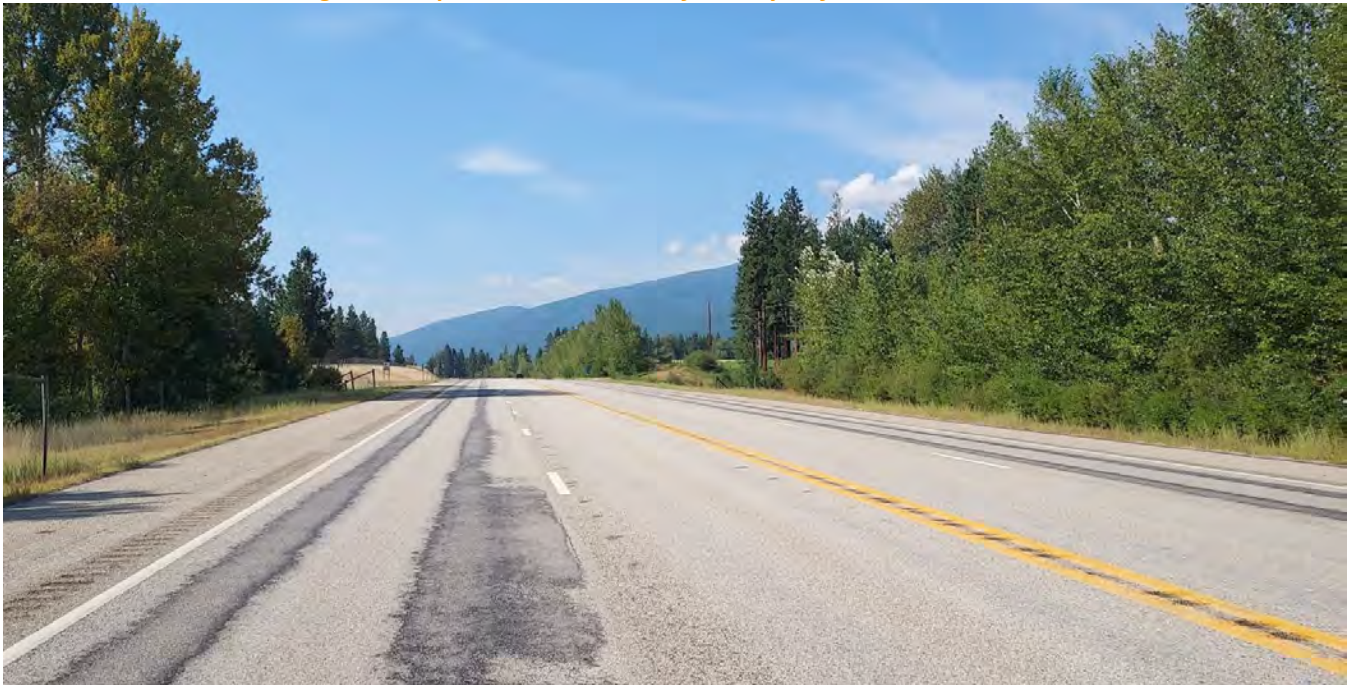
Figure 2 - Representative Section of US Hwy 93 from RP 67.8 to 74.0

The representative typical cross section for this study segment consists mainly of four 11-ft bituminous travelling lanes, and two 10-ft bituminous shoulders. The pavement is generally in good condition. The shoulders are wide enough for safe parking of disabled vehicles. The northern one-half mile of the segment has four-lanes with a center TWLTL.

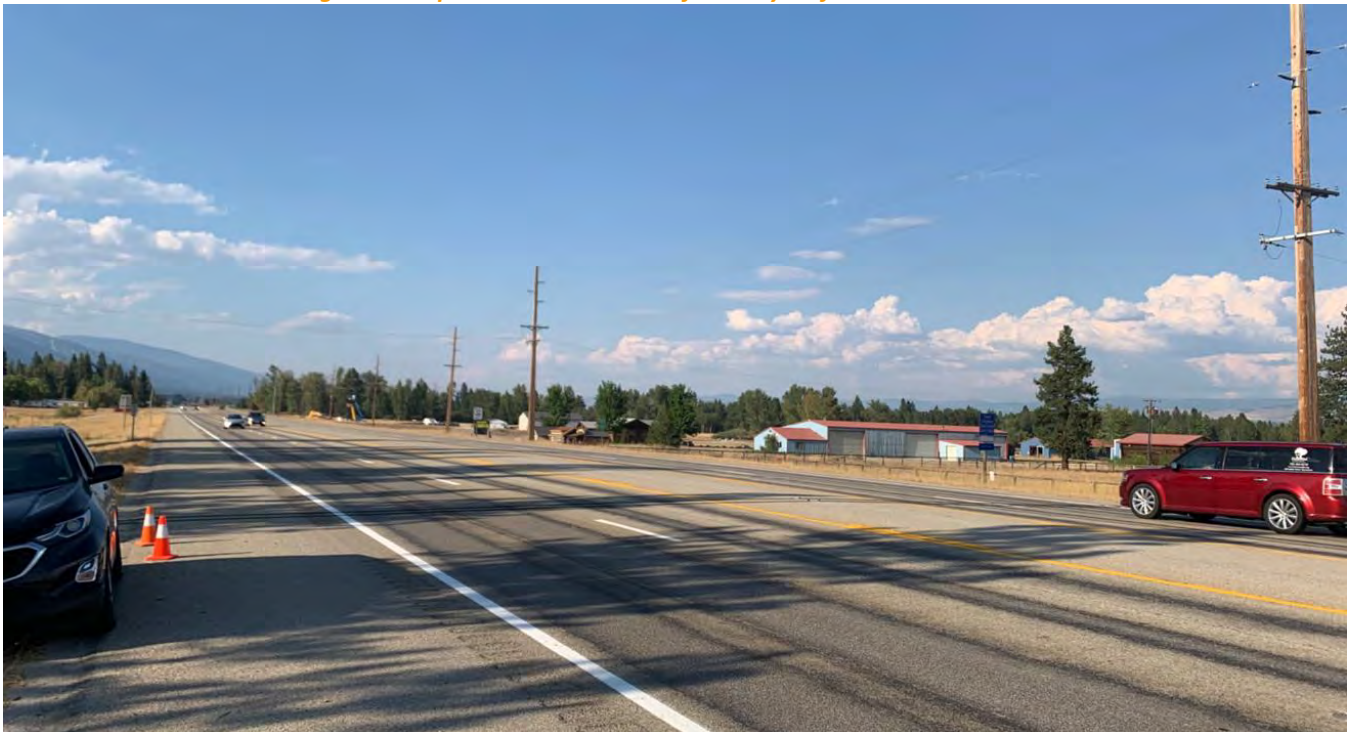
Figure 2 - Representative Section of US Hwy 93 from RP 56.0 to 58.6

The typical cross section for this study section consists mainly of four 11-ft bituminous travelling lanes, 15-ft center two-way-left-turn-lane (TWLTL), and two 10-ft bituminous shoulders. The pavement is generally in good condition. The shoulders are wide enough for safe parking of disabled vehicles.

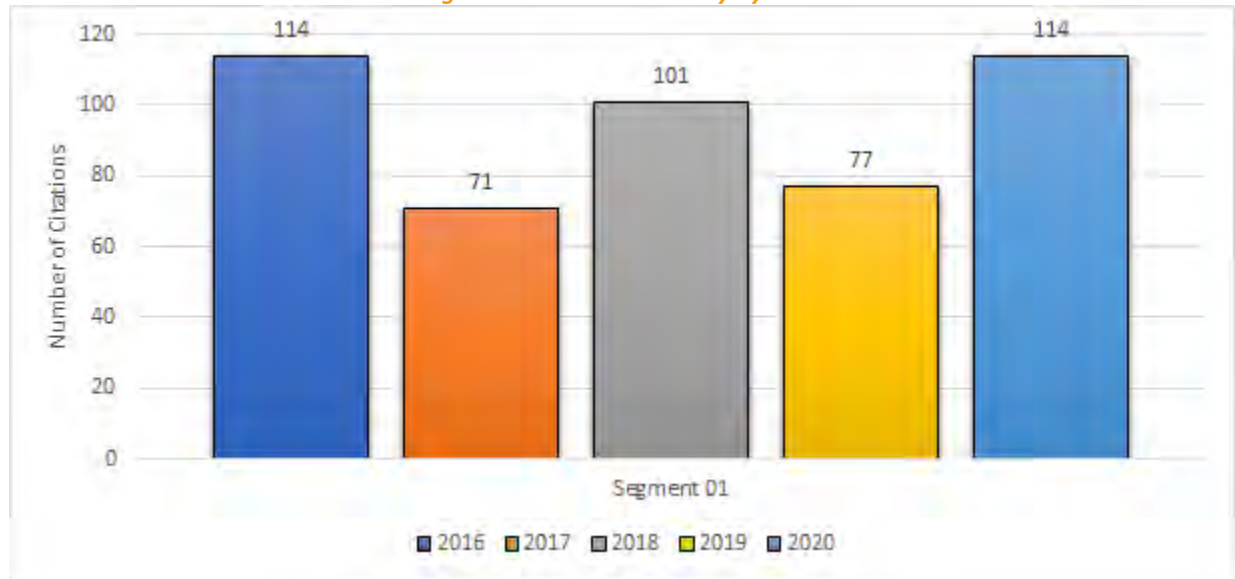
Figure 4 - Citation Summary by Year

Five years of citation records between January 1, 2016, through December 31, 2020, were requested from the MDT Traffic & Safety Bureau. The citation records were shared in a spreadsheet format. The five-year citation summary in the segment is shown in **Figure 4**. There were 477 citations issued in the study segment during the analysis period of which 209 citations (44%) were speeding violations.

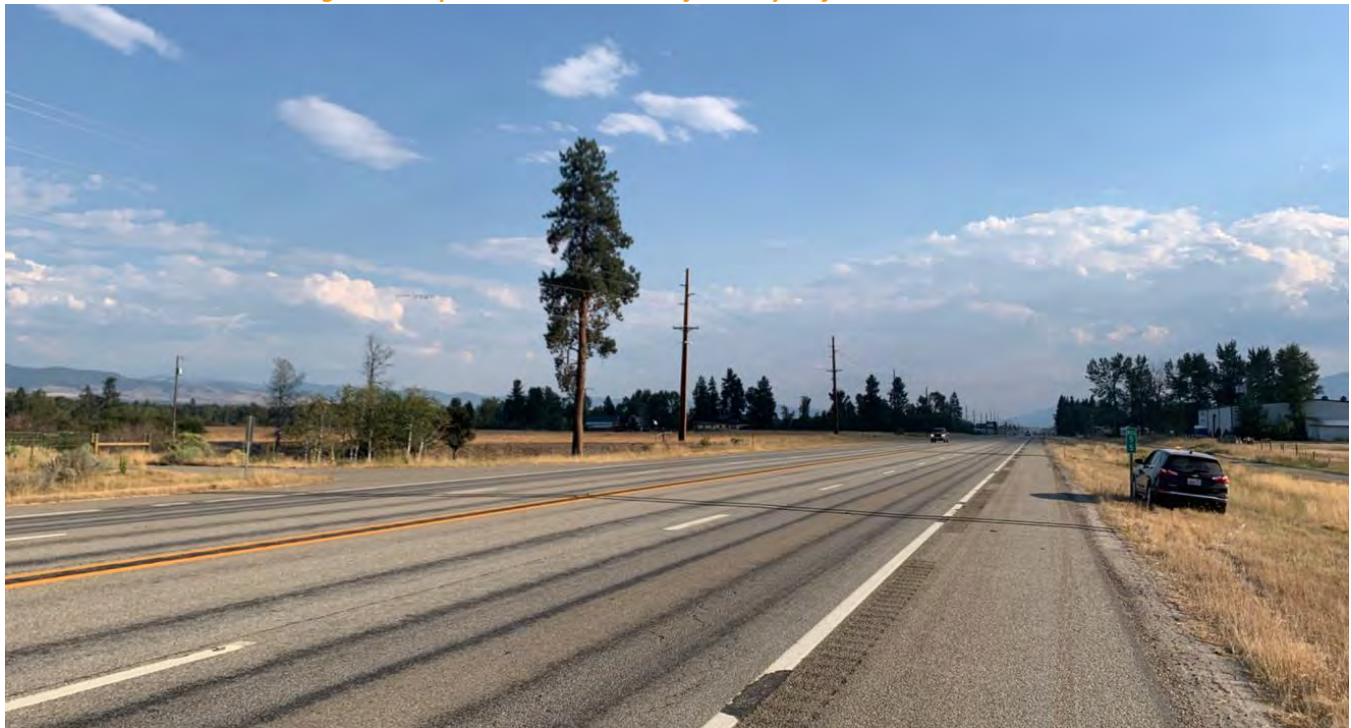
Figure 2 - Representative Section of US Hwy 93 from RP 54.5 to 56.0

The typical cross section for this study section consists mainly of four 12-ft bituminous travelling lanes, and two 11.5-ft bituminous shoulders. The pavement is generally in good condition. The shoulders are wide enough for safe parking of disabled vehicles.

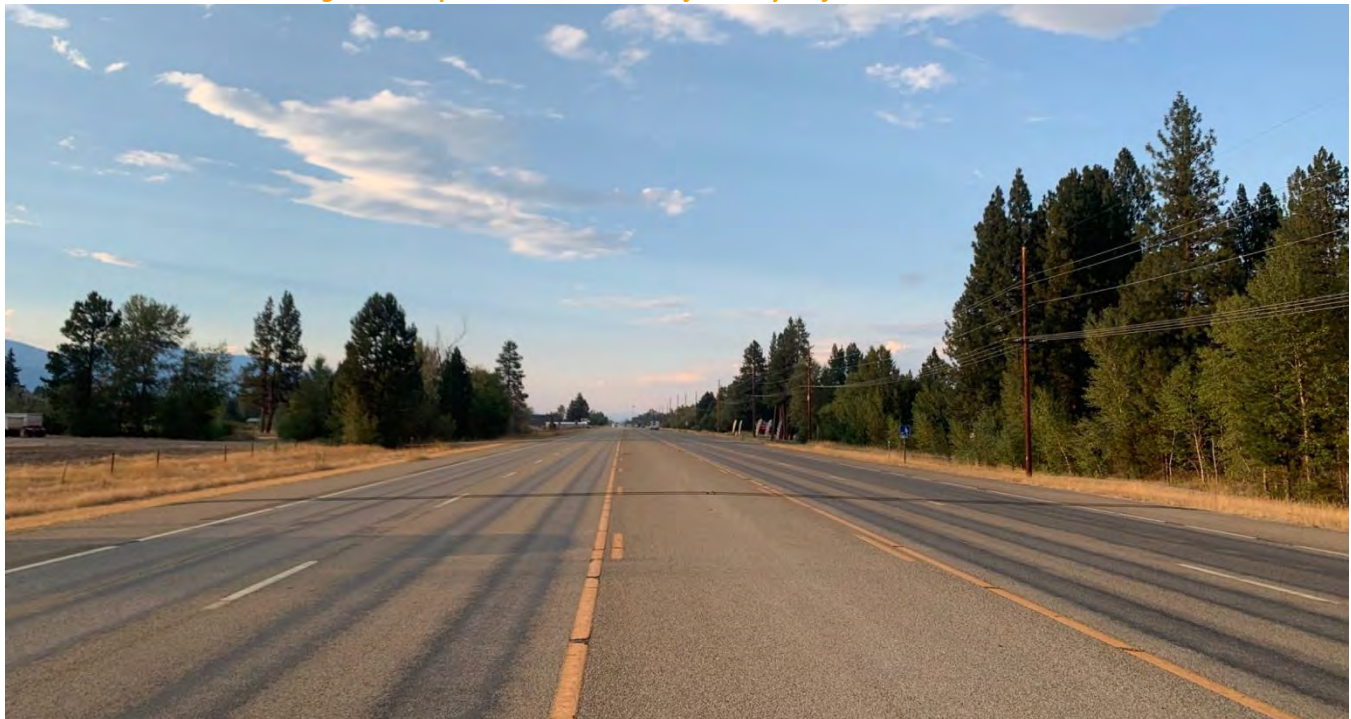
Figure 2 - Representative Section of US Hwy 93 from RP 50.0 to 52.0

The typical cross section for this study section consists mainly of four 12-ft bituminous traveling lanes, one 15-ft bituminous two-way-left-turn-lane in the center, and two 10-ft bituminous shoulders. The pavement is generally in good condition. The shoulders are wide enough for safe parking of disabled vehicles.

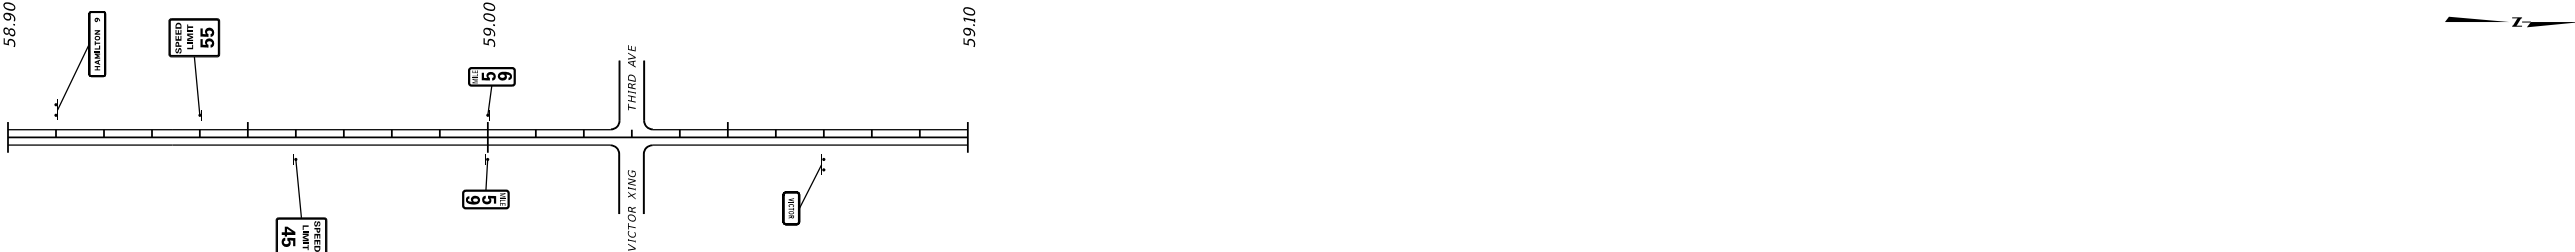
<p>SPEED ZONE SURVEY HAMILTON Location <u>TO MISSOULA</u> County <u>RAVALLI/MISSOULA</u> Roadway <u>C000007 (US 93)</u> RP from <u>49.50</u> to <u>59.10</u> Scale <u>1 UNIT = 0.10 MILES</u> Date <u>JANUARY 2023</u></p>

Roadway Width	TRANSITION-01 86- FEET	
Number of Striped Lanes	4	
Type of Divider	TWLTL	
Average Daily Traffic	14,200	
Direction	NB	SB
Number of Vehicles	7,100 VEH	7,100 VEH
85th Percentile	54 MPH	55 MPH
50th Percentile	48 MPH	50 MPH
10 MPH Pace (% in Pace)	44-54 MPH (65%)	46-56 MPH (68%)
Existing Speed Zone	45 MPH	55 MPH
SPEED PROFILE	MPH	
LEGEND
