# Investigation of Concrete Bridge Deck Cracking

Wiss, Janney, Elstner Associates, Inc.

Todd Nelson, P.E. – Associate Principal

February 27 and 28, 2018

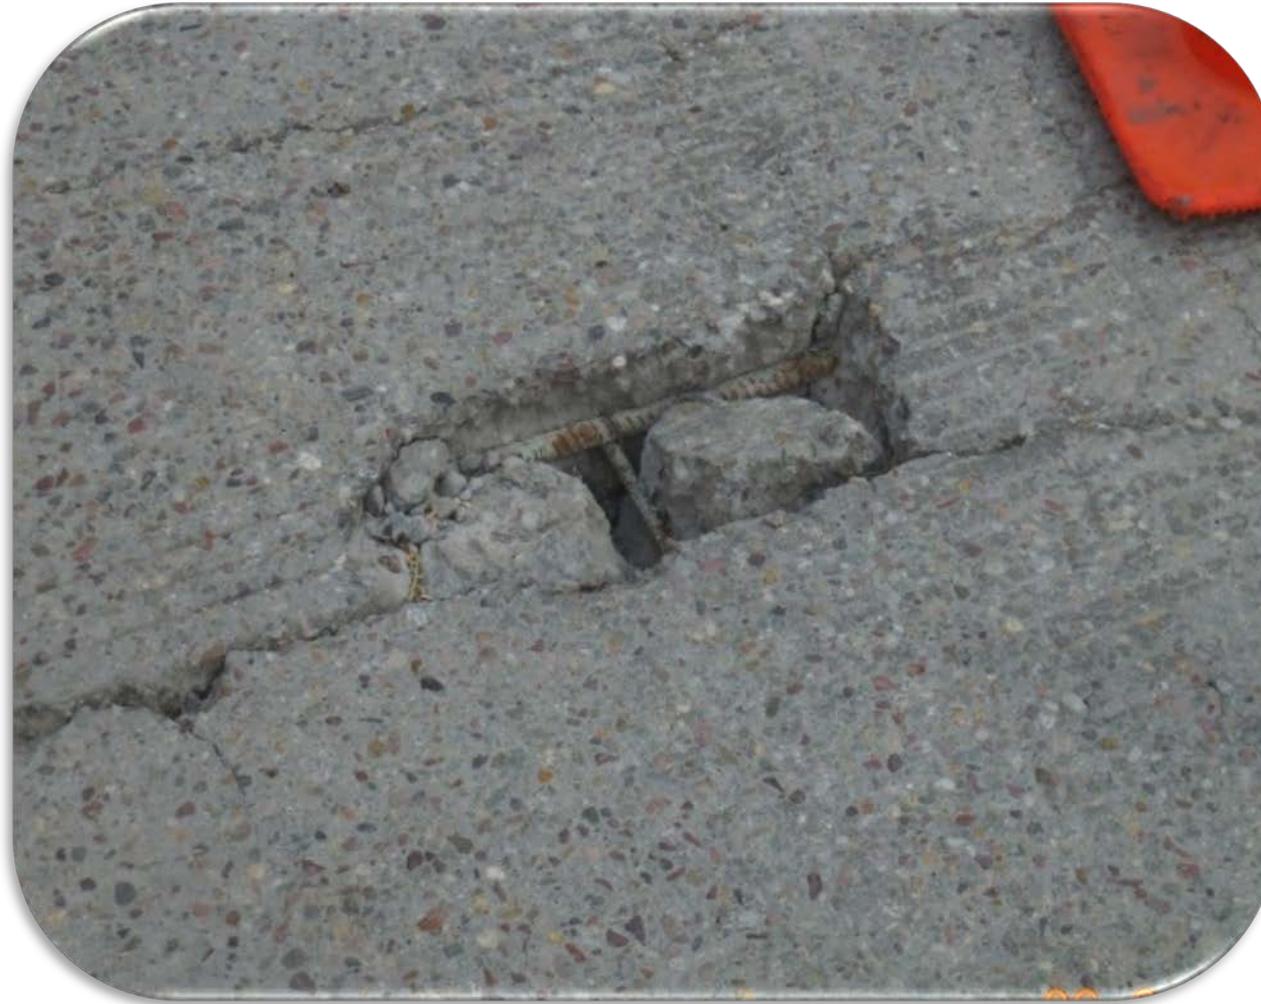
# Background – Distress Reported by MDT

- MDT communicated to WJE that severe transverse cracking was noted on a number of bridge decks in western Montana
- In three bridges, cracking led to deck penetrations (holes in the deck)
- Concrete decks were only 1 to 9 years old
- MDT and FHWA commissioned WJE in early 2016 to investigate the problem

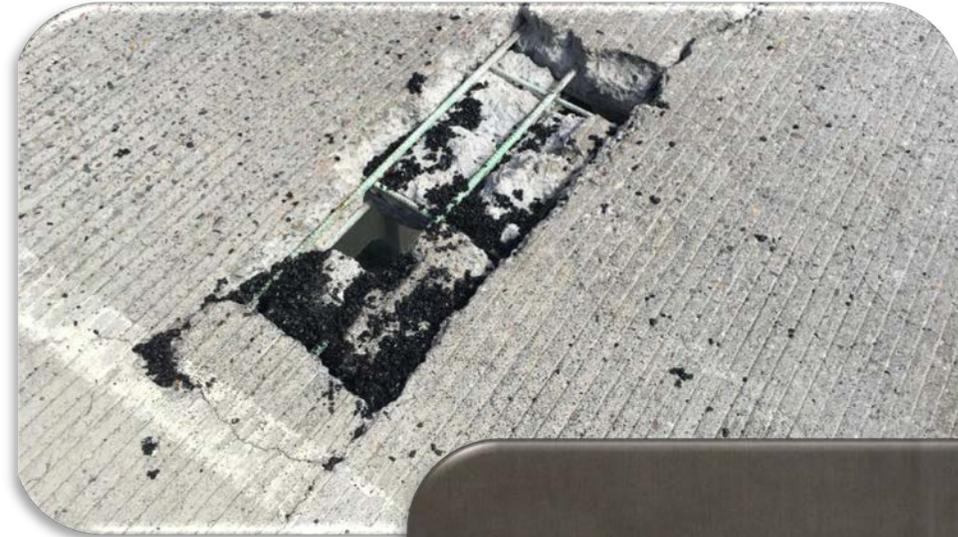
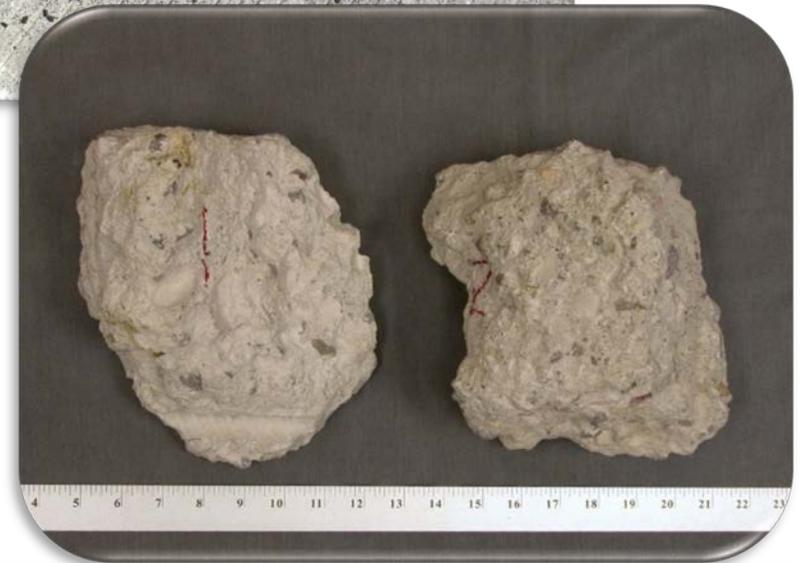
# Project Background – Preliminary Lab Studies

- Concrete chunks were retrieved from MDT – fallen from LZ
- Based on photographs and information provided by MDT – WJE’s original hypothesis - materials deterioration
- WJE performed preliminary petrographic analyses and chemistry
- Focus on any material related distress

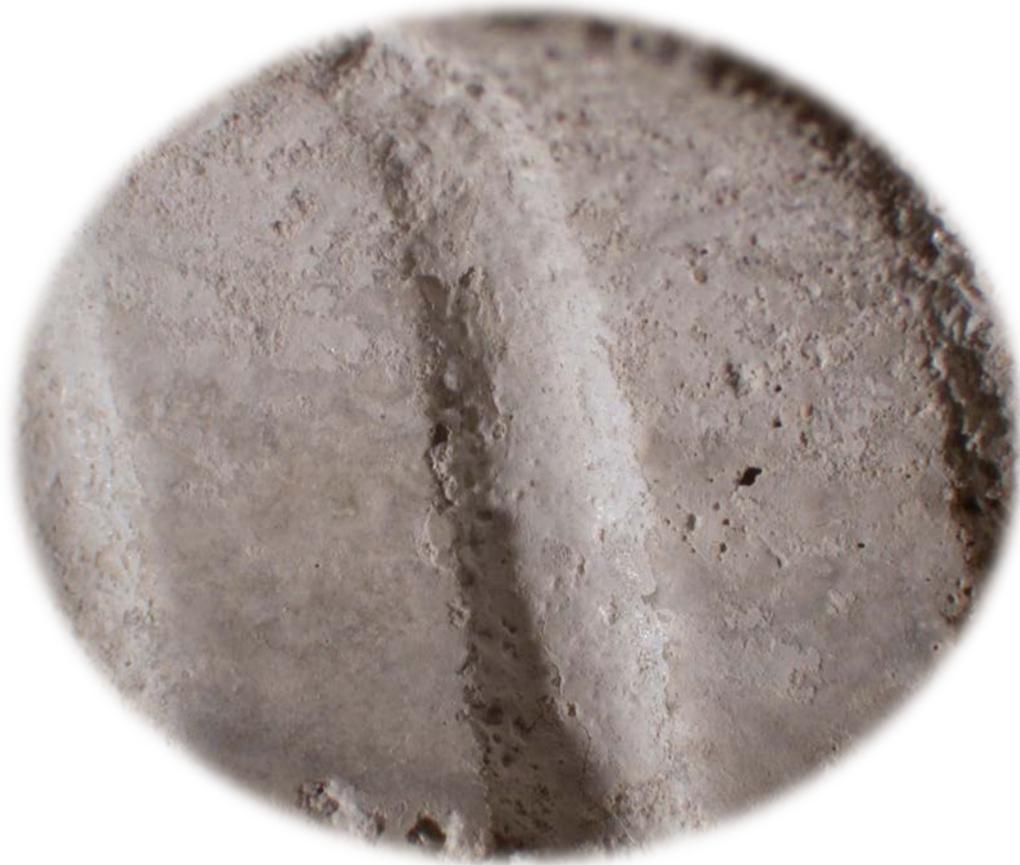
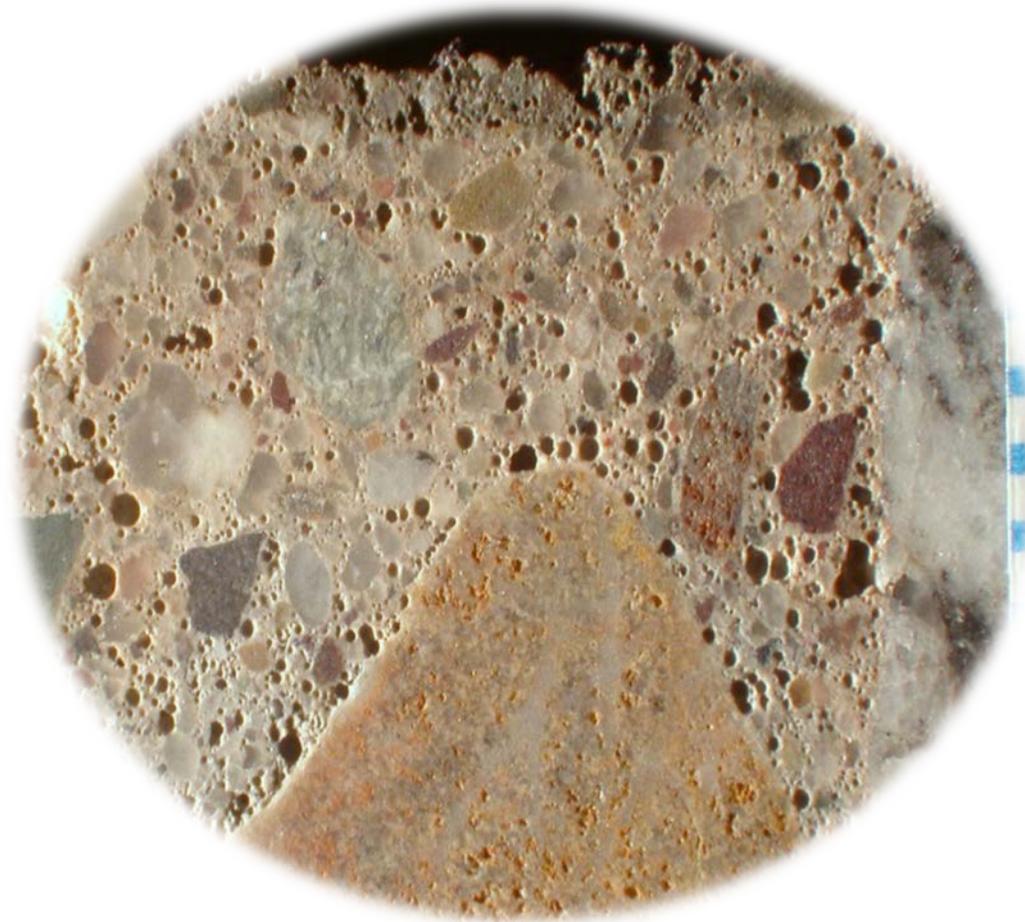
# Project Background – Preliminary Lab Studies

- No signs of internal distress (ASR, Freeze/Thaw, chemical attack, etc.)
- Aggregate quality good
- W/cm adequate
- High air content – 9 to 12 %
- White glaze on steel imprint and fractured surfaces
  - Consistent with leaching of the cement paste
- Weak paste-to-aggregate bond
- No direct contributing cause(s) to the cracking/deck penetration

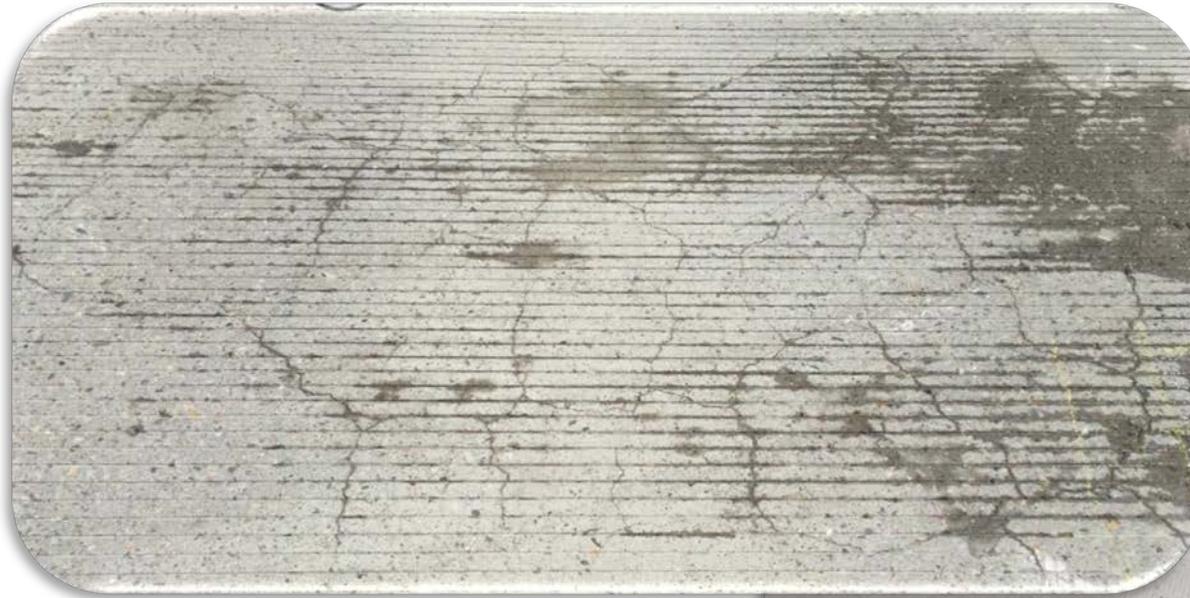
Map cracking

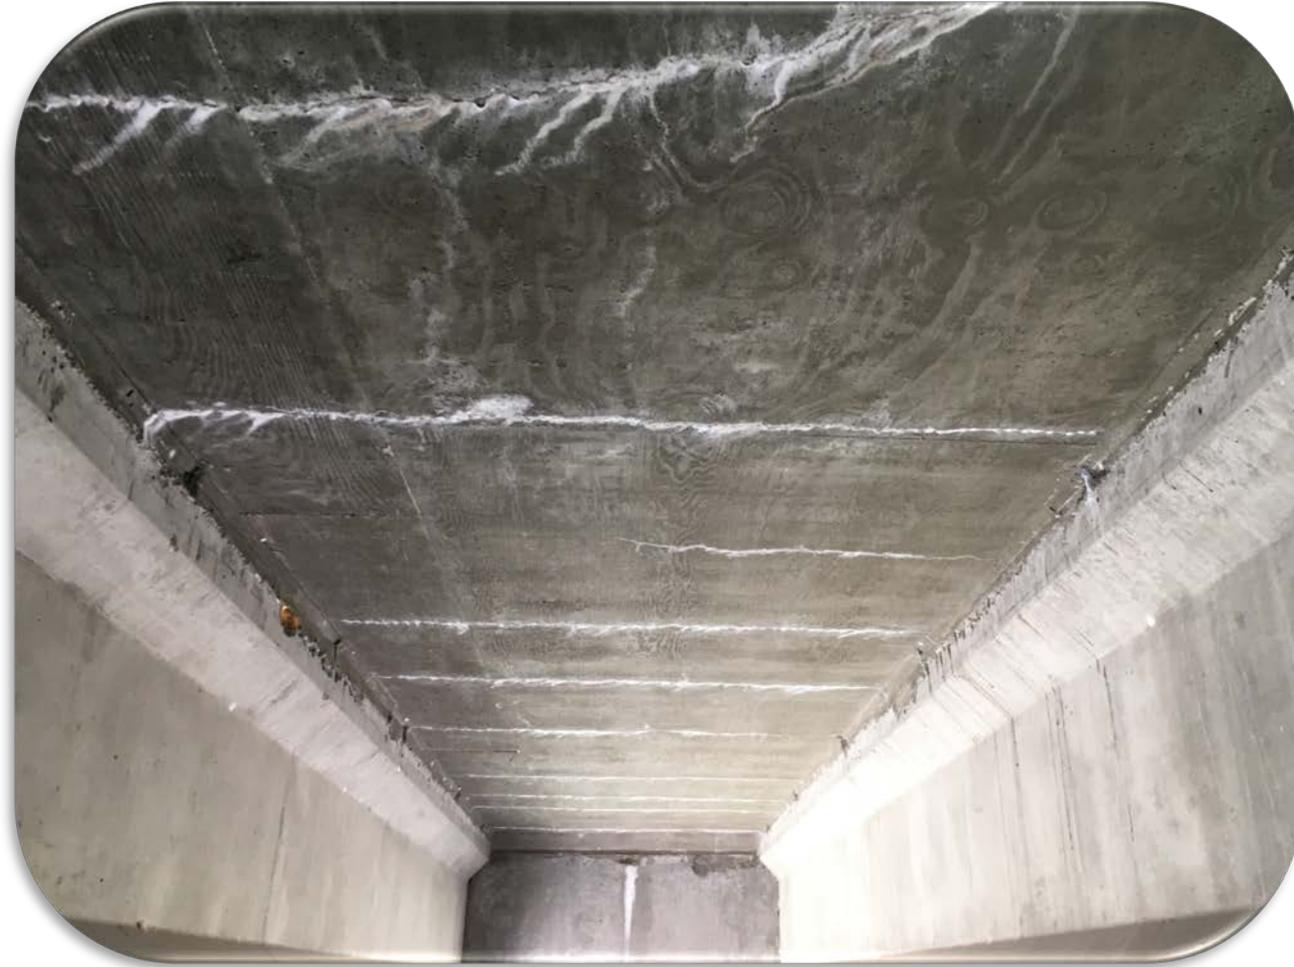
Transverse cracking - Underside

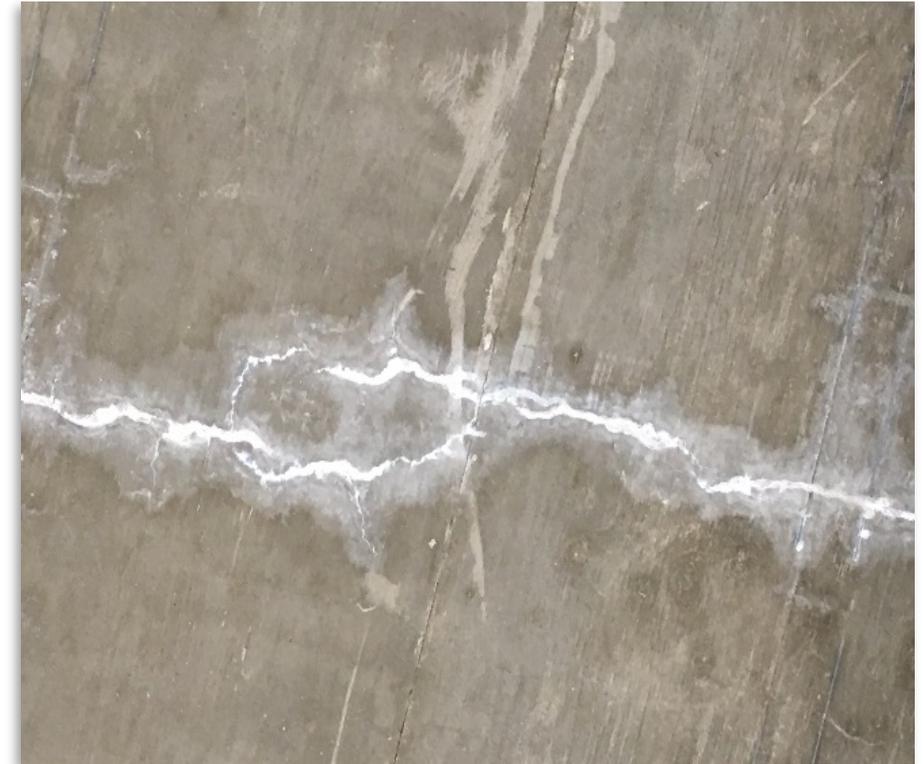
"Jump" cracking

- Hypothesis on crack progression:
  1. Transverse cracks develop, likely early
  2. Transverse cracks progress over time
  3. Closely-spaced transverse cracks form “jump” cracks
  4. Continued volumetric movement and traffic loading - widen and ravel transverse and “jump” crack
  5. Deck penetrations may develop at “jump” cracks with the right conditions:
    - Deck penetrations more prone to occur with top and bottom mats aligned
    - The more closely spaced the transverse cracks, the more likely deck penetrations will occur
    - Driving lanes and under wheel paths more susceptible

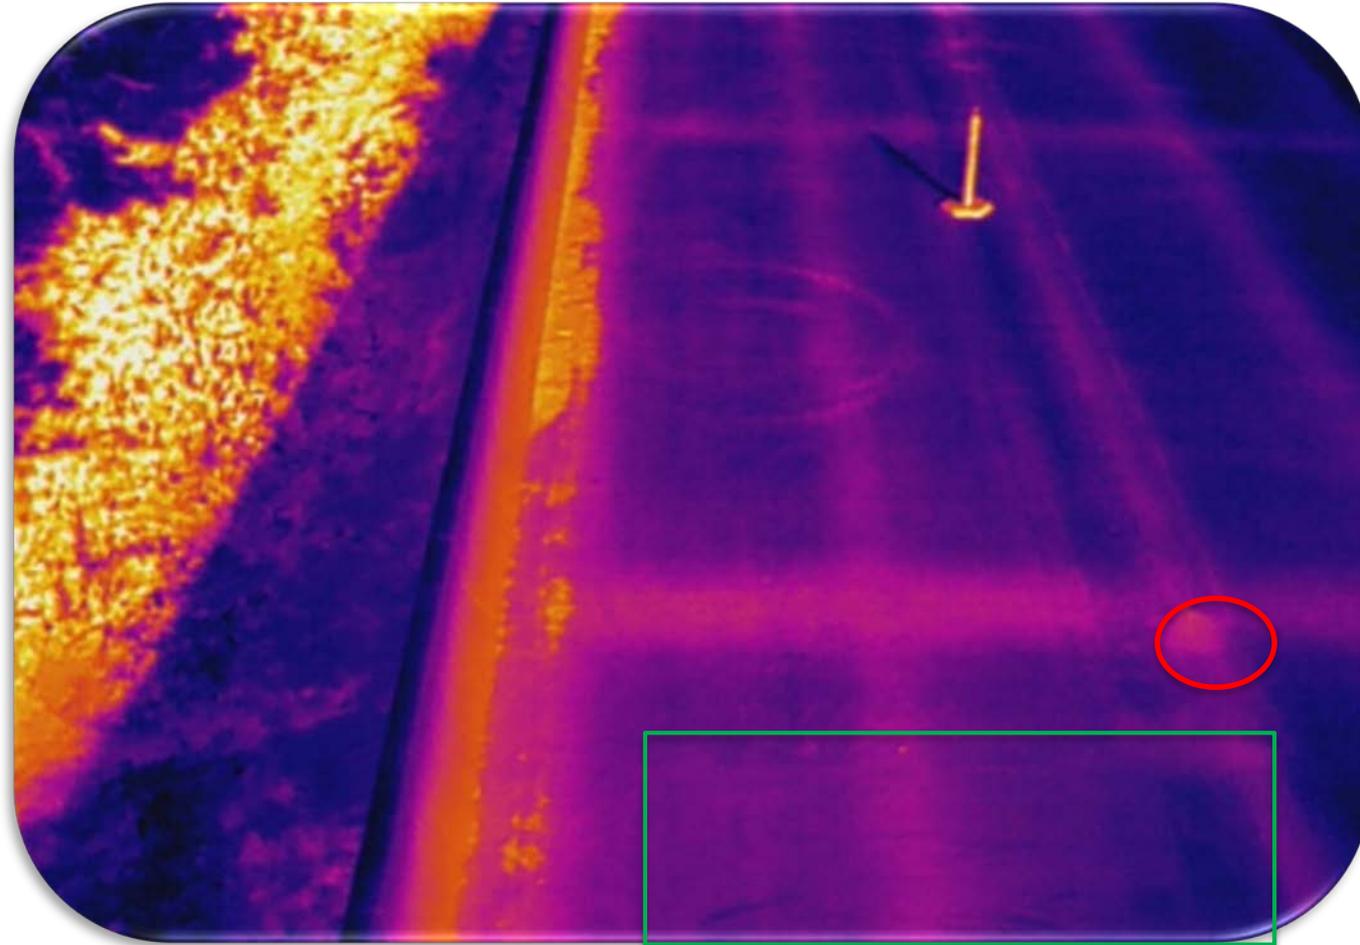
# Field Investigation – Infrared Thermography

- Very little delamination noted on any of the bridges
  - Based on chain dragging and infrared images of representative areas
- Deck overlays appear to be performing well
  - 3 of the inspected bridges had overlays (as opposed to re-decks)
  - Much less cracking – transverse cracking 5 to 8 feet apart
  - Very little delamination noted
  - Overlays appeared to be cementitious/silica fume mix

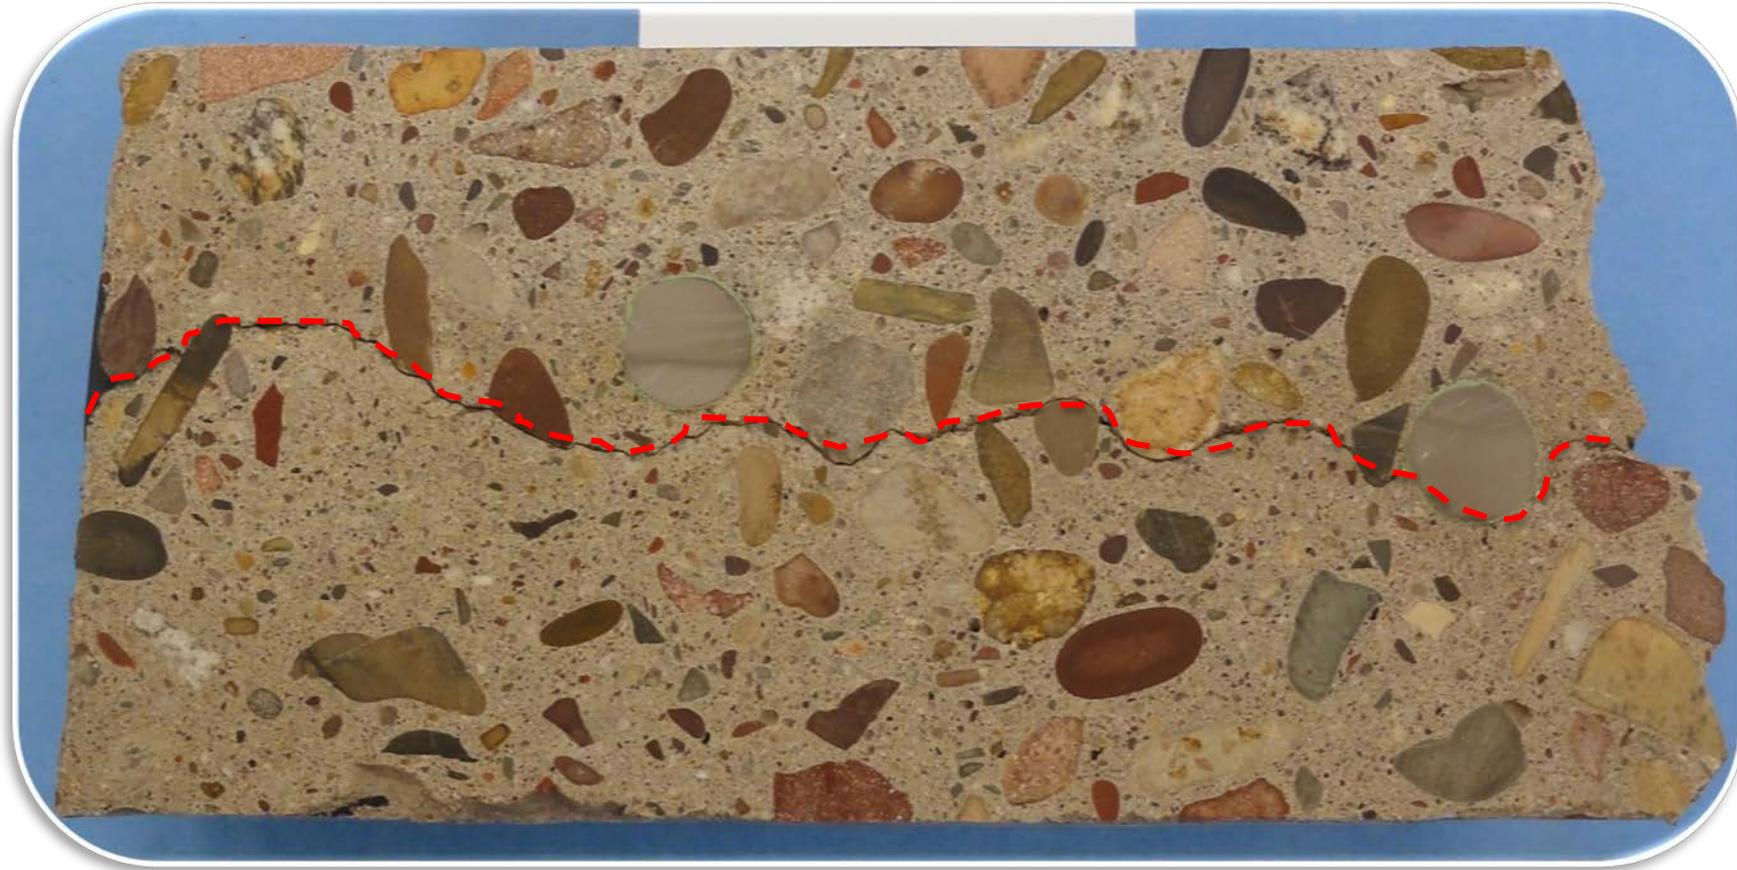
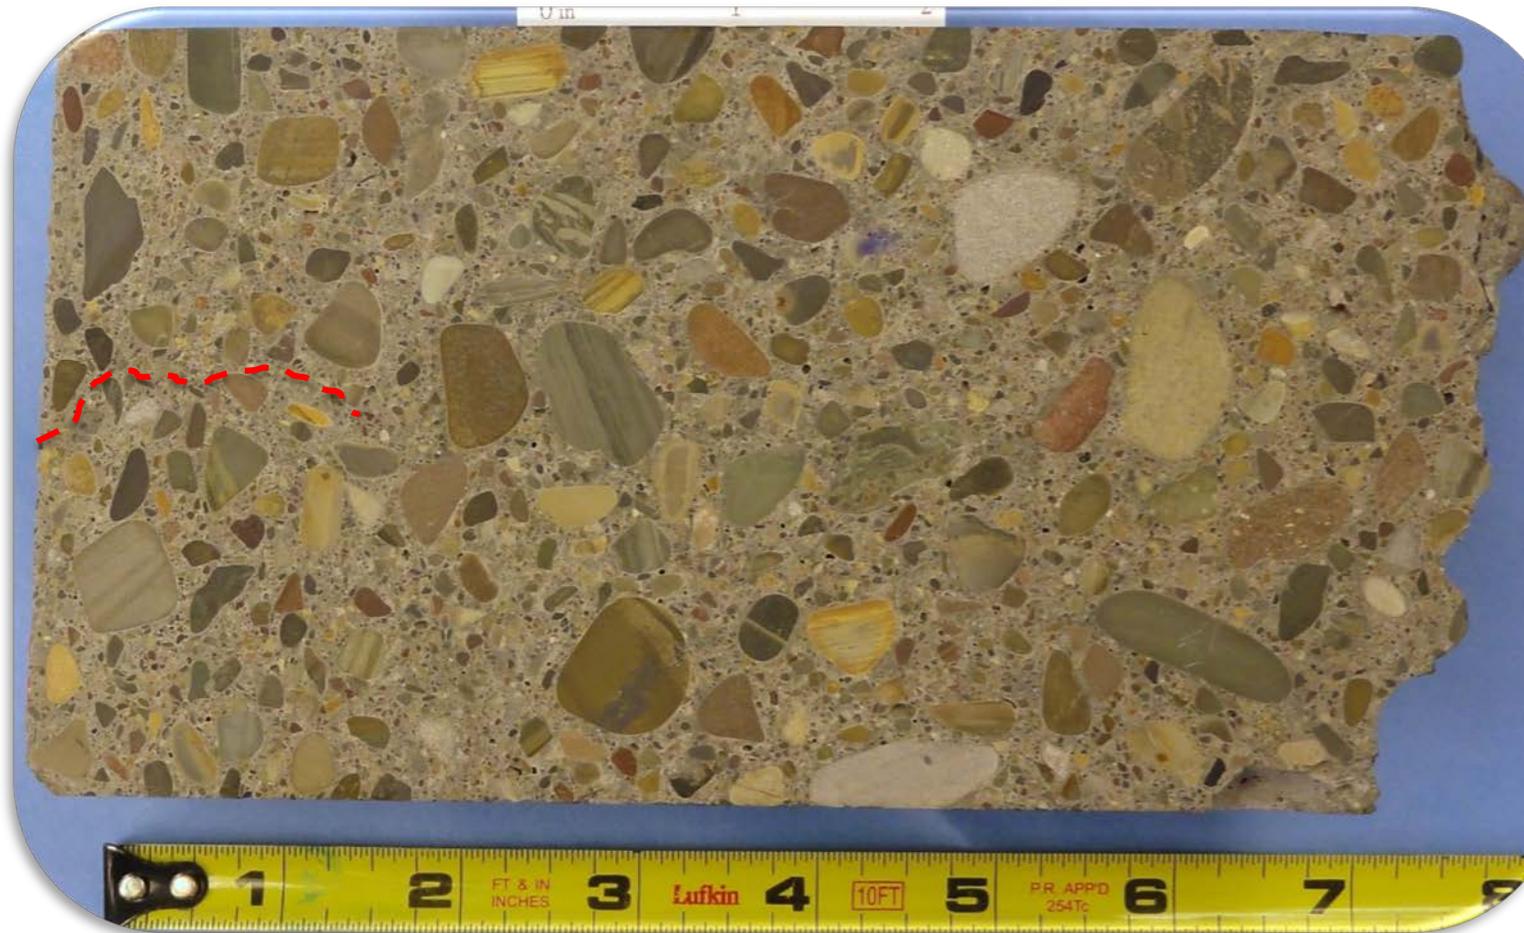
- All transverse and “jump” cracks appeared to have initiated very early – cracks propagate around aggregates
- No signs of internal distress
- Air void system is good for freeze/thaw durability
  - Excessively high on some cores – 12%
- Aggregates are sound
- W/cm ratios were adequate, occasionally slightly elevated

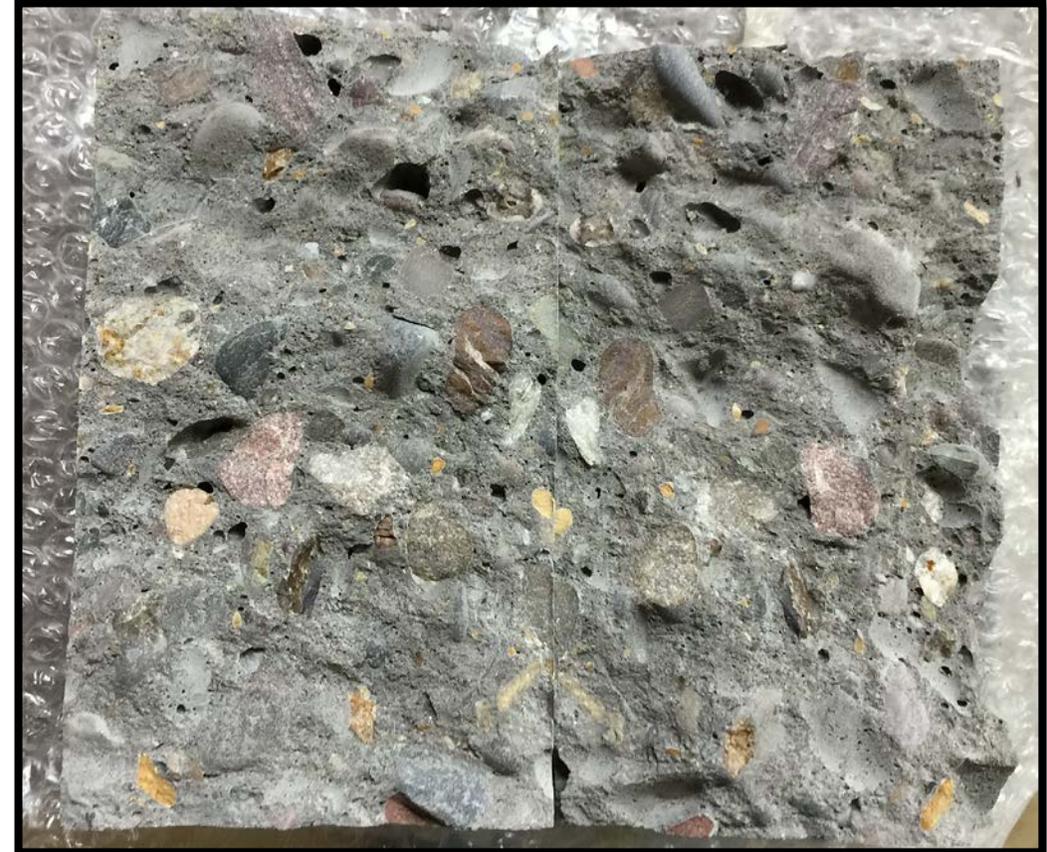
# Laboratory Evaluations – Physical Properties

- Compressive strength
  - 5,090 to 7,370 psi (specified 4,500 psi)
- Modulus of Elasticity
  - $3.3$  to  $4.5 \times 10^6$  psi
- Splitting tensile strength
  - 600 to 770 psi
- Coefficient of thermal expansion
  - $3.6$  to  $5.0 \times 10^{-6}$
