Cold Recycling in Montana

Montana Department of Transportation

August 2015

Surfacing Design Unit

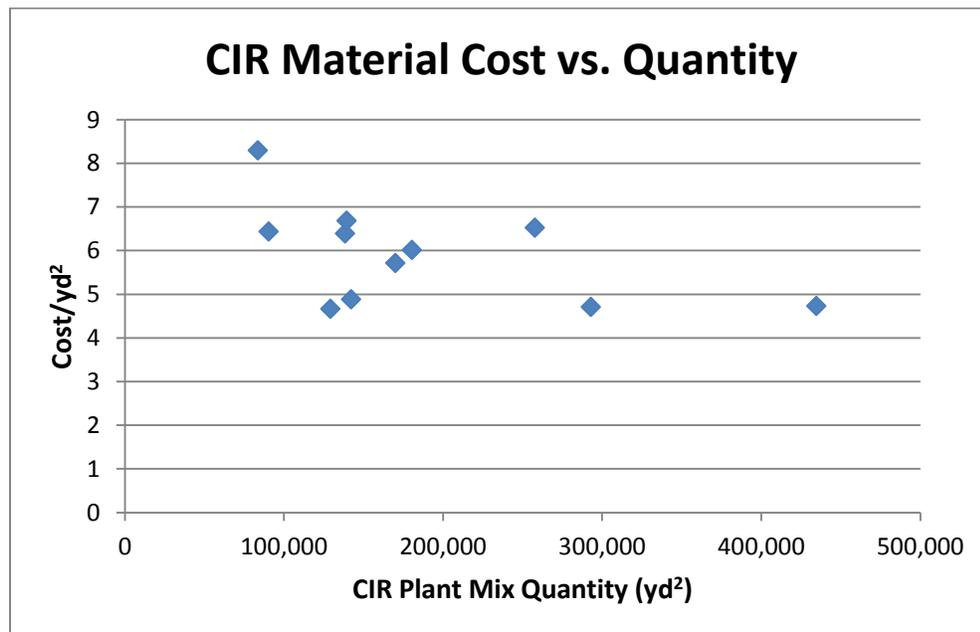
Graph 1: Cost vs Quantity – CIR Materials

Graphs 1 and 2 display cost vs quantity and cost vs time of CIR materials for projects from 2007 to 2015. CIR materials used to calculate total costs included cold recycled plant mix, recycling agent, and mineral filler which can be seen in Table 9 on the previous page.

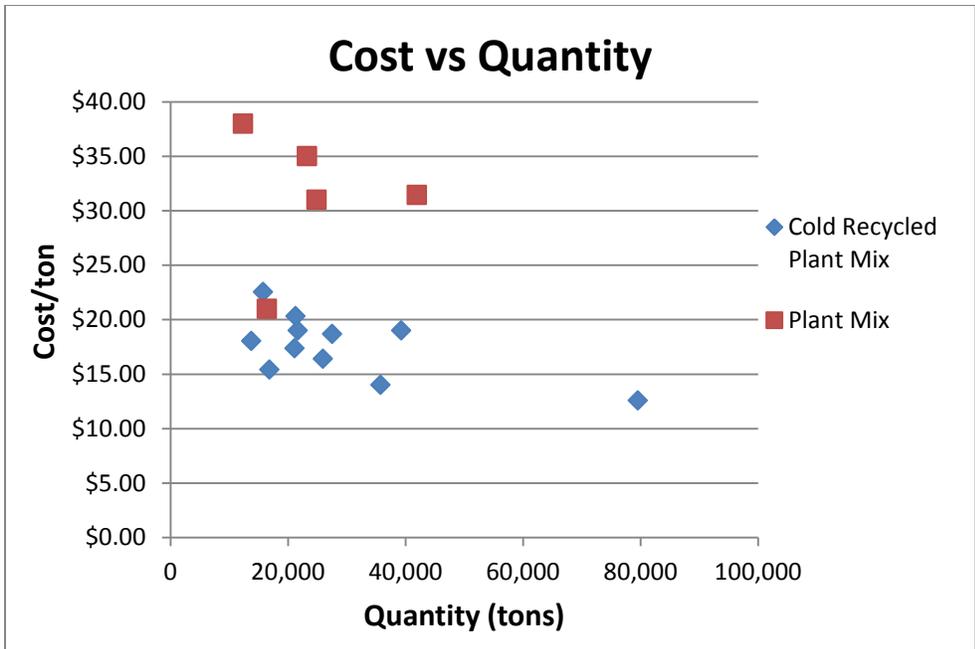
Graph 3: Cost vs Quantity – CIR Plant Mix and Plant Mix

Refer to Table 10 to see comparisons between cold recycled plant mix and plant mix. Graphs 3 and 4 display cost vs. quantity and cost vs. time comparisons between cold recycled plant mix and plant mix. Cost of cold recycled plant mix is considerably lower than plant mix and appears to be decreasing with time.

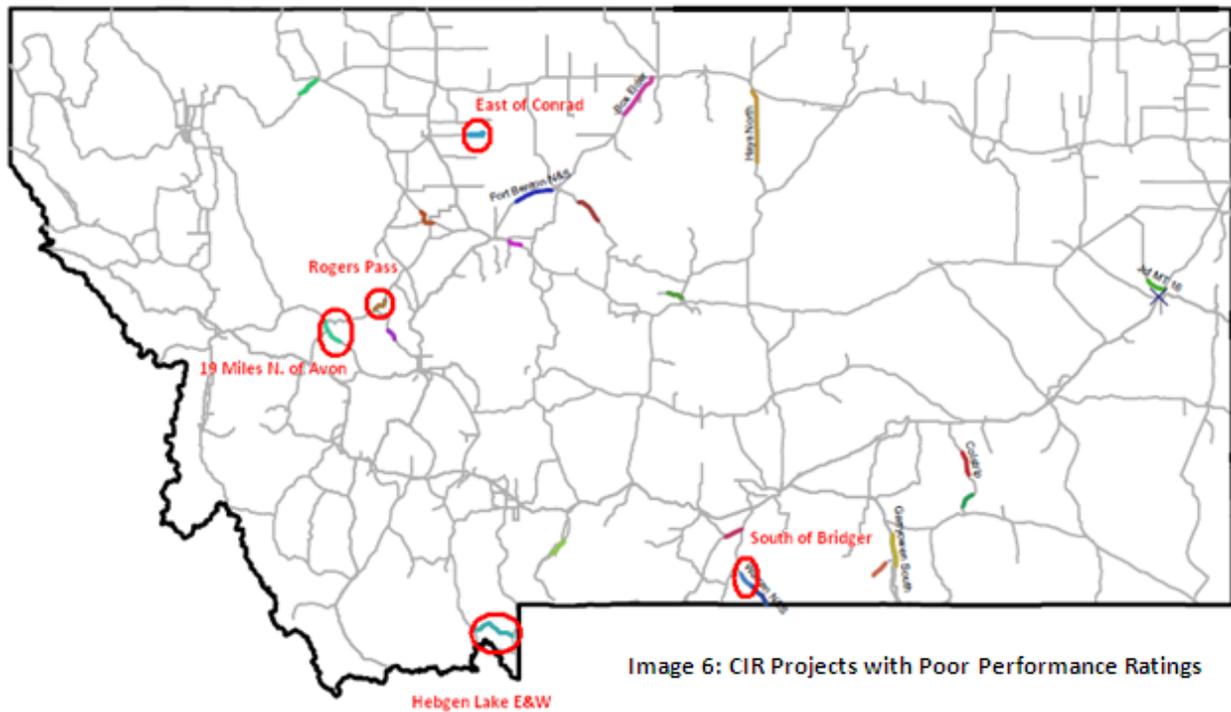
As displayed by Image above, past CIR projects are spread throughout the state. Projects with poor performances are circled in red in the image. CIR projects that have performed well extend throughout the state indicating that CIR can perform well in all districts in Montana. CIR without an overlay may not be suitable in much of the Missoula district due to the increased freeze thaw cycles in the winter and spring months and also in certain locations in the Butte district where roadways travel through cold and wet climates.

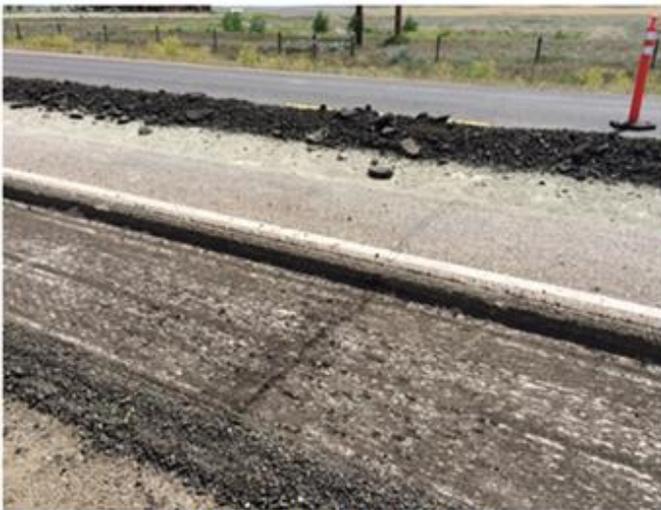
Transverse cracking through milled and existing pavement

Severe cracking was present in this stretch of roadway. As seen by pictures above, cracking occurred deep in the mat and milling could not eliminate all of the cracks. Reflective cracking through the CIR and overlay should be expected in the future.

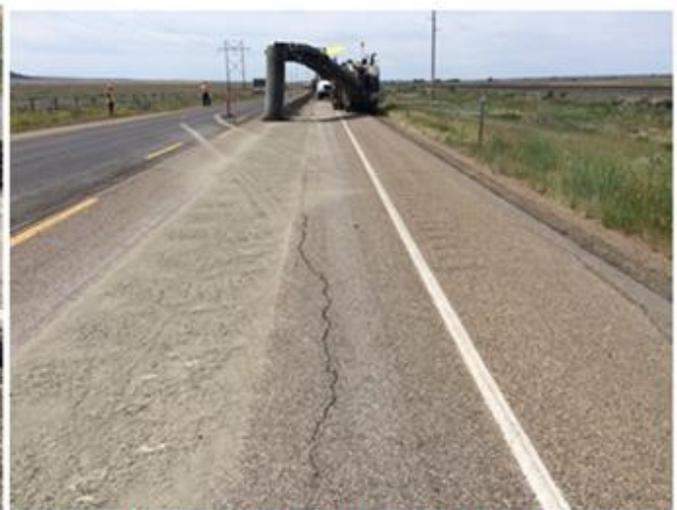
Cement used as mineral filler in CIR mix is spread on the roadway

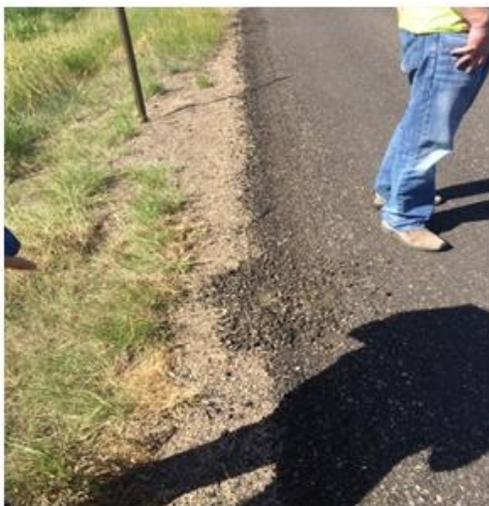
Pictures below provide an accurate representation of the CIR surface. The material was very loose around the edges and crumbled when any load was applied around the outer margins of the mat.

Loose material near the edge of the mat

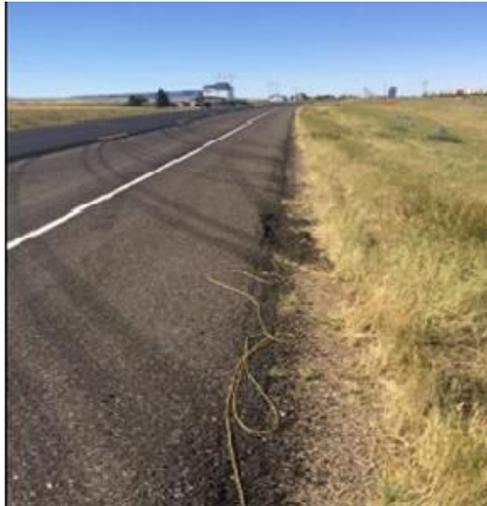
Vehicle loading is observed near the edge of the mat

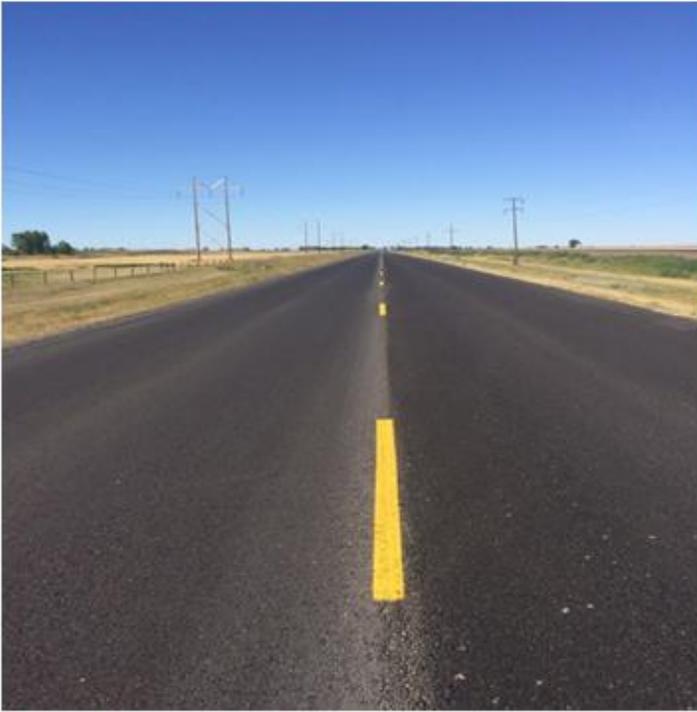
Surface after CIR was overlaid

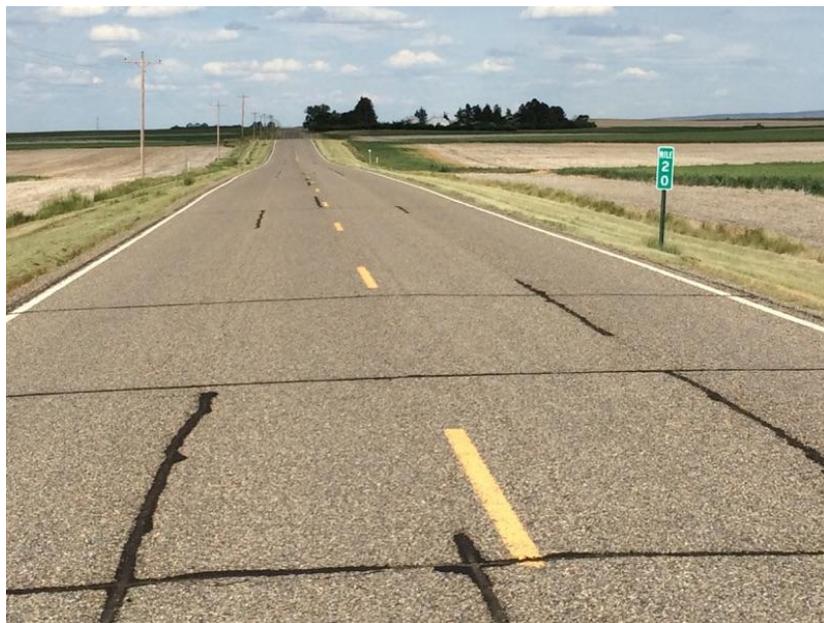
2015 Image: Recent photo of East of Conrad project

A trip was taken to the East of Conrad project location on June 24, 2015. The roadway was severely cracked as seen by the 2015 image above. To see more pictures of the June 24, 2015 trip select the following link: [East of Conrad Photos – June 24, 2015](#).

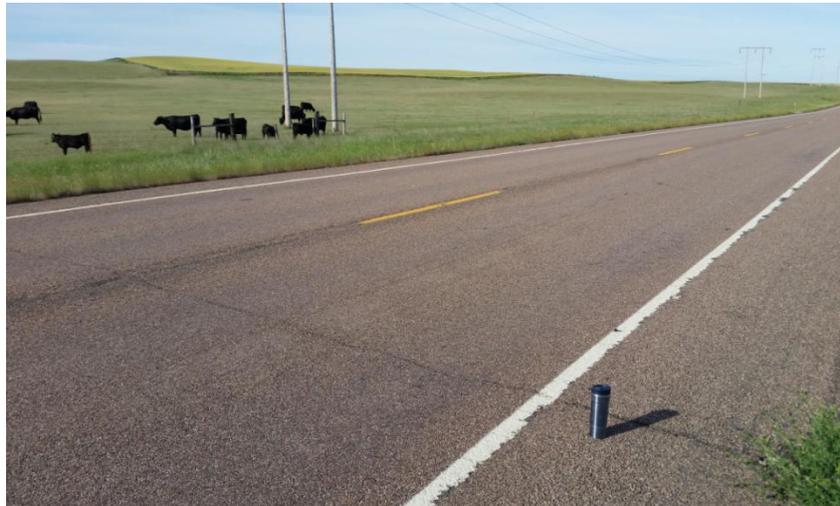
A visit was taken to Fort Benton N&S on June 24, 2015 to evaluate the performance of the roadway. The road was analyzed at RP 20.4. Spacing of transverse cracks measured approximately 65 to 85 feet apart propagating across both lanes. Chip seal delamination was present along the shoulders of the roadway as well as along the centerline most likely due to snowplows. The following pictures show cracking and chip seal delamination in the roadway.

Transverse cracking across both lanes of the highway

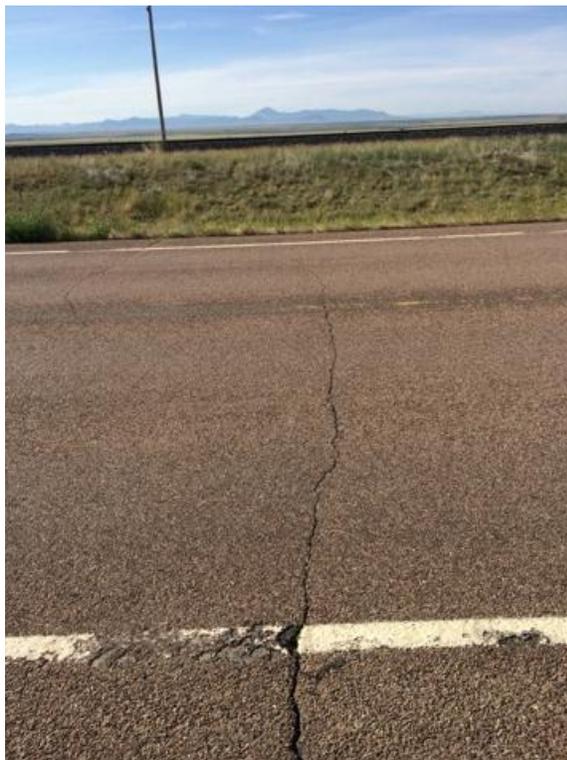
Transverse cracking and delamination

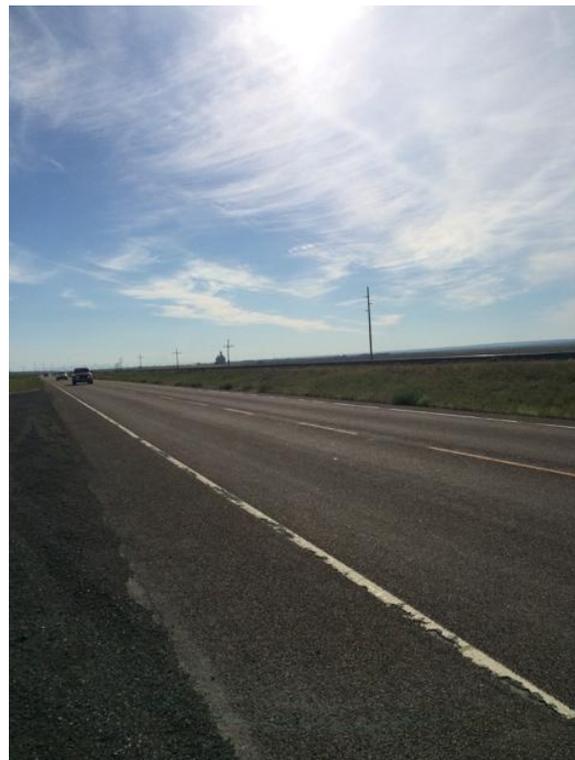
Delamination on the shoulders of the highway
