Subject: Construction Review Report – Great Falls District
STPS 218-1(10)19
East of Conrad - East
Control Number: 6977
Contract Number: 10710

CONSTRUCTION ENGINEERING SERVICES PROJECT REVIEW REPORT

Project Number:	STPS 218-1(10)19	Letting Date:	29 July 2010
Project Description:	East of Conrad – East	MDT District:	Great Falls
Control Number:	6977	EPM:	Mike Klette
Contract Number:	10710		
Review Date:	16 June 2011		
Reviewed By:	Terry W. Wickman	In Company With:	Mike Klette, EPM Dan Ferestad, CET 5
Project Description:	<p>The project is located on State Secondary Route 218 in Pondera and Liberty Counties, beginning at RP 18.8 east of Conrad and extending east and north approximately 6.9 miles to RP 25.9.</p> <p>The work consists of either a cold in-place recycling paving option, or cold milling and Grade S Plant Mix Surfacing option. Other improvements consist of guardrail and bridge rail improvements, seal and cover, and other miscellaneous improvements.</p>		
Review Type:	<input type="checkbox"/> Constructability <input type="checkbox"/> Investigatory <input checked="" type="checkbox"/> Oversight <input type="checkbox"/> Post Construction <input type="checkbox"/> Subject Specific

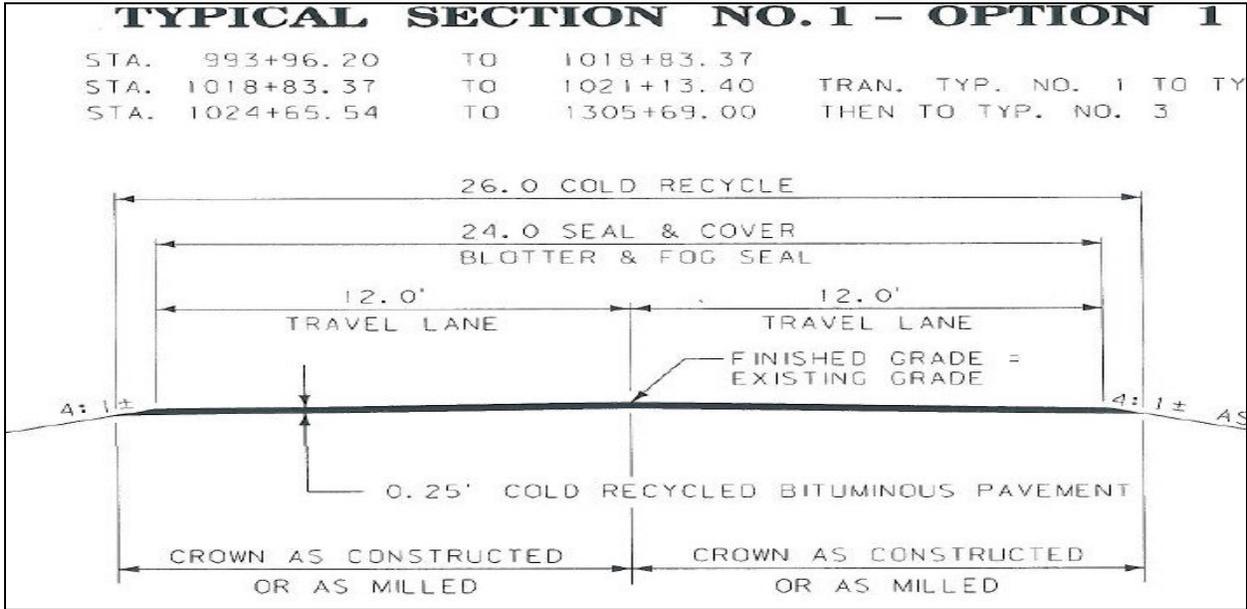
Plan Typical Section

The plans called for the existing plant mix to be milled and recycled to a depth of 0.25' over the full-width of the roadway (26.0' to 26.6' per Typical Sections). The Contractor submitted a proposal to mill to an overall width of 25.0', which would leave an approximately 6" wedge of existing plant mix along each edge of pavement. Their rationale was that the remaining wedge of material would provide lateral constraint to minimize rollout and shoving during compaction, as well as reduce the risk of the mat breaking after the work is completed.

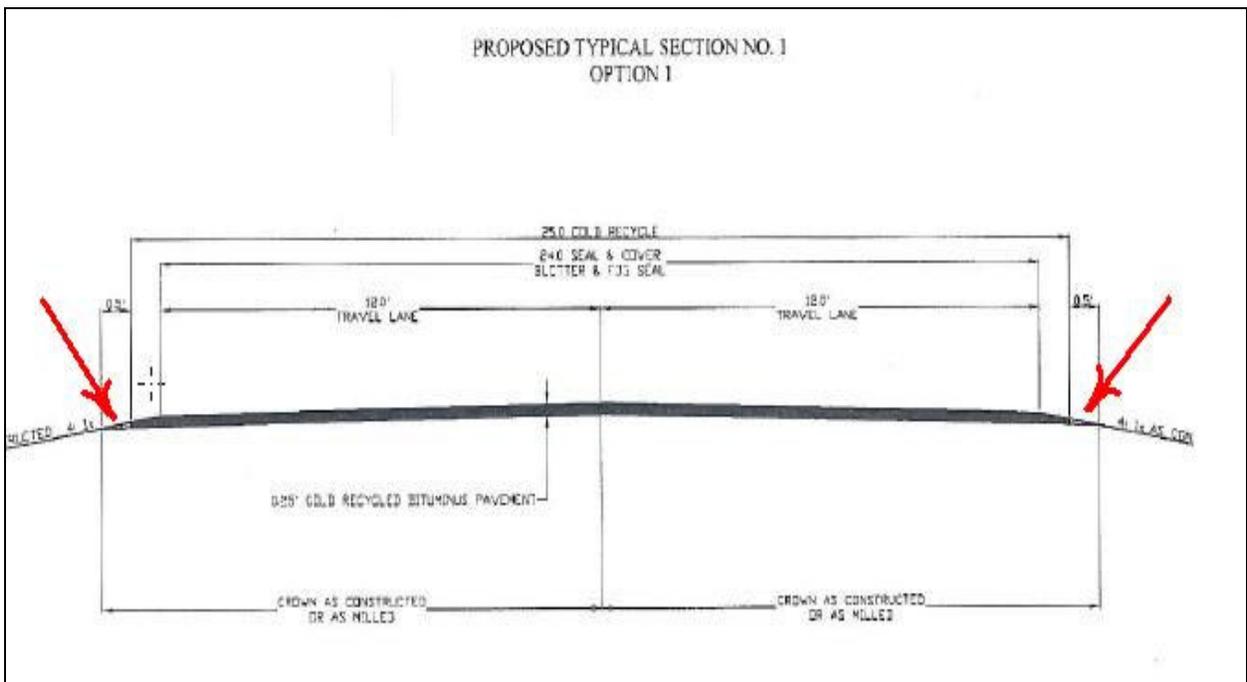
This proposal was reviewed by the MDT Pavement Analysis Section. They expressed concern that, if more than 6" of existing plant mix were to remain on the edges, it could lead to sympathy cracking from the existing

transverse cracks. While it was not discussed specifically during this review, it should also be noted that with the plan design requiring only a partial depth of the plant mix be milled (i.e., 0.25'), the recycled mat may also be subject to premature reflective cracking from the existing plant mix remaining after milling.

Cold Recycle Width of 25.0' Proposed by Contractor – Leaving 6" +/- “Wedge” of Existing Plant Mix @ Each Edge

The District was receptive to this proposal and issued Change Order No. 2 for this change.

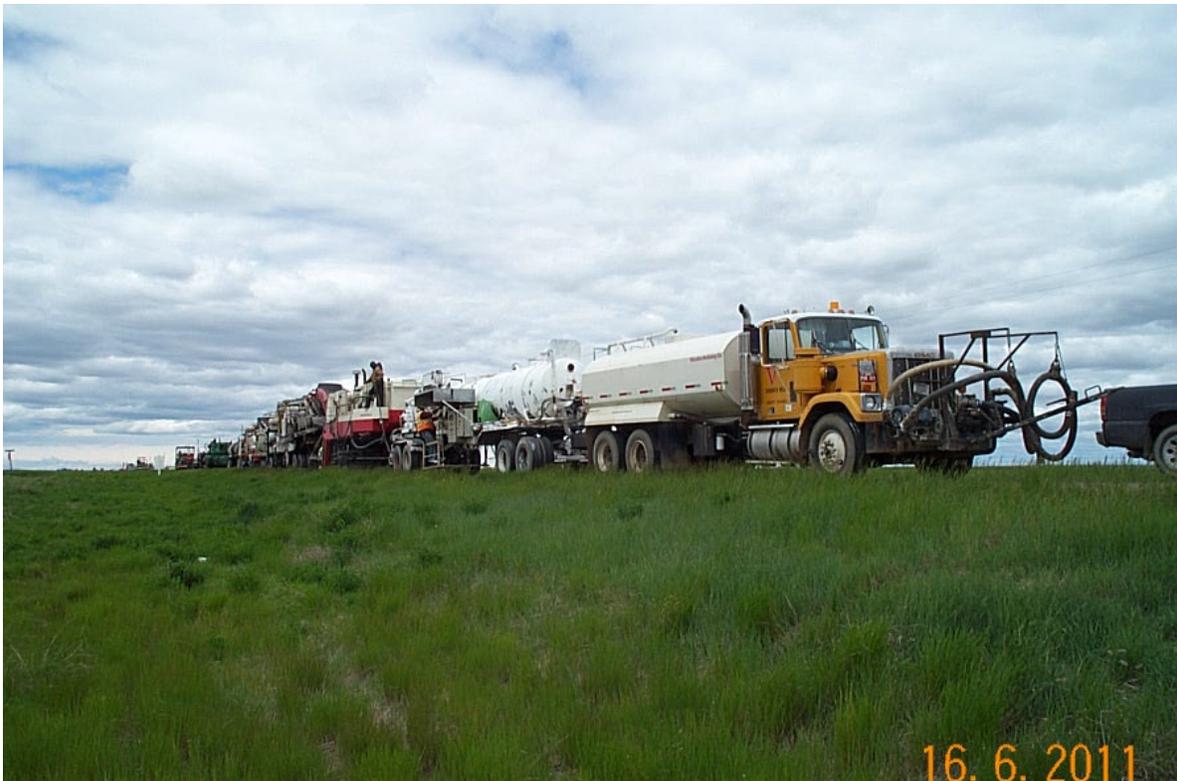
The mechanically-coupled equipment “train” extended some 185’ (±) and consisted of the following equipment: 1-water tender truck; 1-lime slurry tanker trailer; 1-cold milling machine (w/12.5’ cutting head); 1-vibratory screen deck/crusher combination unit; 1-pugmill-type reclaimer/blending unit; 1-asphalt emulsion tanker (pup); 1-paver w/pickup attachment; 2-tandem, steel drum rollers and 1- rubber-tire roller. The length of the “train” does not include the paver or rollers.

Cold In-Place Recycling Paving (CIPR) Equipment “Train” – Approximately 185’ in Length

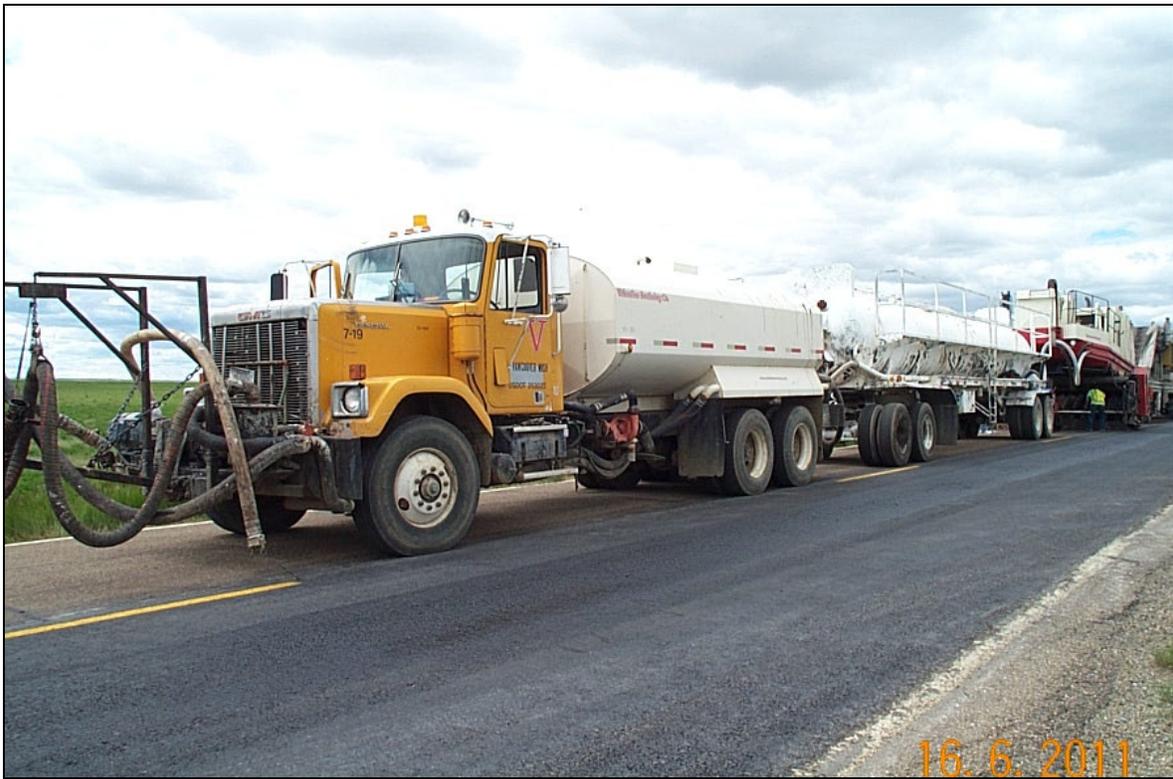
Water Tender Truck Followed by Lime Slurry Tanker Trailer

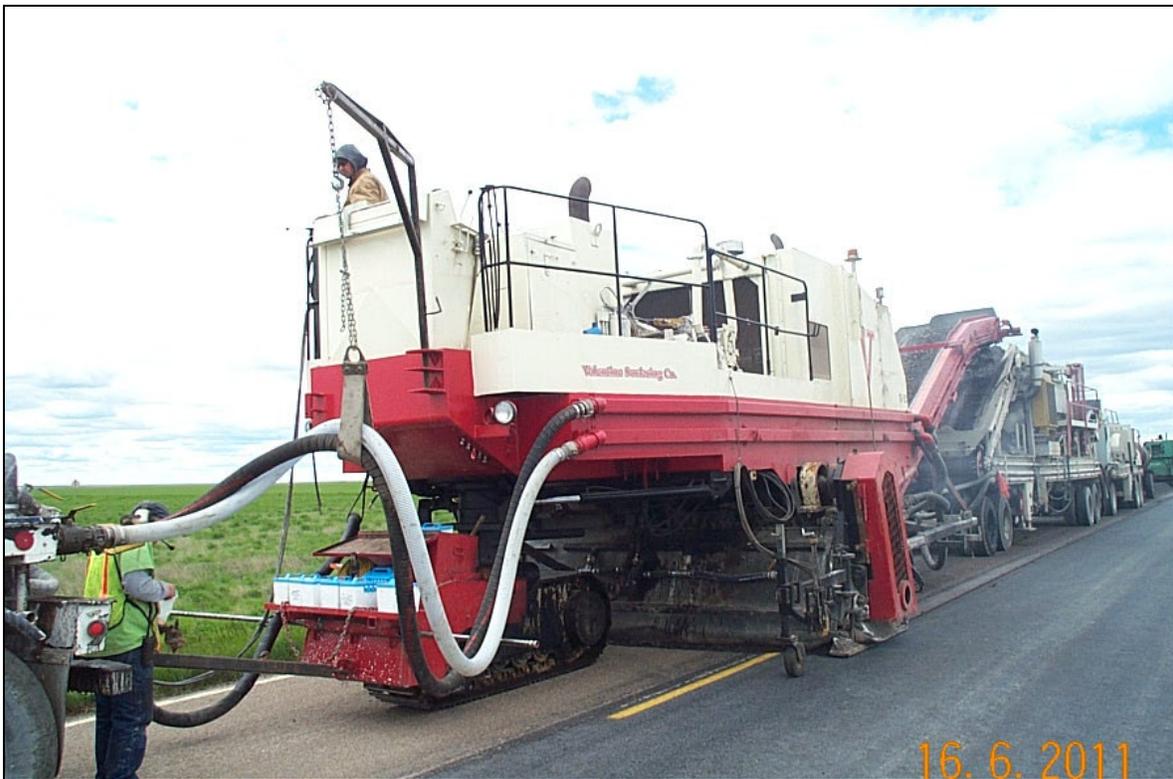
Cold Milling Unit w/12.5' Cutting Head

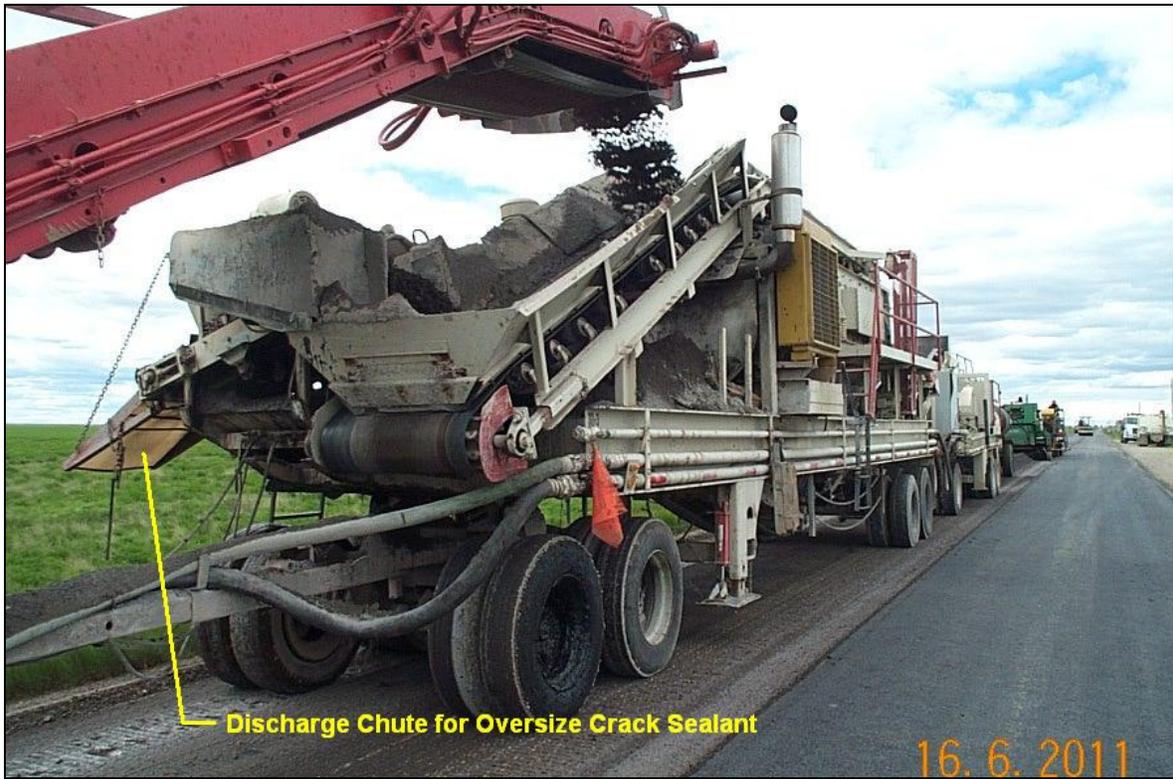
Discharge Chute for Oversize Crack Sealant

Vibrating Screen Deck w/Crushing Unit

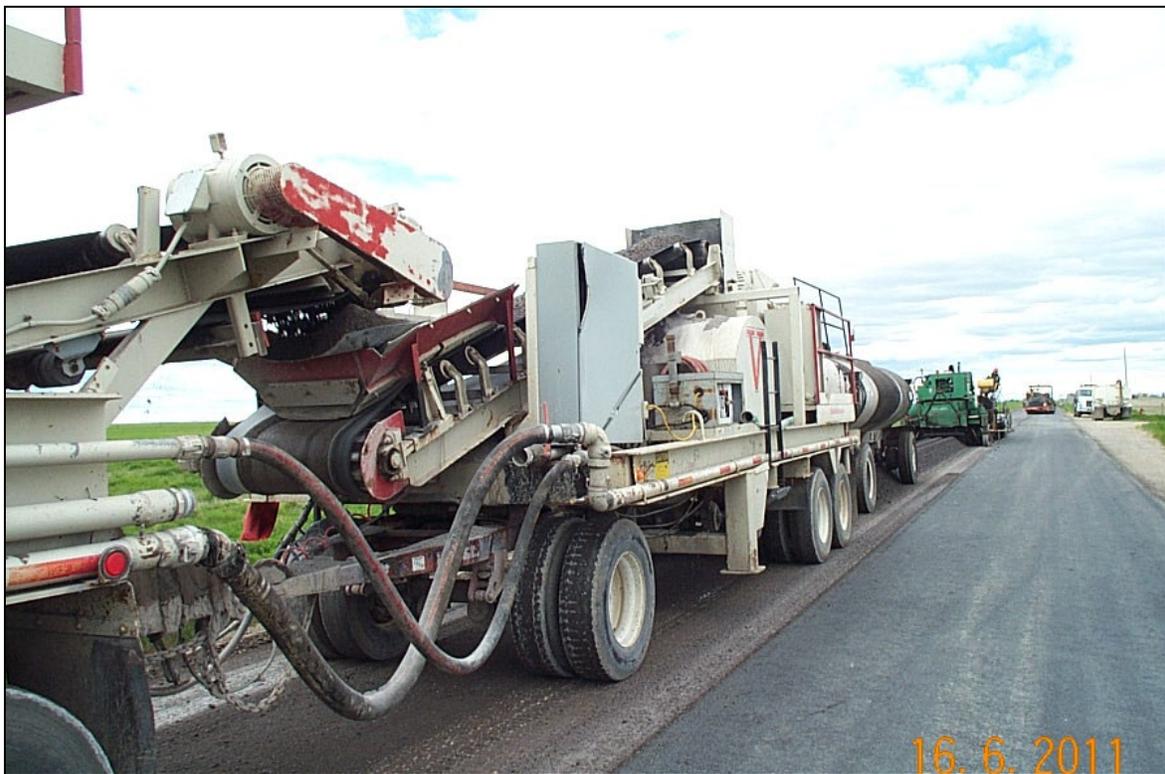
Pugmill-Type Mixer Unit – Combines Recycled Asphalt Pavement/Lime Slurry/Emulsified Asphalt

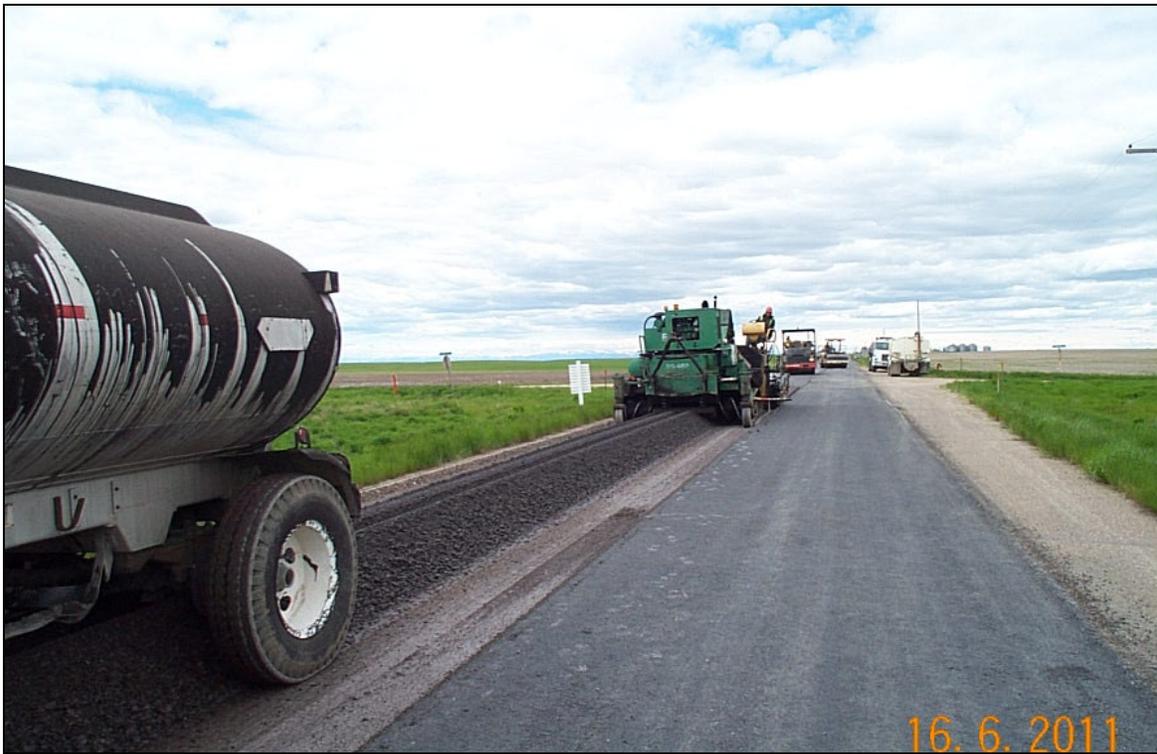
**Processed Windrow of Recycled Asphalt Pavement/Lime Slurry/Emulsified Asphalt
Emulsified Asphalt Trailer (Pup) – Left**

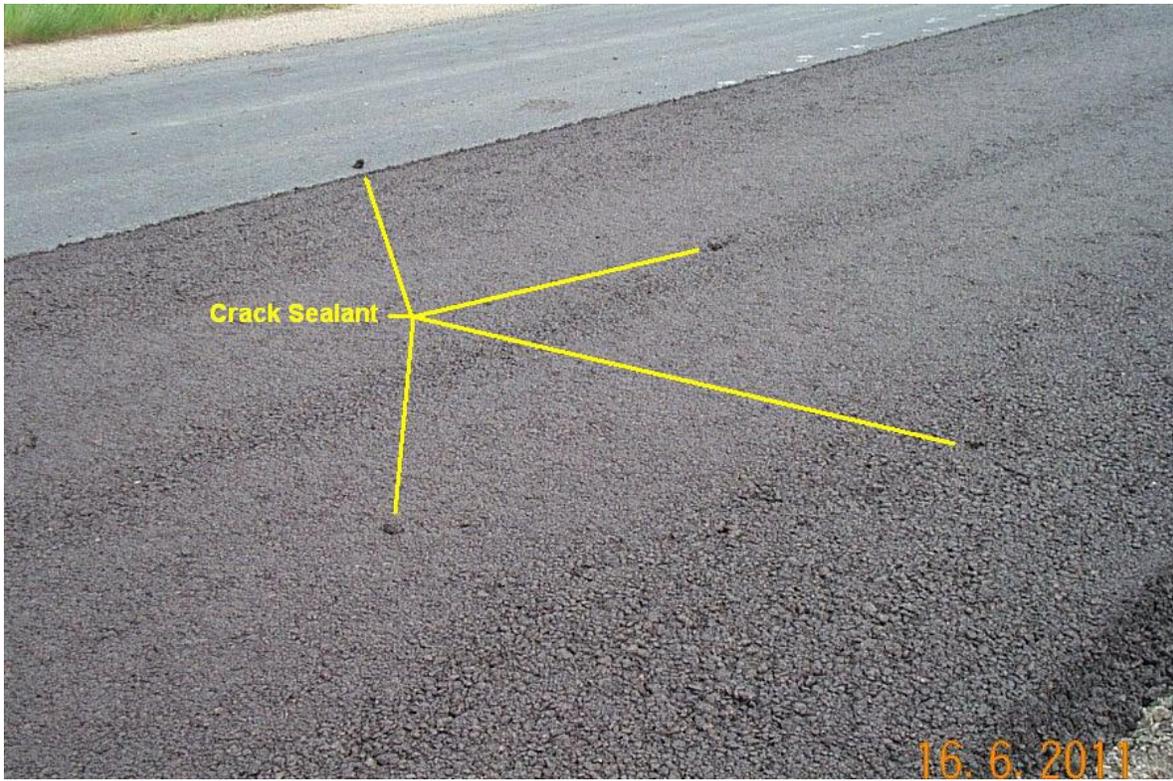
Special Provision No. 30.C.3) specifically requires that 100% of the cold milled plant mix material is to pass a 1.25” screen. And, that all crack sealant retained on the 1.25” screen is to be rejected and wasted. However, the Special Provision does not address what is to be done with the pieces of crack sealant passing the 1.25” screen. The two photos on page 9 illustrate those 1.25” minus pieces that typically made it through the screen deck and ended up in (or on) the reclaimed mix behind the paver. While the pieces on the surface can be easily seen and removed, those that can still be seen but end up being partially embedded in the mix are another matter. If those partially embedded pieces are removed, they would end up leaving “divots” in the new pavement surface. In addition, there is undoubtedly an unknown amount of crack sealant that is fully embedded in the new mix that cannot be seen. Since the Special Provision didn’t address this issue, the EPM doesn’t have much in the way of any “teeth” to hold the Contractor to under the contract, as far as requiring any corrective action is concerned. It is recognized that 100% removal of all strings or pieces of crack sealant from within the new mat may not be practical or cost effective. But, for future projects with significant amounts of crack sealant (such as this one), it is recommended that consideration be given to addressing any corrective action that may be needed to remove and repair the “divot” areas, especially if the recycled mat is to only receive a seal and cover application afterward (such as this project).

Remnants of Crack Sealant Visible on Surface or Partially Embedded in Reclaimed Mix Directly Behind Paver

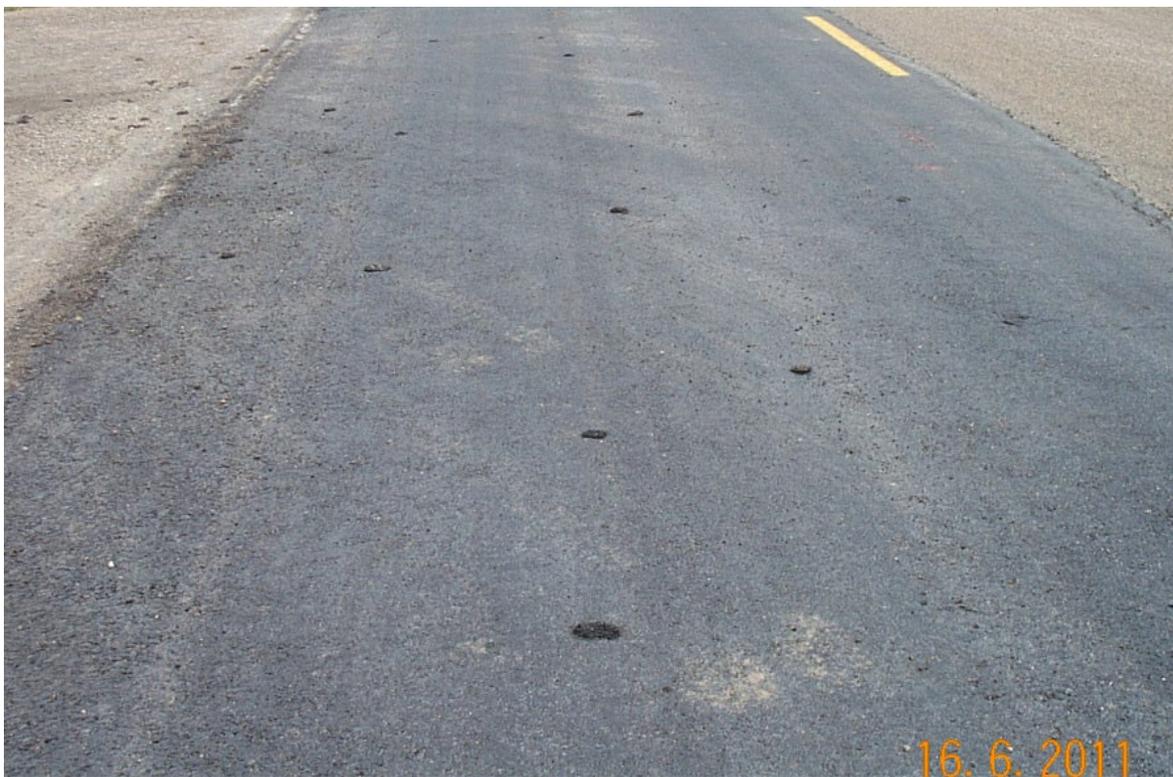
Remnants of Crack Sealant on Surface of Reclaimed Mat

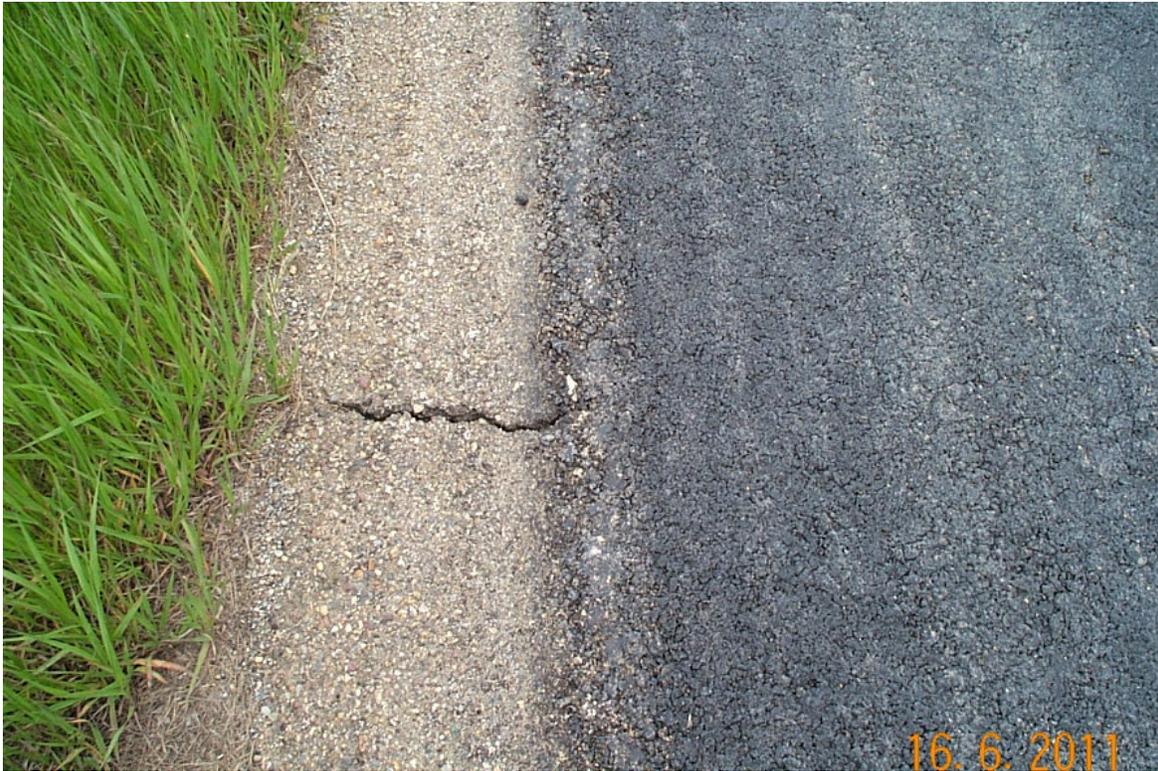
Example of Transverse Crack Within Remaining “Wedge” of Existing Plant Mix After CIPR Paving That May Lead to Sympathy Cracking (See Discussion on Page 3)

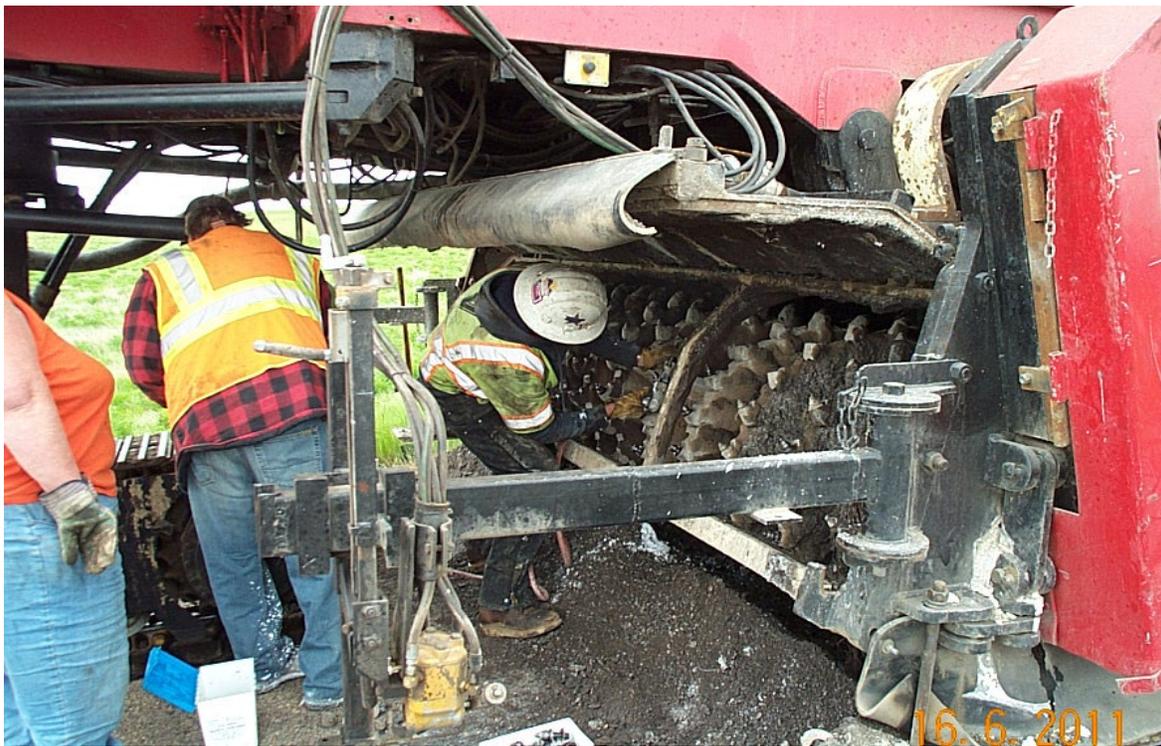
Changing Worn Teeth on Cutting Drum – Teeth Needed to be Changed Twice per Day with this Material
