# MONTANA DEPARTMENT OF TRANSPORTATION STREAM MITIGATION MONITORING REPORT

## **STREAM MITIGATION MONITORING REPORT #2**

*Spring Creek  
Flathead County, Montana*

MDT Project Number: NH-MT 5-3(59) 109  
Control Number: 2038

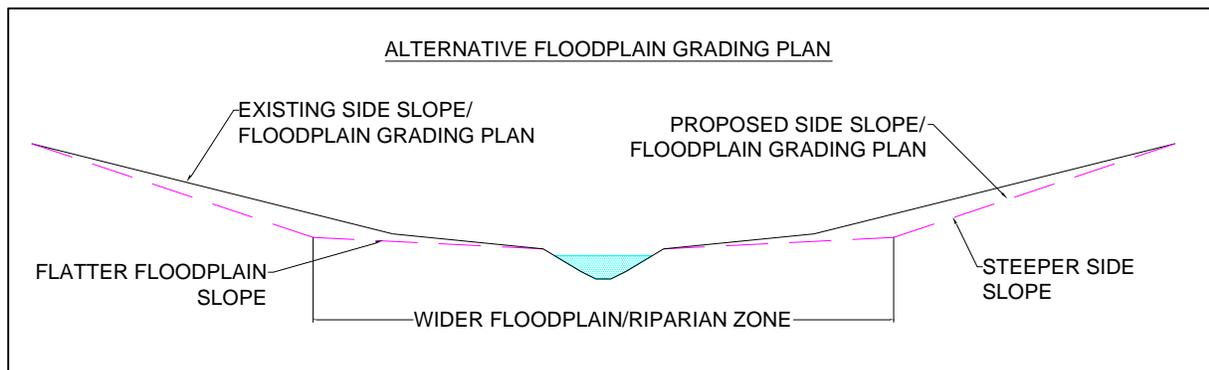
Figure 2. Alternative grading plan to increase floodplain and riparian areas.

The reconstructed channel segment is designed with upland side slopes that transition to a narrow, 17.5-foot wide floodplain bench. Perpendicular transect survey results (Appendix B) illustrate floodplain slopes down to the channel which reduces the area available for overbank flooding to a narrow zone adjacent to the channel. This design configuration results in a relatively limited riparian/floodplain zone approximately three times wider than the active channel. Integrating a slightly steeper upland side slope design would provide for a wider, more functional floodplain and riparian zone by allowing the stream to access a larger, flat floodplain adjacent to the active channel (Figure 2). Constructing steeper side slopes and a wider floodplain area requires additional excavation; therefore a cost/benefit analysis of creating additional floodplain and wetland features, and the associated mitigation credits, is potentially worth consideration for future stream and riparian mitigation designs.

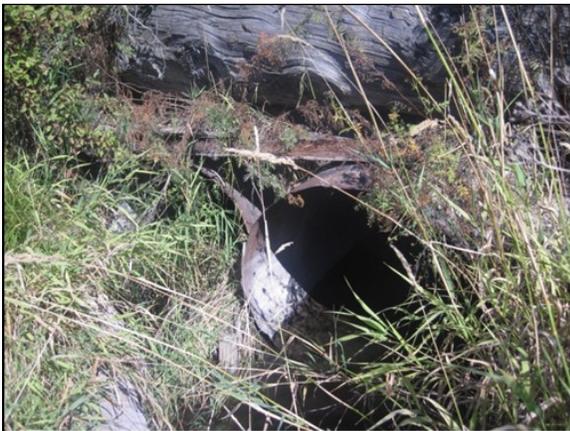
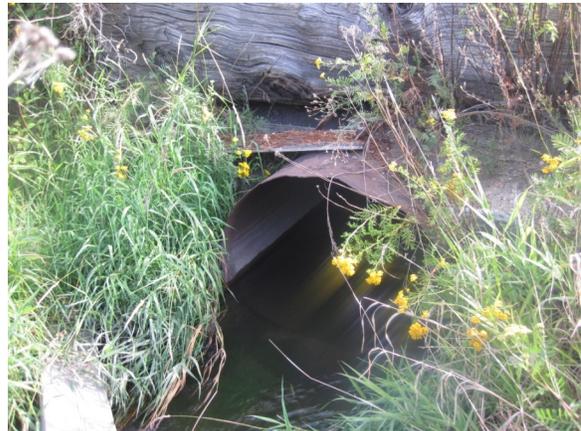
**Photo 1—2013**  
**Description:** Culvert at upstream end of project area.  
**Compass:** 25 (North-Northeast)

**Photo 1—2014**  
**Description:** Culvert at upstream end of project area.  
**Compass:** 25 (North-Northeast)

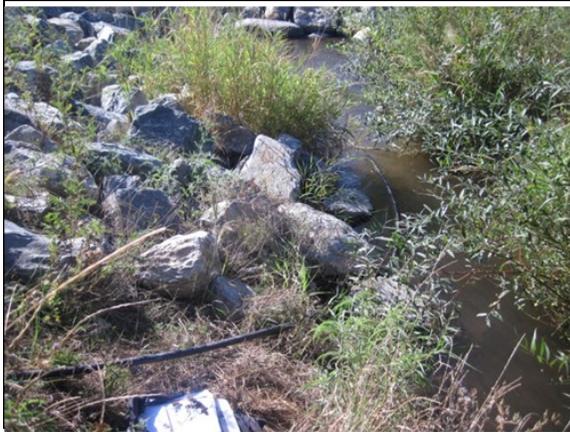
**Photo 2—2013**

**Description:** Hose in stream channel.

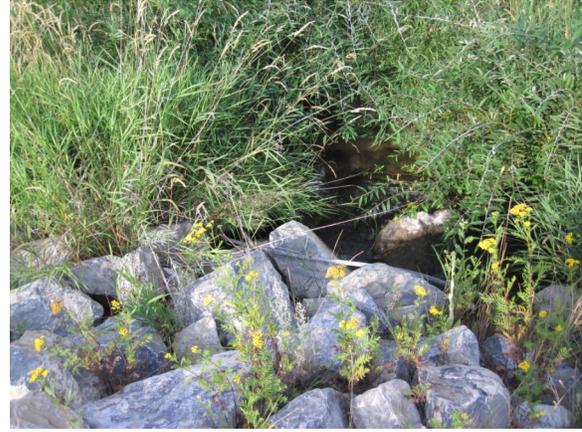
**Photo 2—2014**

**Description:** Hose in stream channel.

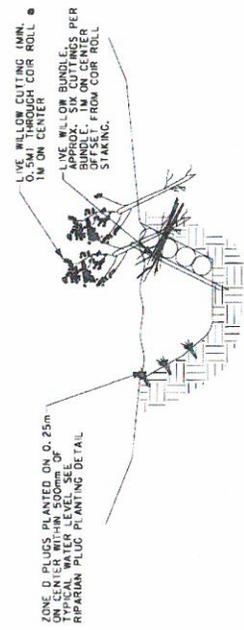
ZONE D COIR BUNDLES WITH WILLOW CUTTINGS AND LAYERING SCALE: NOT TO SCALE

- HARVESTING AND INSTALLATION NOTES:**
1. HARVEST AND PLANT CUTTINGS DURING OPTIMUM SEASON.
  2. USE HEALTHY STRAIGHT AND LIVE WOOD AT LEAST 1 YEAR OLD.
  3. MAKE CLEAN CUTS AND DO NOT DAMAGE CUTTINGS OR SPLIT ENDS.
  4. BRIEFLY SOAK CUTTINGS IN WATER AND ROOTING HORMONE PRIOR TO INSTALLATION.
  5. BIODEGRADABLE BUNDLES CUTTINGS TOGETHER AND BIND WITH BINDER.
  6. INSTALL WILLOW CUTTING AND WILLOW BUNDLE LAYERING.
  7. PLANT BUNDLES AND WILLOW BUNDLES SHALL EXTEND INTO EXPECTED MOISTURE SOIL ZONES.
  8. LIVE WILLOW CUTTING SMALL HOLES IN COIR ROLLS AND INSERT BUNDLES INTO SOIL BETWEEN COIR ROLLS.
  9. INSERT BUNDLES INTO SOIL BETWEEN COIR ROLLS.

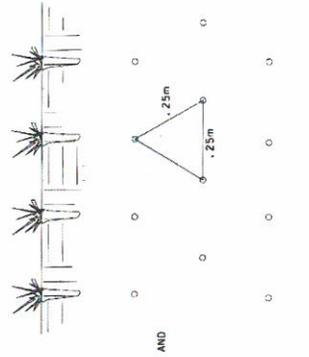
ZONE D RIPARIAN PLUG PLANTING FOR INSIDE BAND OF SPRING CREEK MOLES SCALE: NOT TO SCALE
