US 2 - SWAMP CREEK MITIGATION SITE

Montana Department of Transportation Stream Mitigation Monitoring Report

Monitoring Year: 2023

Years Monitored: 9th year of monitoring

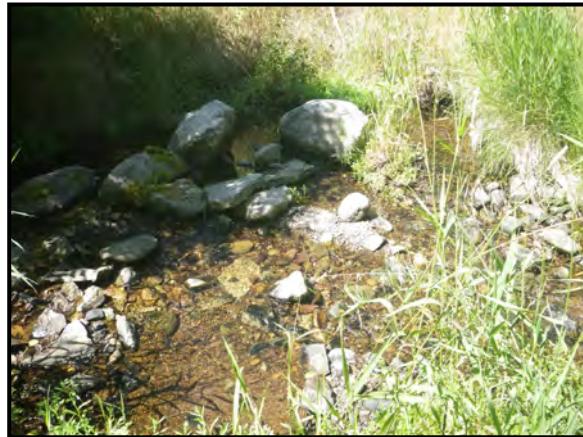
2023

Additional Photo 2: Failed rock weir flanked by channel at upstream end of Reach 3.1.

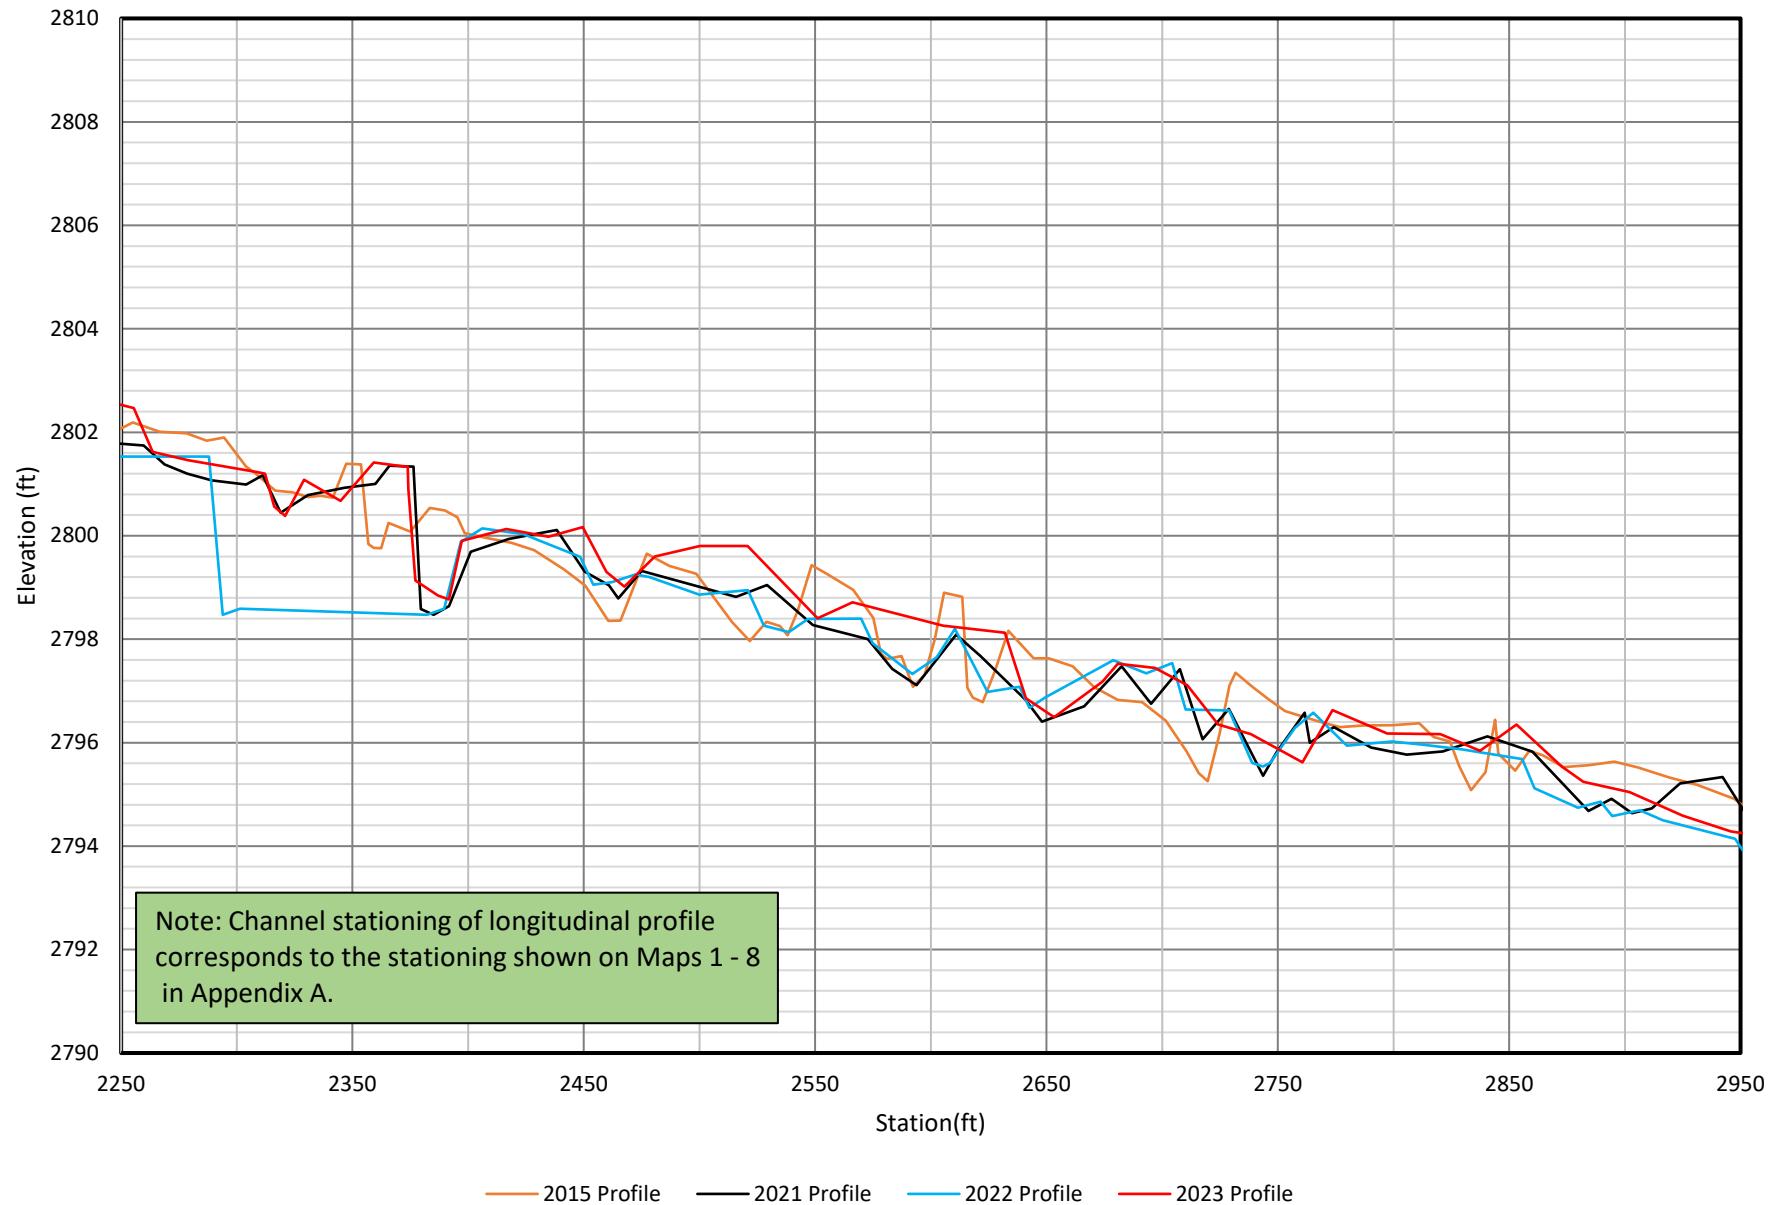
Reaches 3.2, 3.3, 3.4, 5, and 7.2 displayed longitudinal profiles that were similar to those surveyed in 2022, but all these profiles also displayed a few locations where the bed elevation appears to have increased by 0.5-2.5 feet. Increased bed elevations were most commonly observed at riffle crest locations and generally occurred without a corresponding increase in pool depth (Appendix G). One large pool within Reach 3.3 also appears to have filled in by 3.5 feet over the last year. These observations indicate that gravel and cobble are being transported through Swamp Creek and that some of that substrate was retained within the project reaches in 2023. The longitudinal profile through Reach 3.4 indicates the headcut that was stabilized in this reach has not continued to advance upstream. Although the bed elevation has remained consistent in the vicinity of the armored headcut, the rock weir installed to prevent further headcutting is beginning to show signs of deterioration. The channel has not responded and no immediate action is warranted; however, continued deterioration may result in additional maintenance needs.

Swamp Creek Longitudinal Profile: Reach 3.2
