# MONTANA DEPARTMENT OF TRANSPORTATION WETLAND MITIGATION MONITORING REPORT: YEAR 2001

*Roundup Wetland  
Roundup, Montana*

July 2002

Project No: 130091.031

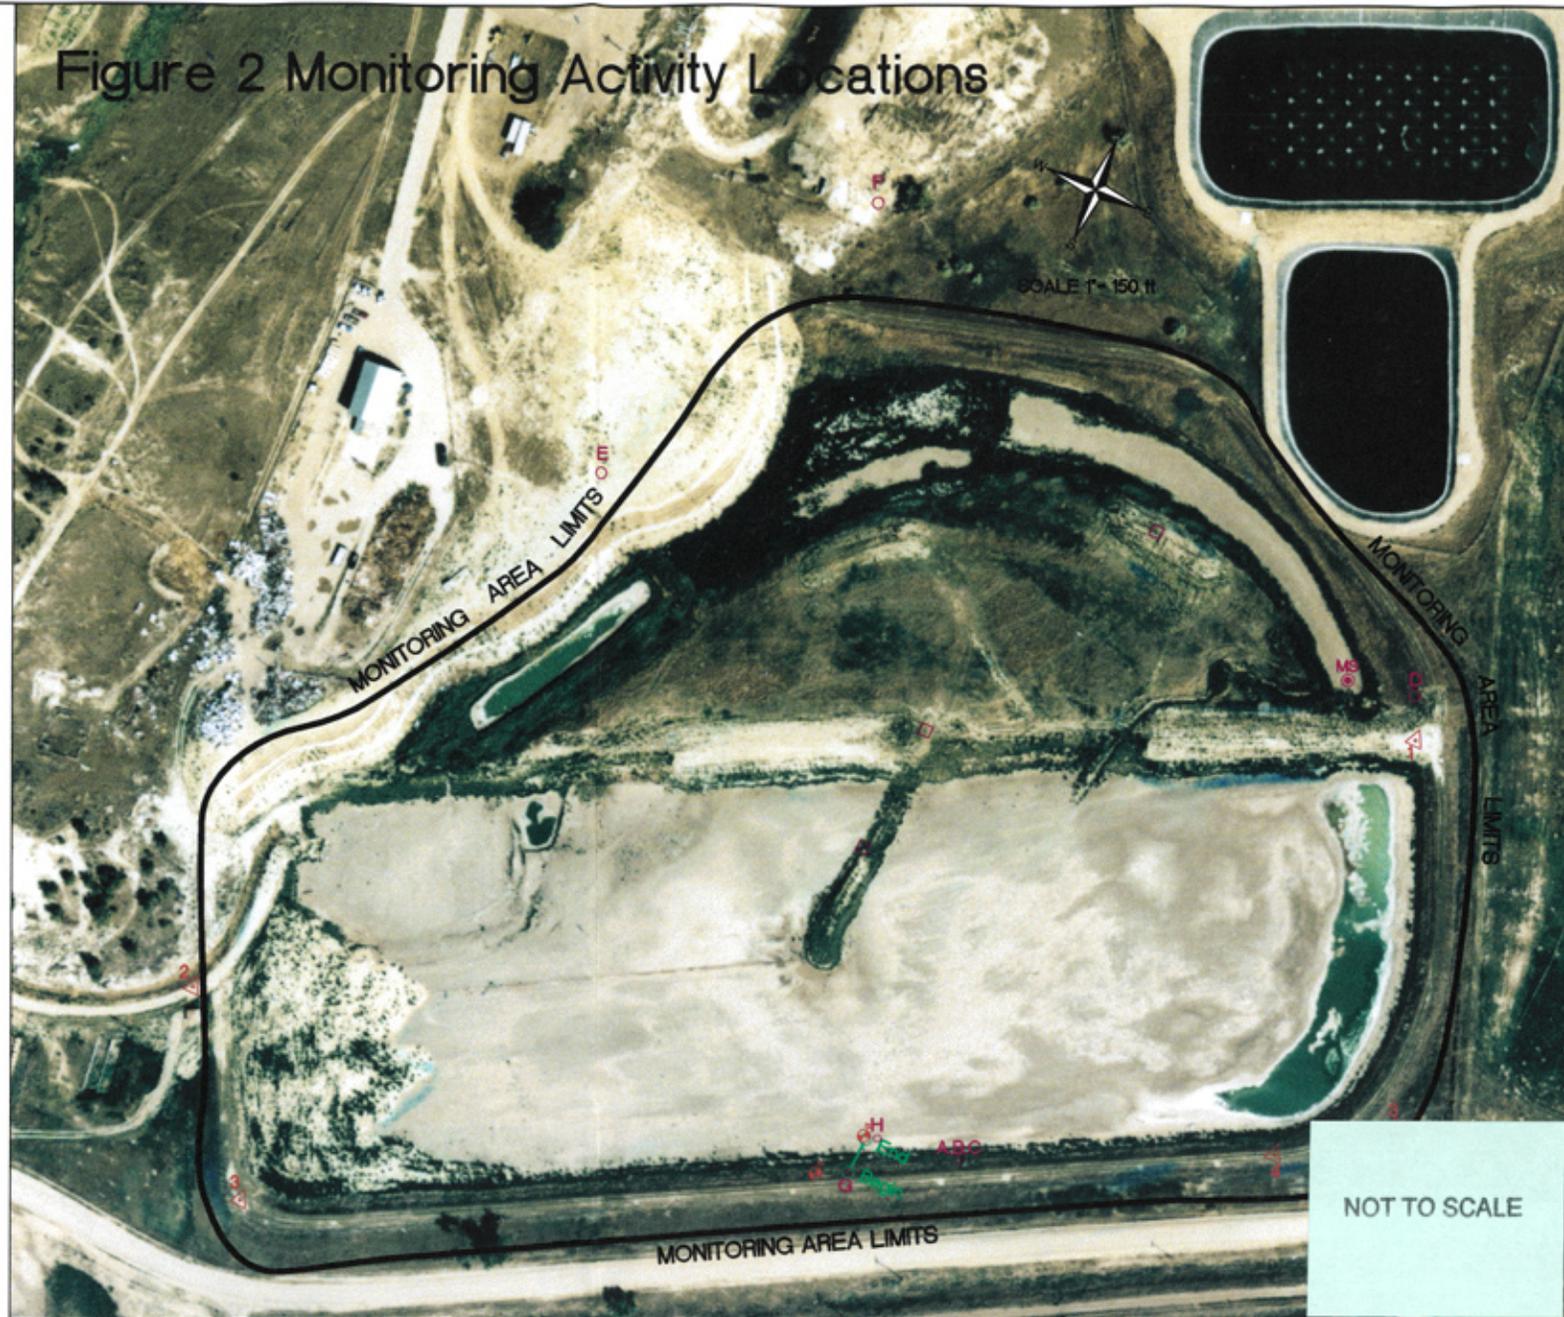
PROJ. NO.: 150011031 FILE NAME: TASK3-BASE.dwg SCALE: 1" = 150' LOCATION: Roundup Lagoon	DRAWN: RA CHECKED: BD APP'D: BD PROJ. MGR: BD	PROJECT NAME <b>MDT Roundup Lagoon Wetland Mitigation</b> DRAWING TITLE <b>Monitoring Activity Locations</b>
SHEET NUMBER <b>2</b> REV: .01 DATE:

The mitigation site is located at the site of the former wastewater lagoons for the city of Roundup (**Figure 2, Appendix A**). This former two-celled treatment facility, covering approximately 26 acres, contained a sludge of varying depths with concentrations of nitrates, and possibly heavy metals of which portions were capped during construction modification. Five monitoring wells were installed around the lagoon to monitor any possible groundwater contamination from the sludge. After a review of groundwater quality sampling data, both the DEQ and EPA agreed that there was not a groundwater contamination problem associated with the lagoons (MDT). The organic "sludge" was left in the southern end of the wetland bed and capped with one foot of soil during construction. The dam between cells was breached as shown in **Figures 2 and 3**.

One transect was established during the 2001 monitoring event to represent the range of current vegetation conditions. The location of this transect is shown on **Figure 2, Appendix A**. Percent cover for each species was recorded on the vegetation transect form within the monitoring form (**Appendix B**). The transect will be used to evaluate changes over time, especially the establishment and increase of hydrophytic vegetation. Transect ends were marked with metal fence posts and their locations recorded with the GPS unit. Photos of the transect were taken from both ends during the site visit.

One macroinvertebrate sample was collected during the site visit following the 2001 protocol (**Appendix D**). Samples were preserved as outlined in the sampling procedure and sent to a laboratory for analysis. The approximate sampling location is indicated on **Figure 2, Appendix A**.

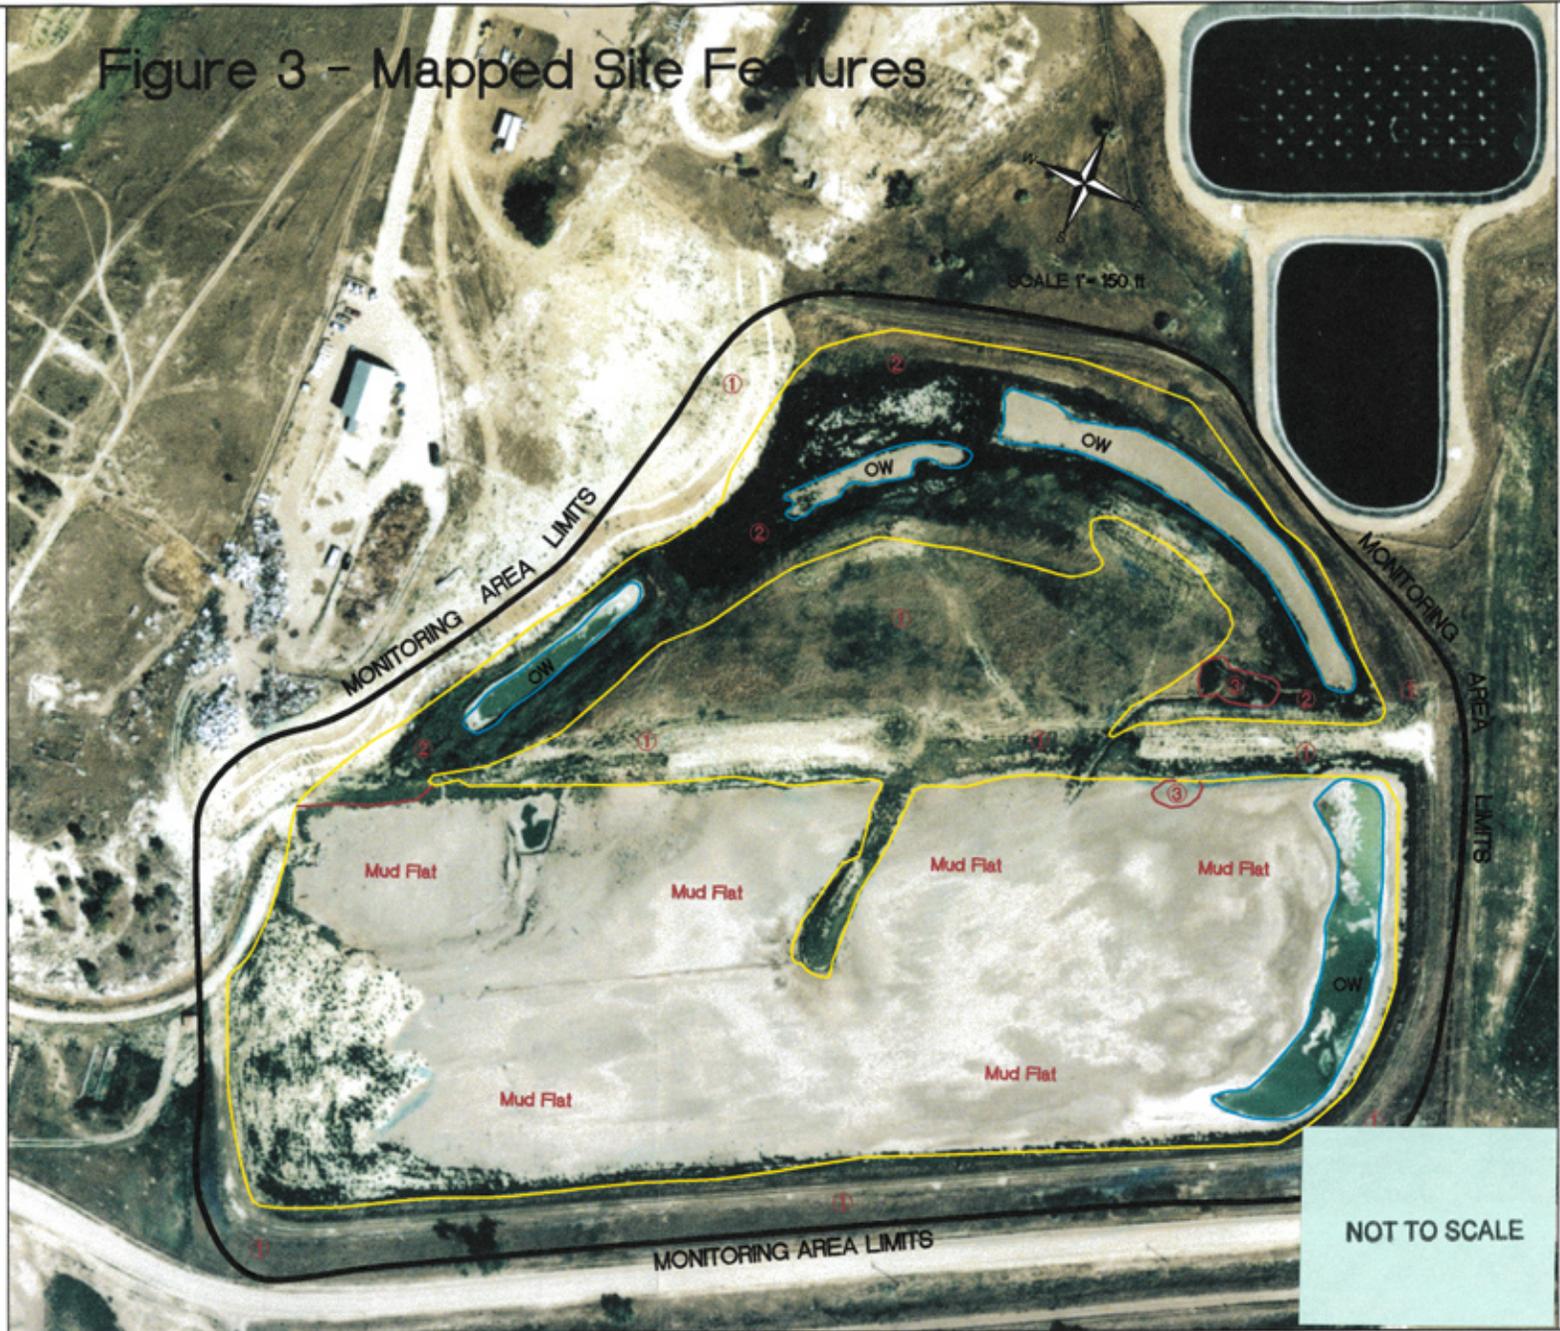
# Figure 3 - Mapped Site Features

General vegetation types were delineated on an aerial photograph during the site visit (**Figure 3, Appendix A**). Coverage of the dominant species in each community type is listed on the monitoring form (**Appendix B**). A comprehensive plant species list for the entire site was compiled and will be updated as new species are encountered. Observations from past years will be compared with new data to document vegetation changes over time. Minimal woody vegetation was planted at this site by the Conservation District.

The delineated “wetland” boundary, which is actually in part a mudflat (special aquatic site) is depicted on **Figure 3, Appendix A**. The area anticipated to develop into vegetated wetlands encompasses 18.517 acres with 1.439 acres of open water habitat. The COE data forms are included in **Appendix B**. Technically, the area is not a true wetland because it lacks hydrophytic vegetation in the mudflat areas. However, this was the first year for the site to have water.

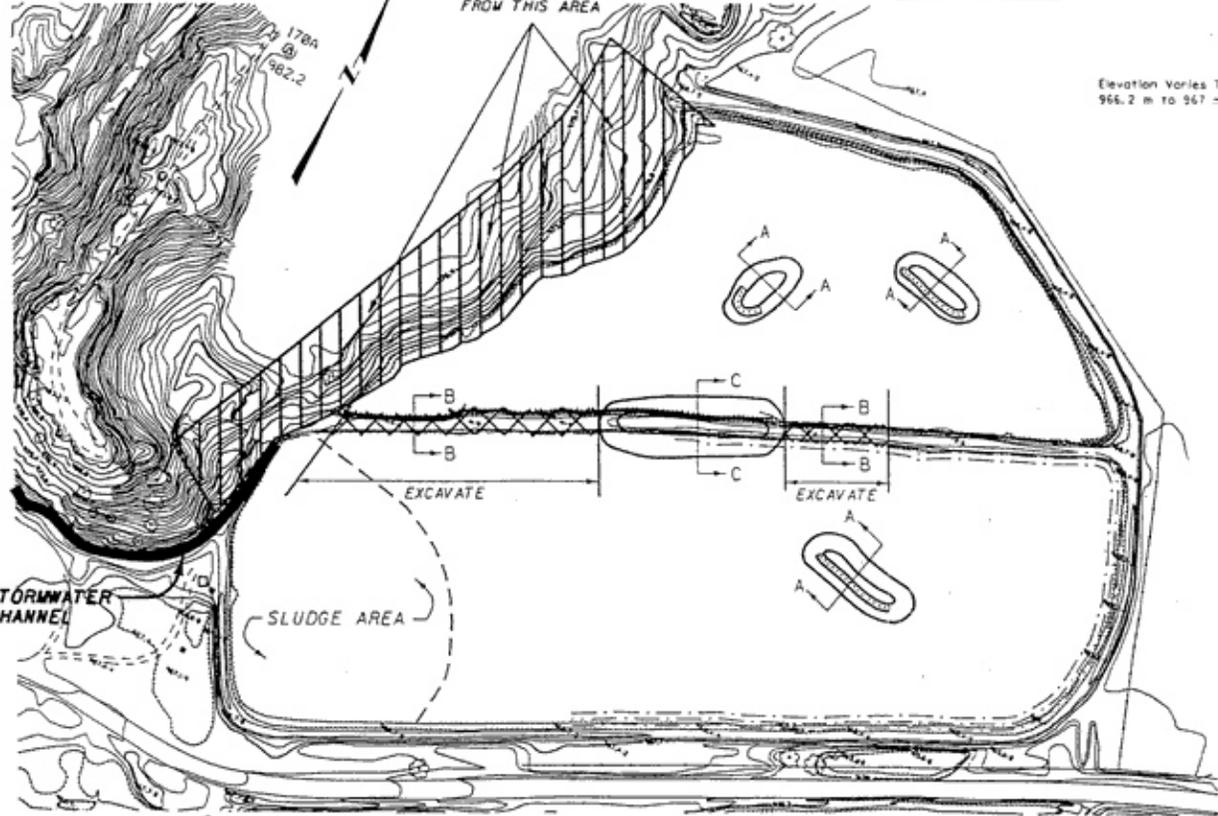
# DETAIL

REMOVE HOUSEHOLD AND AUTOMOTIVE SCRAP/DEBRIS FROM THIS AREA

Elevation Varies Typical  
966.2 m to 967 m  
BOTTOM OF LAGOON

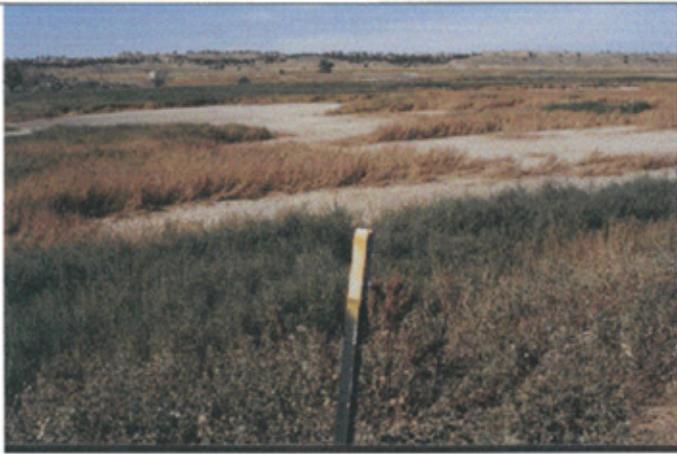
Photo point G, begin transect

The transect was established on and adjacent to the original dike on the south side of the complex. Though this area may flood and convert to wetland in the future, a more appropriate site for the transect will be located in the vicinity of the constructed islands and central dike that appears to flood annually, even in dry years.
