MONTANA DEPARTMENT OF TRANSPORTATION WETLAND MITIGATION MONITORING REPORT: YEAR 2002

*Cow Coulee
Townsend, Montana*

February 2003

Project No: 130091.013

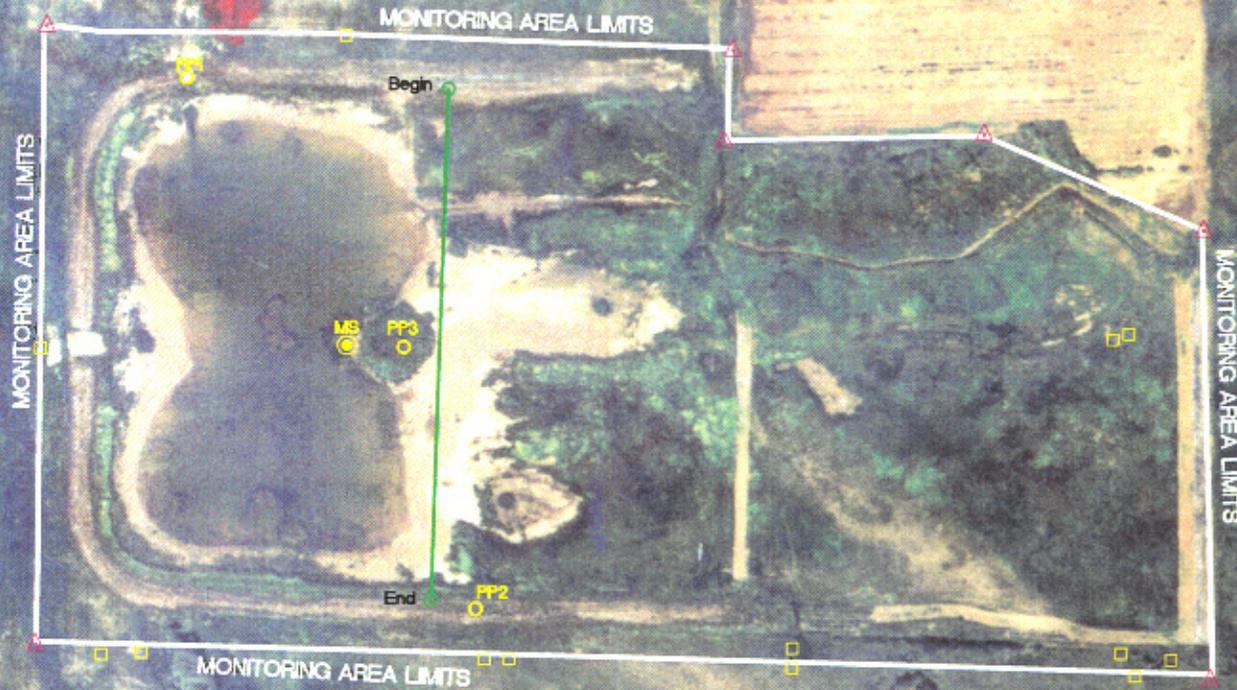
PROJECT NAME	MDT Cow Coulee Wetland Mitigation
DRAWING TITLE	Monitoring Activity Locations
PROJ. NO.	130091.013
FILE NAME	TASK/ISSUE.dwg
SCALE	1" = 100 ft
LOCATION	Cow Coulee
DRAWN	PA
CHECKED	MT
APPROV.	BD
PROJECT MGR.	BD
SHEET NUMBER	2
REV.	-
DATE	12-11-01

This site was first monitored in 2001, and is scheduled to be monitored three times per year over the 3-year contract period to document wetland and other biological attributes. The area to be monitored is illustrated in **Figure 2 (Appendix A)**.

The 10-foot wide belt transect that was established in 2001 was evaluated for the second time **Figure 2 (Appendix A)**. Percent cover was estimated for each vegetative species encountered within the “belt” using the following values: + (<1%); 1 (1-5%); 2 (6-10%); 3 (11-20%); 4 (21-50%); and 5 (>50%).

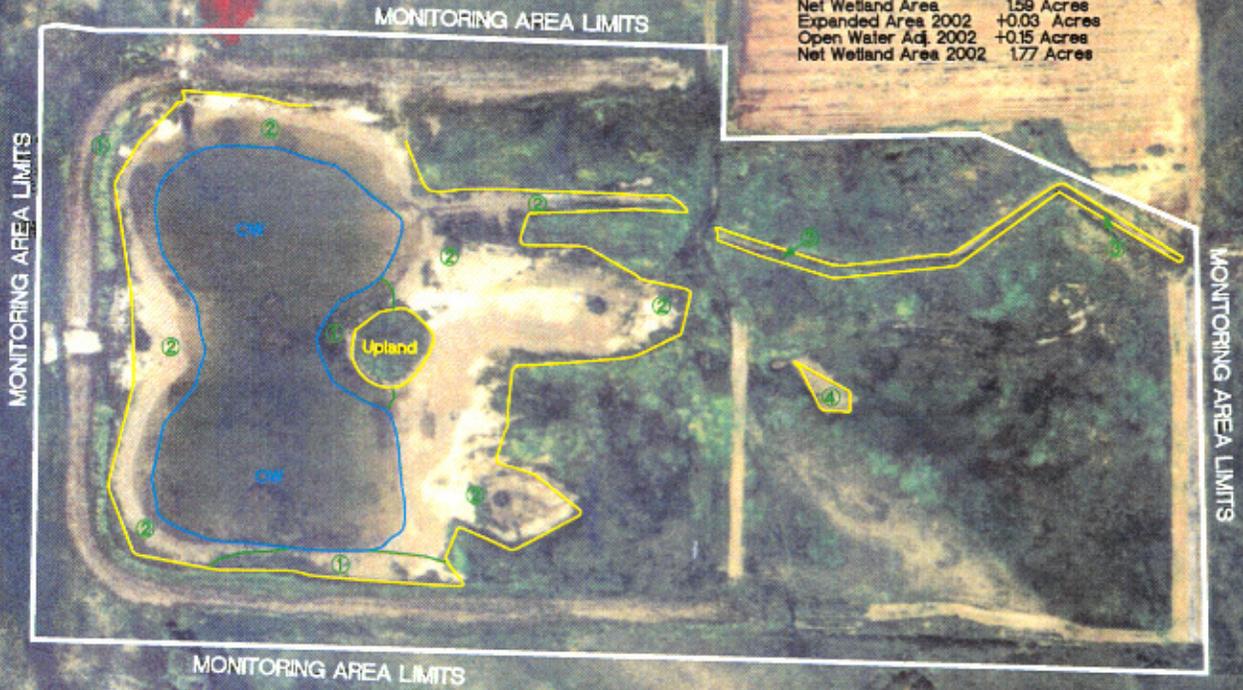
Water depth at open water/rooted vegetation interfaces was approximately one foot for the main impoundment. The shallow open water area east of the small island began to develop hydrophytic vegetation during the 2002 growing season and thus the open water boundary was revised on **Figure 3 (Appendix A)** to reflect this. The main impoundment had an average depth of two to three feet and a range of depths from one inch to an estimated four feet. Deepest areas were located near the center of the impoundment, which is as of yet, unvegetated. Open water areas are shown on **Figure 3 (Appendix A)**.

Vegetation species identified on the site are presented in **Table 1** and on the attached data form. Four wetland community types were identified and mapped on the mitigation area (**Figure 3, Appendix A**). These included Type 1: *Typha latifolia/Scirpus acutus*, Type 2: *Carex rostrata/Juncus balticus*, Type 3: *Scirpus maritimus*, and Type 4: *Hordeum jubatum/Iris missouriensis*. Dominant species within each of these communities are listed on the attached data form (**Appendix B**).

Gross Wetland Area	2.91 Acres
Open Water Area	1.32 Acres
Net Wetland Area	1.59 Acres
Expanded Area 2002	+0.03 Acres
Open Water Adj. 2002	+0.15 Acres
Net Wetland Area 2002	1.77 Acres

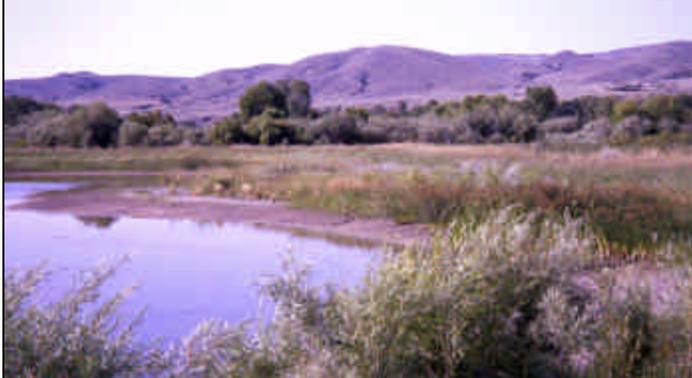
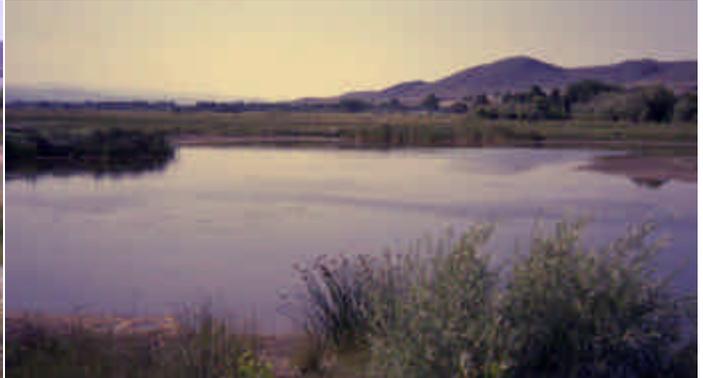
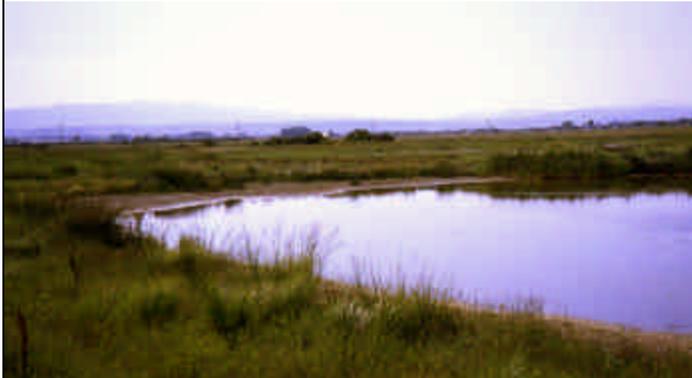
<p>Photo point 1: 185 degrees south Photo taken while standing on top of outlet control structure.</p>	<p>Photo point 1: 145 degrees southeast Photo taken while standing on top of outlet control structure.</p>

<p>Photo point 1: 90 degrees east Photo taken while standing on top of outlet control structure.</p>	<p>Photo point 2: 80 degrees east</p>

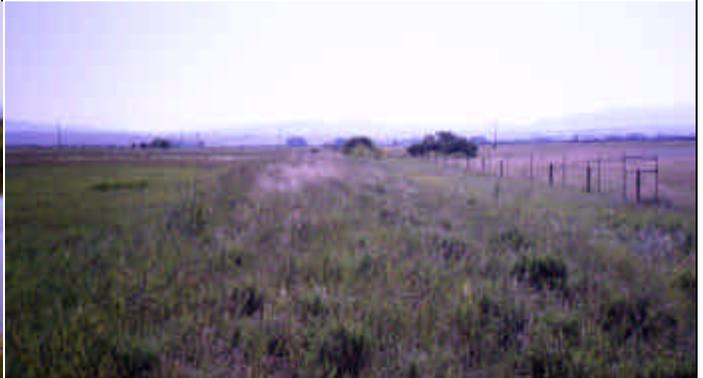
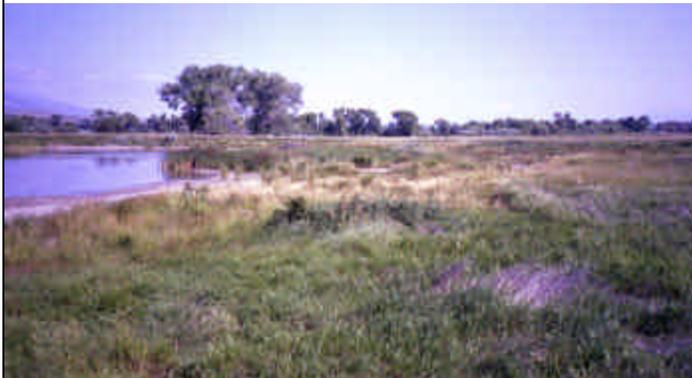
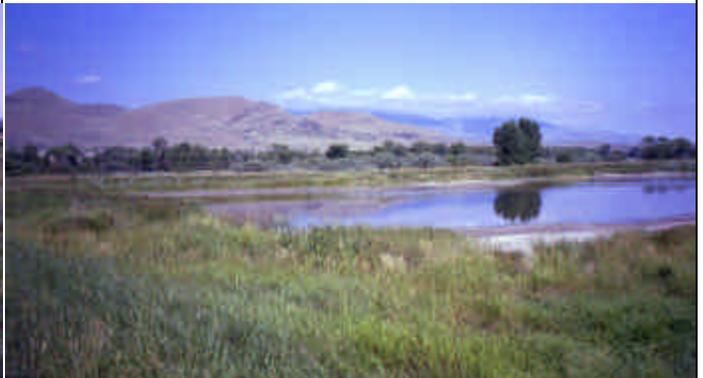
<p>Photo point 2: 338 degrees northwest</p>	<p>Photo point 2: 290 degrees west</p>

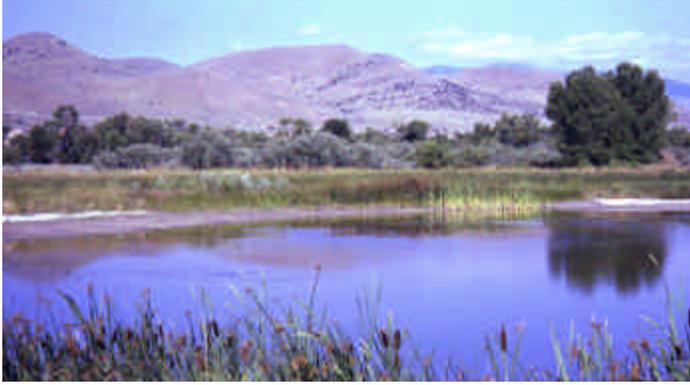
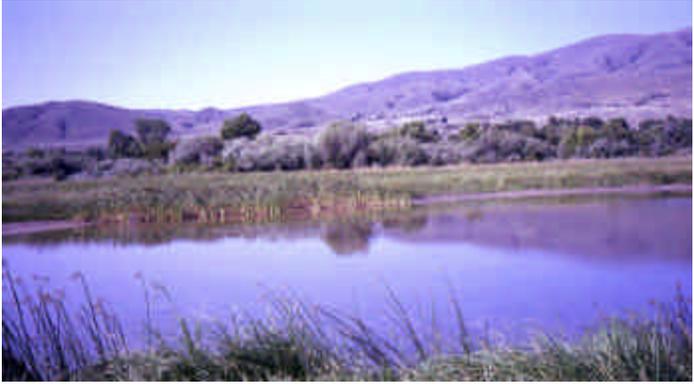
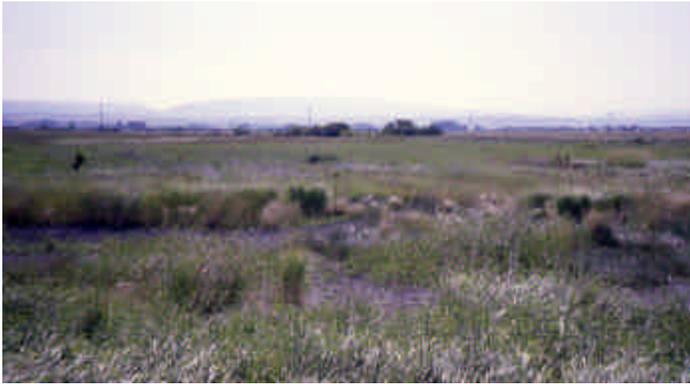
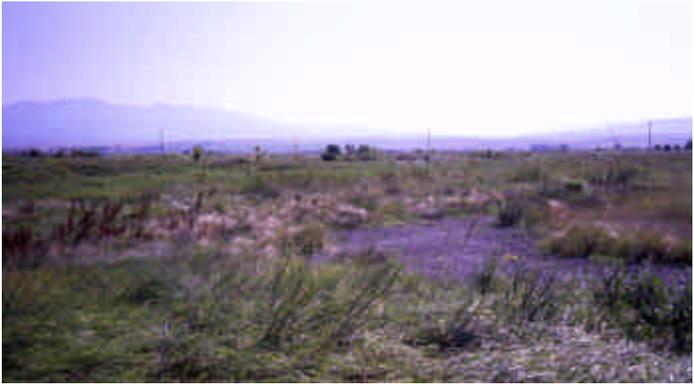
<p>Photo point 3: 284 degrees northwest Photo taken from middle of Island.</p>	<p>Photo point 3: 200 degrees southwest Photo taken from middle of Island.</p>

<p>Photo point 3: 116 degrees east Photo taken from middle of Island.</p>	<p>Photo point 3: 66 degrees northeast Photo taken from middle of Island.</p>

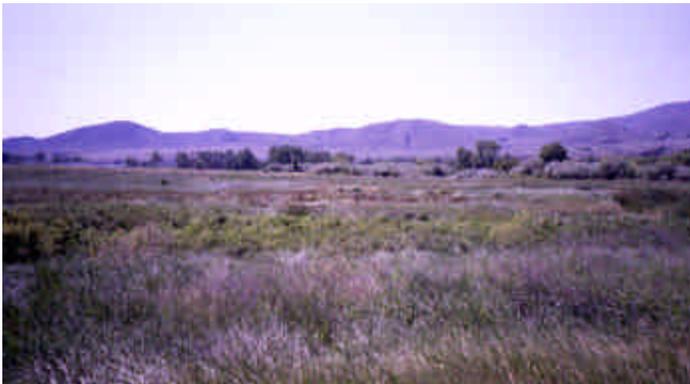
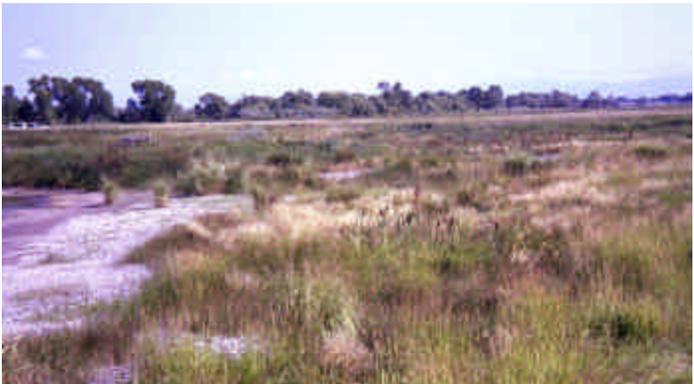
<p>Vegetation Transect Start: 170 degrees South</p>	<p>Vegetation Transect End: 350 degrees North</p>

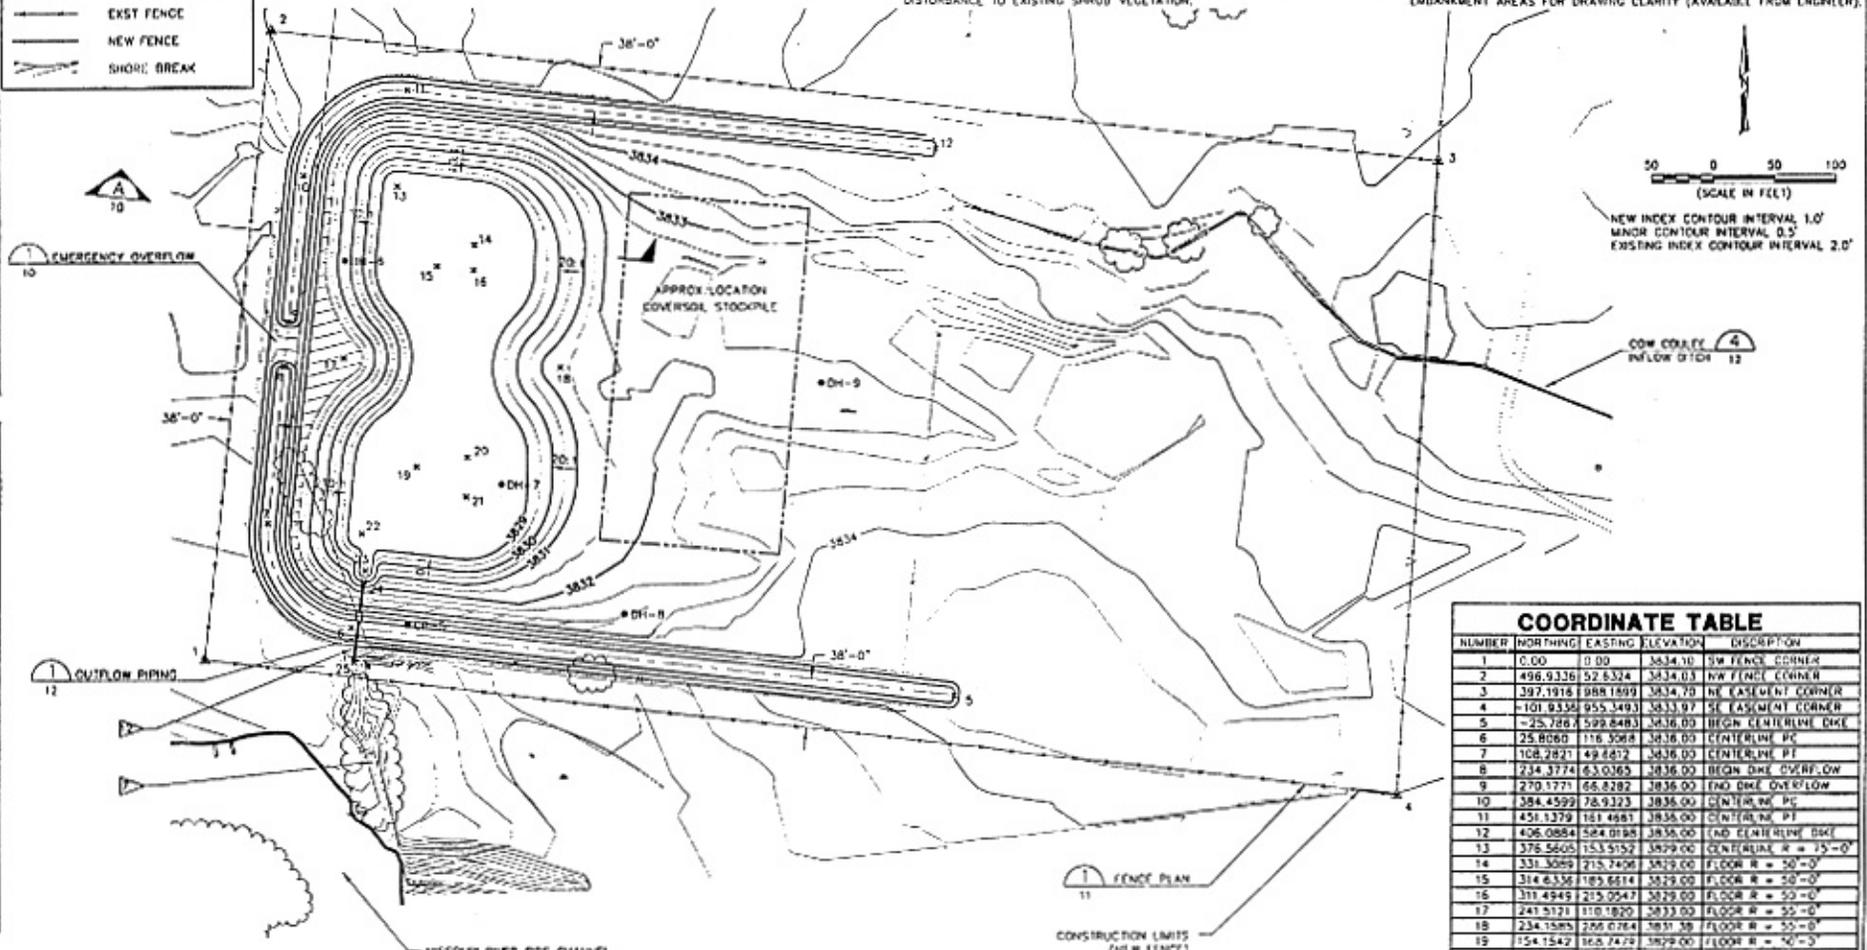
11. ELEVATIONS: DIKE TOP @ 3826.0. DESIGN WATER LEVEL 3833.0. EMERGENCY OVERFLOW 3834.0.
12. DISCONTINUE GRANULAR PIPE BEDDING 10' FROM EACH END OF PIPE.

13. EXISTING CONTOURS ARE OMITTED FROM WETLAND EXCAVATION & EMBANKMENT AREAS FOR DRAWING CLARITY (AVAILABLE FROM ENGINEER).
