MONTANA DEPARTMENT OF TRANSPORTATION WETLAND MITIGATION MONITORING REPORT: YEAR 2013

*Big Hole Grazing Association
Beaverhead County, Montana*

MDT Project Number STPX-0001(45)
Control Number 4668

Confluence Consulting, Inc.
P.O. Box 1133
Bozeman, MT 59771

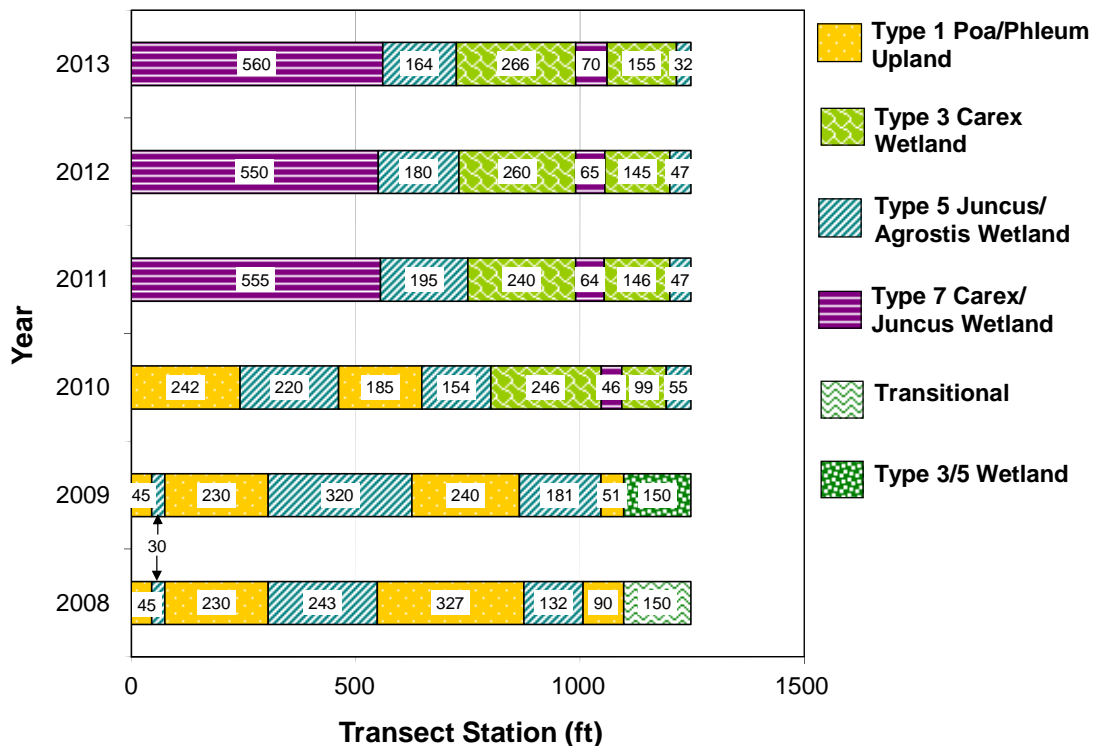
Chart 1. Transect map showing community types on Transect 1 from beginning (0 feet) to end (1,247 feet) from 2008 to 2013 at the BHGA Wetland Mitigation Site.

The transect traversed community 7 – *Carex* spp./*Juncus* spp., community 5 – *Juncus* spp./*Agrostis gigantea*, and community 3 – *Carex* spp. Hydrophytic communities have dominated 100 percent of the transect from 2011 to 2013. The data reflect the increased wetland hydrology, development of hydrophytic vegetation, and expansion of wetland acreage within the BHGA mitigation site
