**MONTANA DEPARTMENT OF TRANSPORTATION
WETLAND MITIGATION MONITORING REPORT: YEAR 2013**

*Woodson Creek
Ringling, Meagher County, Montana*

MDT Project Number: NH-STPX-STPP 30(15)
Control Number: 5912

CCI Project No: MDT.006

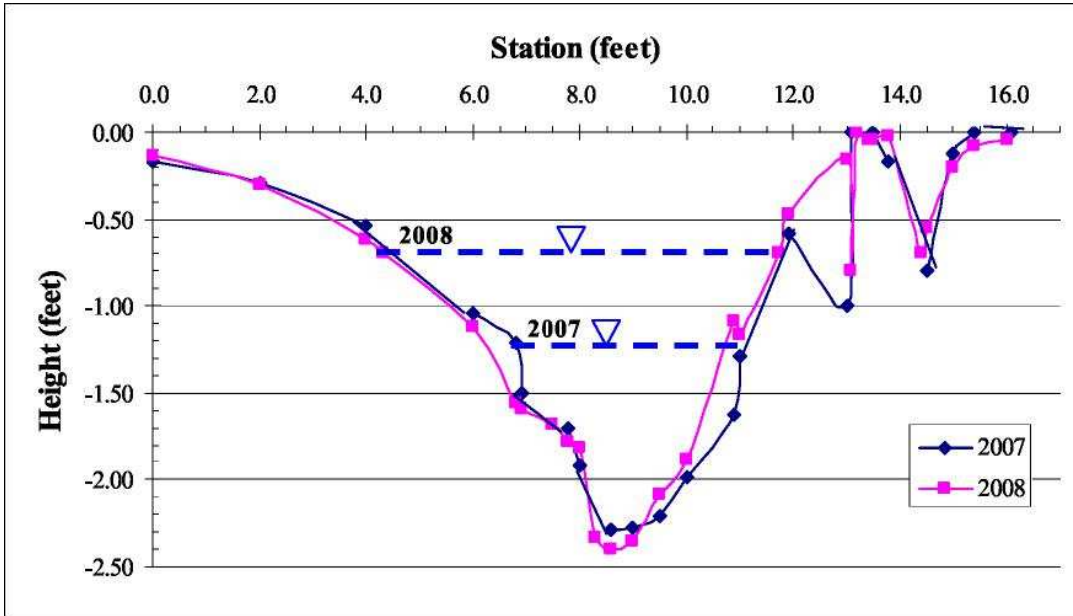
Chart 7. Survey data at XS-1 collected in 2007 and 2008.
XS-1

Locations of the two channel cross-sections are shown on Figure 2 (Appendix A) and photographs are shown on page C-24 of Appendix C. The 2007, 2008, and 2010 to 2013 cross-section data are illustrated on Charts 7 through 10. Slight increases in channel depth and width were observed at both survey locations in 2007. The cause was unclear and assumed to be the result of minor adjustments in the channel geometry and settling of streambanks. Cross section 1 showed little change in channel geometry from 2010 to 2012. This cross section was not surveyed in 2013 due to an overly aggressive otter protecting its nearby den. Cross section 2 exhibited minor lateral channel migration in 2013. The streambanks were well vegetated by species with high soil stability ratings, which contributed to the overall stability of the stream morphology. The
