MONTANA DEPARTMENT OF TRANSPORTATION WETLAND MITIGATION MONITORING REPORT: YEAR 2015

*American Colloid Mitigation Site
Alzada, Carter County, Montana*

Initial Construction: 2001
MDT Project Number NH STPS BR 6(10)
Control Number 1396

Watershed 16 Repair: 2010
MDT Project Number STPX 6(15)
Control Number 6714

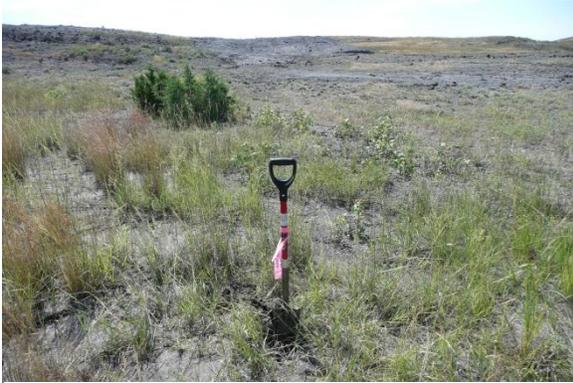
Data Point – SP02-u
Bearing: 170 Degrees

No groundwater monitoring wells were installed within this site. Hydrological data were collected at two data points, SP01-w and SP02-u. Data point SP01-w, located a few feet from the water's edge, exhibited saturation to the ground surface, salt crust, drainage patterns, surface soil cracks, geomorphic position, and FAC-Neutral test. No primary or secondary indicators of wetland hydrology were observed at SP02-u, located in upland community Type 2, approximately 20 feet from SP01-w.

saturated to surface with evidence of inundation earlier in the year. The soil profile at SP02-u, located in the adjacent upland approximately 20 feet upslope of SP01-w, was a black (10 YR 2/1) silty clay. There were no hydric soil indicators observed in this soil profile.

Location: Veg Comm 2
Taken in 2015

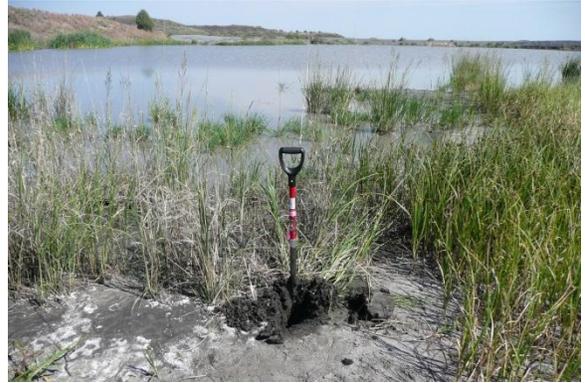
Data Point – SP01-w
Bearing: 20 Degrees

Location: Veg Comm 3
Taken in 2015
