MONTANA DEPARTMENT OF TRANSPORTATION WETLAND MITIGATION MONITORING REPORT: YEAR 2016

AMERICAN COLLOID MITIGATION SITE ALZADA, CARTER COUNTY, MONTANA

MDT Project Number NH STPS BR 6(10)
Control Number 1396

Watershed 16 Repair: 2010
MDT Project Number STPX 6(15)
Control Number 6714

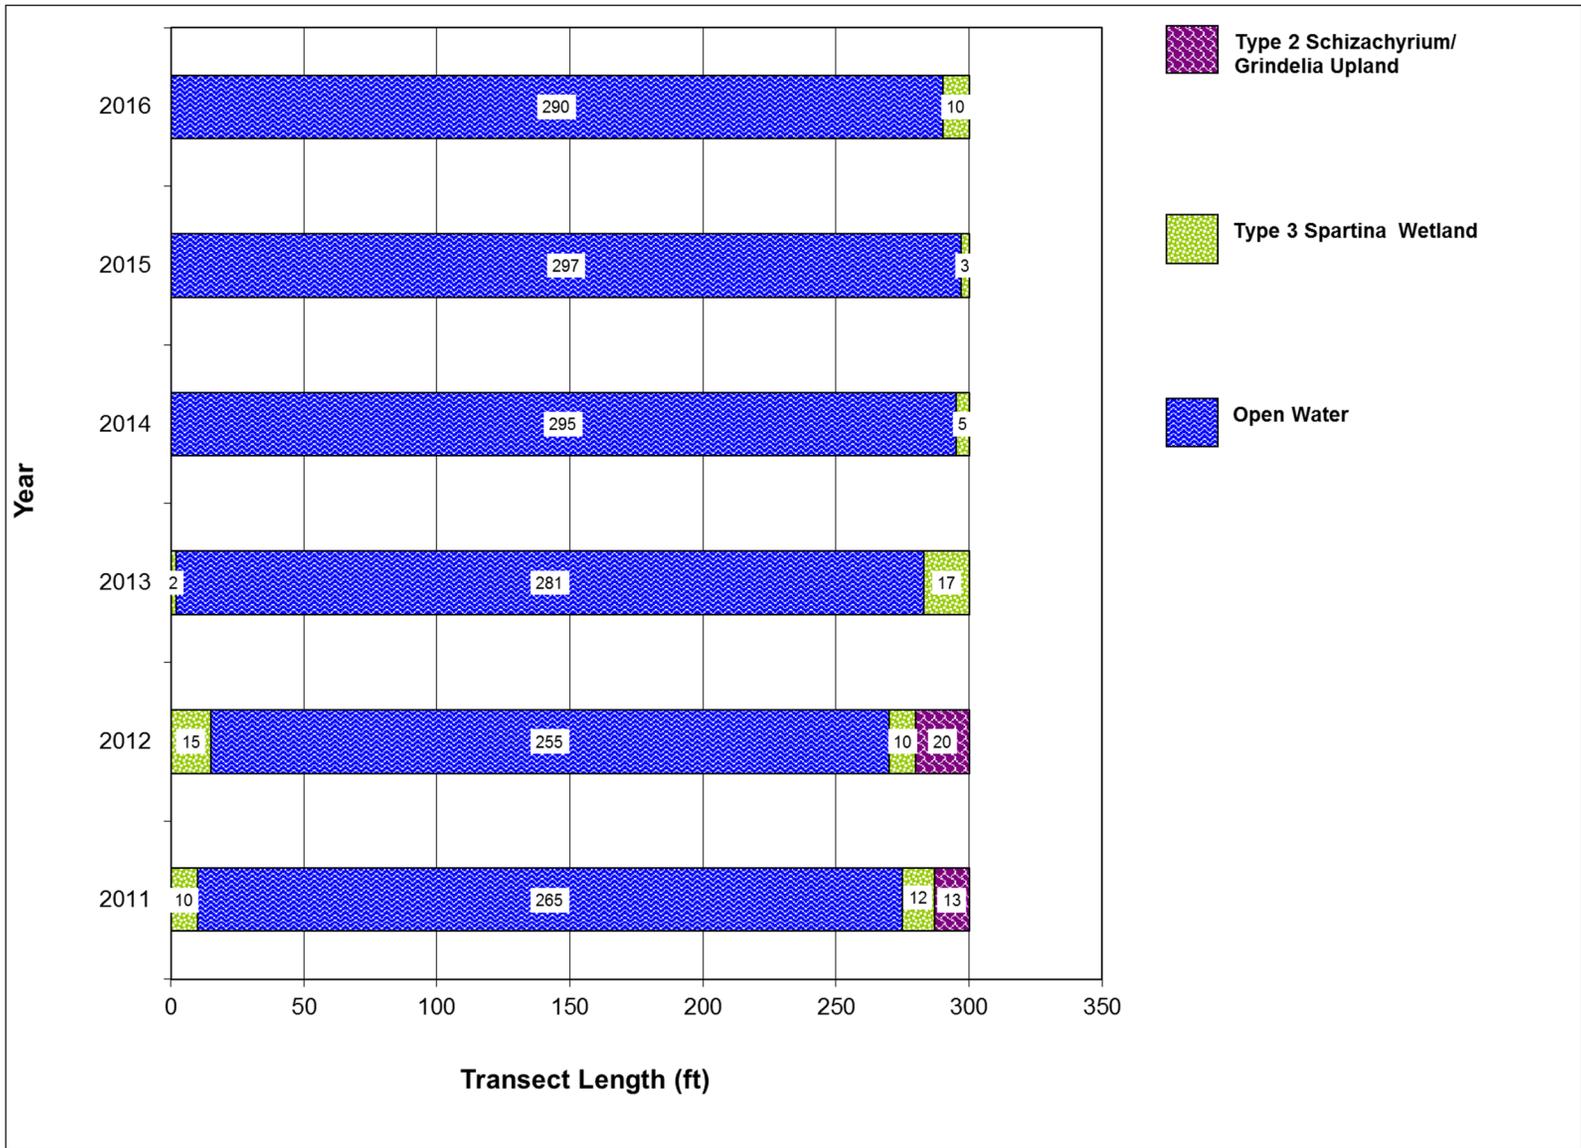
Chart 3-1. Transect Map Showing Community Types on T-1 From 2011 Through 2016 From Start (0 Foot) to End (300 Feet) at the American Colloid Site.

Monitoring Year	2011	2012	2013	2014	2015	2016
Transect Length (feet)	300	300	300	300	300	300
Vegetation Community Transitions Along Transect	3	3	2	1	1	1
Vegetation Communities Along Transect	2	2	1	1	1	1
Hydrophytic Vegetation Communities Along Transect	1	1	1	1	1	1
Total Vegetative Species	7	12	11	8	12	9
Total Hydrophytic Species	4	5	4	5	6	7
Total Upland Species	3	7	7	3	6	2
Estimated % Total Vegetative Cover	12	15	15	15	15	15
Estimated % Unvegetated	88	85	85	85	85	85
% Transect Length Comprising Hydrophytic Vegetation Communities	7.3	8.3	6.3	1.7	1.0	3.0
% Transect Length Comprising Upland Vegetation Communities	4.3	6.7	0.0	0.0	0.0	0.0
% Transect Length Comprising Unvegetated Open Water	88.3	85.0	93.7	98.3	99.0	97.0
% Transect Length Comprising Mudflat	0.0	0.0	0.0	0.0	0.0	0.0

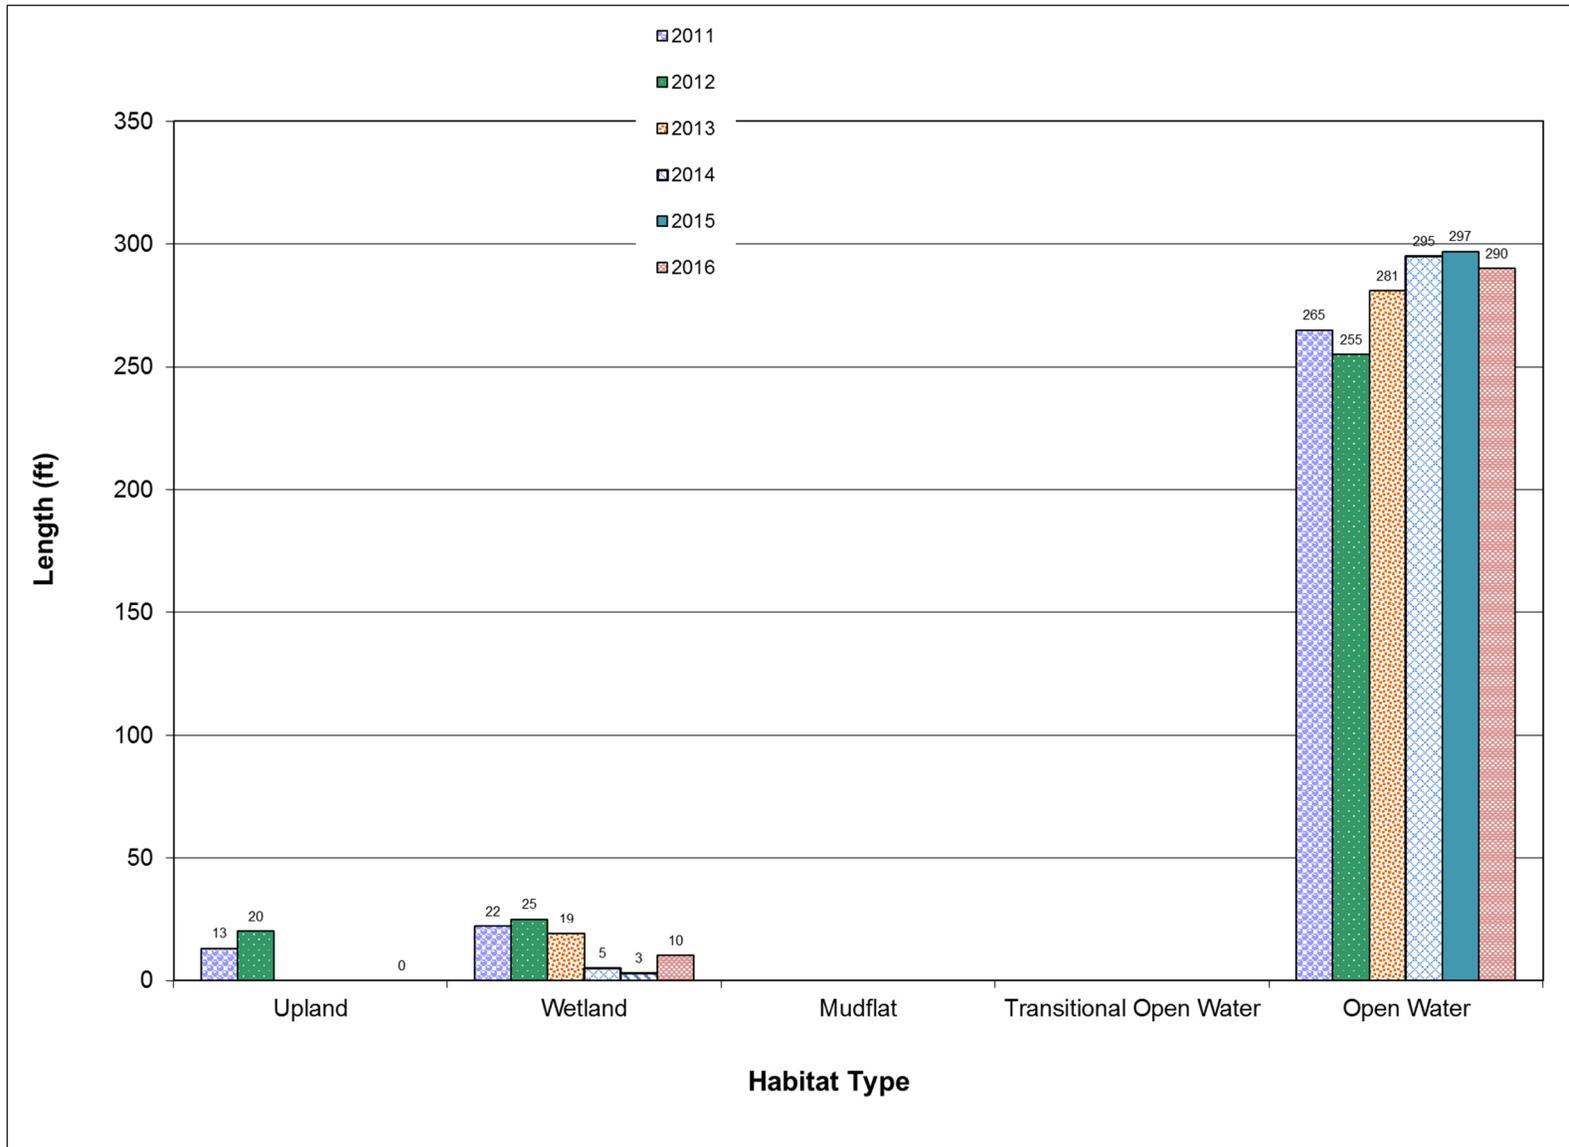
Chart 3-2. Length of Habitat Types Within T-1 From 2011 Through 2016 at the American Colloid Site.

Canada thistle, which is a Priority 2B noxious weed, was noted at the start of T-1 at the edge of wetland and open water. This infestation covers less than 0.1 acre at 5 percent cover. MDT has an ongoing weed-control program that annually manages state-listed noxious weed infestations on each mitigation site. According to MDT records, the American Colloid site was not treated for weeds in 2016.

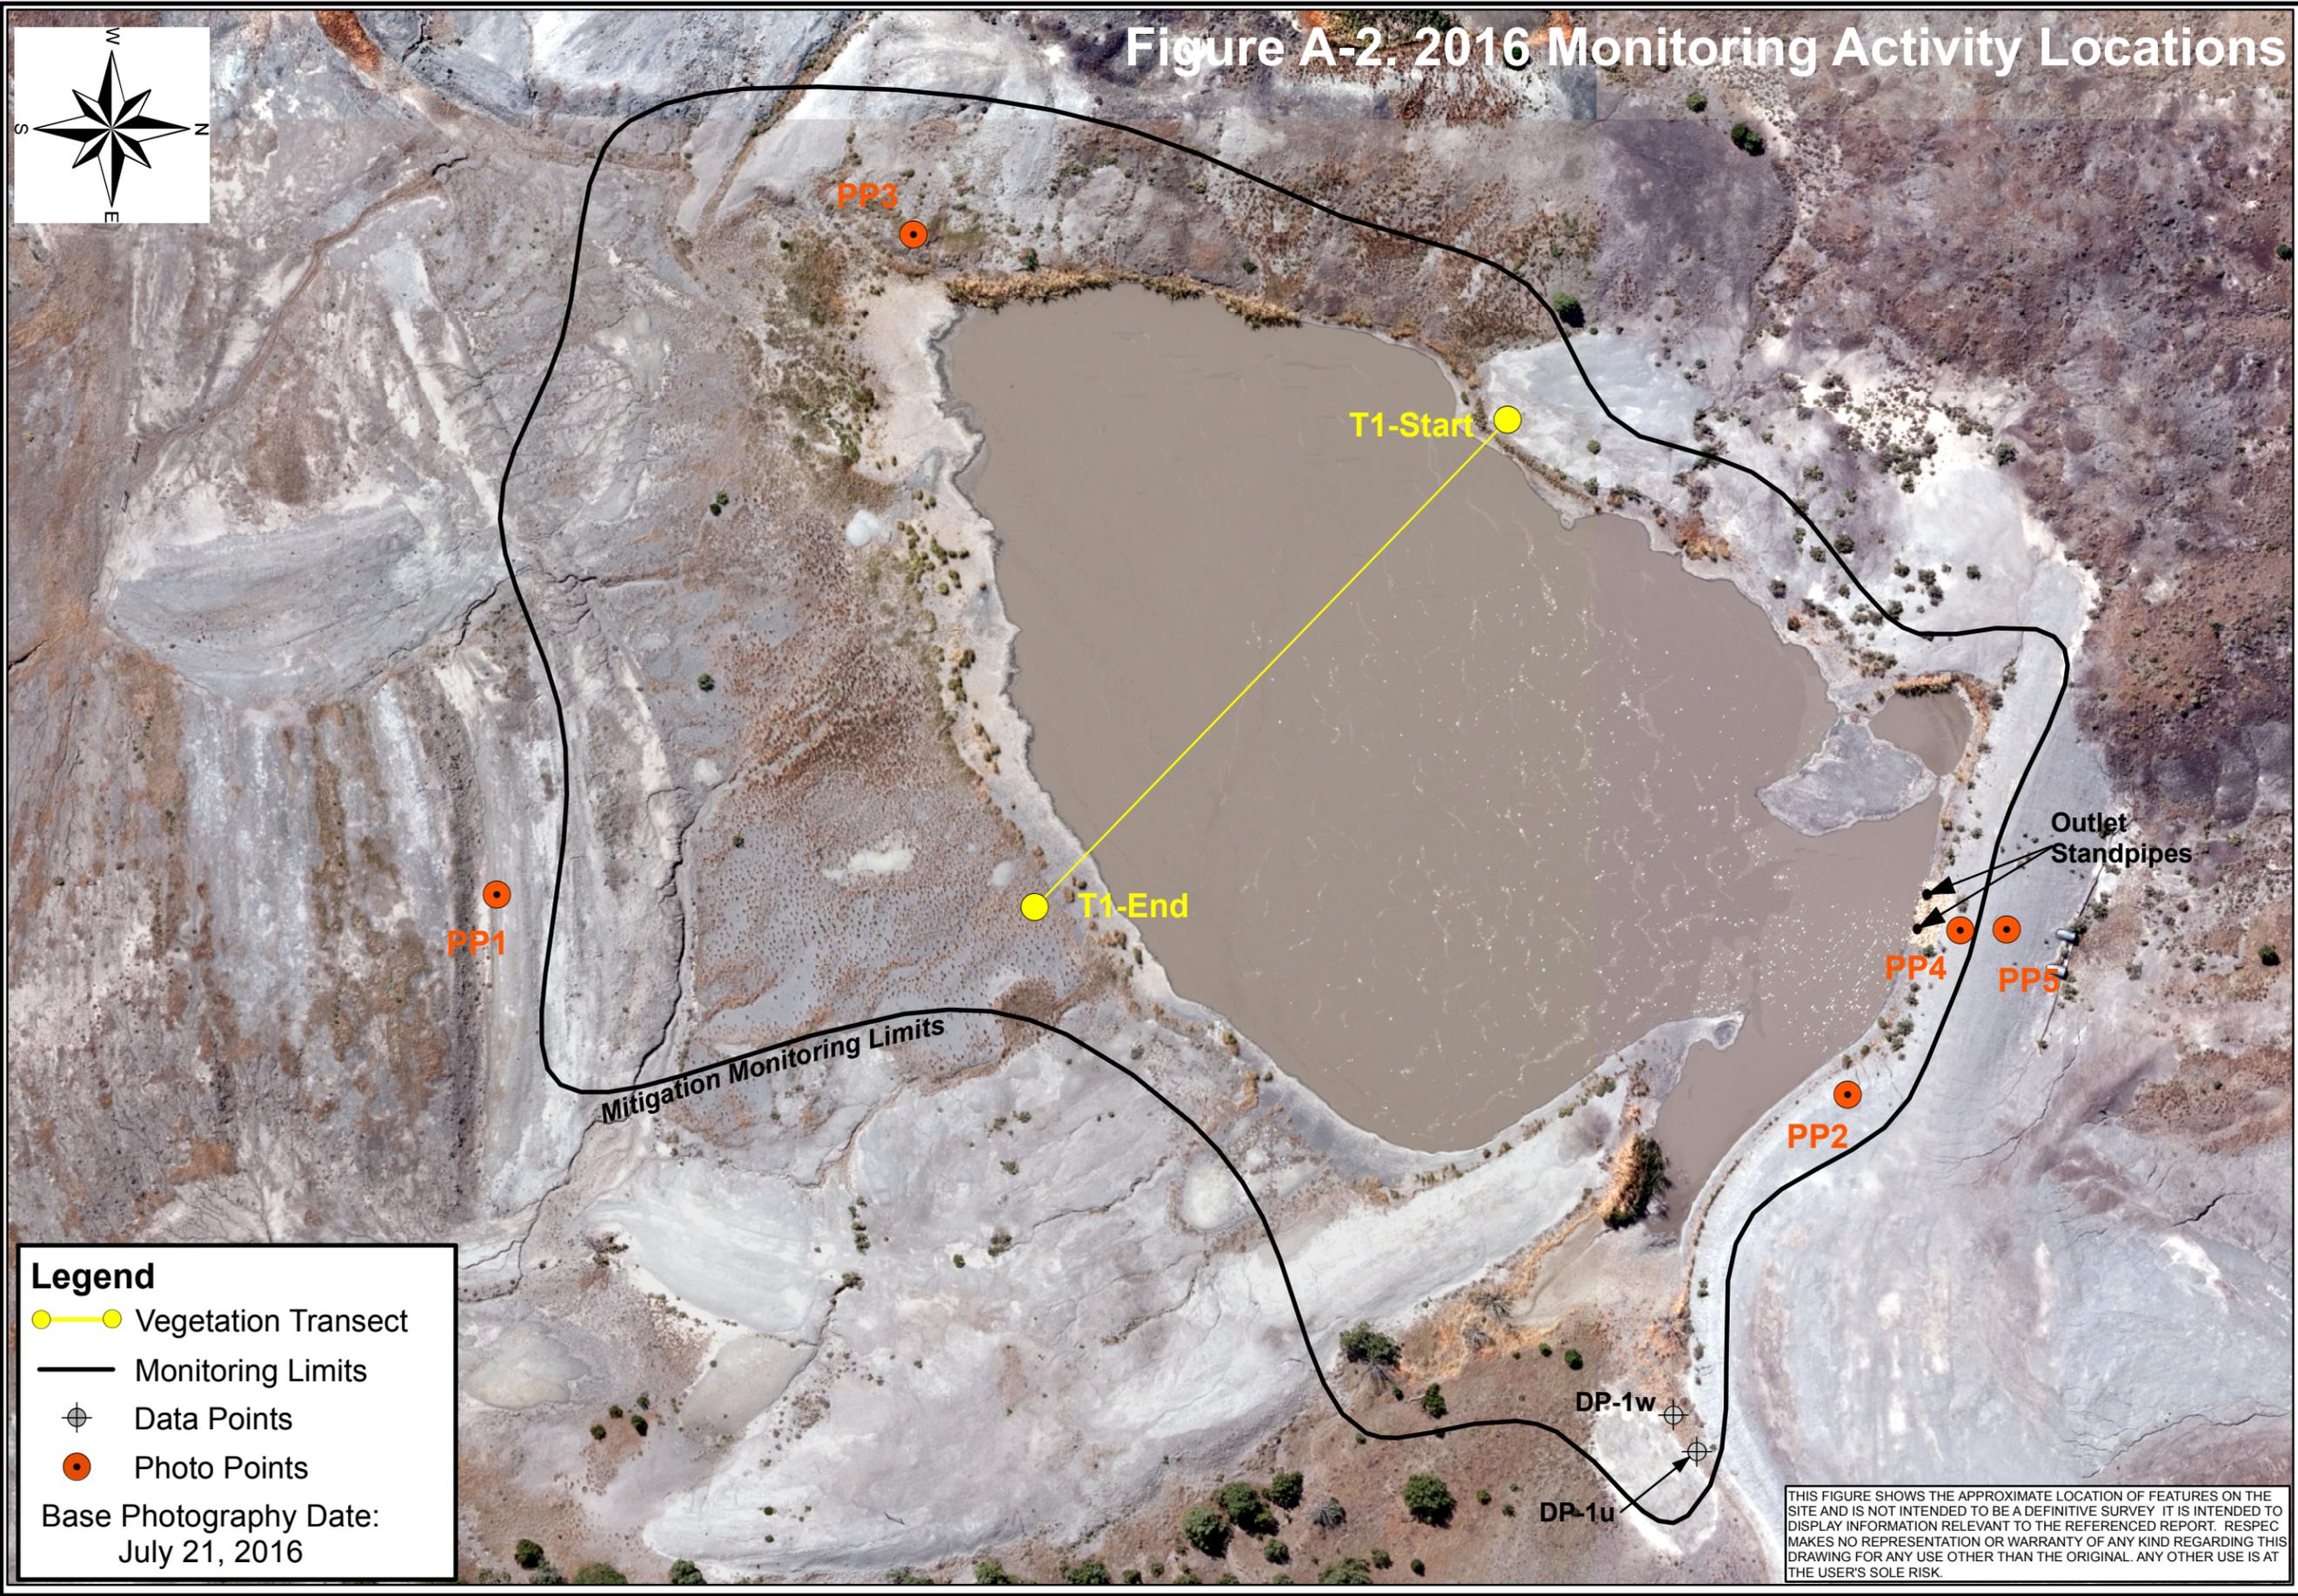
Figure A-2. 2016 Monitoring Activity Locations

- — Vegetation Transect
- Monitoring Limits
- Data Points
- Photo Points

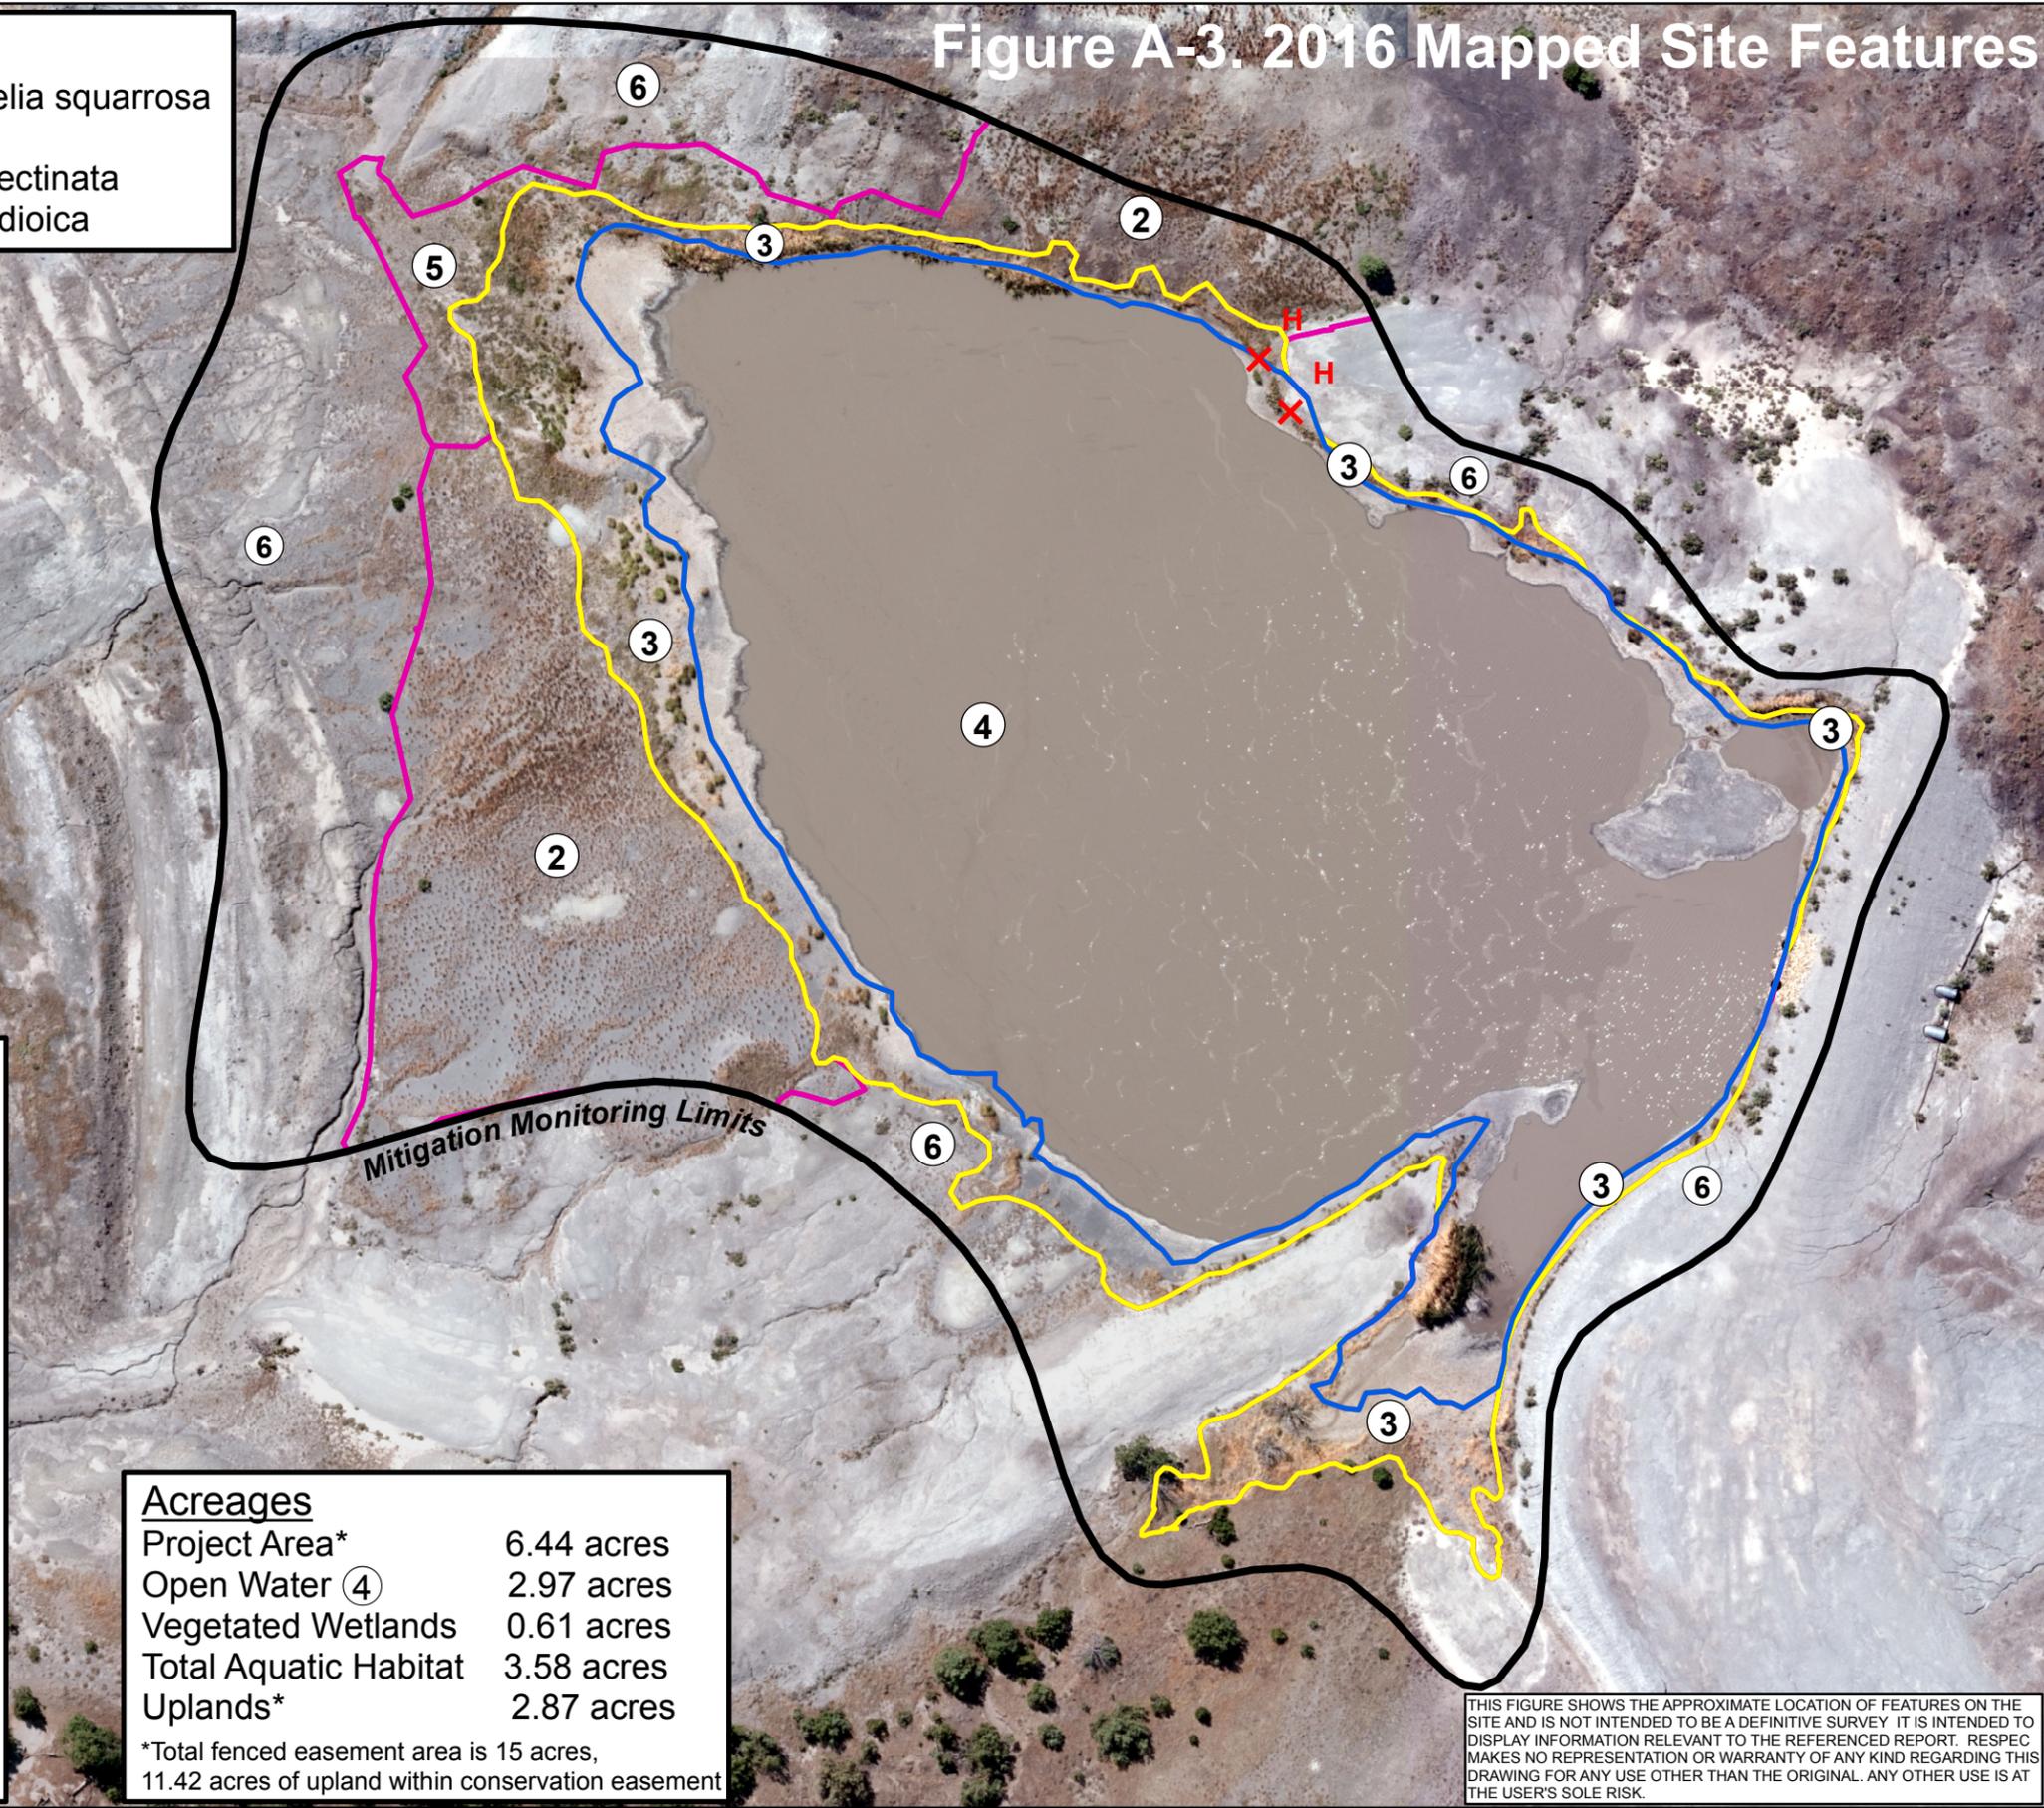
**American Colloid Mitigation Site
 2016 Mapped Site Features**

Project Area*	6.44 acres
Open Water ④	2.97 acres
Vegetated Wetlands	0.61 acres
Total Aquatic Habitat	3.58 acres
Uplands*	2.87 acres

*Total fenced easement area is 15 acres,
11.42 acres of upland within conservation easement

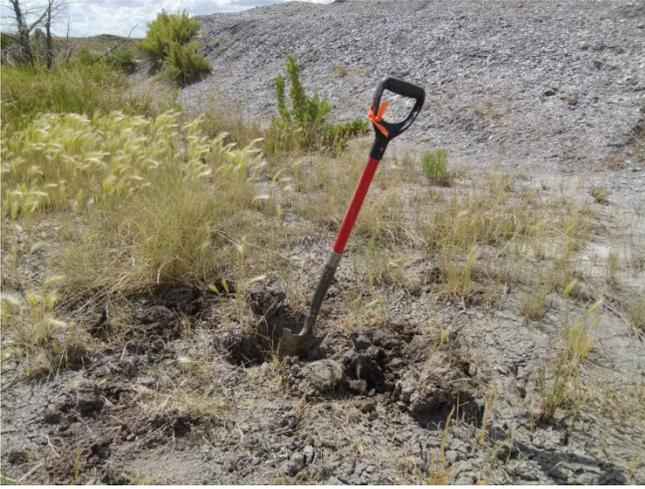
Data Point: DP-1U
Year 2016

No groundwater monitoring wells were installed within this site. Hydrological data were collected at two data points: DP-1U and DP-1W. DP-1W is located approximately 40 feet from the water's edge and exhibited saturation to the ground surface, drainage patterns, surface soil cracks, geomorphic position, and oxidized rhizopheres. No primary indicators of wetland hydrology were observed at DP-1U, which is located in upland community Type 6 and approximately 10 feet from DP-1W.
