MONTANA DEPARTMENT OF TRANSPORTATION WETLAND MITIGATION MONITORING REPORT: YEAR 2016

EASTON RANCH MITIGATION SITE PARK COUNTY, MONTANA

EASTON RANCH
PARK COUNTY, MONTANA
CONSTRUCTED: 2009

MDT Project Number STPX-0034(14)
Control Number 4866

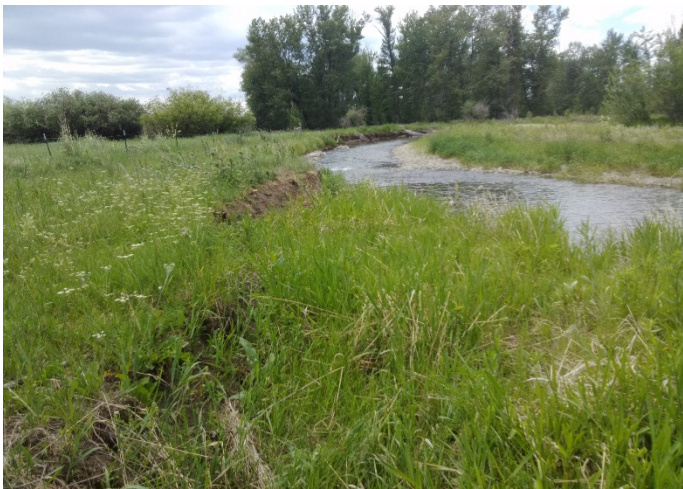
The east bank of the Shields River along the northwestern corner of the Easton Ranch mitigation site remained relatively stable from project completion through the 2011 runoff event. The structural integrity of the coir-wrapped soil lifts was intact after high flows. Fine-grain deposits accumulated on the lifts as floodwaters receded. The 2011 flood flows caused a wider base-flow channel to form because of a slight westward shift of the western bank, away from the site.

Photo Point: 4A
Bearing: 170 degrees

Location: Shields Bank DS
Year: 2016

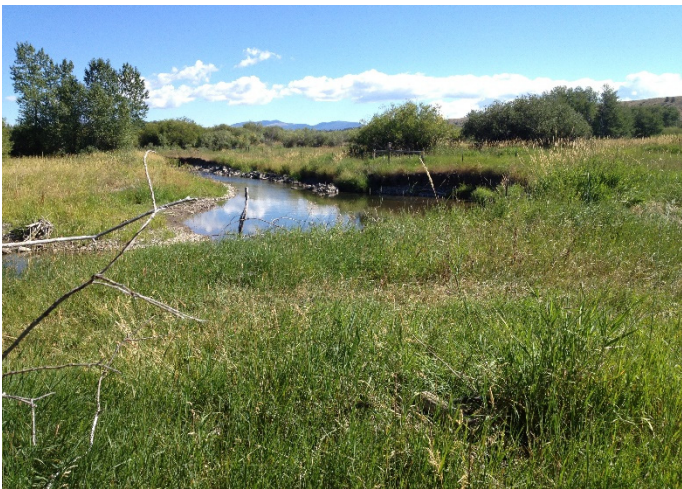
Some reaccumulation of woody debris in the former log jam location was noted in 2014, but 2016 showed little additional accumulation. Stacked piles of wood debris were noted in the floodplain to be burned or hauled away. Although additional bank erosion has been noted since the dramatic lateral cutting event of 2013, this section of bank remains exposed and vulnerable. The 2016 runoff period was fed by below-average precipitation. If some measures are not taken to provide additional stability to the outer bends of the Shields River through this reach, a future high-water event may result in significant additional movement of the bank, which already threatens to capture the northwest fence corner of the project area.

Photo Point: 4B
Bearing: 20 degrees

Location: Shields Bank US
Year: 2016
