# MONTANA DEPARTMENT OF TRANSPORTATION

## WETLAND MITIGATION MONITORING REPORT: YEAR 2016

### REDSTONE – EAST AND WEST SHERIDAN COUNTY, MONTANA

MDT Project Number STPP 22-1 (5)14  
Control Number 2024

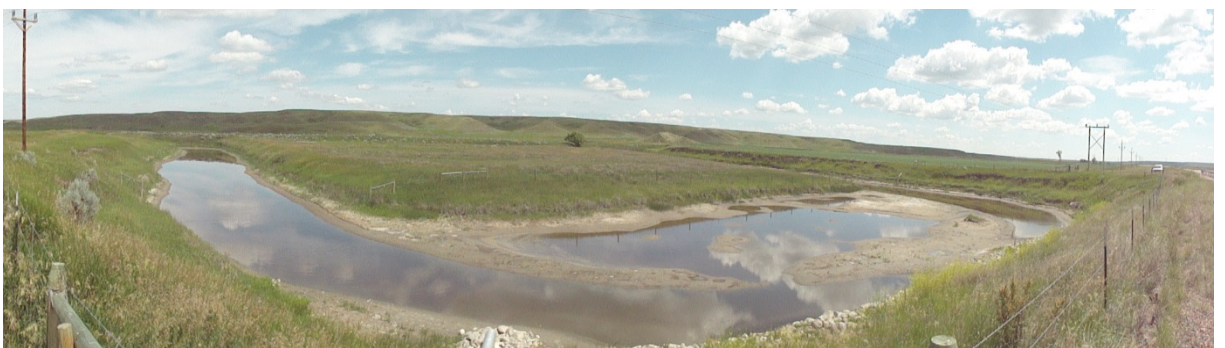
**Photo Point 3 – Panorama; Location: SW Fence Post; Bearing 75 degrees; Year 2016**

No man-made diversion structures were installed at the site. Two bluebird boxes were installed at the site, but only one was observed and in use during the 2016 visit. One bluebird box should be reinstalled at PP-3. Two infestations of Canada thistle (*Cirsium arvense*), which is a Priority 2B noxious weed, were observed along the south edge of the site. The largest infestation covered less than 0.1 acre with a moderate cover class of 10 percent; while the smaller infestation was less than 0.1 acre with less than 0.1 percent cover. Less than 0.1 acre of field bindweed (*Convolvulus arvensis*) with 1–5 percent cover was observed in 2016. The infestation was located at the southeast boundary of the mitigation site. MDT will use the annual monitoring results to determine appropriate weed-control efforts. The fence that was installed around the perimeter of the site was in good working order when inspected during the 2016 field survey.

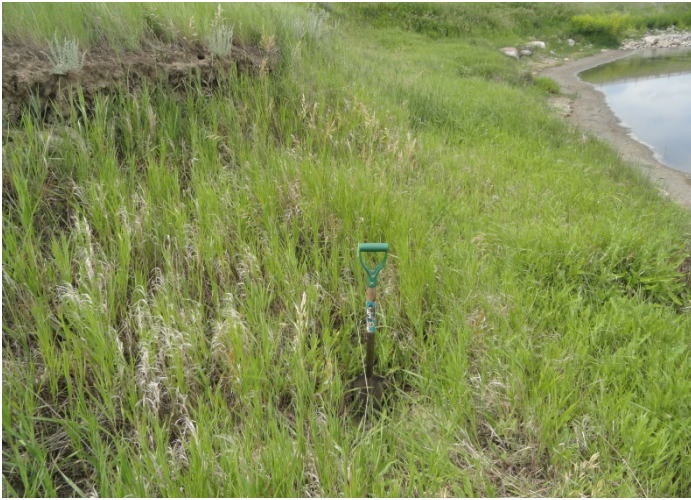
**Data Point: DP-01u  
Bearing 200 degrees**

**Location: Veg Community 2  
Year 2016**

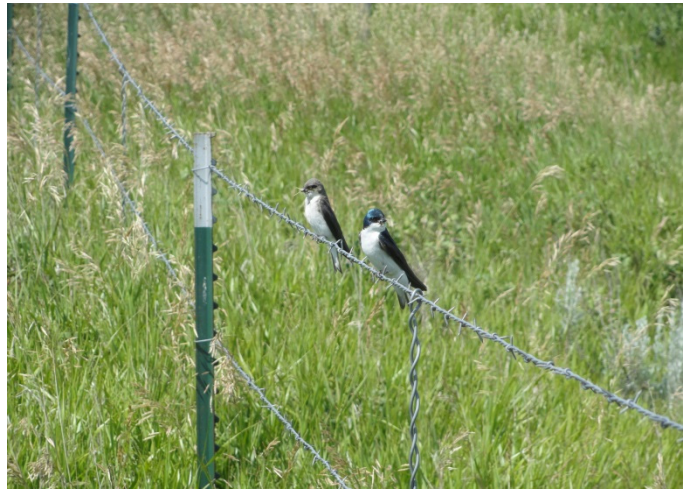
**Comments / Problems:** Bluebird box is being used by a tree swallow pair. One nest box is missing / has fallen down.

**Tree Swallow Pair – Documented Using Artificial Bird  
Box.**

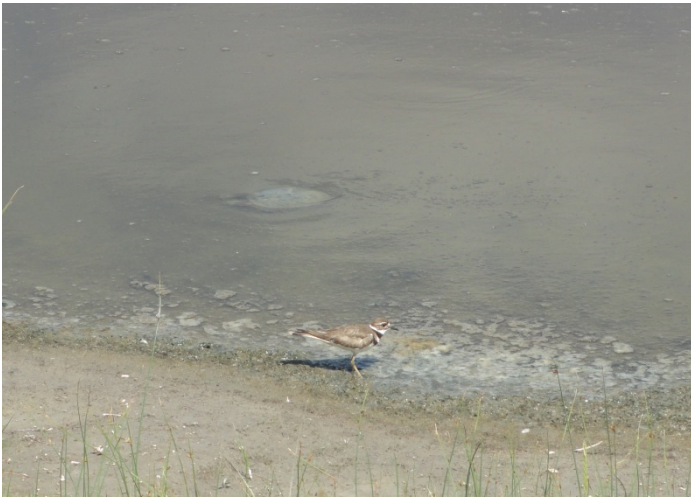
**Killdeer and Painted Turtles Common Onsite in 2016.**
