# MONTANA DEPARTMENT OF TRANSPORTATION WETLAND MITIGATION MONITORING REPORT: YEAR 2016

# ROSTAD RANCH MITIGATION SITE MEAGHER COUNTY, MONTANA

MDT Project Number STPX-0002 (749) Control Number 5565

USACE: NWO-2006-90851-MTB

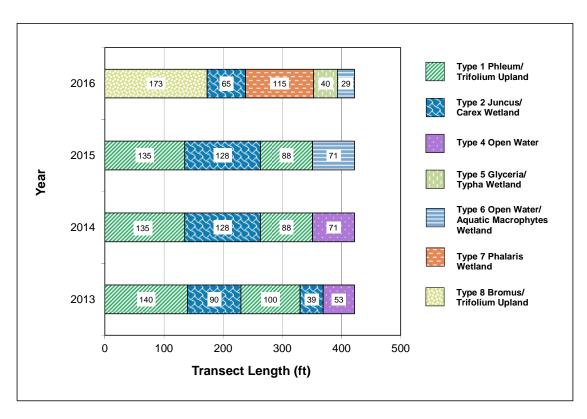
**Chart 3-1.** Transect Maps Showing Community Types on T-1 From 2013 Through 2016 at the Rostad Ranch Site.

Monitoring Year	2013	2014	2015	2016
Transect Length (feet)	422	422	422	422
Vegetation Community Transitions Along Transect	4	3	3	4
Vegetation Communities Along Transect	2	2	3	5
Hydrophytic Vegetation Communities Along Transect	1	1	2	4
Total Vegetative Species	27	30	30	26
Total Hydrophytic Species	9	9	9	10
Total Upland Species	18	21	21	16
Estimated % Total Vegetative Cover	90	95	95	95
Estimated % Unvegetated	10	5	5	5
% Transect Length Comprising Hydrophytic Vegetation Communities	30.6	30.3	47.2	59.0
% Transect Length Comprising Upland Vegetation Communities	56.9	52.8	52.8	41.0
% Transect Length Comprising Unvegetated Open Water	12.6	16.8	0	0
% Transect Length Comprising Mudflat	0	0	0	0

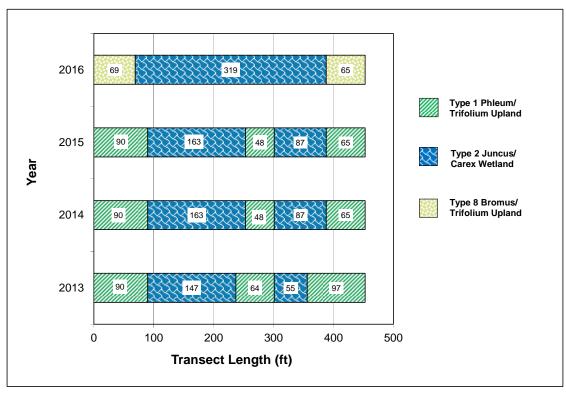
**Chart 3-3.** Transect Maps Showing Community Types on T-2 From 2013 Through 2016 at the Rostad Ranch Site.

Monitoring Year	2013	2014	2015	2016
Transect Length (feet)	453	453	453	453
Vegetation Community Transitions Along Transect	4	4	4	2
Vegetation Communities Along Transect	2	2	2	2
Hydrophytic Vegetation Communities Along Transect	1	1	1	1
Total Vegetative Species	26	27	27	25
Total Hydrophytic Species	8	7	7	7
Total Upland Species	18	20	20	18
Estimated % Total Vegetative Cover	90	95	95	95
Estimated % Unvegetated	10	5	5	5
% Transect Length Comprising Hydrophytic Vegetation Communities	44.6	55.2	55.2	70.0
% Transect Length Comprising Upland Vegetation Communities	55.4	44.8	44.8	30.0
% Transect Length Comprising Unvegetated Open Water	0	0	0	0
% Transect Length Comprising Mudflat	0	0	0	0

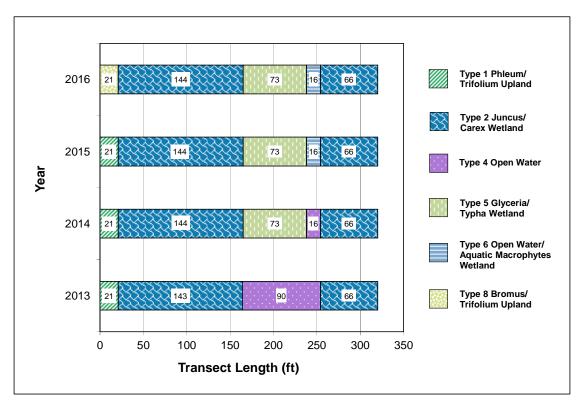
**Chart 3-5.** Transect Maps Showing Community Types on T-3 From 2013 Through 2016 at the Rostad Ranch Site.

T-3 was established in the south end of the mitigation site and traversed the excavated reestablishment and rehabilitation credit areas. Data collected on T-3 (Wetland Mitigation Site Monitoring form, Appendix B) are summarized in tabular and graphic formats in Table 3-4 and Charts 3-5 and 3-6, respectively. T-3 also began at a mature narrow-leaf cottonwood tree and extended east for 320 feet (Figure A-2, Appendix A). Photographs of the transect endpoints are shown in Appendix C. This transect originated in upland community Type 8, transitioned into wetland community Type 2, continued through wetland community Types 5 – *Glyceria grandis/Typha latifolia* and 6 – Open Water/Aquatic Macrophytes, and ended in wetland community Type 2. Wetland community Type 5 replaced a majority of the open water observed on the transect in 2013. Hydrophytic vegetation communities represented 93.4 percent of the transect intervals. Bare ground accounted for approximately 10 percent of the transect. Because of the presence of an active sandhill crane next at the east end of this transect (Figure A-2, Appendix A), field crews expedited their review of this transect and did not stretch a tape or walk the entire transect. No changes were apparent in the transect communities from 2015 based on a rapid assessment of the area.

Monitoring Year	2013	2014	2015	2016
Transect Length (feet)	320	320	320	320
Vegetation Community Transitions Along Transect	3	4	4	4
Vegetation Communities Along Transect	2	3	4	4
Hydrophytic Vegetation Communities Along Transect	1	2	3	3
Total Vegetative Species	25	31	31	31
Total Hydrophytic Species	14	16	16	16
Total Upland Species	11	15	15	15
Estimated % Total Vegetative Cover	85	90	90	90
Estimated % Unvegetated	15	10	10	10
% Transect Length Comprising Hydrophytic Vegetation Communities	65.3	88.4	93.4	93.4
% Transect Length Comprising Upland Vegetation Communities	6.6	6.6	6.6	6.6
% Transect Length Comprising Unvegetated Open Water	28.1	5	0	0
% Transect Length Comprising Mudflat	0	0	0	0
