# MONTANA DEPARTMENT OF TRANSPORTATION WETLAND MITIGATION MONITORING REPORT

## EASTON RANCH MITIGATION SITE PARK COUNTY, MONTANA

MONITORING REPORT #8: DECEMBER 2017

MDT Project Number STPX-0034(14)  
Control Number 4866

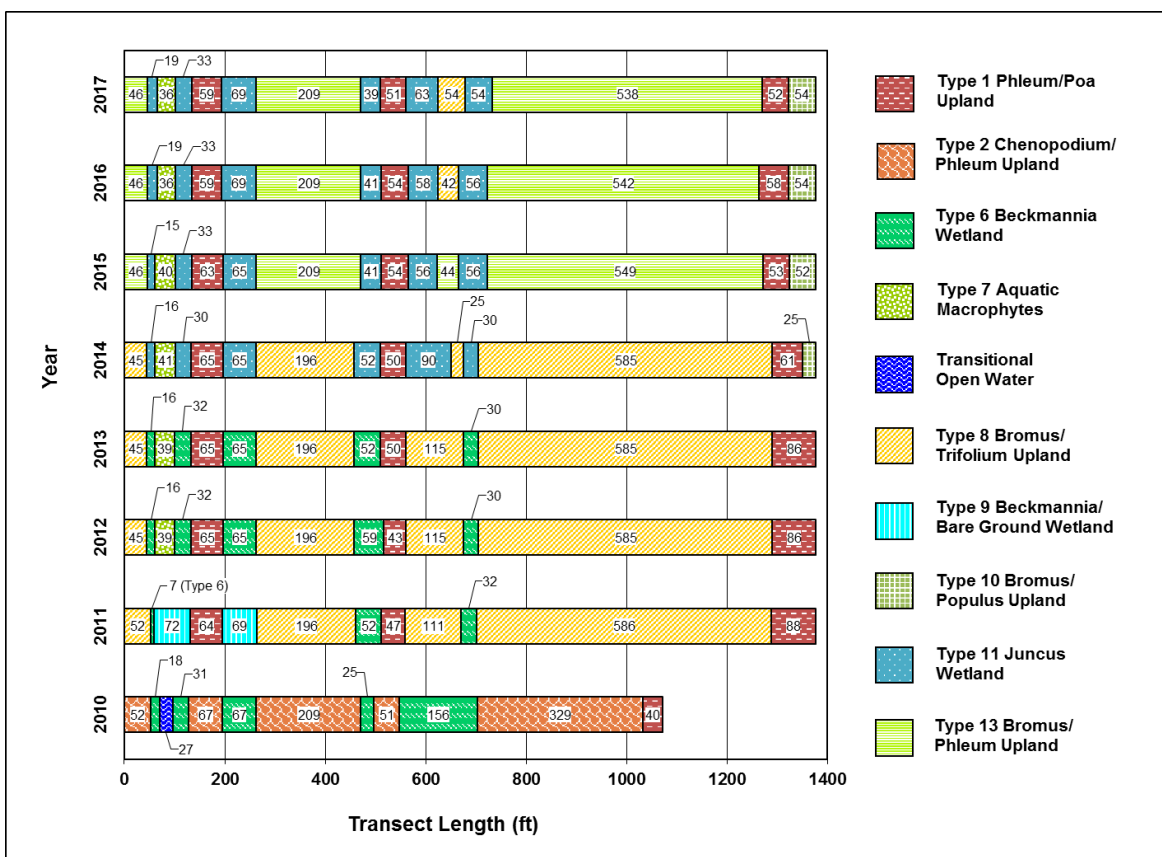
**Chart 3-1. Transect Maps Showing Community Types on T-1 From Start/South (0 Foot) to Finish/North (1,072 Feet in 2010 and 1,376 Feet From 2011 Through 2017) at the Easton Ranch Site.**

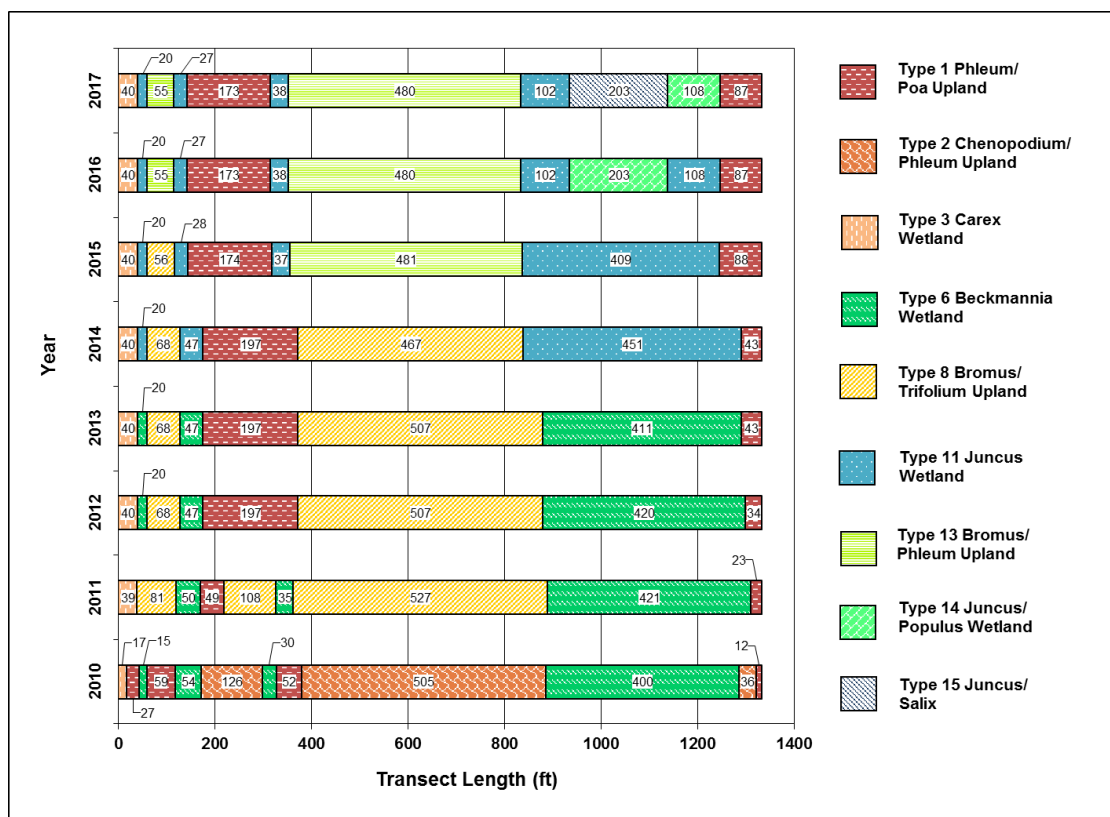
Data collected on T-2 (Wetland Mitigation Site Monitoring form, Appendix B) are summarized in tabular and graphic formats in Table 3-3 and Charts 3-3 and 3-4, respectively. The endpoints of T-2 were photographed (Appendix C). Wetland Types 3 – *Carex* spp., 11 – *Juncus* spp., 14 – *Juncus* spp./*Populus balsamifera* and Type 15 – *Juncus* spp./*Salix* spp. Upland Types 1 – *Phleum pratense*/*Poa pratensis* and 13 – *Bromus inermis*/*Phleum pratense* were identified along this transect. Community Type 14 was identified in 2016 as a result of a dominance of balsam cottonwood root suckers mixed with rush species (*Juncus* spp.) within a portion of wetland Cell 3. Balsam cottonwood plants ranged in height from 18 to 32 inches tall and represented approximately 30 percent of the total cover. Other woody plants included narrow-leaf cottonwood, yellow willow, specked alder, and narrow-leaf willow. Community Type 15 was added in 2017 to a portion of wetland Cell 3 where a variety of young willows surpassed the cover by young cottonwoods. Willows included yellow willow, Drummond willow and gray willow. Hydrophytic vegetation communities composed 40.4 percent of T-2 in 2017, which is the same as 2016. An increase of four hydrophytic species, for a total of 45 species, was documented along T-2 in 2017.

**Chart 3-3. Transect Maps Showing Community Types on T-2 From 2010 Through 2017 From Start/North (0 Foot) to Finish/South (1,333 Feet) at the Easton Ranch Site.**

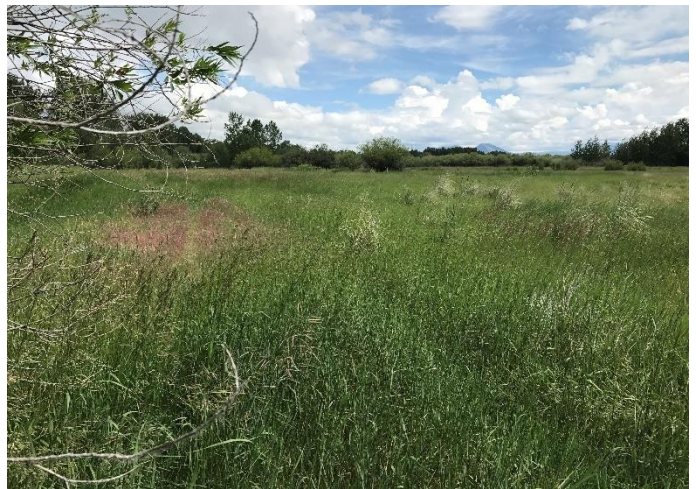
Photo Point: 5  
Bearing: 90 degrees

Location: West Boundary  
Year: 2017 (fence removed)
