# MONTANA DEPARTMENT OF TRANSPORTATION WETLAND MITIGATION MONITORING REPORT

### ROSTAD RANCH MITIGATION SITE MEAGHER COUNTY, MONTANA

MONITORING REPORT #5: DECEMBER 2017

MDT Project Number STPX-0002 (749) Control Number 5565

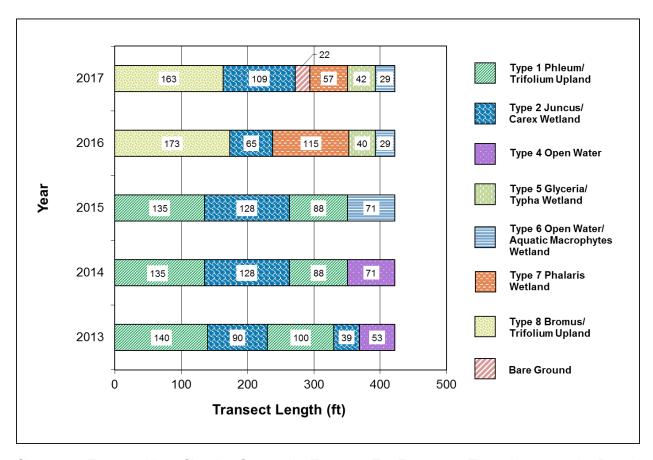
**Chart 3-1.** Transect Maps Showing Community Types on T-1 From 2013 Through 2017 at the Rostad Ranch Site.

Table 3-2. Data Summary for T-1 From 2013 Through 2017 at the Rostad Ranch Site

Monitoring Year	2013	2014	2015	2016	2017
Transect Length (feet)	422	422	422	422	422
Vegetation Community Transitions Along Transect	4	3	3	4	5
Vegetation Communities Along Transect	2	2	3	5	5
Hydrophytic Vegetation Communities Along Transect	1	1	2	4	4
Total Vegetative Species	27	30	30	26	23
Total Hydrophytic Species	9	9	9	10	10
Total Upland Species	18	21	21	16	13
Estimated % Total Vegetative Cover	90	95	95	95	95
Estimated % Unvegetated	10	5	5	5	5
% Transect Length Comprising Hydrophytic Vegetation Communities	30.6	30.3	47.2	59.0	56.0
% Transect Length Comprising Upland Vegetation Communities	56.9	52.8	52.8	41.0	44.0
% Transect Length Comprising Unvegetated Open Water	12.6	16.8	0	0	0
% Transect Length Comprising Mudflat	0	0	0	0	0

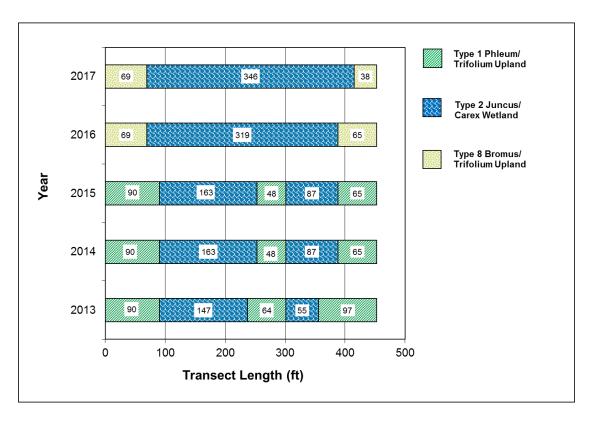
**Chart 3-3.** Transect Maps Showing Community Types on T-2 From 2013 Through 2017 at the Rostad Ranch Site.

Data collected on T-2 (Wetland Mitigation Site Monitoring form, Appendix B) are summarized in tabular and graphic formats in Table 3-3 and Charts 3-3 and 3-4, respectively. Photographs at the transect endpoints are provided in Appendix C. This transect began at a mature narrow-leaf cottonwood (*Populus angustifolia*) tree near the entrance of the site, extended 453 feet, and alternated between upland community Type 8 and wetland community Type 2. Six hydrophytic and eleven upland species were identified along the transect. Hydrophytic vegetation composed 76 percent of T-2 in 2017.

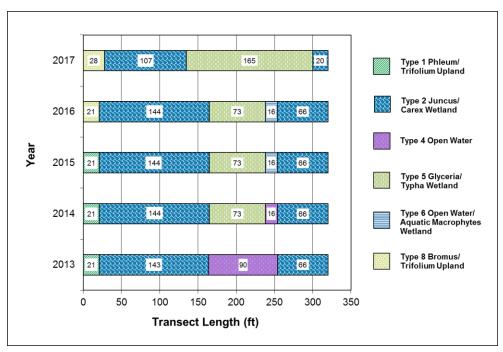
**Chart 3-5.** Transect Maps Showing Community Types on T-3 From 2013 Through 2017 at the Rostad Ranch Site.

T-3 was established in the southern end of the mitigation site and traversed the excavated reestablishment and rehabilitation credit areas. Data collected on T-3 (Wetland Mitigation Site Monitoring form, Appendix B) are summarized in tabular and graphic formats in Table 3-4 and Charts 3-5 and 3-6, respectively. T-3 also began at a mature narrow-leaf cottonwood tree and extended east for 320 feet (Figure A-2, Appendix A). Photographs of the transect endpoints are shown in Appendix C. This transect originated in upland community Type 8, transitioned into wetland community Type 2, continued through wetland community Type 5 and ended in wetland community Type 2. Wetland community Type 5 has replaced all of the open water along this transect. Hydrophytic vegetation communities represented 91 percent of the transect intervals.

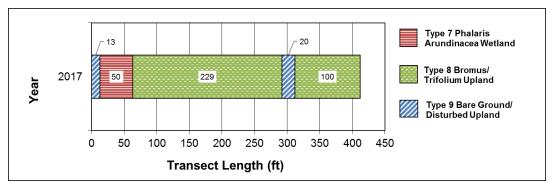
Chart 3-7. Transect Maps Showing Community Types on T-4 in 2017 at the Rostad Ranch Site.

T-4 was established in 2017 to assess hydrologic and plant community changes on the western portion of the site caused by the adaptive management changes initiated in 2017. Data collected on T-4 (Wetland Mitigation Site Monitoring form, Appendix B) are summarized in tabular and graphic formats in Table 3-5 and Charts 3-7 and 3-8, respectively. T-4 starts on a newly constructed berm, extends northerly for 412 feet, and terminates at an interpretive sign adjacent to the main roadway adjacent to the property (Figure A-2, Appendix A). Photographs of the transect endpoints are shown in Appendix C. This transect originates in upland community Type 9 – Bare Ground/Disturbed, transitions into wetland Type 7 – *Phalaris arundinacea*, and then alternates between upland Types 8 – *Bromus inermis/Trifolium* spp. and 9. Inundation was noted across much of this transect in 2017 because of irrigation water being spread across the site. Recent inundation had not caused plant community changes in this area in 2017.

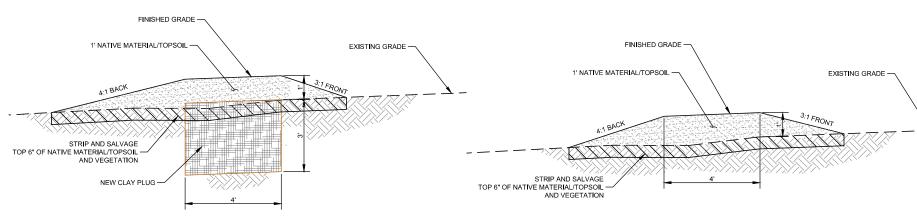
SPREADER BERM 1 AND DITCH PLUG 1 DETAIL 2

SPREADER BERM 2, 3 AND 4 DETAIL 3
