# MONTANA DEPARTMENT OF TRANSPORTATION WETLAND MITIGATION MONITORING REPORT

## SCHRIEBER LAKE MITIGATION SITE LINCOLN COUNTY, MONTANA

MONITORING REPORT #7: DECEMBER 2017

MDT Project Number NH 27(029)  
Control Number 1027007

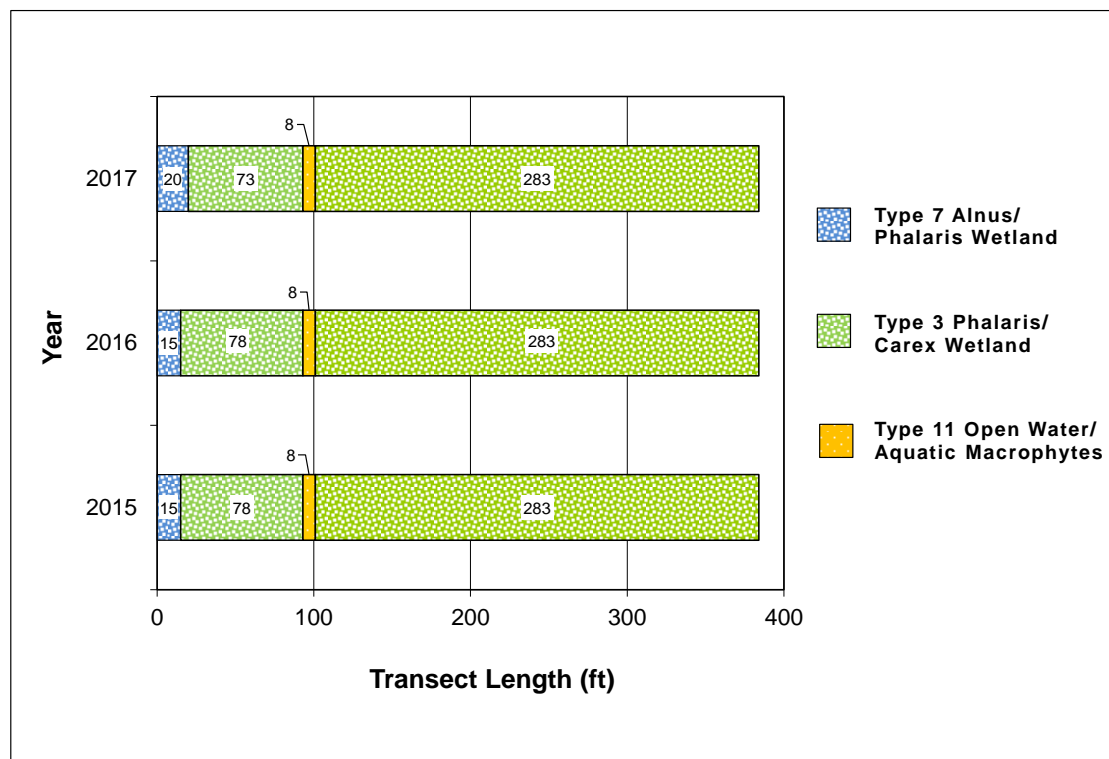
**Chart 3-1. Transect Map Showing Community Types on T-1 From 2015 Through 2017 From Start (0 Foot) to Finish (384 Feet).**

Trends in plant species composition were measured on three transects (T-1, T-2, and T-3) in 2017. Photographs of the transect end points are shown in Appendix C. T-1 consists of a 384-foot transect that was established during initial monitoring at the site in 2015. Table 3-2 and Charts 3-1 and 3-2 summarize the data for T-1 (Wetland Mitigation Site Monitoring form, Appendix B). Community Types 3, 7, and 11 were identified along this transect. All three vegetative communities are considered wetland communities. Site conditions in 2017 remained mostly similar to those observed in 2016.

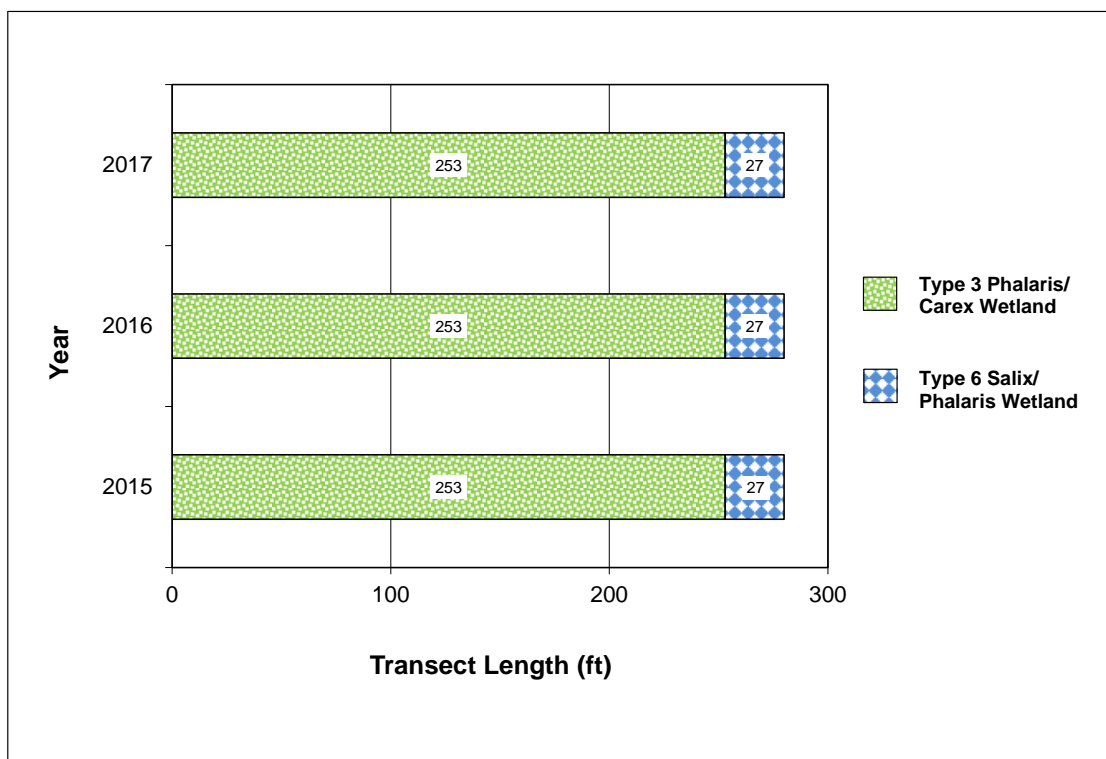
**Chart 3-3.** Transect Map Showing Community Types on T-2 From 2015 Through 2017 From Start (0 Foot) to Finish (280 Feet).

T-2 crossed wetland community Type 3 – *Phalaris arundinacea*/*Carex* sp. and wetland community Type 6 – *Salix bebbiana*/*Phalaris arundinacea* in the middle of the restored wetland area (Figure A-2, Appendix A). Hydrophytic vegetation communities dominated 100 percent of the transect (Figure A-3, Appendix A). Details of the transect data are summarized and graphed on Table 3-3 and Charts 3-3 and 3-4. Site conditions in 2017 remained similar to those observed in 2016. Photographs of the endpoints of T-2 are shown in Appendix C.

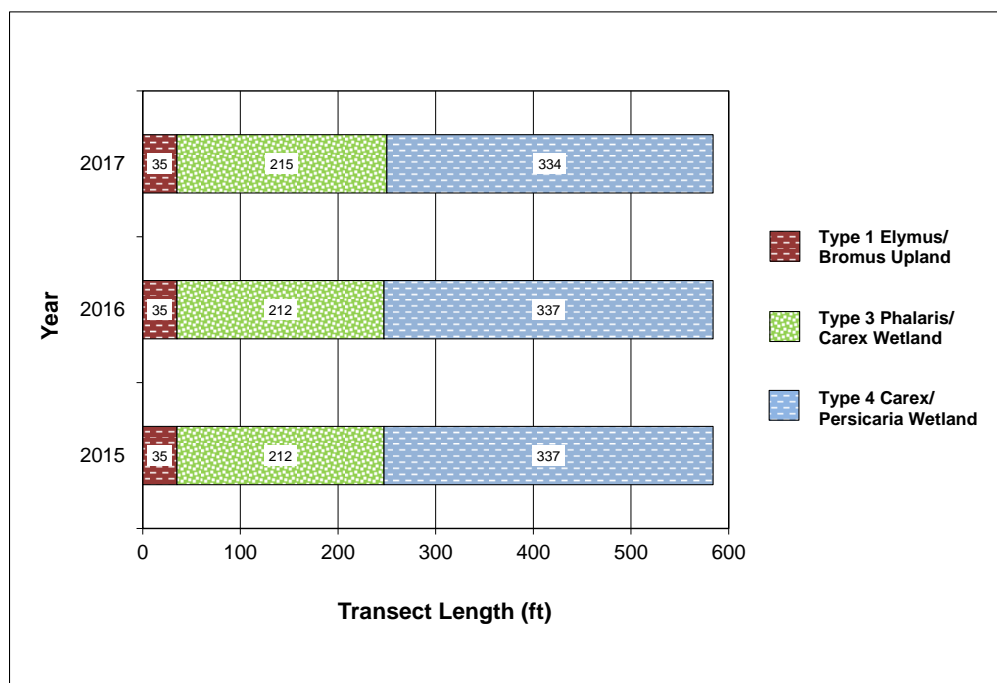
**Chart 3-5. Transect Map Showing Community Types on T-3 From 2015 Through 2017 From Start (0 Foot) to Finish (584 Feet).**

T-3 extended 584 feet at 175 degrees on the western side of the restored area (Figure A-2, Appendix A). Transect details are shown on Table 3-4 and Charts 3-5 and 3-6 (Wetland Mitigation Site Monitoring forms, Appendix B). Site conditions in 2017 remained similar to those observed in 2016. The transect crossed three communities: wetland community Types 3 – *Phalaris arundinacea*/*Carex* sp. and 4 – *Carex simulate*/*Persicaria amphibia* and upland community Type 1 – *Elymus repens*/*Broums inermis*. Sixteen plant species were identified along the transect. Photographs of the T-3 endpoints are shown in Appendix C.

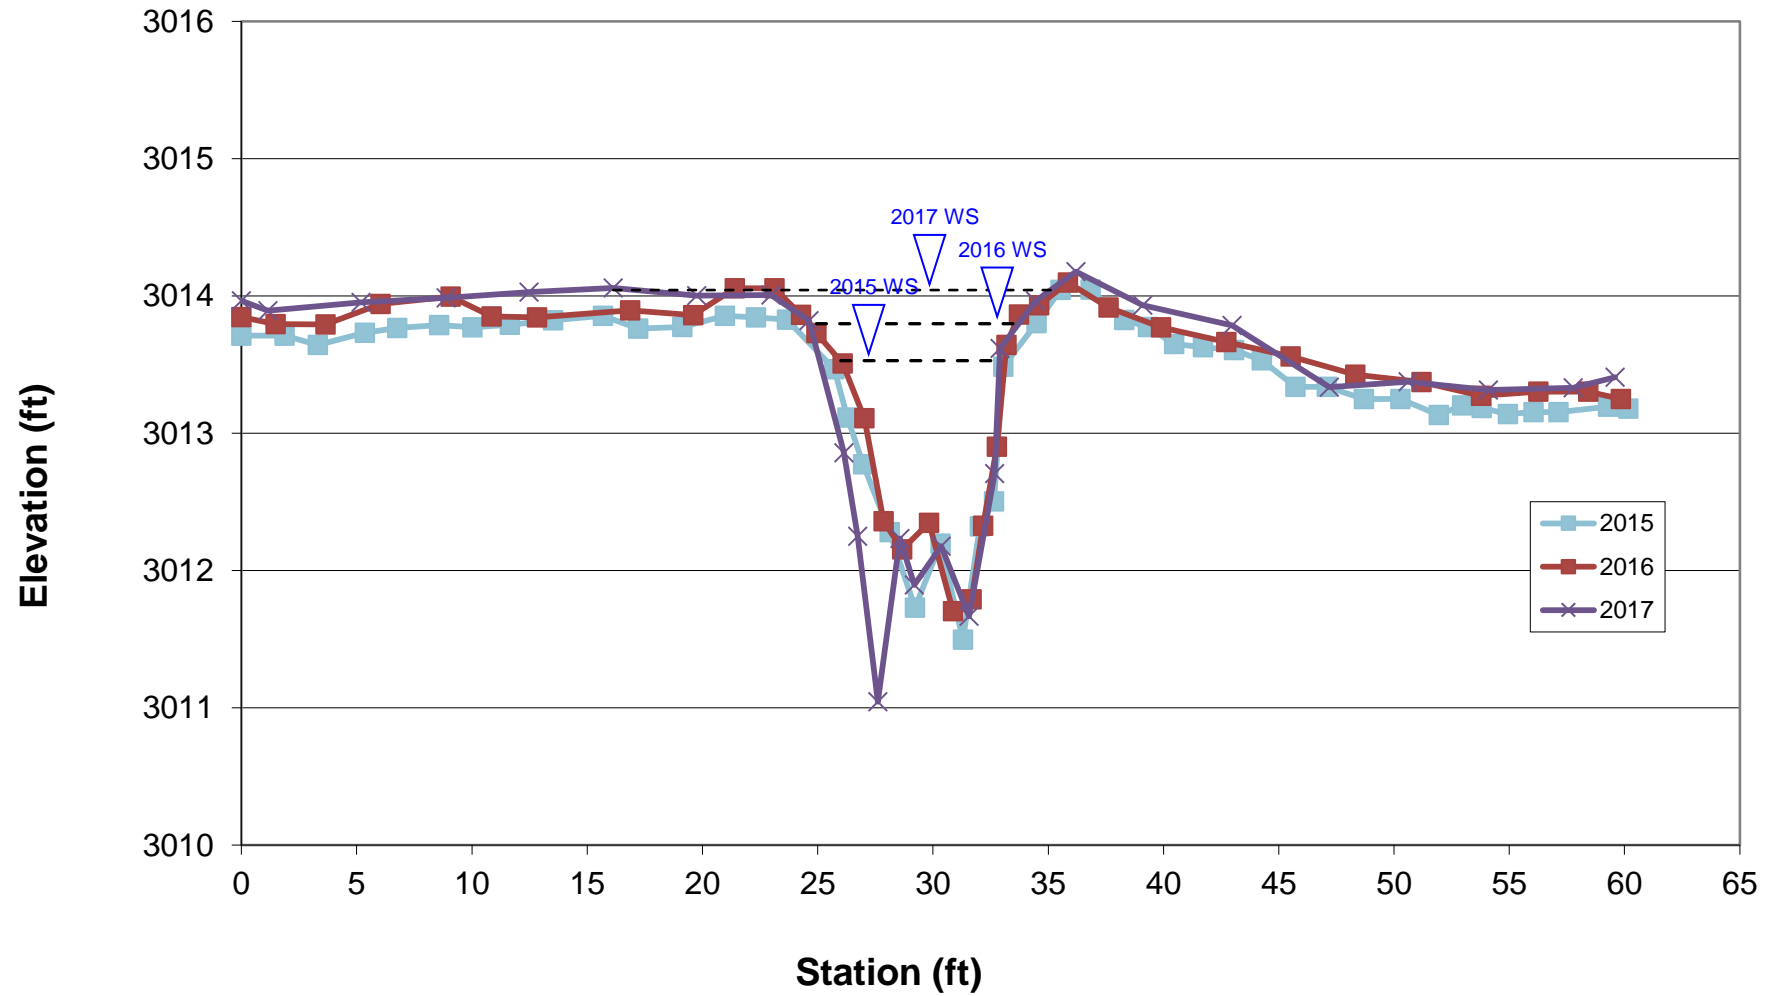
# SC7-1

The most apparent change in the monitored cross sections from the current year occurred at SC7-1. At this location, a slight deepening and widening produced changes in bankfull channel width, cross-sectional area, and W:D ratio. This cross section is located in a reactivated historic reach, similar to CC1B-1, both at breaks in the dense riparian canopy. Substantial muck comprises the channel bottom at both of these sections. The depositional conditions at these sections complicate surveying the channel bottom and banks, which potentially influences comparisons between monitoring years.

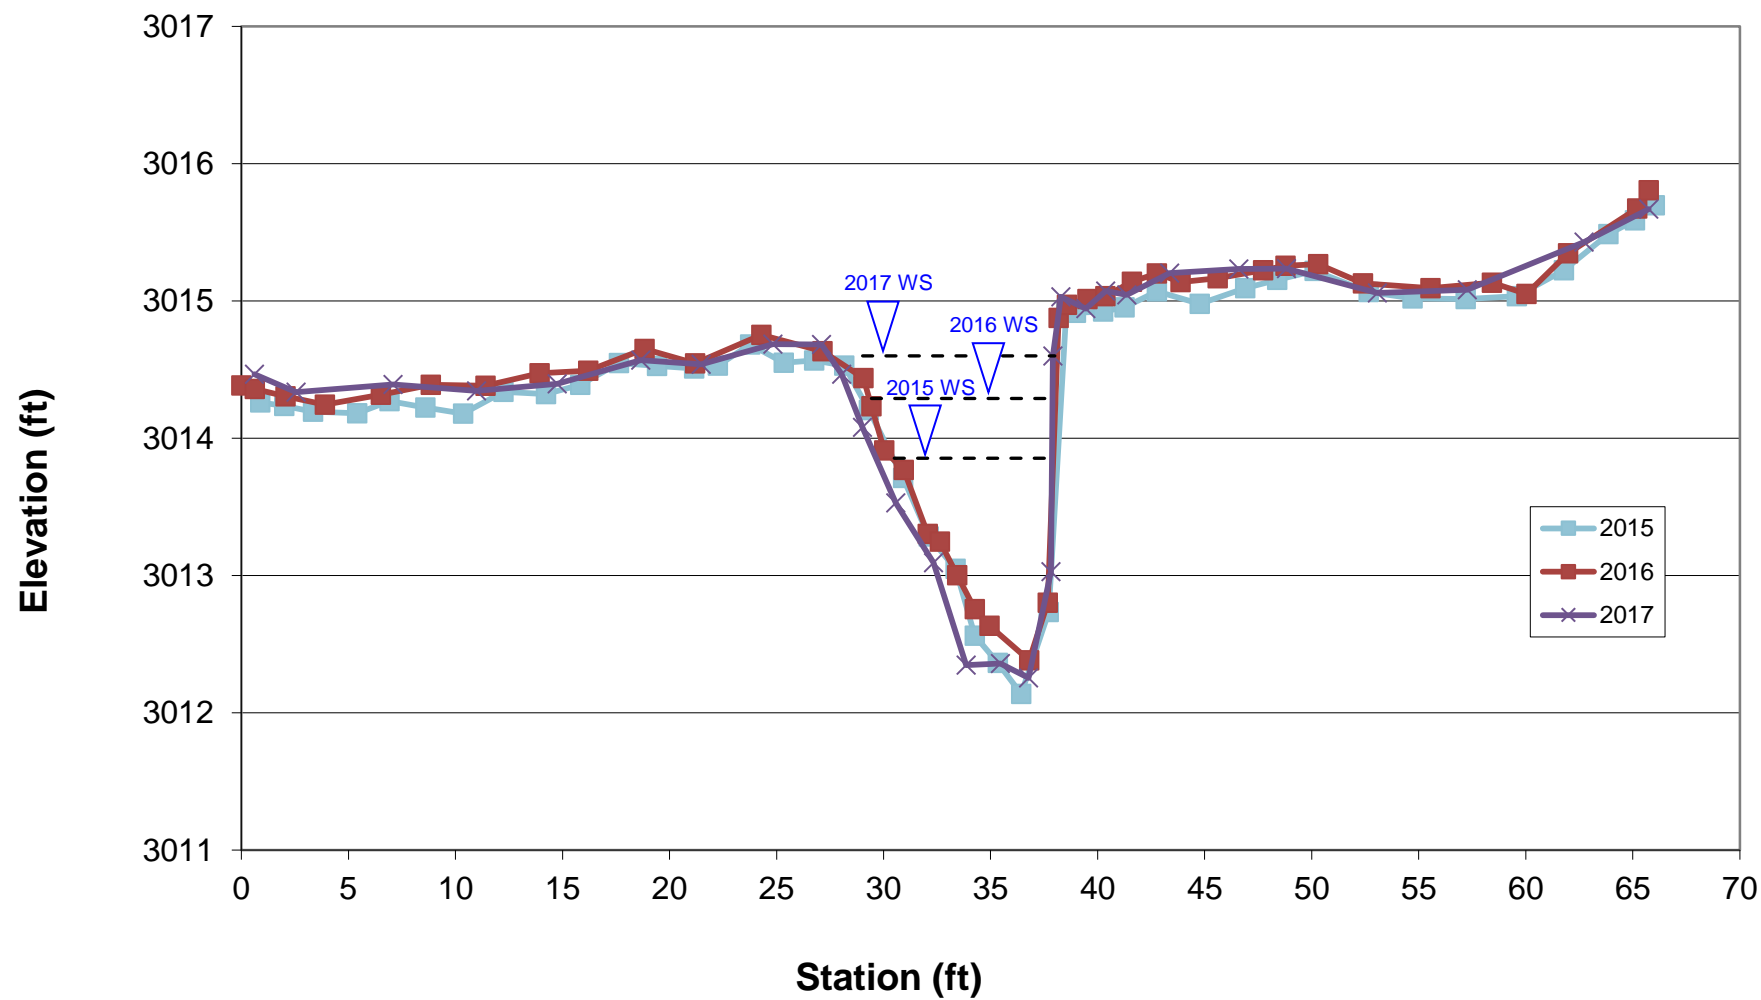
# CC1A-1

Reach 1 of Coyote Creek was designed as a perennial, Rosgen E-type channel through the lower hay meadow. Two cross sections were surveyed within Reach 1 of Coyote Creek and displayed very low W:D ratios that indicate an E-type channel. CC1A-1 displayed a bankfull width (10.2 feet) that was higher than the range of design widths specified for Reach 1 (6.6–8.2 feet). Channel sinuosity through Reach 1A is 1.8, which falls within the range that is often observed in E-type channels.

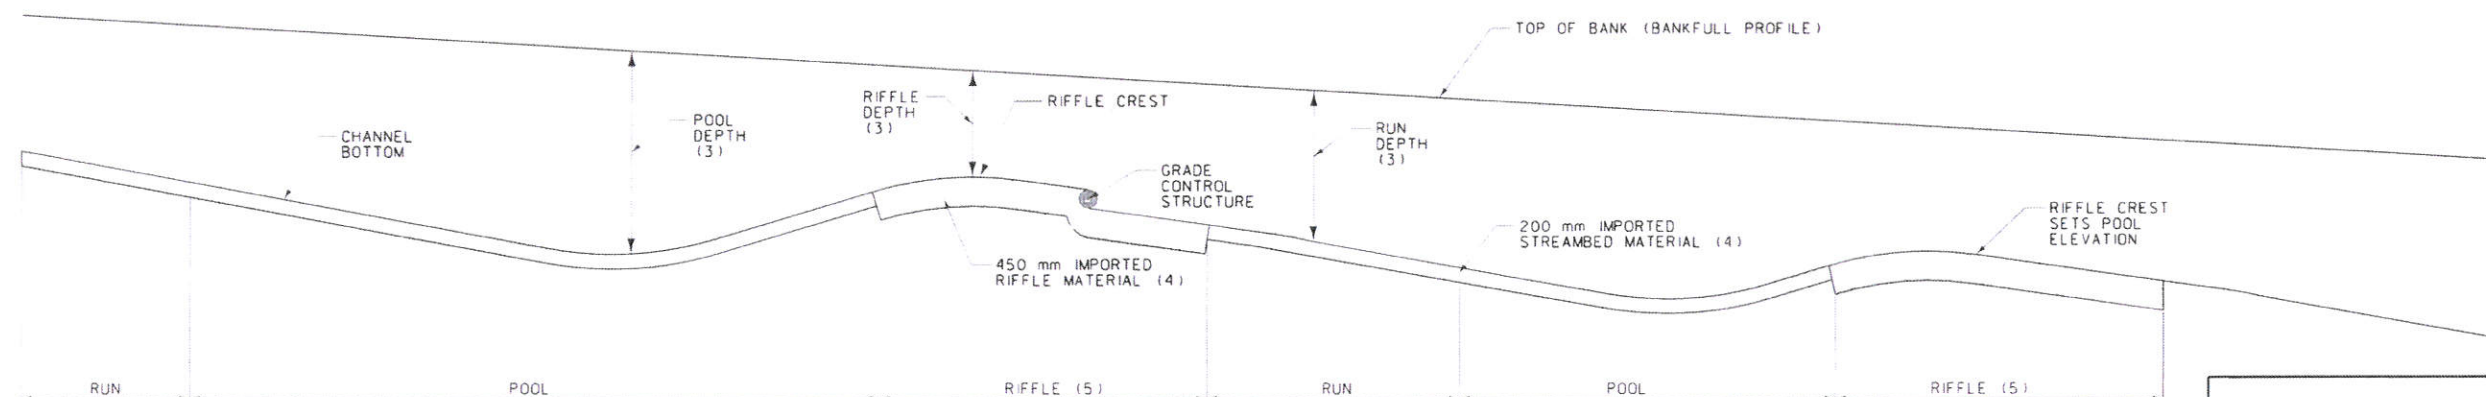
BANK PROTECTION PLAN  
(NOT TO SCALE)

- (1) THIS DETAIL SHOWS TYPICAL BANK PROTECTION INSTALLATION. SEE PLANS, SPECIALS, AND SUMMARIES FOR MORE INFORMATION.
- (2) GRADE CONTROL STRUCTURES IN SEGMENT 1 WILL BE LOCATED PER PLANS OR AS DIRECTED BY THE SRS.
- (3) SEE TYPICAL CHANNEL SECTION DIMENSIONS DETAIL FOR CHANNEL DEPTHS & WIDTHS.
- (4) SEE SPECIAL PROVISIONS FOR MATERIAL AND CONSTRUCTION REQUIREMENTS FOR IMPORTED STREAMBED AND RIFFLE MATERIALS.
- (5) RIFFLE LENGTH VARIES BUT IS APPROXIMATELY 2 TIMES THE BANKFULL WIDTH. THE EXACT LENGTH TO BE DETERMINED BY THE SRS.

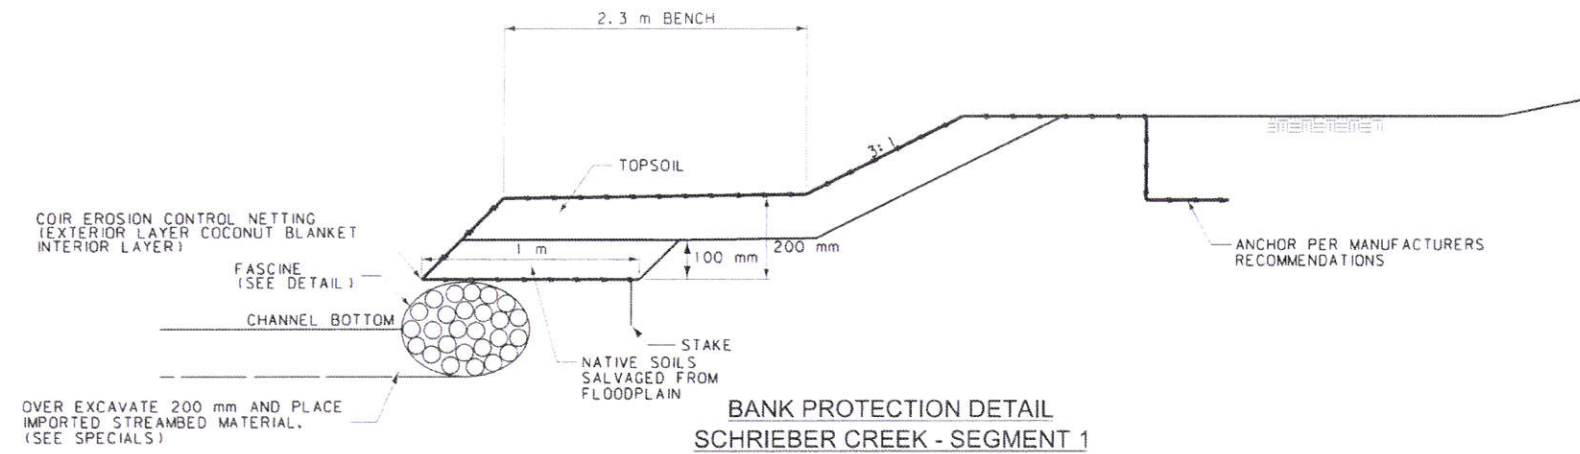
CHANNEL STRUCTURE  
AND STREAM BANK  
PROTECTION DETAILS  
(NOT TO SCALE)

FASCINE

NOTE: OBTAIN LIVE CONIFER BRANCHES  
13 mm TO 50 mm  
DIAMETER, 1.5 m TO 3.0 m LONG.  
SIDE BRANCHES CAN BE LEFT INTACT.  
STAGGER CUTTINGS IN A UNIFORM BUNDLE,  
1.5 m TO 6.1 m LONG DEPENDING ON SITE  
CONDITIONS AND HANDLING CAPABILITIES.  
VARY ORIENTATION OF CUTTINGS.  
TIE BUNDLE WITH 100% BIODEGRADABLE  
BINDING MATERIAL

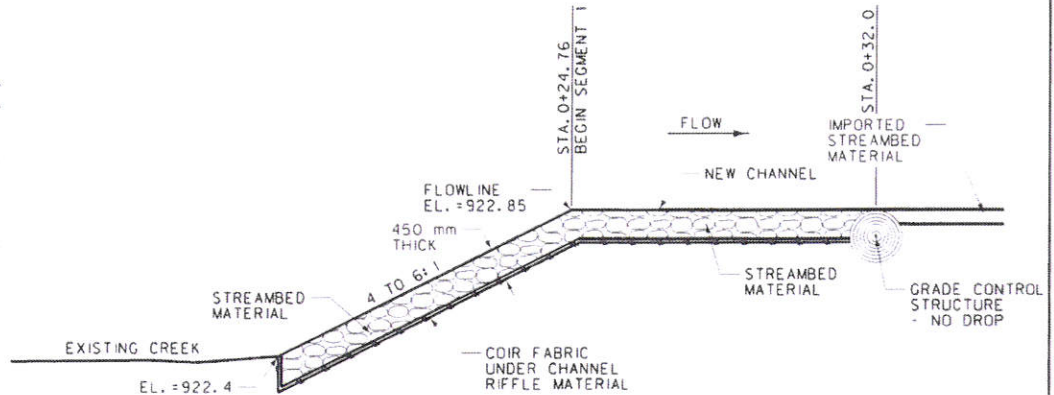
SECTION B-B  
SCHRIEBER CREEK  
EXISTING CHANNEL TO  
NEW CHANNEL TRANSITION

- (1) BURY AND ANCHOR PERMANENT EROSION CONTROL GEOTEXTILE SO THAT NO PORTION OF THE FABRIC IS EXPOSED.  
(2) PLACE AND COMPACT SUITABLE MATERIALS PER SECTION 203, EARTH EMBANKMENT.
