## WETLAND MITIGATION MONITORING REPORT

### **US HIGHWAY 93 ONSITE: PETERSON PROPERTY**

### **LAKE COUNTY, MONTANA**

MONITORING REPORT #9: DECEMBER 2017

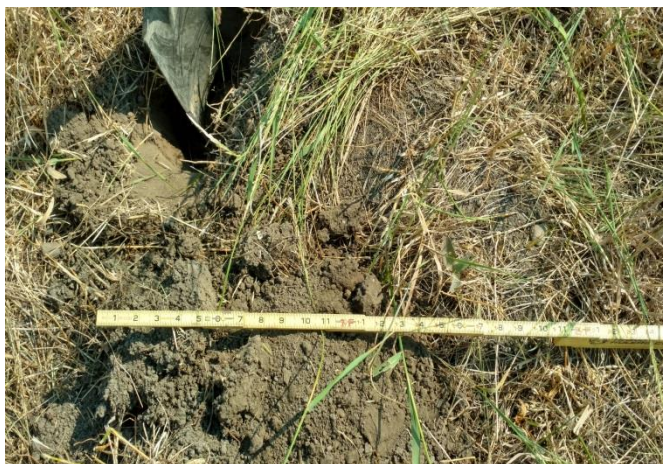
Data Point: DP-1U  
Year: 2017

the surface, which indicated a hydric soil. The profile at DP-1U revealed a very dark brown (10 YR 3/2), clay loam without redoximorphic features. No positive indicators of hydric soil were observed at DP-1U.
