MONTANA DEPARTMENT OF TRANSPORTATION WETLAND MITIGATION MONITORING REPORT

EASTON RANCH MITIGATION SITE PARK COUNTY, MONTANA

MONITORING REPORT #9: DECEMBER 2018

MDT Project Number STPX-0034(14)
Control Number 4866

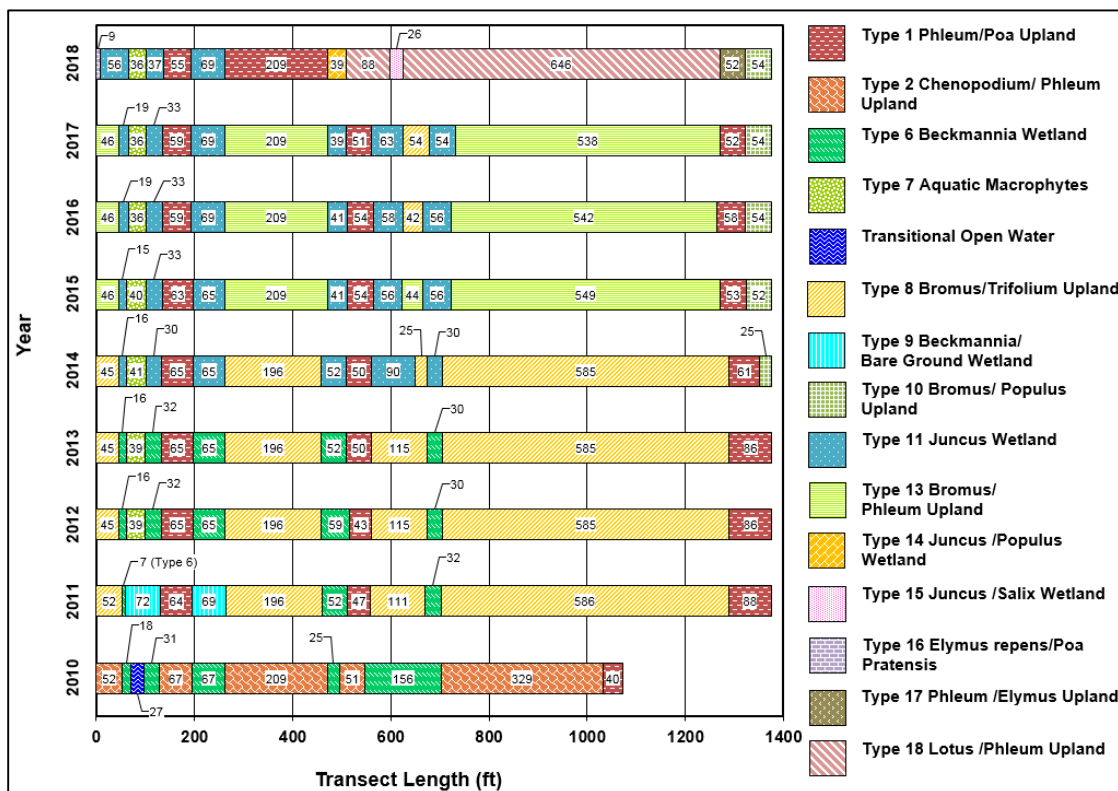
Chart 3-1. Transect Maps Showing Community Types on T-1 From Start/South (0 Foot) to Finish/North (1,072 Feet in 2010 and 1,376 Feet From 2011 Through 2018) at the Easton Ranch Site.

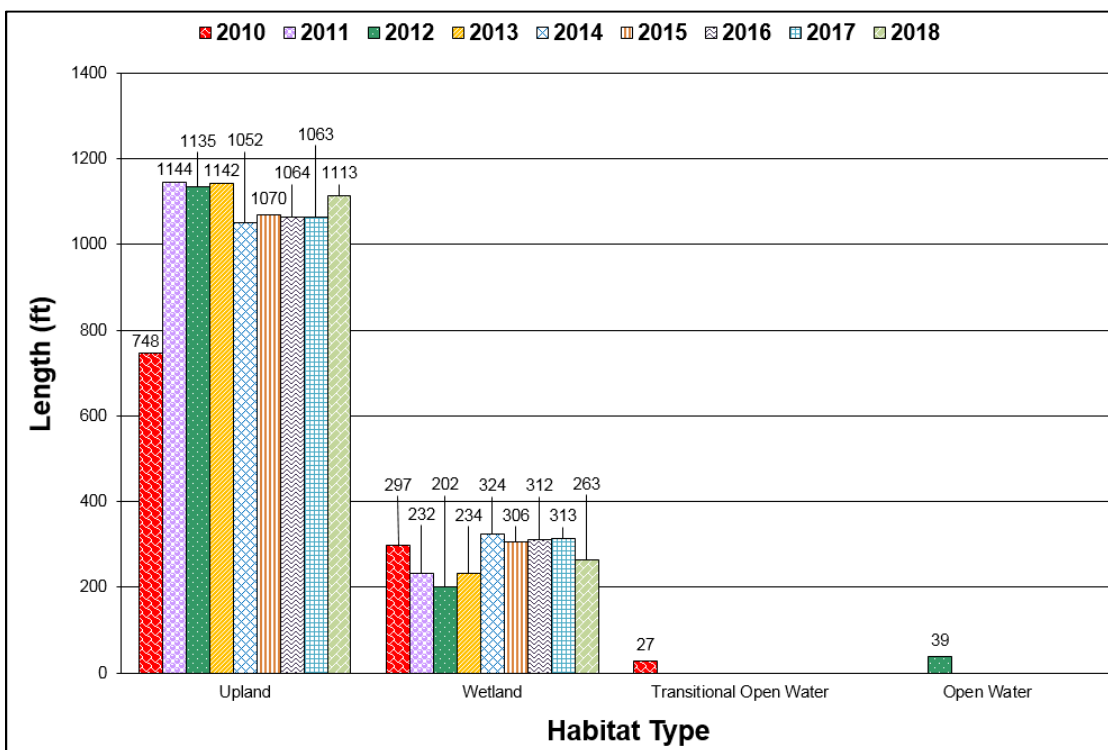
Chart 3-2. Length of Habitat Types Within T-1 From 2010 Through 2018 at the Easton Ranch Site.

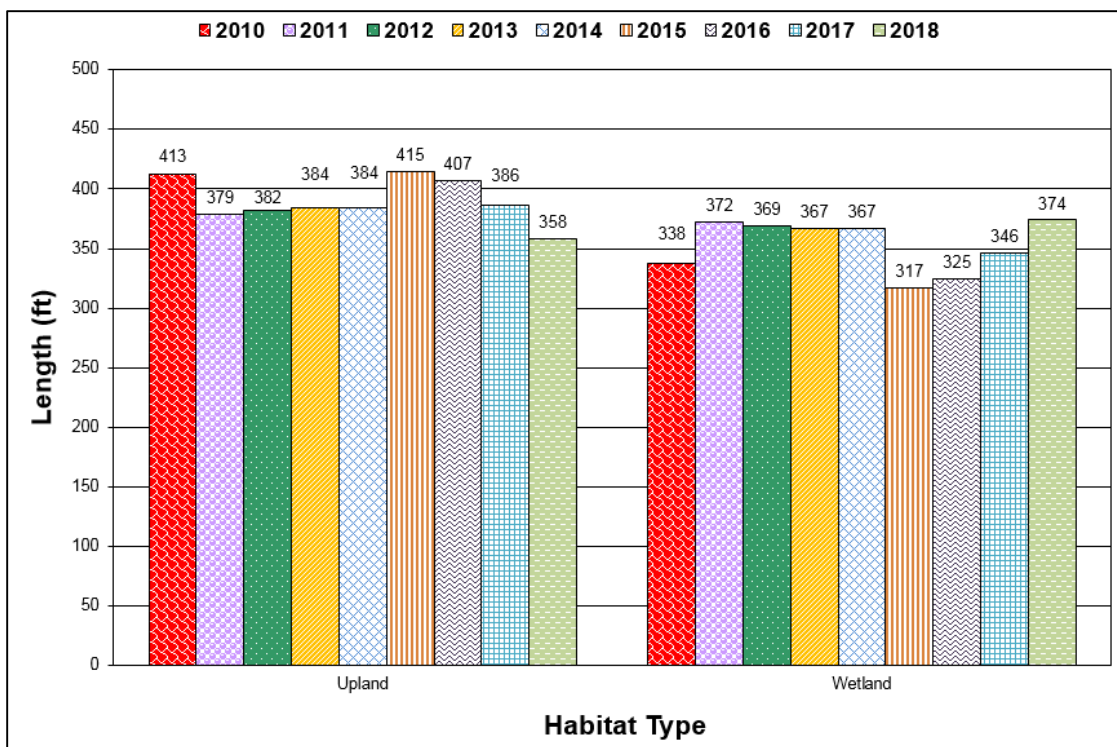
Chart 3-6. Length of Habitat Types Within T-3 From 2010 Through 2018 at the Easton Ranch Site.

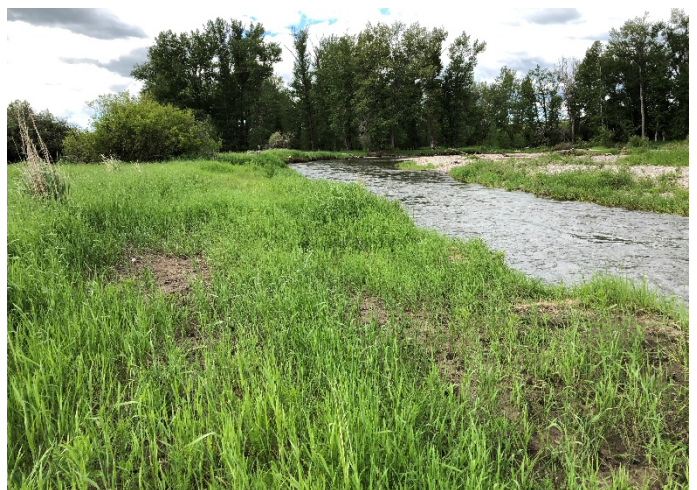
Photo Point: 4A
Bearing: 170 degrees

Location: Shields Bank DS
Year: 2018

The eastern bank of the Shields River along the northwestern corner of the Easton Ranch mitigation site remained relatively stable from project completion through the 2011 runoff event. The structural integrity of the coir-wrapped soil lifts was intact after high flows. Fine-grain deposits accumulated on the lifts as floodwaters receded. The 2011 flood flows caused a wider base-flow channel to form because of a slight westward shift of the western bank, away from the site.

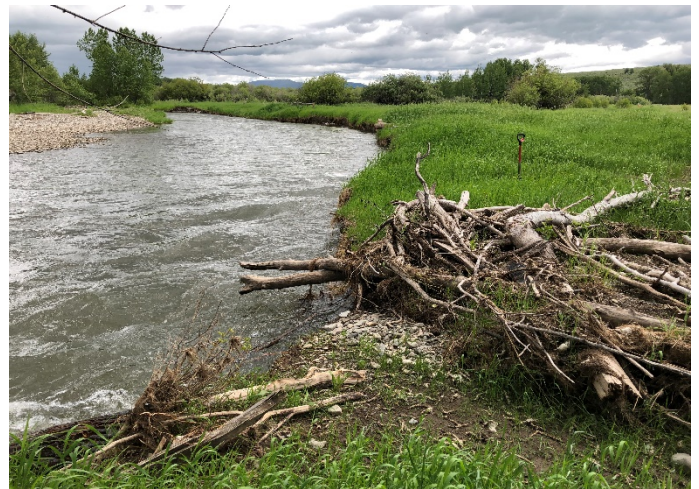
Location: Shields Bank US
Year: 2018 – New location*

* new photo point location due to bank loss during high flows in 2018.

Some re-accumulation of woody debris in the former log jam location was noted in 2018,. Stacked piles of wood debris were noted previously in the floodplain were burned or hauled away. Photo point PP4B, which is located on the south side of the river, needed to be relocated further to the south in 2018 because of the bank erosion and woody debris accumulation. Although additional bank erosion

has been noted since the dramatic lateral cutting event of 2013, this section of bank remains exposed and vulnerable. The 2018 runoff period was supported by above-average precipitation in June.
