## EASTON RANCH MITIGATION SITE

### **Project Overview**

**Monitoring Year:** 2020

MDT Wetland Mitigation Monitoring  
Easton Ranch  
Park County, Montana

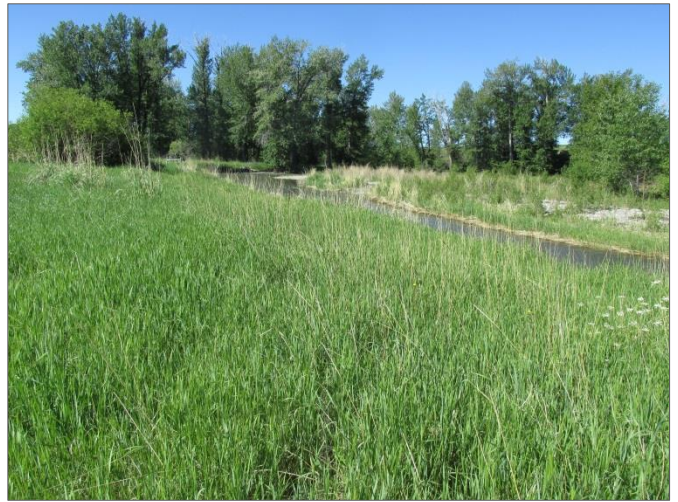
Photo Point: 4A  
Bearing: 170 degrees

Location: Shields Bank DS  
Year: 2020

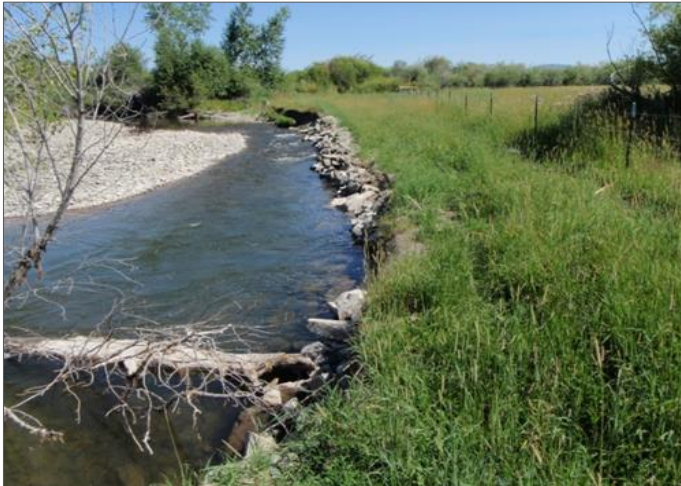
Photo Point: 4B  
Bearing: 20 degrees

\* new photo point location due to bank loss during high flows in 2018.

**Activity:** Weed Spraying **Date:** July 4, 2020 **Specific recommendations for any additional corrective actions:** Weed treatment will continue in 2021. Soil lifts and riprap installed along the bank of the Shields River are eroding in northwestern corner of the site. This bank area is generally dominated by shallow-rooting pasture grasses. MDT will assess this bank erosion and potential need for woody plant installation.

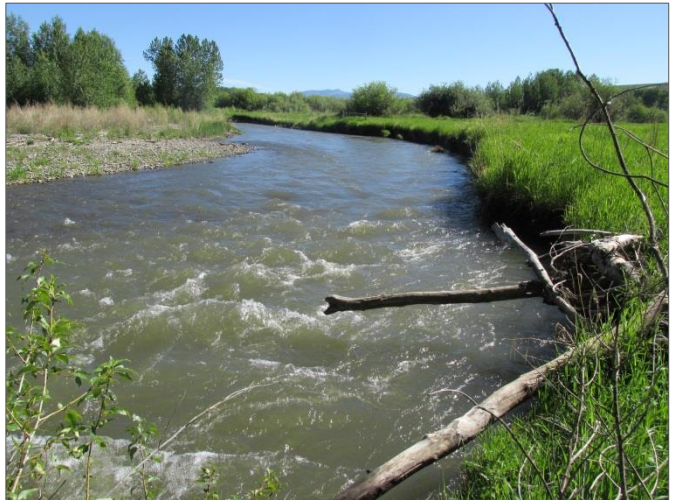
Photo Point: 4B  
Bearing: 20 degrees

Location: Shields Bank US  
Year: 2020 – New location\*

**Stream Bank Stabilization** – During the 2013 high-flow event (spring 2013), significant bank erosion occurred immediately upstream of PP4B. This erosion exposed the riprap and undermined the riprap along an approximately 85-foot-long reconstructed bank and undermined the coir-wrapped soil lifts, which caused significant loss of soil and willow cuttings. Photo point PP4B, located at the south end of the reconstructed bank, had to be relocated because of bank erosion and woody debris accumulation. Additional bank erosion has been noted since the dramatic lateral cutting event of 2013, and this section of bank remains exposed and vulnerable. The 2018 runoff period was supported by above-average precipitation in June. In 2019 and 2020, bank erosion had continued along the downstream or southern portion of the 85-foot-long bank and resulted in areas of undercutting or loss of finer textured subsoils.

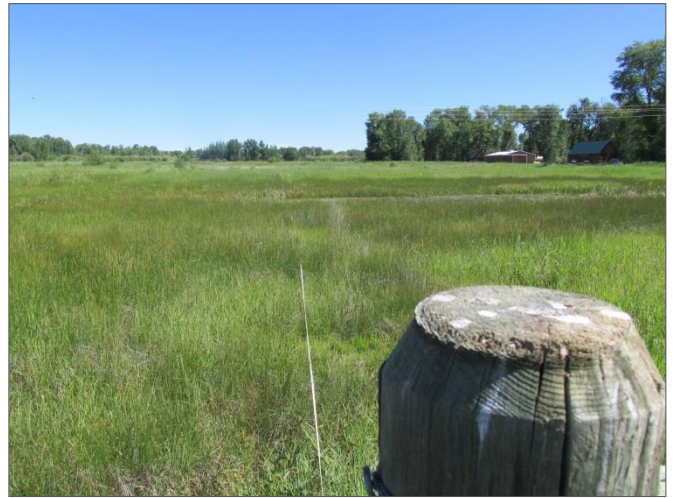
Transect 1: Start  
Bearing: 5 degrees  
Location: Veg Com 21 foreground  
Year: 2020

A new community type mapped in 2019, within transects 1 and 2. In 2020, an increase in Carex spp. within CT 11 has expanded CT 21 and replaced portions of CT 11.
