## ROSTAD RANCH MITIGATION SITE

**Monitoring Year:** 2020

**Corps Permit Number:** NWO-2006-90851-MTB

**Monitoring Conducted By:** Confluence Consulting Inc.

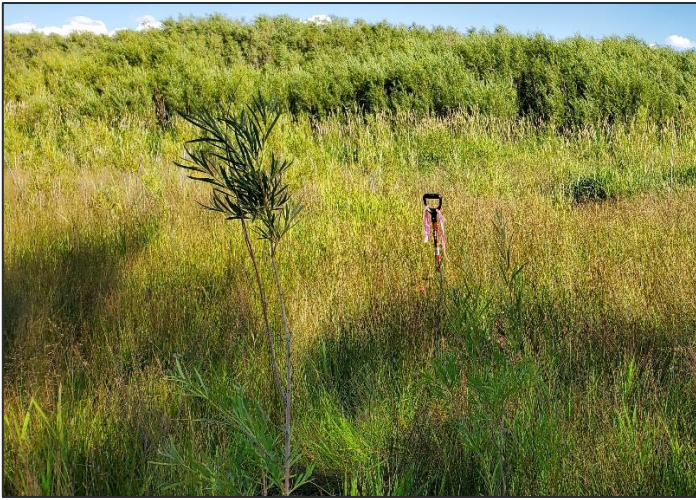
**Data Point:** DP01w      **Location:** Southwest corner of site.  
**Year:** 2020

Depth (inches)	Matrix		Redox Features				Texture	Remarks
	Color (moist)	%	Color (moist)	%	Type <sup>1</sup>	Loc <sup>2</sup>		
0-11	7.5YR 3/2	98	2.5/0	1	D	M	Sandy Clay Loam	Depletions.
0-11	7.5YR 3/2	98	7.5YR 5/6	1	C	M	Sandy Clay Loam	Concentrations.
11-13	10YR 6/3	98	2.5/0	2	D	M	Loamy Sand	Depletions.

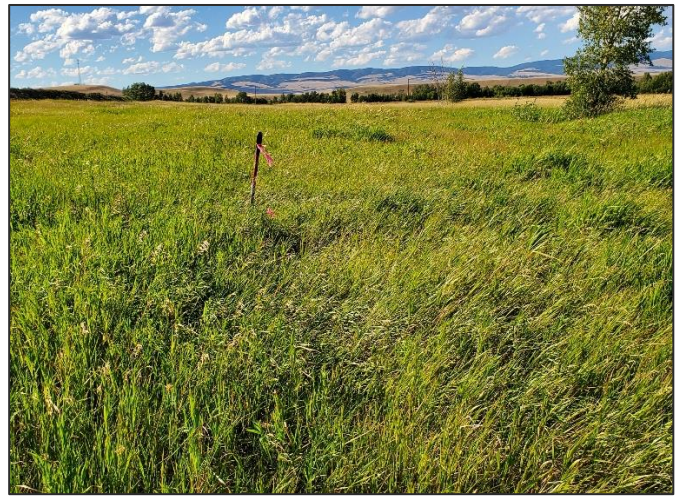
**Data Point:** DP01u      **Location:** West across wetland boundary from DP01w in SW corner of site.      **Year:** 2020

Depth (inches)	Matrix		Redox Features				Texture	Remarks
	Color (moist)	%	Color (moist)	%	Type <sup>1</sup>	Loc <sup>2</sup>		
0-14	10YR	3/2		100			Sandy Loam

Remarks: No hydric soil indicators observed.

Remarks: No evidence of wetland hydrology observed.

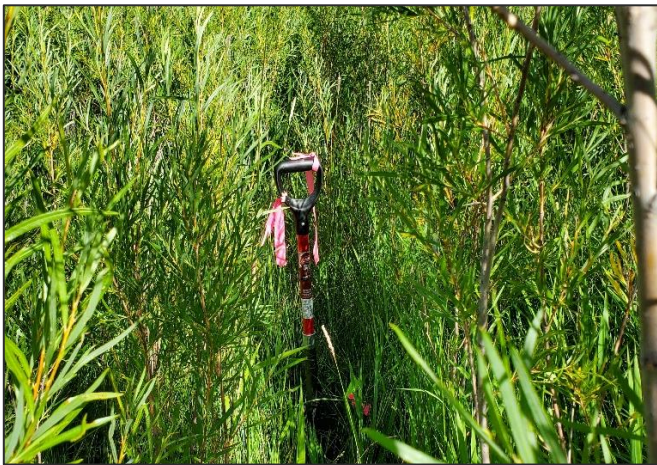
**Data Point:** DP02w      **Location:** Southwest corner of site, south of DP01w.  
**Year:** 2020

The soil profile at DP02w, contained a 10 inch surface horizon of very dark grayish-brown (10YR 3/2) sandy clay loam with 5% reddish-yellow (7.5YR 6/6), redoximorphic concentrations, and 15% black gleyed depletions (2.5/N). Below 10 inches was a depleted, gray (10YR 6/1), sandy loam that was observed to a depth of 16 inches. The soil met the criteria for depleted matrix (F3) as a hydric soil indicator. DP02u, which is located upslope from DP02w, exhibited a very dark grayish-brown (10YR 3/2) sandy loam and did not display any hydric soil indicators.

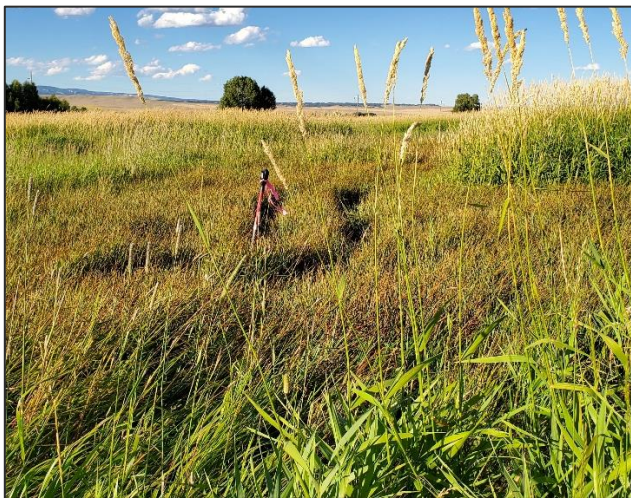
**Data Point:** DP03w      **Location:** Near southern boundary in northwest corner of site.  
**Year:** 2020

The soil profile at DP03w, revealed a 5-inch layer of very dark grey (10YR 3/1) sapric, organic material on top of 10 inches of depleted sandy clays. Two sandy clay horizons were observed. The first was observed from 5-13 inches and was greyish brown (10YR 5/2) with 2% reddish yellow (7.5YR 6/8) redoximorphic concentrations in the matrix. The second horizon, observed from 13-15 inches, was grey and contained 5% reddish yellow (7.5YR 6/8) redoximorphic concentrations in the matrix. This soil met the criteria for depleted matrix (F3) as a hydric soil indicator. DP03u, which is located upslope from DP03w, exhibited a brown (10YR 4/3) sandy loam and did not display any hydric soil indicators.
