US 93 PETERSON MITIGATION SITE

Project Overview

Monitoring Year: 2020

Monitoring Conducted By: Confluence Consulting Inc

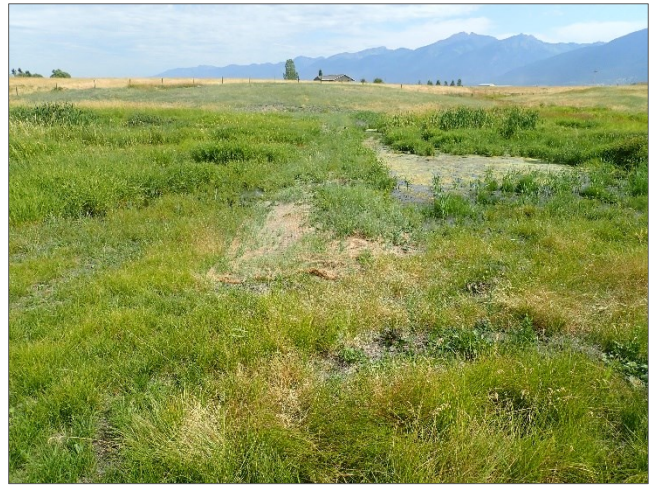
Photo Point: 8

Photo point created in 2020.

Location: New crib structure.
Year: 2020

Activity: Adaptive management actions were undertaken this spring to replace failing log crib dams constructed with the original project in 2004. Construction work entailed the replacement of Log Dam 1 and Log Dam 2, installation of earthen berms, repairs of the earthen berm at Log Dam 6, and installation of a new Log Dam (1A) and earthen berm. Appendix D contains the adaptive management plan set used for the repairs. **Date:** May 2020

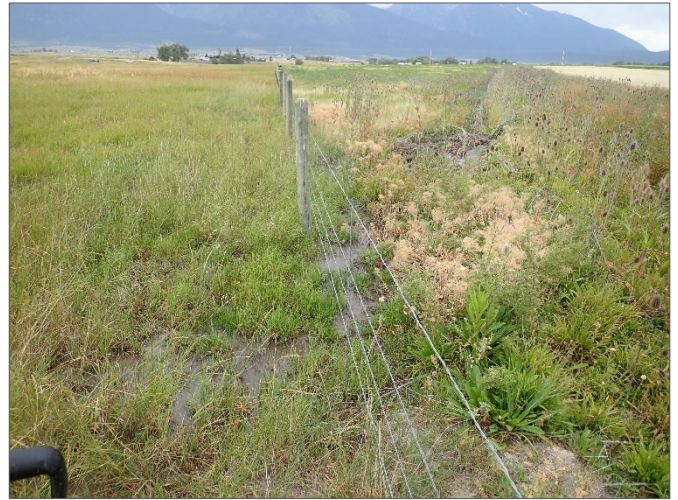
Facing upgradient (southeast) at irrigation water flowing onto site from south-adjacent property in the southwest portion of the mitigation site.

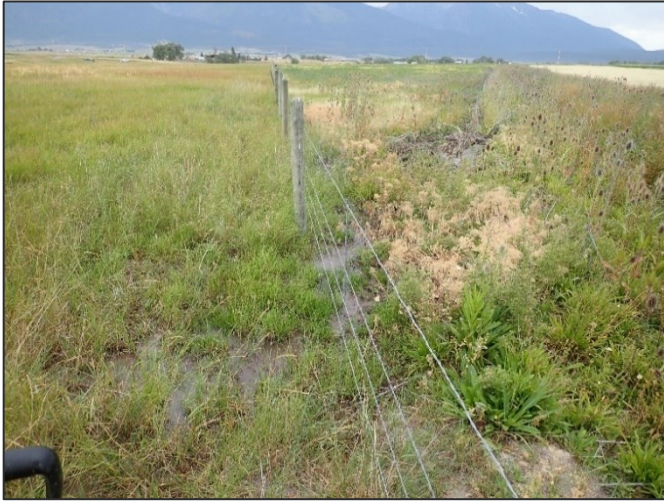
Location: Southwest Property Border

the creek. At the southwest border of the property, water is flowing downhill and north into the mitigation site from the adjacent property (Figure 4, Appendix A), and has increased wetland acreage up the hillslope and outside of the floodplain area.

Water flowing into site from adjacent irrigation overflow.

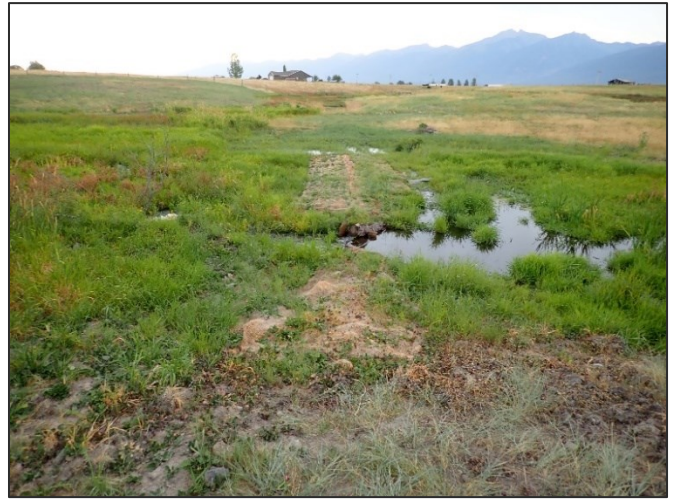
Looking N/E at recently constructed upstream crib structure.

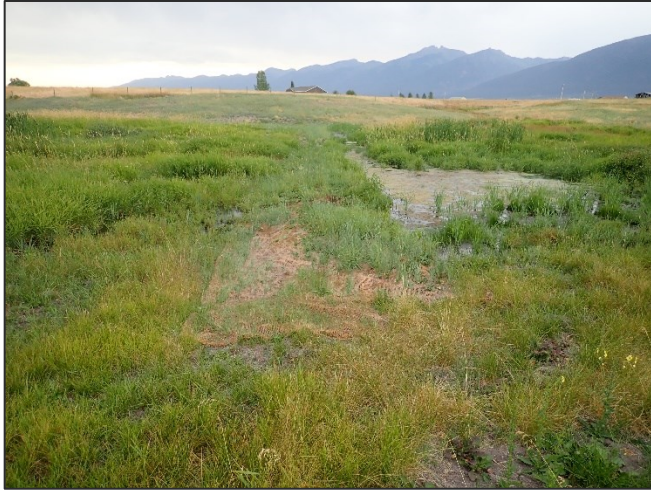
Looking N/NE at new middle crib structure.

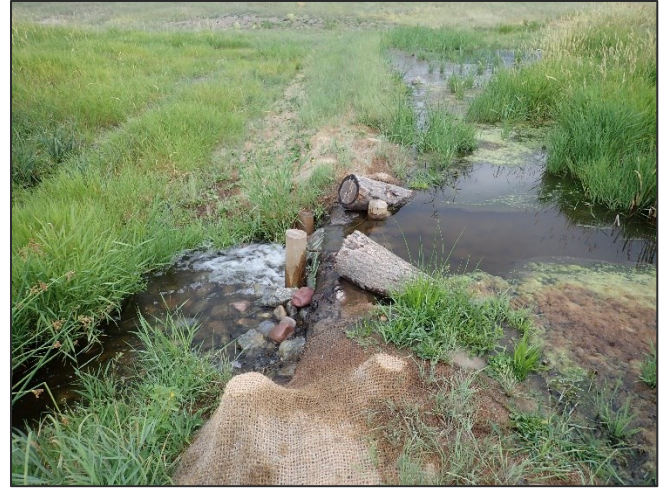
Looking N/NE at middle crib structure outfall.

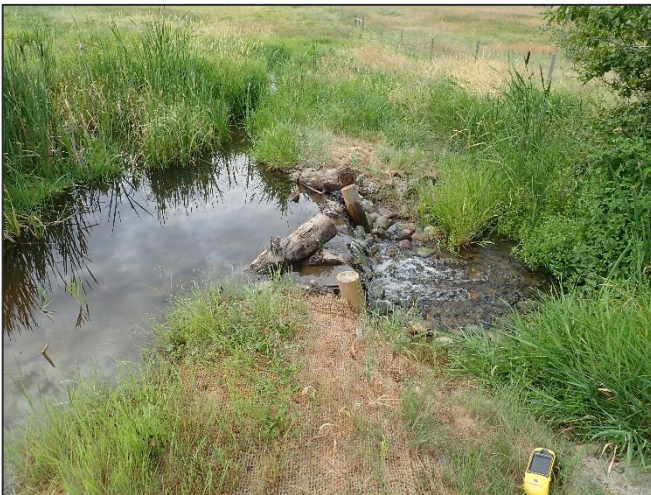
Looking south at downstream outfall structure.

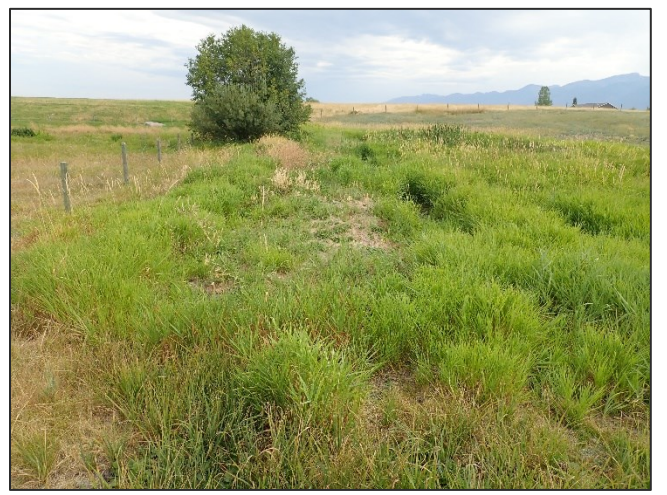
Unlike past years, inundation behind the cib structures at the downstream end was present during the site visit, indicating the structures have been improved and are working as intended. No obvious signs of breaching due to voids, undercuts, etc. were observed. There is some evidence that the site was more heavily inundated earlier in the season with drift lines and stained vegetation.

Looking north from south side of downstream-most crib structure.

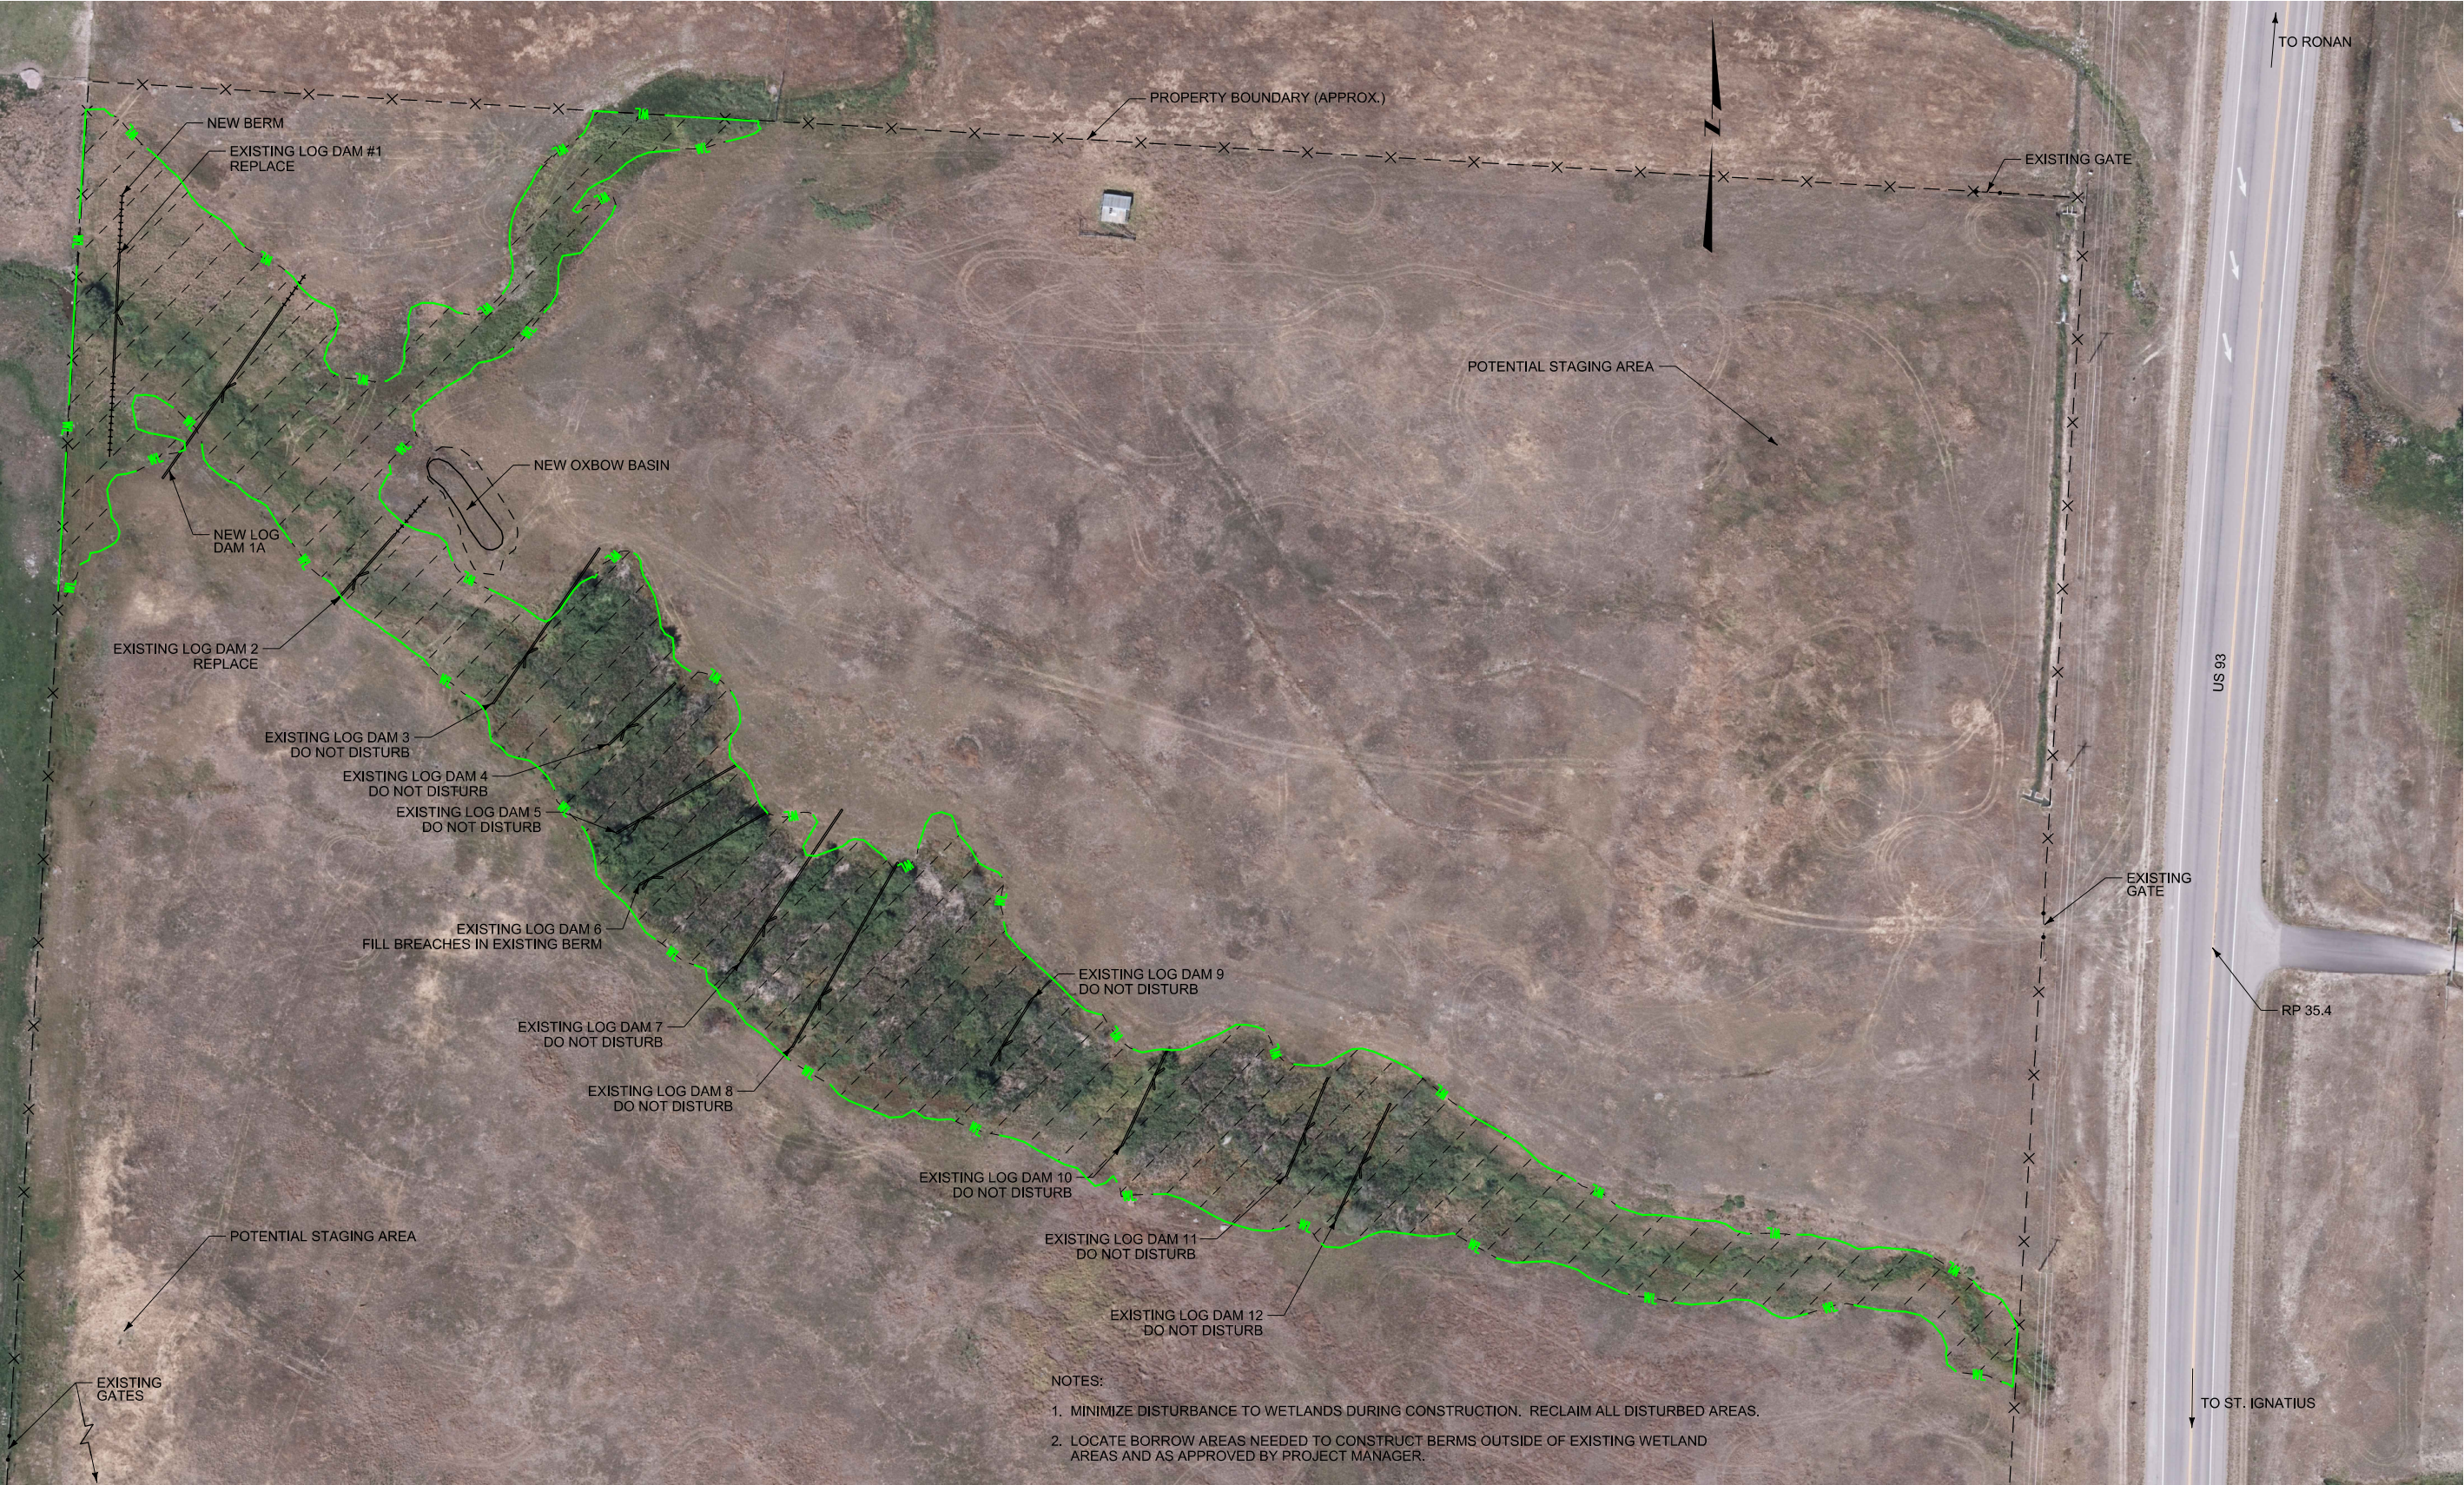
SITE MAP

- LOG DAM 1 - REPLACE AND ADD BERMS.
- LOG DAM 1A - NEW AND ADD BERM.
- LOG DAM 2 - REPLACE AND ADD BERM.
- LOG DAM 6 - REPAIR BREACHES IN EXISTING BERM.

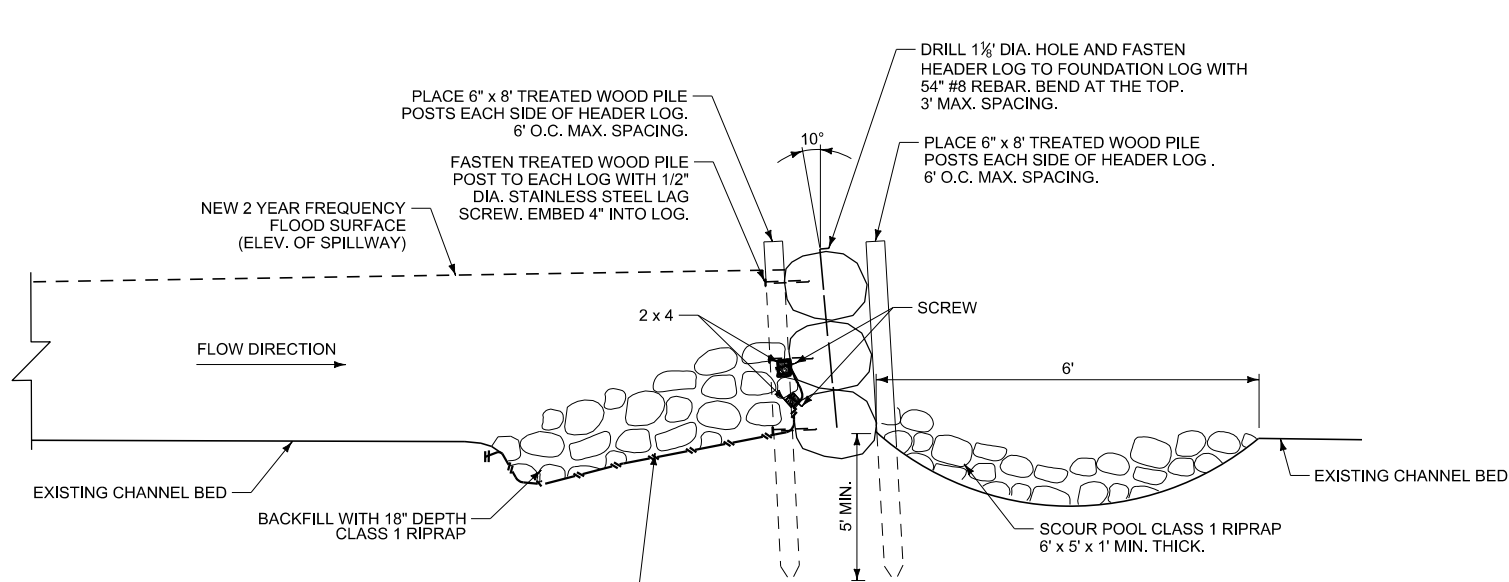
SECTION A

LOG DAM 1A & 2 DETAIL
