SCHRIEBER LAKE MITIGATION SITE

Project Overview

MDT Project Number: NH 27 (029) UPN # 1027007

Monitoring Year: 2021

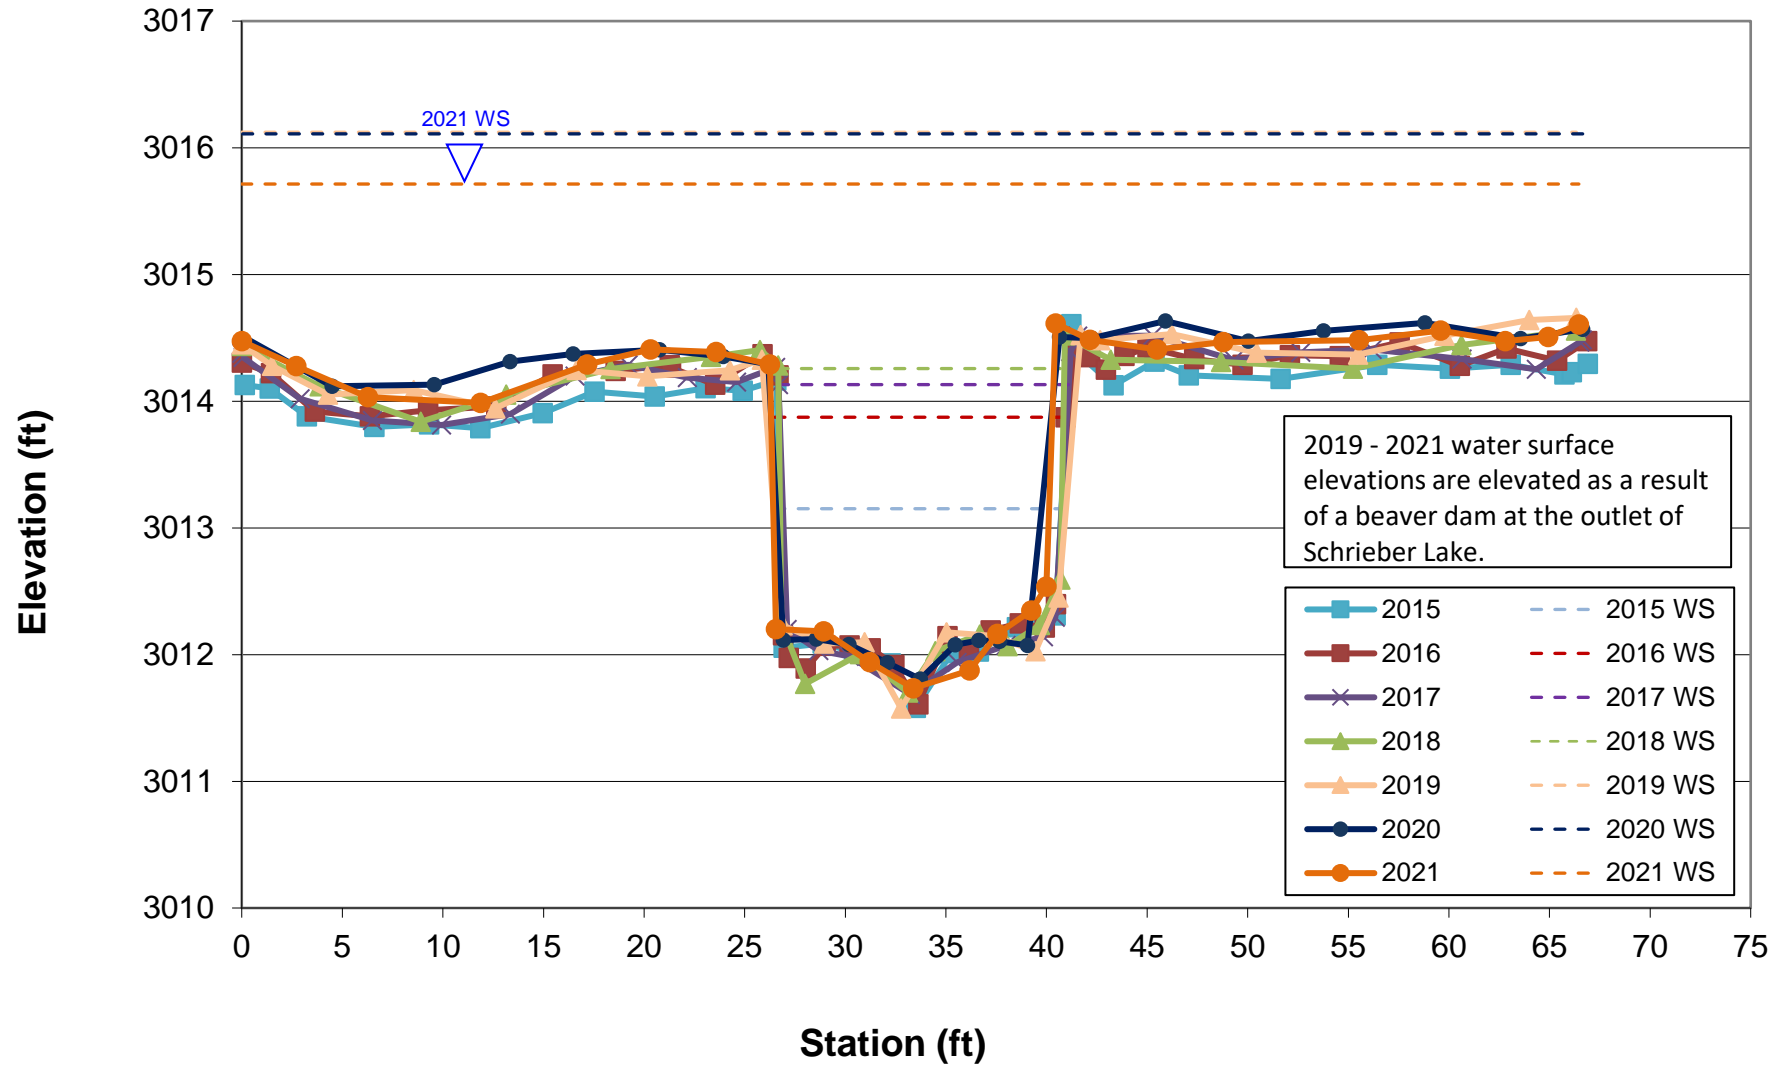
Stream Monitoring – The survey results for 11 permanent cross sections that were established along the constructed Coyote and Schrieber Creeks (Figure A-2, Appendix A) are shown in Appendix D. The 2021 data were compared to the previous surveys and discussions to assess stream channel stability. In 2021, the banks of the constructed channels exhibited stable conditions and, with the exception of Schrieber Creek Reach 1 (SC1), were generally well-vegetated with deep-rooted plant species. The survey results indicate little to no channel morphological changes between 2020 and 2021. The nine cross sections that occur within the 2021 wetland boundary, with the exception of SC3-2, exhibited surface water elevations 0.3 to 0.5 feet below those surveyed in 2020. These results are consistent with the 0.5-foot decrease in average surface water depth observed across the site between 2020 and 2021.
