EASTON RANCH MITIGATION SITE

Project Overview

Monitoring Year: 2022

Corps Permit Number: NWO-2006-90370-MTB

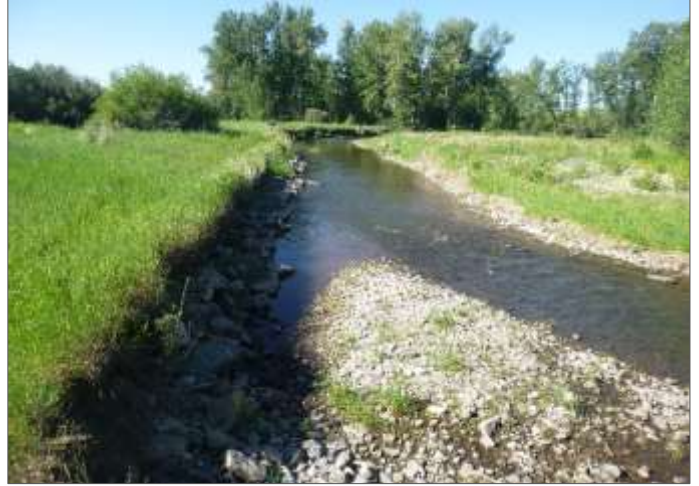
Photo Point: 4A
Bearing: 170 degrees

Stream Bank Stabilization – During the spring 2013 high-flow event, significant bank erosion occurred immediately upstream of PP4B. This erosion exposed the riprap and undermined the riprap and coir-wrapped soil lifts along an approximately 85-foot-long reconstructed bank, which caused significant loss of soil and willow cuttings. Photo point PP4B, located at the south end of the reconstructed bank, had to be relocated because of bank erosion and woody debris accumulation. Additional bank erosion has been noted since the dramatic lateral cutting event of 2013, and this bank section remains exposed and vulnerable. The 2018 runoff period was supported by above-average precipitation in June. From 2019 through 2022, bank erosion continued along the downstream (south) portion of the 85-foot-long bank and resulted in areas of undercutting and loss of finer textured subsoils.

Location: Shields Bank DS
Year: 2022

Specific recommendations for any additional corrective actions: The MDT has an ongoing weed-control program and will assess the need for additional weed treatments in 2023. Soil lifts and riprap installed along the bank of the Shields River are still eroding in the northwestern corner of the site. This bank area is generally dominated by shallow-rooting pasture grasses. MDT will assess this bank erosion and potential need for corrective actions.

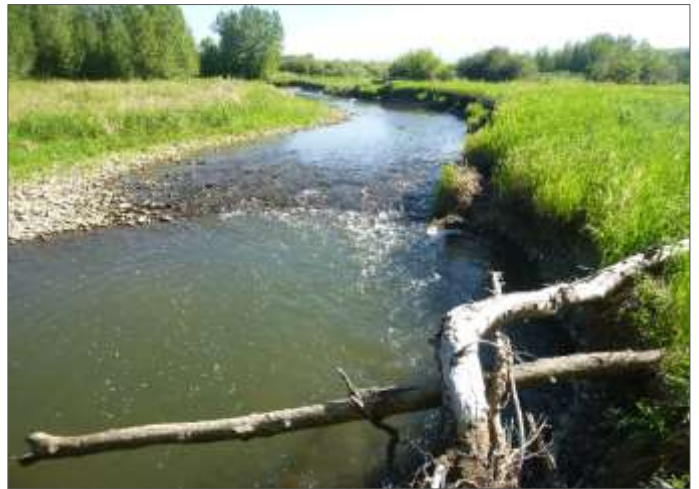
Photo Point: 4B
Bearing: 20 degrees

Location: Shields Bank US
Year: 2022 – 2021 location*

* new (2021) photo point location due to bank loss during high flows in 2018.
