ROSTAD RANCH MITIGATION SITE

Project Overview

MDT Project: STPX 002(749), UPN #5565

Monitoring Year: 2022

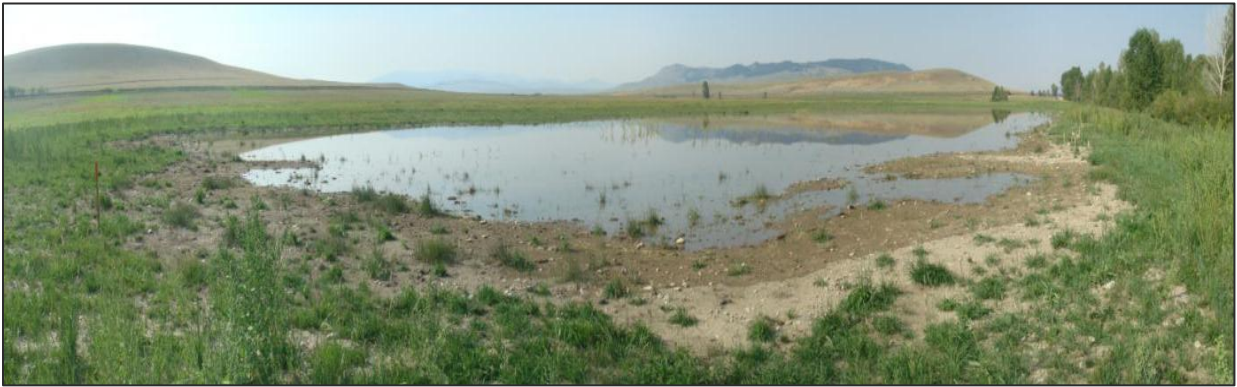
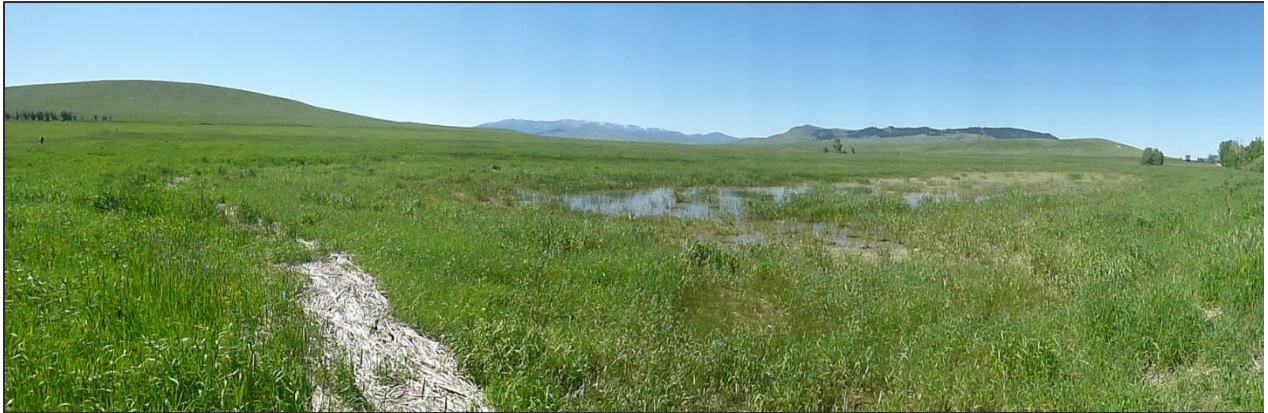
Photo Point 1 – Panorama; Location: Northeast Corner; Bearing 200 degrees; Year 2013

Photo Point 1 – Panorama; Location: Northeast Corner; Bearing 200 degrees; Year 2022

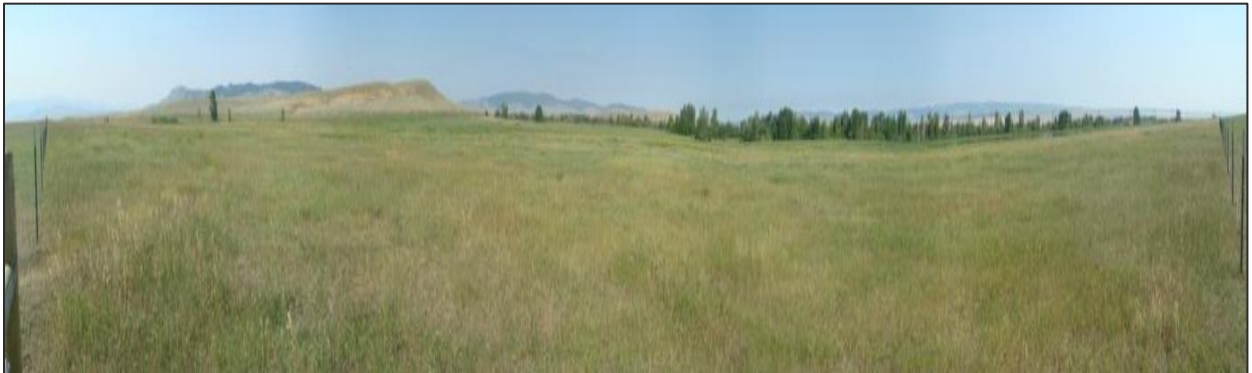
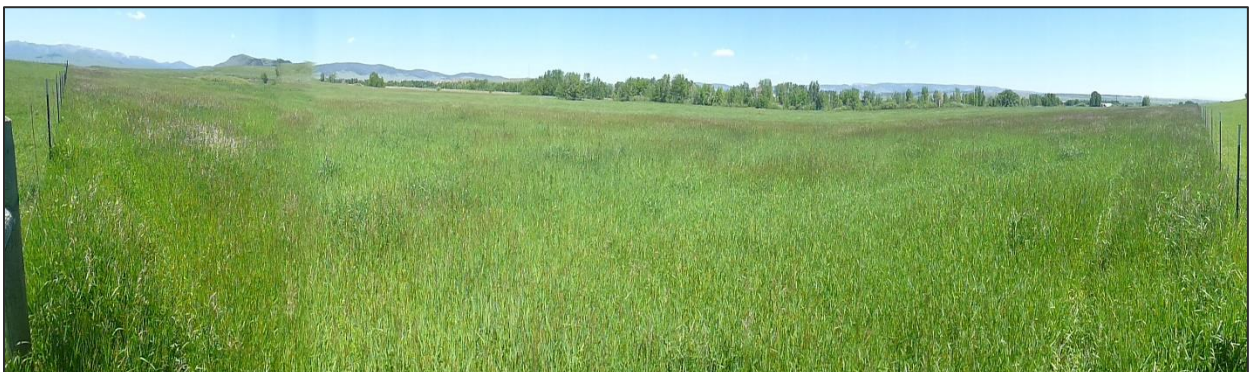
Photo Point 2 – Panorama; Location: East Fence Corner; Bearing 125 degrees; Year 2013

Photo Point 2 – Panorama; Location: East Fence Corner; Bearing 125 degrees; Year 2022

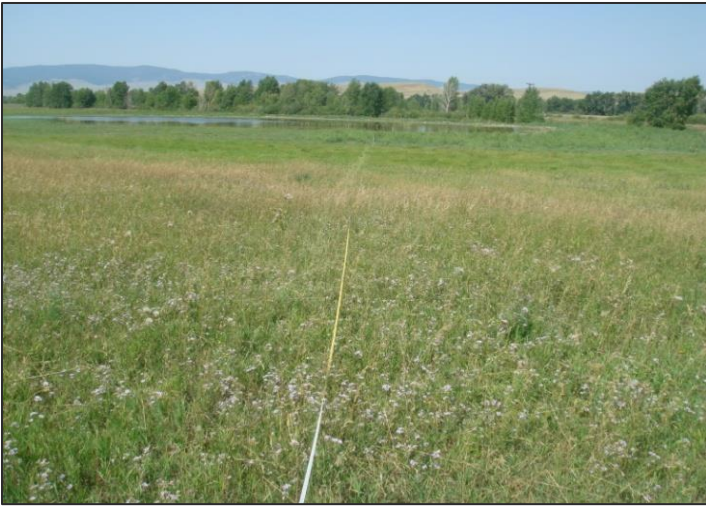
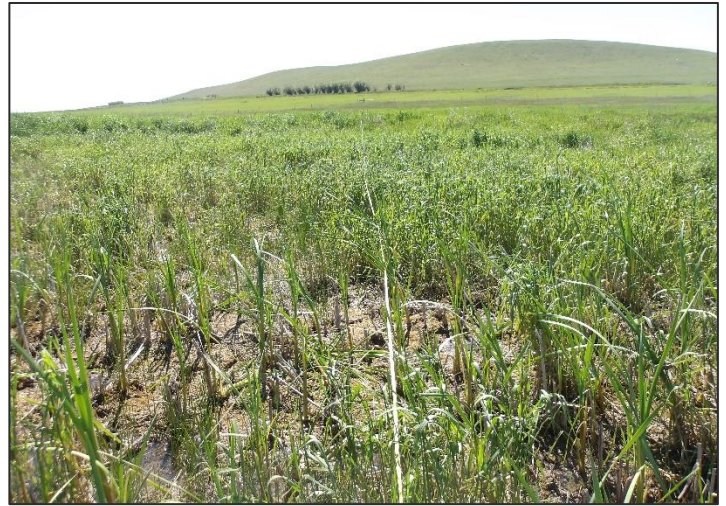
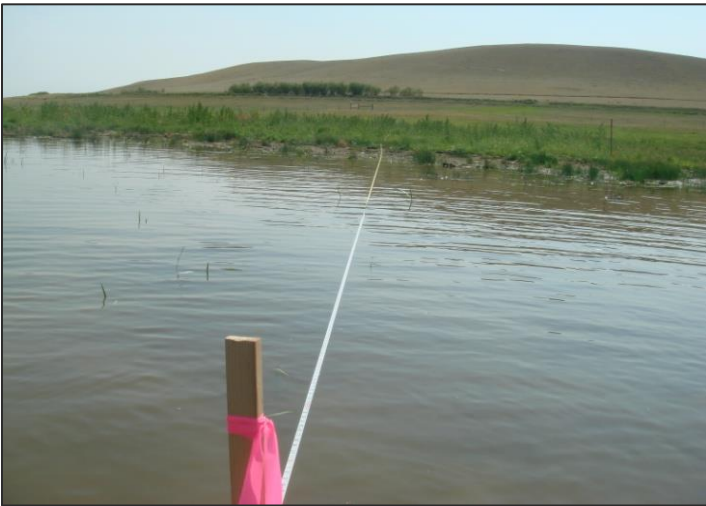
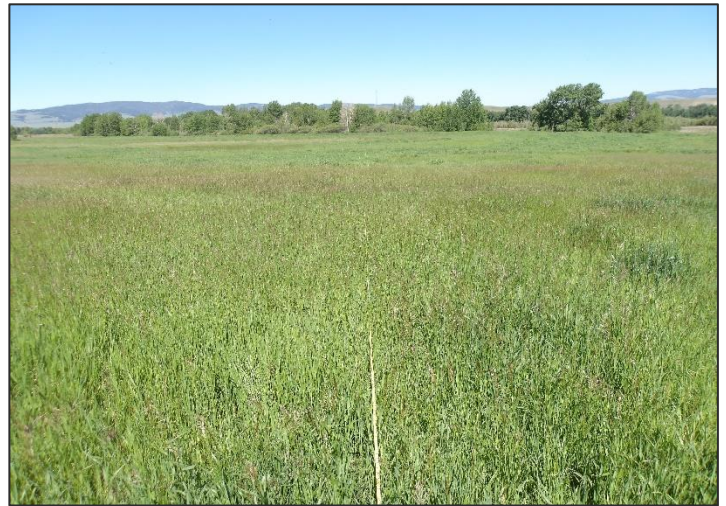
Transect 1: Start **Location:** NE Branch of site
Bearing: 290 degrees **Year:** 2013

Table 2 summarizes the data for T-1 which is 422 feet long and intersects UT 8 and UT 11, and WT 7, WT 14, and WT 15. Wetland habitat along the transect increased five percent from 61% in 2021 to 66% in 2022, and the total number of species observed along the transect increased by two, one upland species and one hydrophytic species. Total vegetative cover has increased slightly from 2021 to 2022.

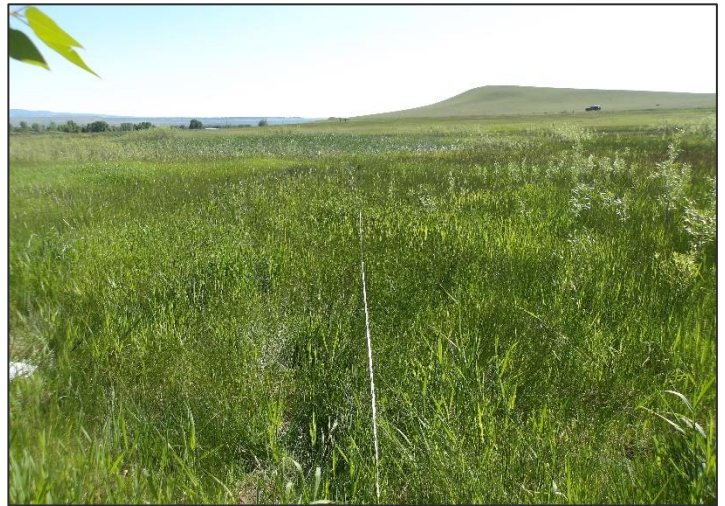
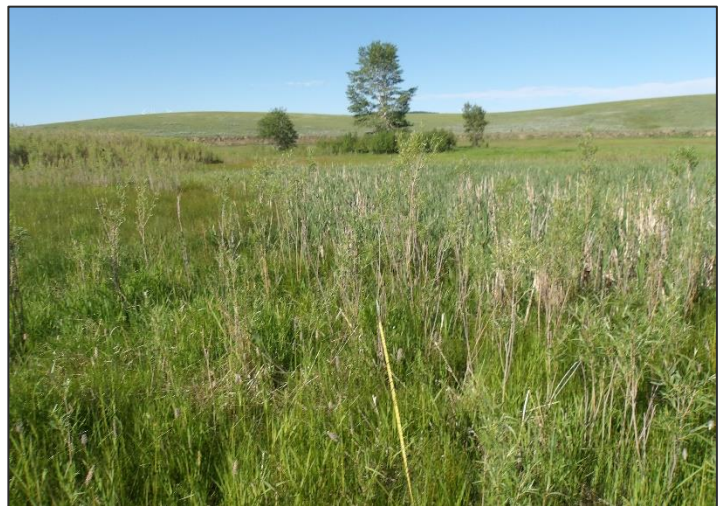
Transect 3: Start
Bearing: 30 degrees

Data collected on T-3 are summarized in Table 4. T-3 is 320 feet long and intersects WT 2, WT 10, and WT 15. The transect is completely comprised of wetland habitat, which is consistent with findings from 2018-2022. The total number of species observed in 2022 increased by one from the previous year, and the number of hydrophytic species remained consistent at twelve. Total vegetative cover is increased by two percent from 2021 to 2022.
