US 93 PETERSON MITIGATION SITE

Project Overview

MDT Project # NH-5-2(122)31 UPN# 1744

Monitoring Year: 2022

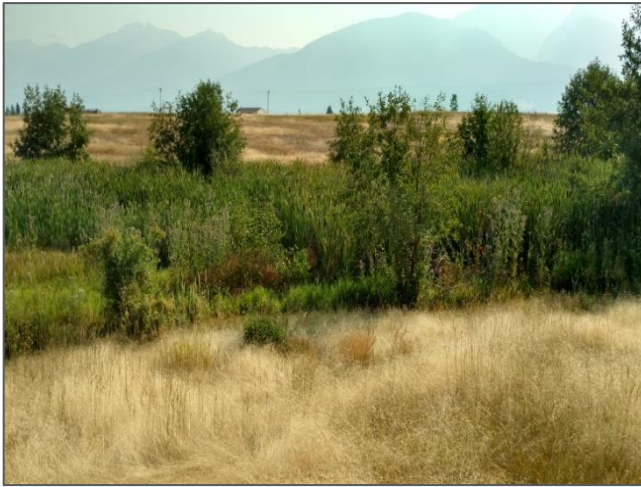
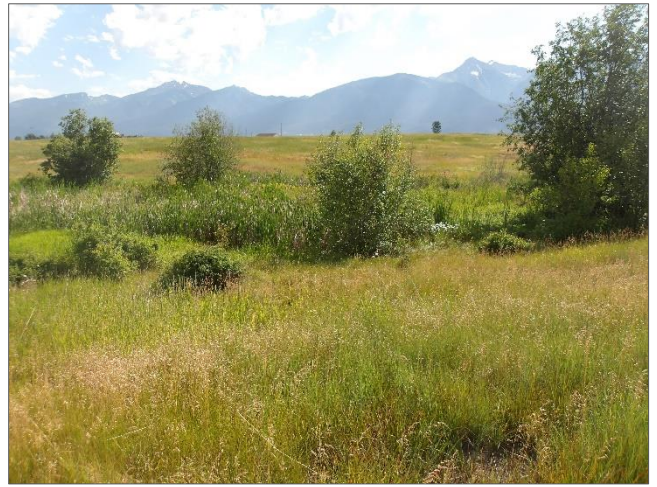
Data collected on T-2 (Wetland Mitigation Site Monitoring form, Appendix B) are summarized in Table 3. T-2 is 325 feet long and intersects Upland Type 7 – *Elymus repens*/*Poa pratensis* and Wetland Type 8 – *Typha latifolia*/*Phalaris arundinacea*; 78.5 percent of the transect crossed wetland habitat in 2022, which is an increase of 6.5% from 2021. Additionally, the number of hydrophytic species increased from 12 to 18, and the total number of species observed along the transect increased from 17 to 28. Total vegetative cover remained unchanged at 95 percent.

Location: Looking across T-2
Year: 2017

Location: Looking across T-2
Year: 2022

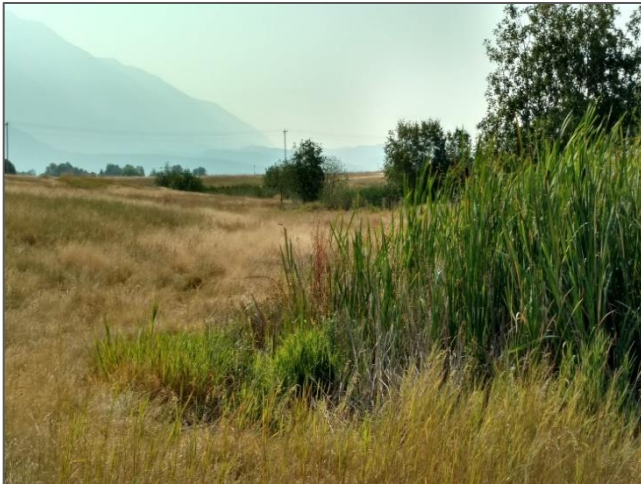
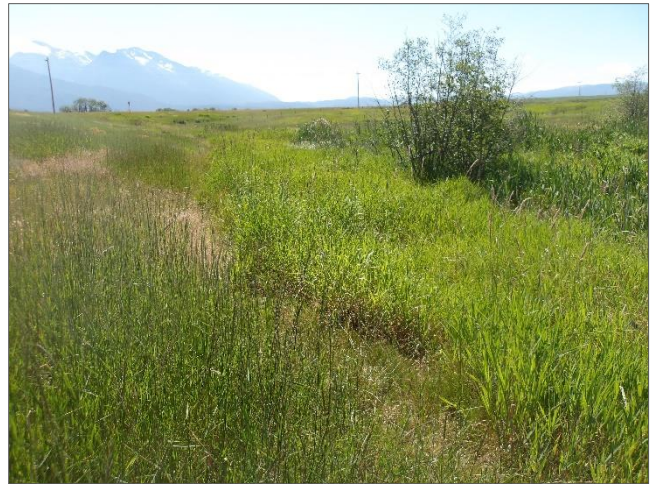
Location: Wetland boundary
Year: 2017

Location: Wetland boundary
Year: 2022

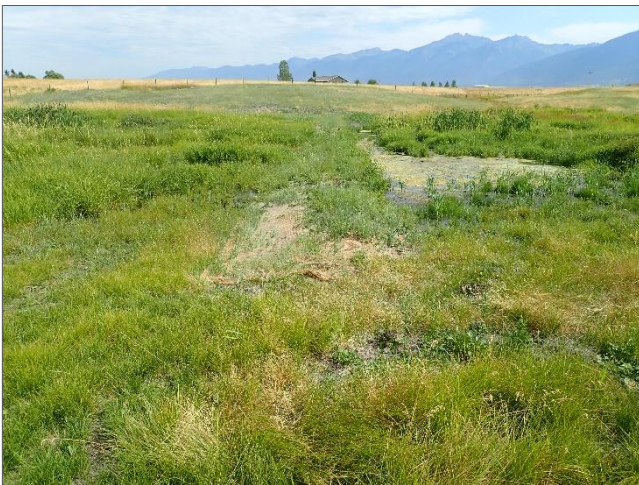
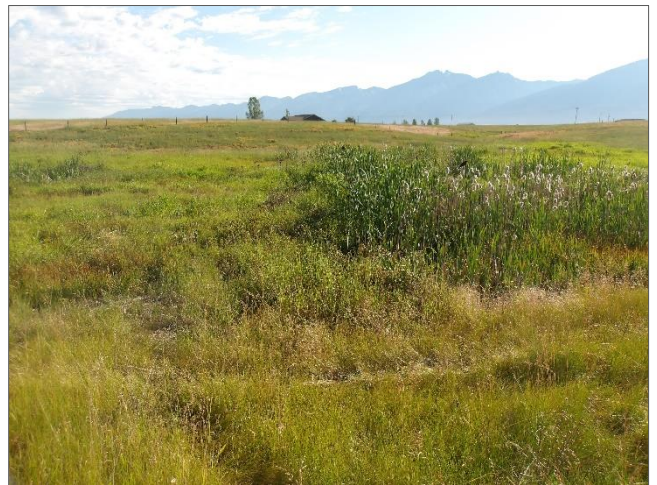
Location: New crib structure.
Year: 2020

Location: New crib structure.
Year: 2022

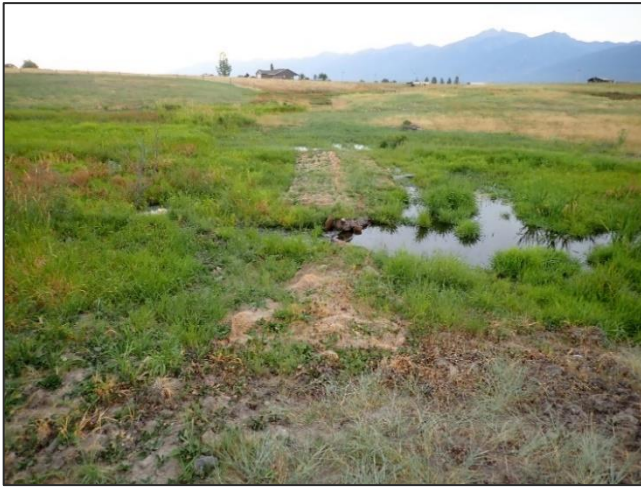
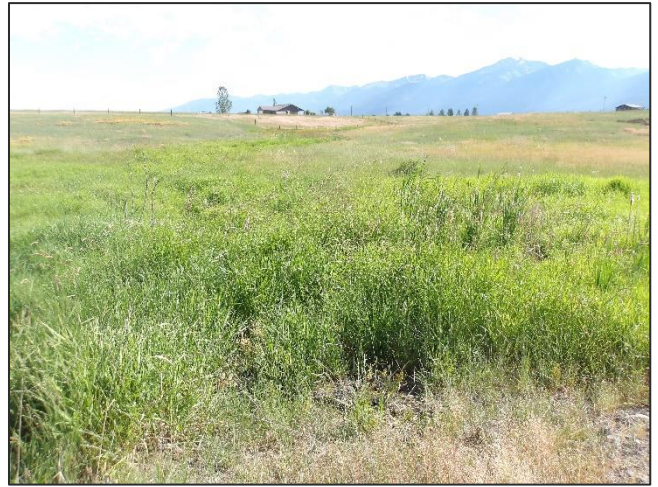
Additional Photo 1. Looking N/E at recently constructed upstream crib structure (2020).

Additional Photo 1. Looking N/E at recently constructed upstream crib structure (2022).

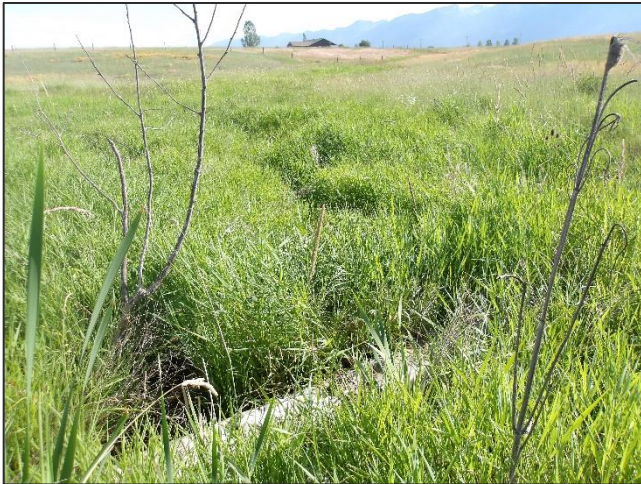
Additional Photo 2. Looking N/NE at new middle crib structure (2022).

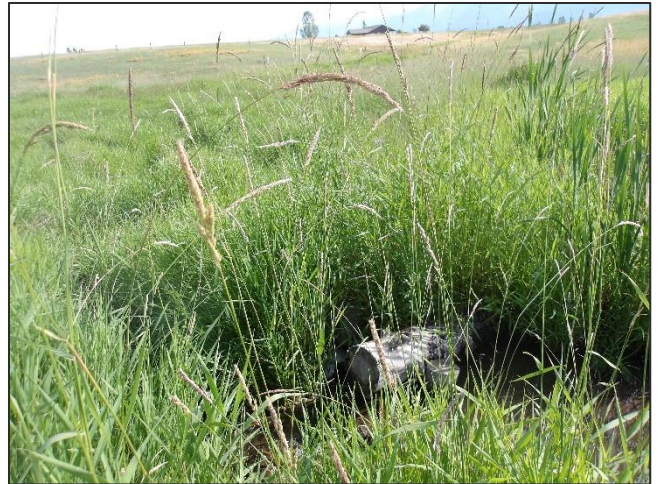
The second wire from the top of fence at the entry gate has been cut and needs repair. Water is flowing around and not over the downstream outfall structure of the middle crib structure, indicating it has failed and requires repair.

Additional Photo 3. Looking N/NE at middle crib structure outfall (2022).

Specific recommendations for any additional corrective actions: Repairs to the failing downstream outfall structure. Weed management will continue in 2023.

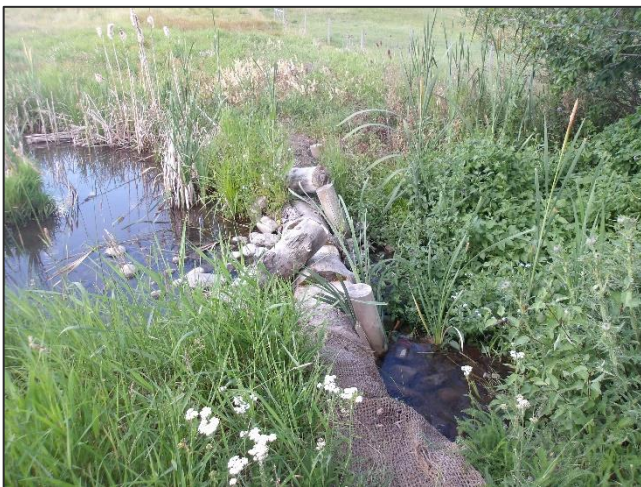
Inundation behind the crib structures at the downstream end was present during the site visit, however, water was flowing under one of the crib structures, indicating failure of the design and requires repair. The wetland/upland boundary at the site is distinct and contained by landscape position. Slope wetlands have decreased in size after a string of dry years.

Additional Photo 4. Looking south at downstream outfall structure (2022).

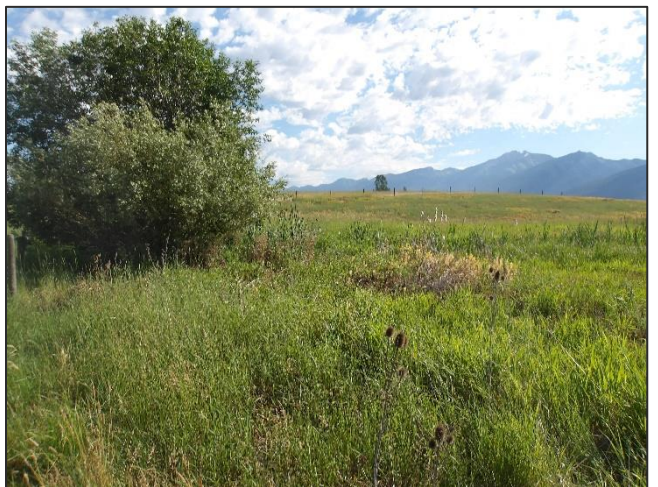
Additional Photo 5. Looking north from south side of last downstream crib structure (2022).
