ROSTAD RANCH MITIGATION SITE

Project Overview

MDT Project: STPX 002(749), UPN #5565

Monitoring Year: 2023

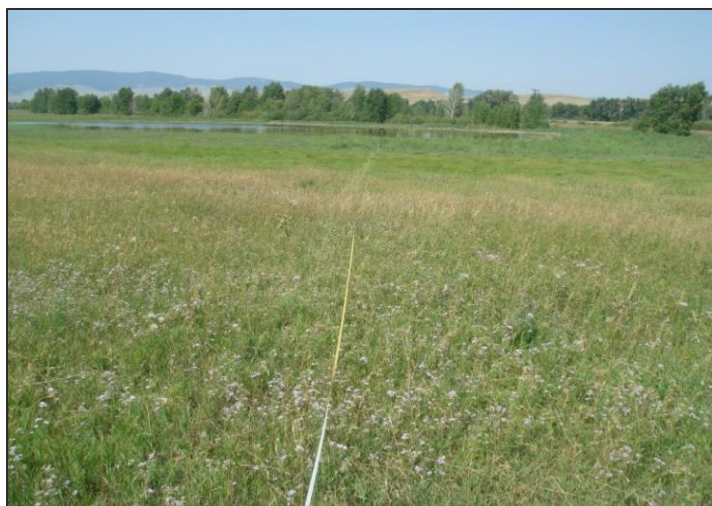
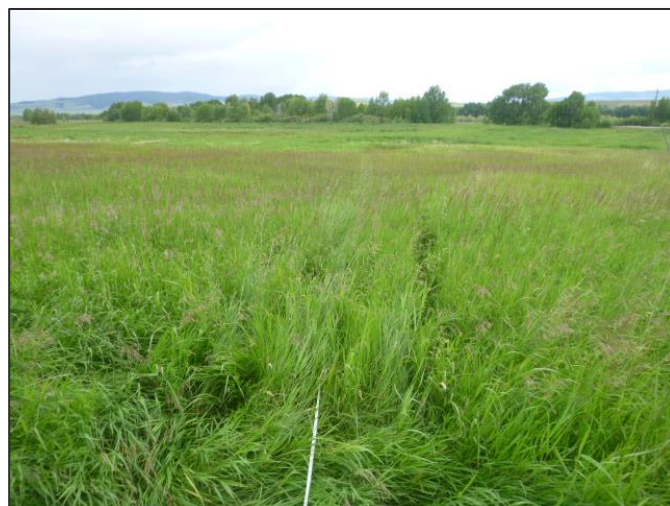
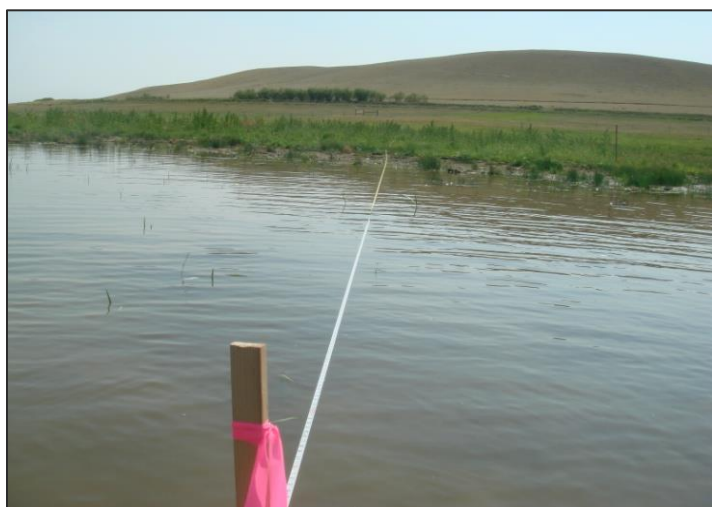
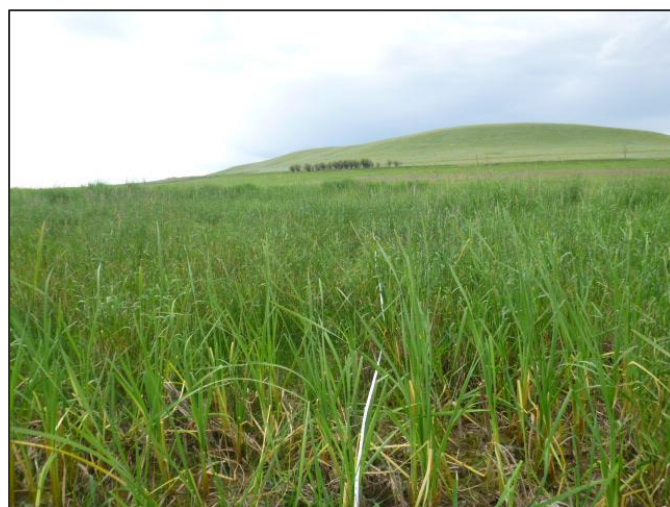
Transect 1: Start
Bearing: 290 degrees
Location: NE Branch of site
Year: 2013

Table 2 summarizes the data for T-1, which is 422 feet long and intersects UT 8, WT 2, WT 7, and WT 17. UT 11 is no longer present at the site, and the upland berm that T-1 crosses was remapped as UT 8, resulting in a decrease in the number of communities along the transect. Wetland habitat increased one percent from 2022, and the total number of species recorded along the transect increased by one. Consistent with trends observed in 2022, total vegetative cover continues to increase slightly along this transect.

No open water was observed along transect 1 in 2023. UT 11 is no longer present at the site and has been replaced with UT 8, decreasing the number of communities observed along the transect.

The birdbox near the start of T-1 is missing and could be replaced.

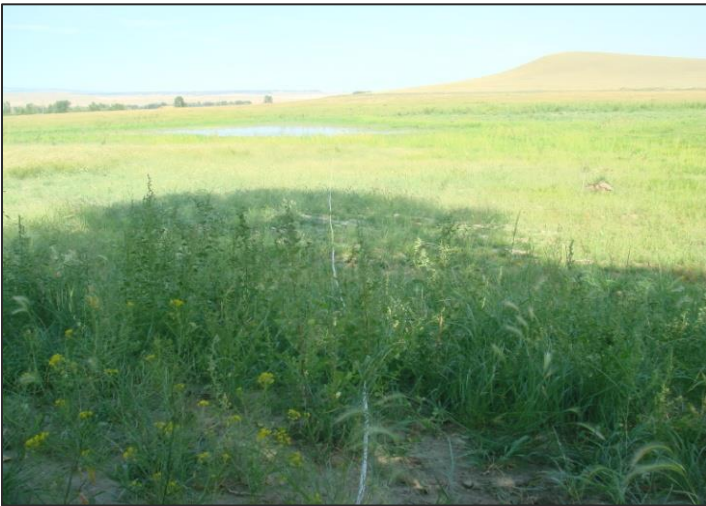
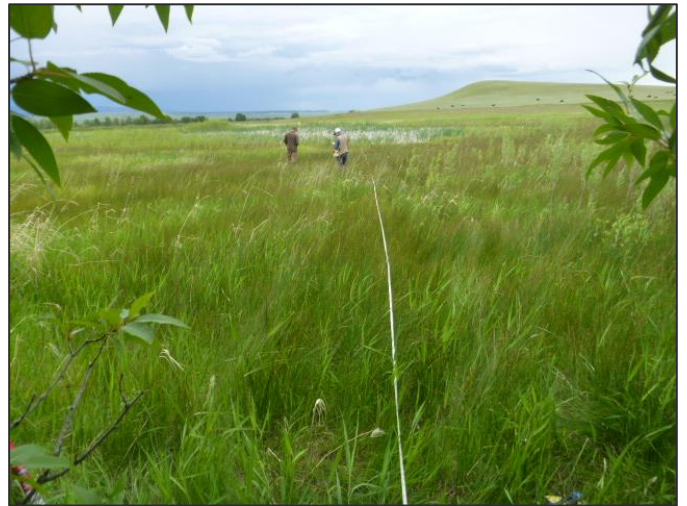
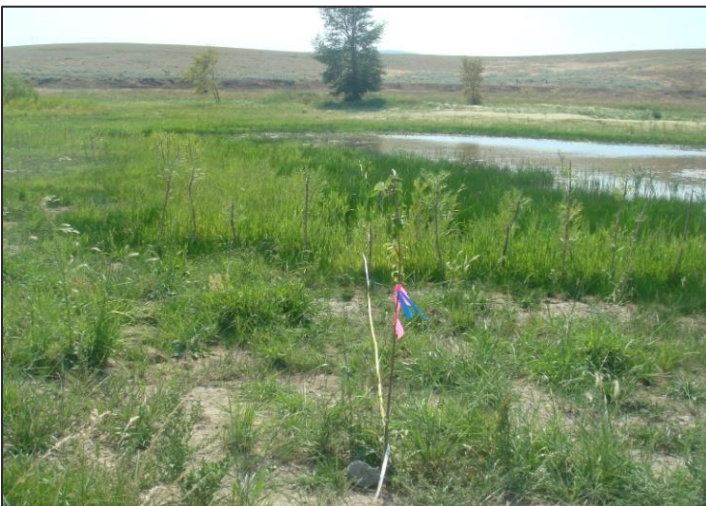
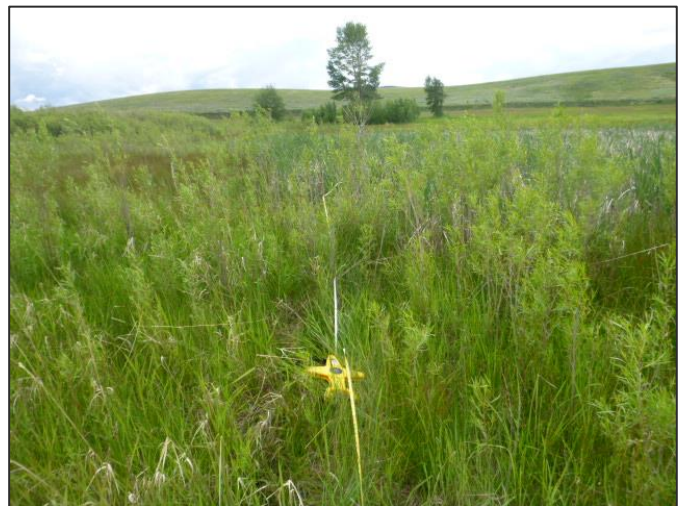
Transect 3: Start
Bearing: 30 degrees

Data collected on T-3 are summarized in Table 4. T-3 is 320 feet long and is composed entirely of wetland habitat, intersecting WT 2, WT 10, and WT 15. The total number of species observed in 2023 remained consistent from 2022, and total vegetative cover increased by one percent.

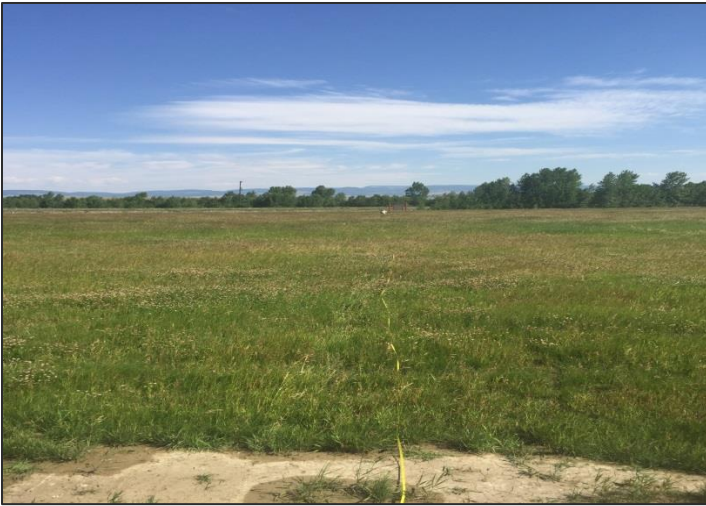
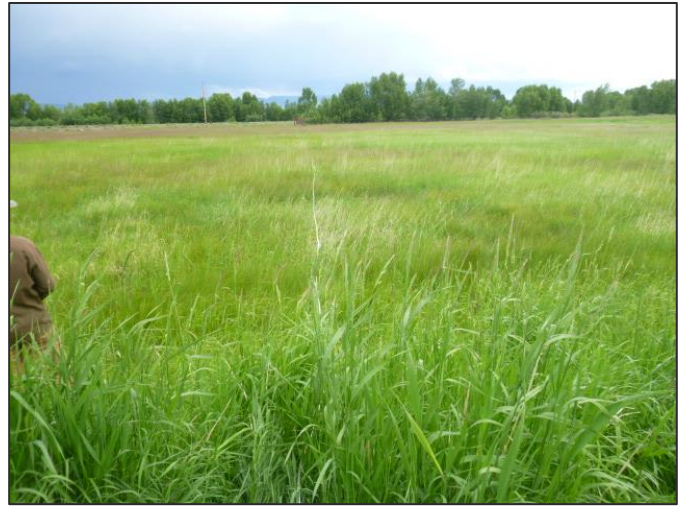
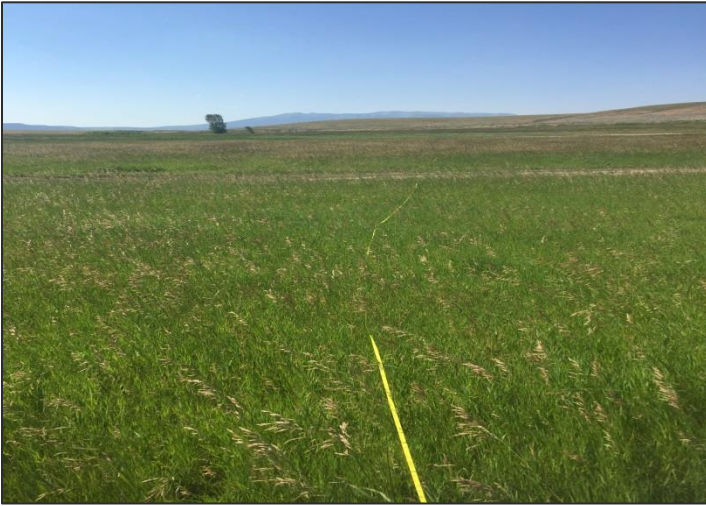
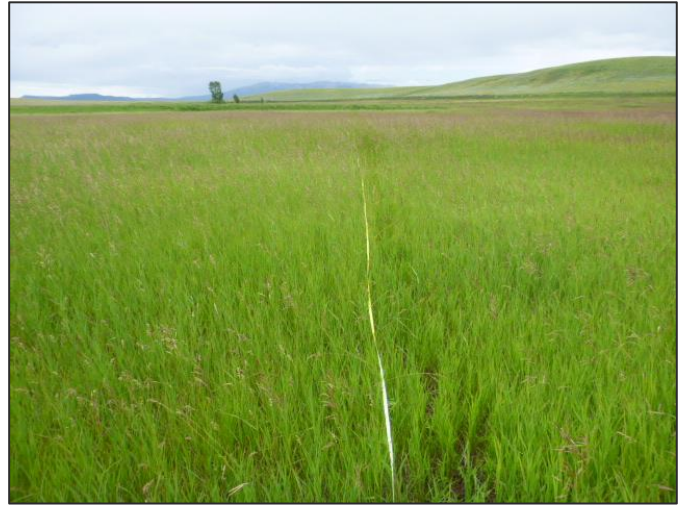
Transect 4: Start
Bearing: 0 degrees

WT created in 2022 to document the transitional species observed along transect 4 where the wetland boundary is expanding north from the berm. The community includes marginal wetland areas that demonstrate wetland hydrology and hydric soil development, but may include more upland rated species.

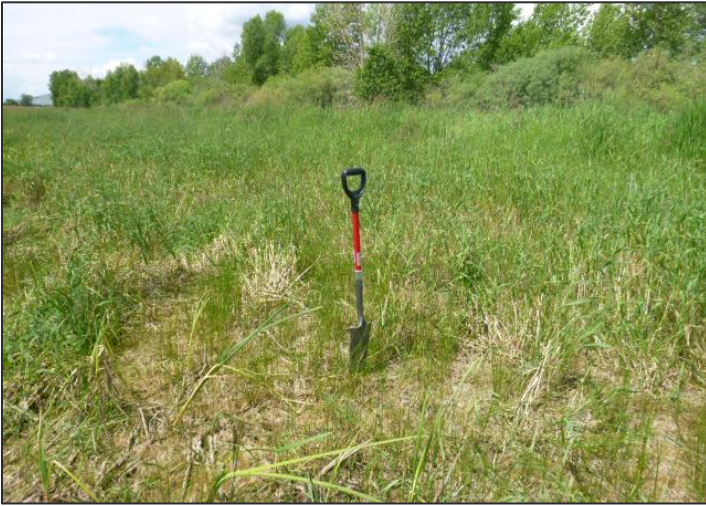
Data Point: DP01w

Depth (inches)	Matrix		Redox Features				Texture	Remarks
	Color (moist)	%	Color (moist)	%	Type ¹	Loc ²		
0 - 7	10YR 3/2	100					Sandy Clay Loam	Roots
7 - 16	2.5Y 4/2	90	2.5Y 5/6	10	C	M	Sandy Clay Loam	Shale fragments throughout.
-								
-								
-								
-								
-								
-

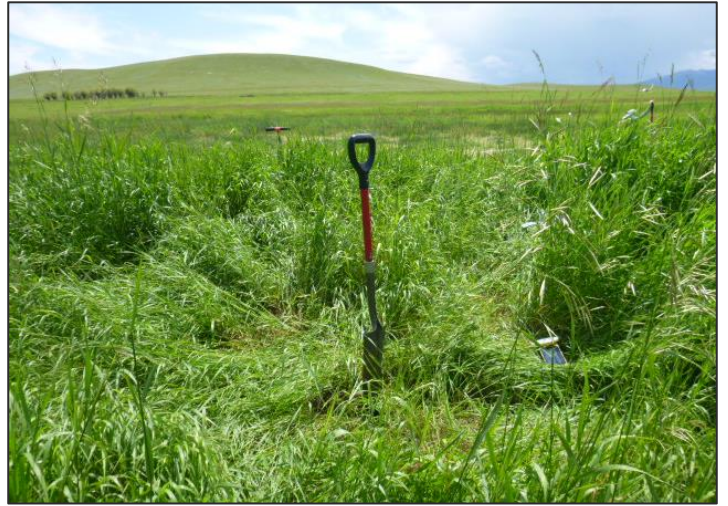
Data Point: DP01u

Although concentrations were observed, this soil does not meet hydric soil requirements.

No evidence of wetland hydrology observed. Soils moist in upper horizon, and drier below.
