## SCHRIEBER LAKE MITIGATION SITE

**MDT Project Number:** NH 27 (029) UPN # 1027007

**Monitoring Year:** 2024

**Years Monitored:** 10<sup>th</sup> year of monitoring

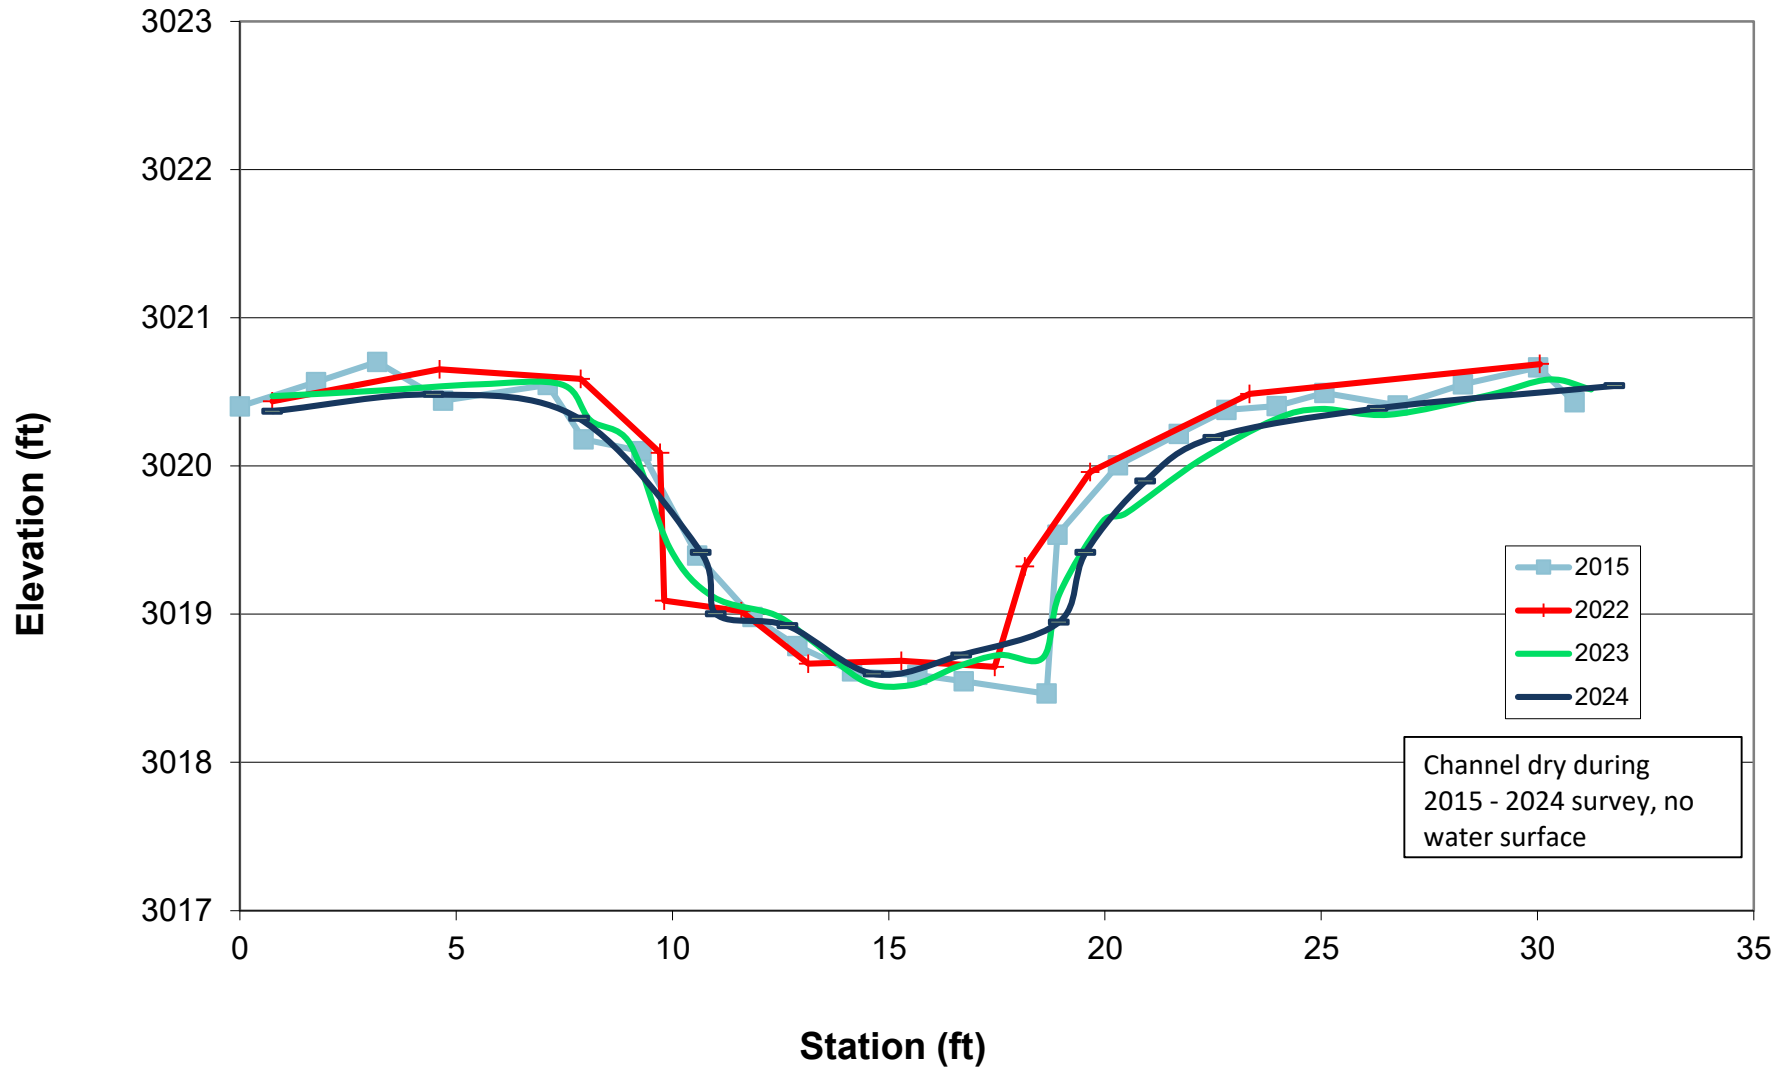
# SC2A-1

**Stream Monitoring** – The survey results for 11 permanent cross sections that were established along the constructed Coyote and Schrieber Creeks (Figure A-2, Appendix A) are shown in Appendix D. The 2024 data were evaluated against the previous surveys to assess stream channel stability. In 2024, the banks of the constructed channels exhibited stable conditions and were generally well-vegetated with deep-rooted plant species. The stream monitoring survey indicates that little to no significant channel morphological changes occurred between 2023 and 2024. The stream beds at two of the cross sections, SC7-1 and CC1B-1, were a foot lower than in 2023, but within the range of normal fluctuations seen in previous years. All cross sections exhibited surface water elevations about 0.5 feet lower than what was surveyed in 2023.

The 2024 PFC assessment rated all stream reaches at the site as Functioning, including Schrieber Creek Reach 1 (SC1), which was rated as in proper functioning condition considering the ephemeral nature of the reach. The 2024 PFC assessment forms can be found in Appendix D. Upper Schrieber Creek appears stable and in dynamic equilibrium with the surrounding landscape. The vegetation that has established within the channel is capable of maintaining channel form and function under the current hydrologic regime. In 2024, some willows were observed establishing within the stream channel, although their cover totaled less than 5 percent.
