#### Montana Department of Transportation Wetland Mitigation Monitoring Report

#### **SCHRIEBER MEADOWS MITIGATION SITE**

MDT Project Number: NH 27 (021) UPN # 1027001 Watershed: Watershed #1 – Kootenai River Basin

**Monitoring Year: 2024**

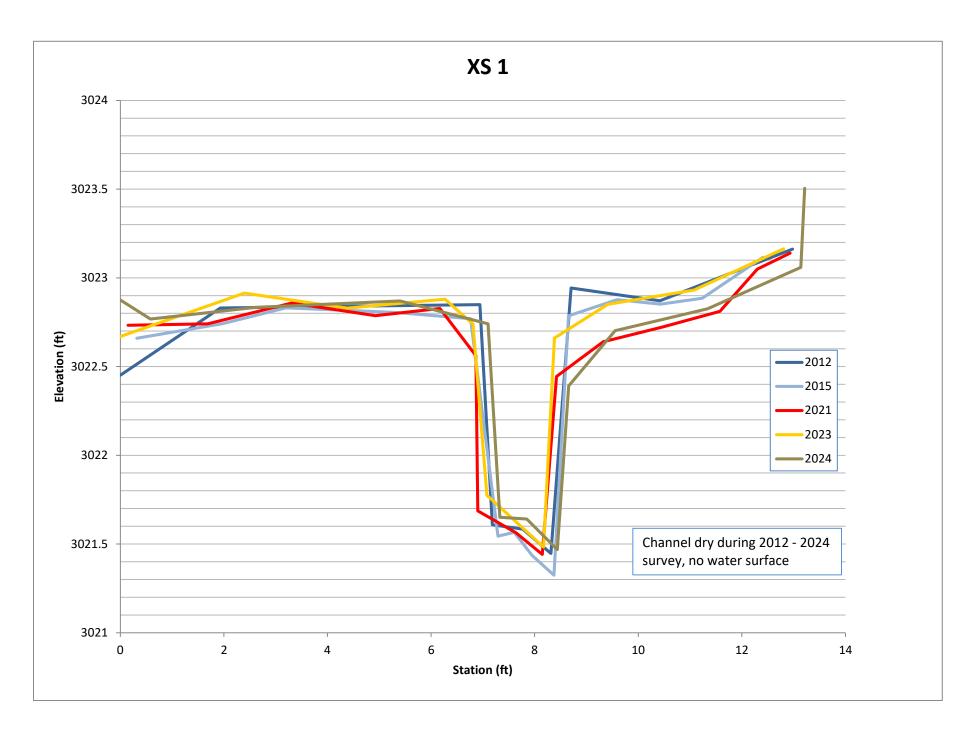
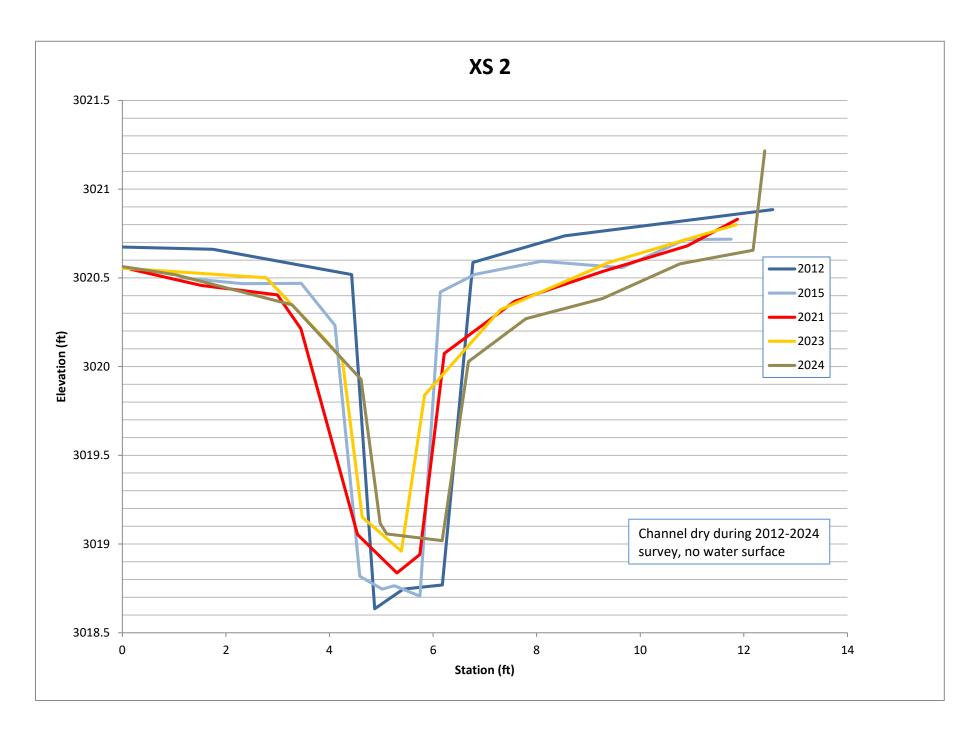
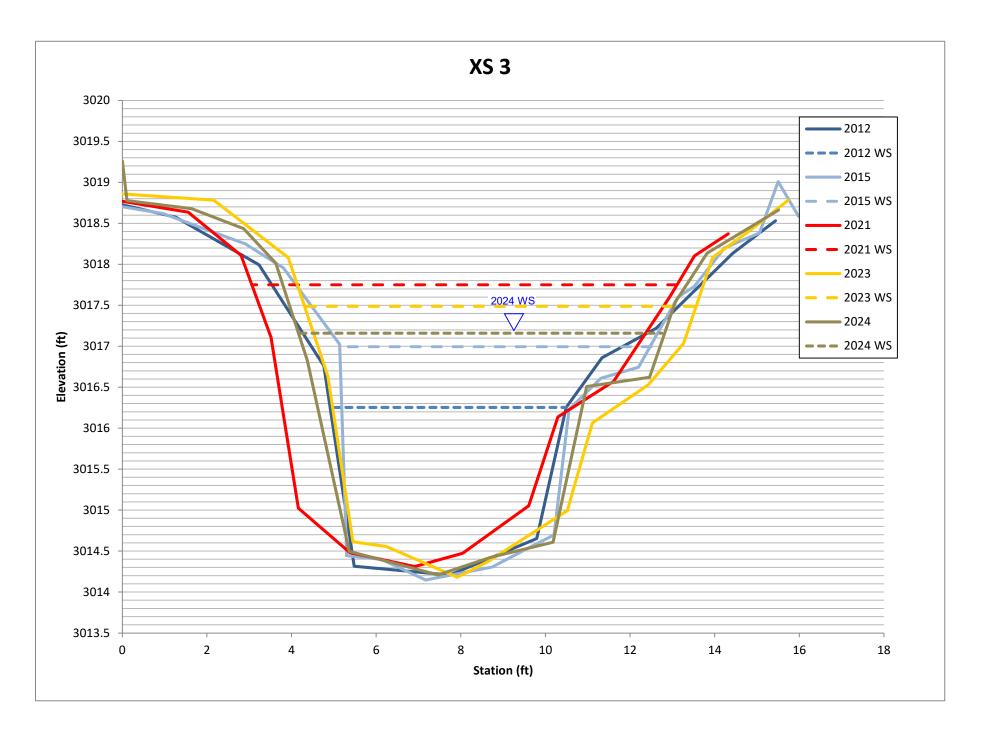
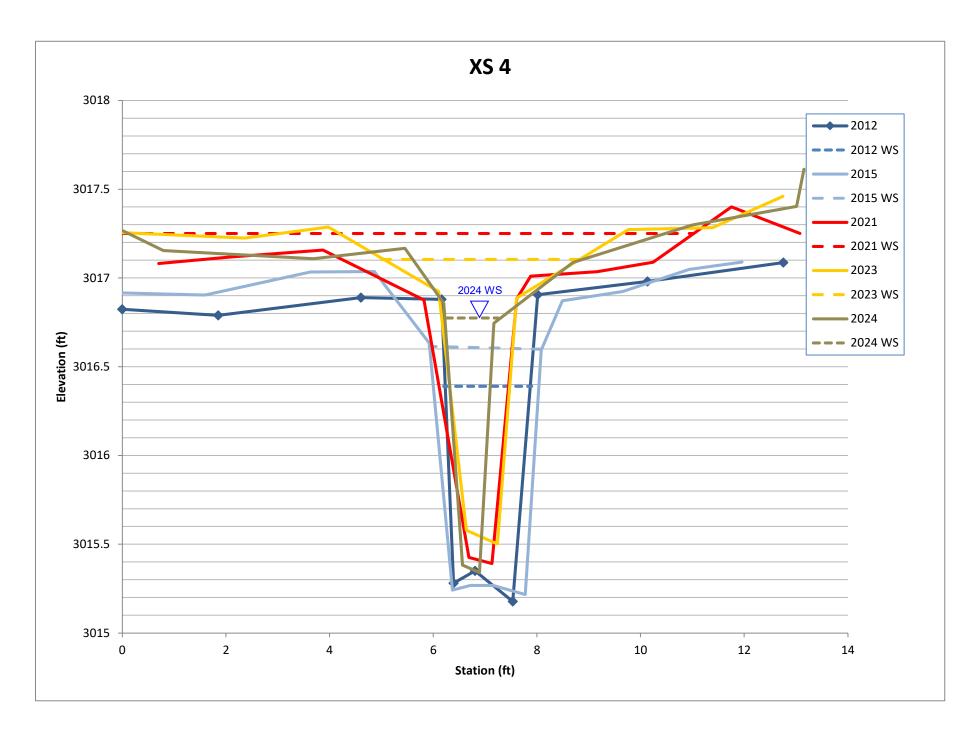
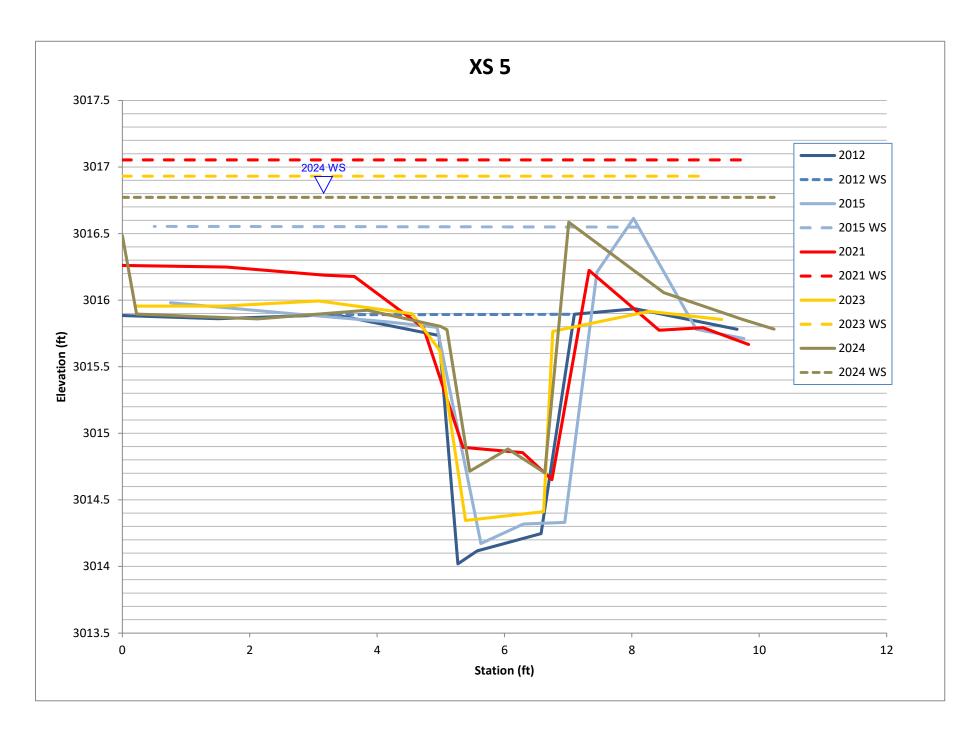
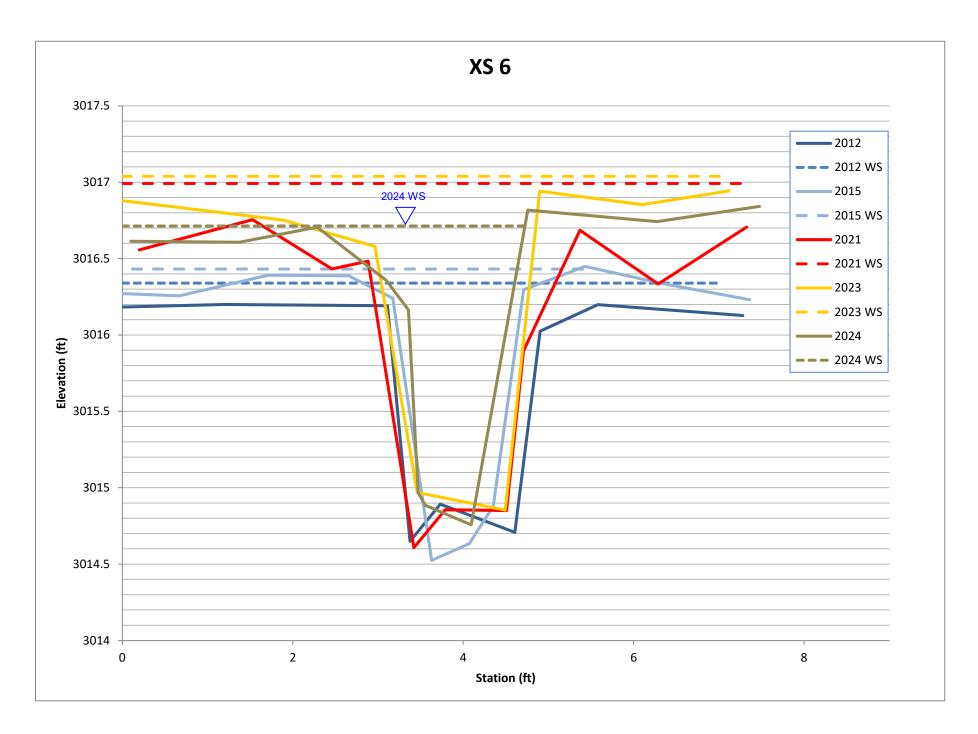
# APPENDIX D STREAM CROSS SECTIONS

**Stream Monitoring** – The survey results for 11 permanent cross-sections established along the constructed Coyote Creek (Figure A-2, Appendix A) are shown in Appendix D. The 2024 data was compared to the previous surveys to assess stream channel stability. Generally, the constructed channel's banks were well-vegetated and exhibited stable conditions. Coyote Creek does not generally experience high-power flows and no major channel morphological changes (i.e. channel migration, aggradation or degradation) have been observed throughout the monitoring years.
