Montana Department of Transportation Wetland Mitigation Monitoring Report
SILICON MOUNTAIN MITIGATION SITE

MDT Project Number: STPX 47 (024) 56 UPN# 6044

Monitoring Year: 2024

Monitoring Conducted By: Confluence Consulting Inc

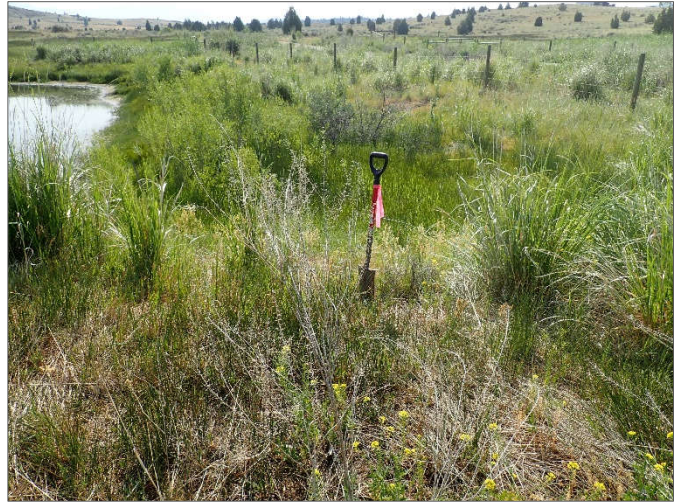
Data Point: DP01u
near Wetland Cell 5

Soil textures within upland test pits consisted of various loams. Test pit DP01u had sandy loam aggregates with relict redoximorphic features mixed throughout the profile, indicating that the soils in this portion of the site were disturbed during construction. This soil was loose and dry and was not classified as a hydric soil.
