US 93 PETERSON MITIGATION SITE

MDT Project # NH-5-2(122)31 UPN# 1744

Monitoring Year: 2024

Monitoring Conducted By: Confluence Consulting Inc

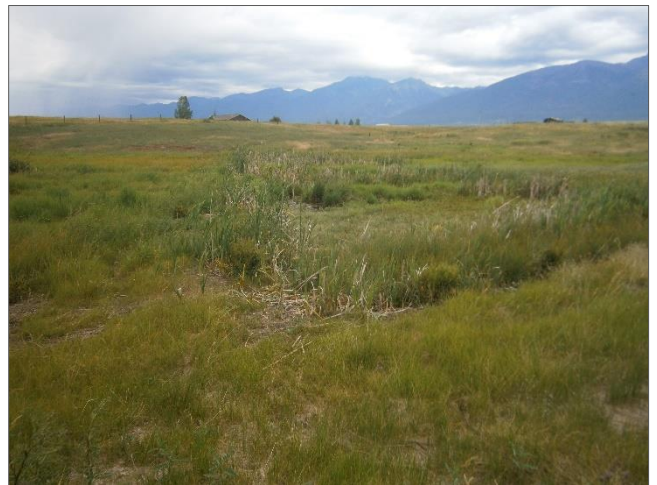
Photo Point: 8
Bearing: 34 degrees

Location: New crib structure.
Year: 2024

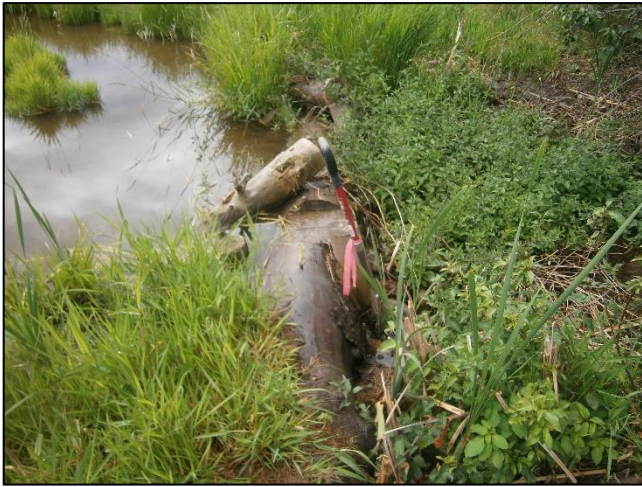
In May 2020, three log crib structures (i.e., log dams 1, 1A, 2, and 6) and earthen berms were installed, repaired, and replaced to improve water impoundment and increase wetland establishment across the site. In 2024, log dams 1 and 2 were failing as indicated by water flow underneath the structures. The failure of these two crib structures may be contributing to the minor decline in wetland acreage at this site. The structures will require repairs to function as intended.

Additional Photo 1. View of downstream log crib structure (log crib #1) facing south across the channel.

Specific recommendations for any additional corrective actions: Repairs are needed to the log crib structures repaired and installed in 2020 as part of adaptive management actions. Weed management by MDT continues within the site.

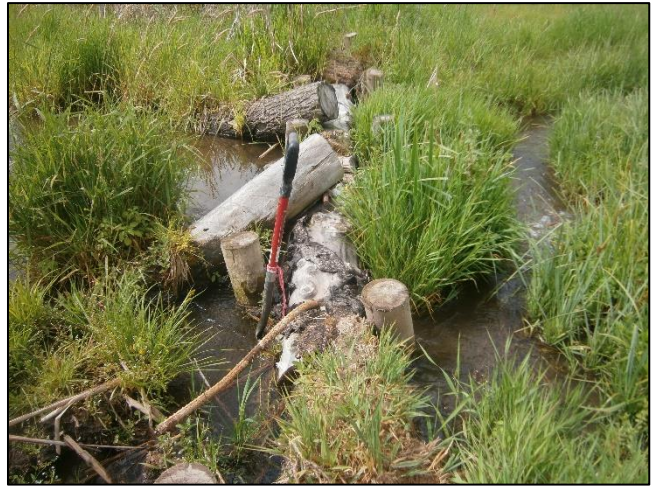
Crib repairs in 2020 aimed to improve effectiveness in lateral water flow. During the 2024 monitoring visit, water was flowing underneath the western and middle crib structures, indicating failure. Repairs will need to be made to failing structures to ensure functionality as intended.

Additional Photo 2. View of middle log crib structure (log crib #2) facing south across the channel.

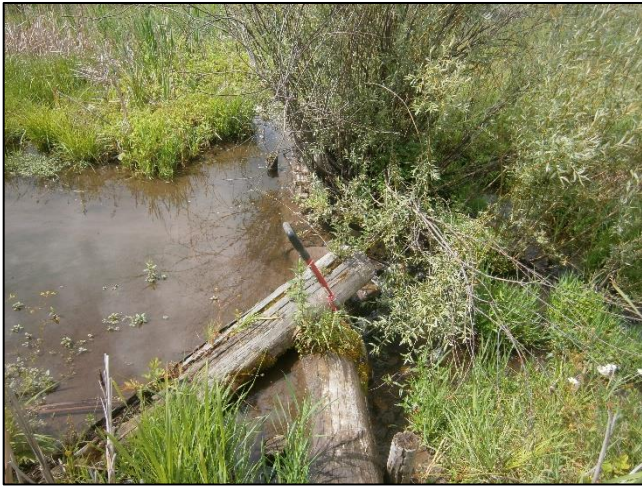
Additional Photo 3. View of upstream log crib structure (log crib #3) facing south across the channel.

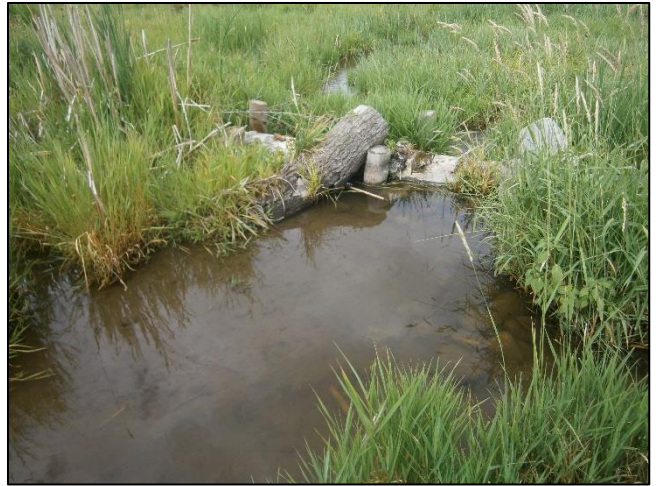
Additional Photo 4. Example photo of water movement at log crib structure (log crib #2) in the central portion of the project site.
