EASTON RANCH MITIGATION SITE

Project Overview

Monitoring Year: 2024

Monitoring Conducted By: Confluence Consulting Inc

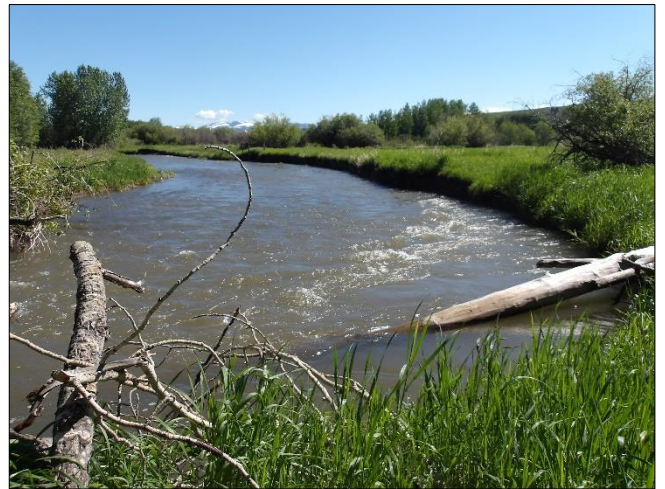
Photo Point: 4B
Bearing: 20 degrees

Location: Shields Bank US
Year: 2024 – 2021 location*

* new (2021) photo point location due to bank loss during high flows in 2018.

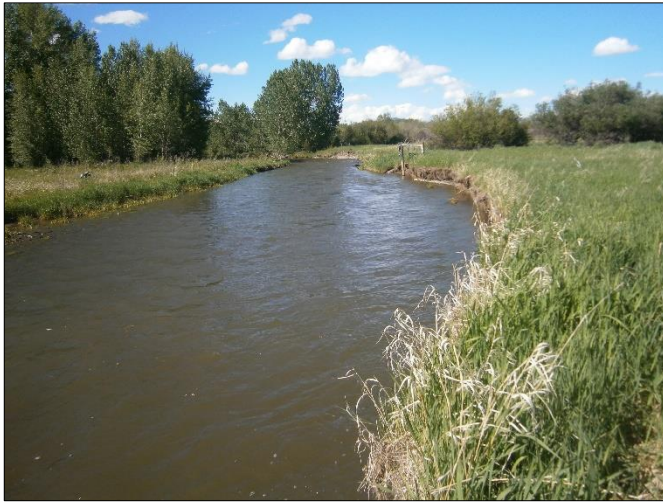
Stream Bank Stabilization – During the spring 2013 high-flow event, significant bank erosion occurred immediately upstream of PP4B. This erosion exposed the riprap and undermined the riprap and coir-wrapped soil lifts along an approximately 85-foot-long reconstructed bank, which caused significant loss of soil and willow cuttings. Photo point PP4B, located at the south end of the reconstructed bank, had to be relocated because of bank erosion and woody debris accumulation. Additional bank erosion has been noted since the dramatic lateral cutting event of 2013, and this bank section remains exposed and vulnerable. The 2018 runoff period was supported by above-average precipitation in June. From 2019 through 2024, bank erosion continued along the downstream (south) portion of the 85-foot-long bank and resulted in areas of undercutting and loss of finer textured subsoils. Photographs showing the bank erosion are provided in Appendix C.

Bank erosion was noted along the Shields River in the northwest portion of the project area. A few bird boxes (see wildlife section) need repair.

Additional Photo: bank erosion on Shields River
Year: 2024

Specific recommendations for any additional corrective actions: The MDT has an ongoing weed-control program and will continue weed treatments. Soil lifts and riprap installed along the bank of the Shields River in the northwestern corner of the site continue to erode. This bank area is generally dominated by shallow-rooting pasture grasses that provide little resistance to bank erosion. MDT will assess this bank erosion and discuss the potential need for adaptive management actions with the landowner and US Army Corps of Engineers. In addition, five bird boxes are broken or have fallen off their posts and need repair.
